# Asbestos Inspection Report

Forestry Commission

Warren Cottage, Lynford, Thetford

## Refurbishment Survey

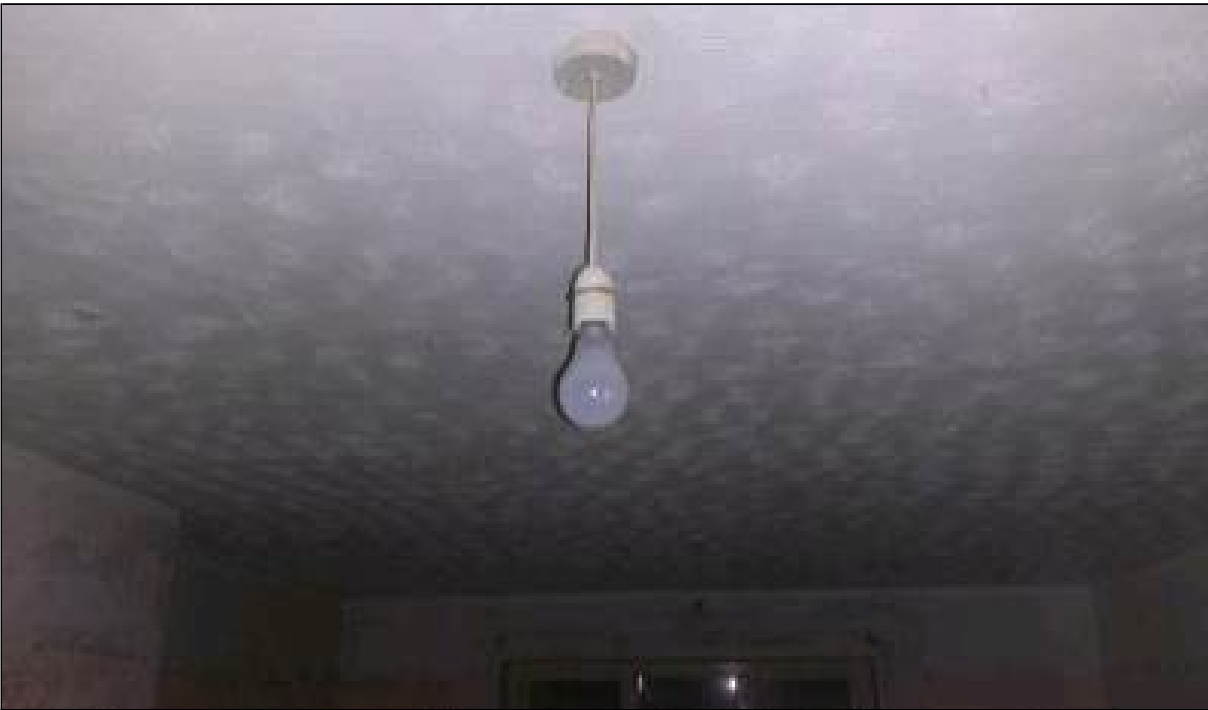
<b>SAMPLE REFERENCE</b>	AE003834	<b>ASBESTOS</b>	<b>YES</b>
<b>PRESUMPTION REFERENCE</b>	N/A	<b>RISK LEVEL</b>	VERY LOW RISK

<b>AREA</b>	Internal	<b>MATERIAL ASSESSMENT</b>	
<b>FLOOR</b>	Ground Floor	<b>PRODUCT TYPE</b>	1 - Decorative plaster
<b>UNIQUE ROOM IDENTIFIER</b>	Living room	<b>DAMAGE</b>	1 - Low Damage
<b>DESCRIPTION OF SAMPLE TAKEN OR PRESUMPTION</b>	textured coating to ceiling	<b>SURFACE TREATMENT</b>	1 - Surface Sealed
<b>EXTENT</b>	20 Sq. m	<b>ASBESTOS TYPE</b>	1 - Chrysotile
<b>ACCESSIBILITY</b>	Low	<b>MATERIAL ASSESSMENT SCORE</b>	4
<b>LEVEL OF IDENTIFICATION</b>	Sampled	<b>POTENTIAL TO RELEASE FIBRES</b>	Very Low Risk
<b>RECOMMENDATIONS</b> <b>C - Removal by Trained Operatives</b>		<b>COMMENTS</b> -

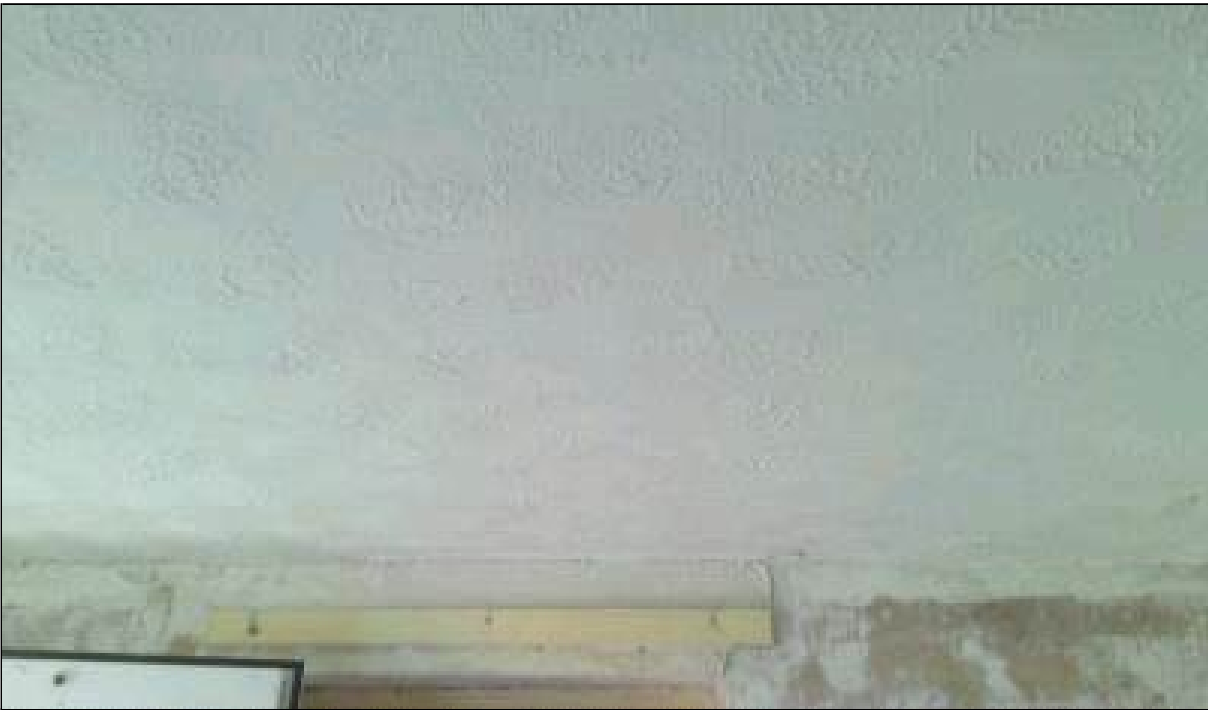
<b>SAMPLE REFERENCE</b>	Item No: 2	<b>ASBESTOS</b>	<b>YES</b>
<b>PRESUMPTION REFERENCE</b>	As Per AE003834	<b>RISK LEVEL</b>	VERY LOW RISK

<b>AREA</b>	Internal	<b>MATERIAL ASSESSMENT</b>	
<b>FLOOR</b>	Ground Floor	<b>PRODUCT TYPE</b>	1 - Decorative plaster
<b>UNIQUE ROOM IDENTIFIER</b>	Entrance Porch Hall	<b>DAMAGE</b>	1 - Low Damage
<b>DESCRIPTION OF SAMPLE TAKEN OR PRESUMPTION</b>	textured coating to ceiling	<b>SURFACE TREATMENT</b>	1 - Surface Sealed
<b>EXTENT</b>	5 Sq. m	<b>ASBESTOS TYPE</b>	1 - Chrysotile
<b>ACCESSIBILITY</b>	Low	<b>MATERIAL ASSESSMENT SCORE</b>	4
<b>LEVEL OF IDENTIFICATION</b>	Strongly Presumed	<b>POTENTIAL TO RELEASE FIBRES</b>	Very Low Risk
<b>RECOMMENDATIONS</b> <b>C - Removal by Trained Operatives</b>		<b>COMMENTS</b> As per AE003834

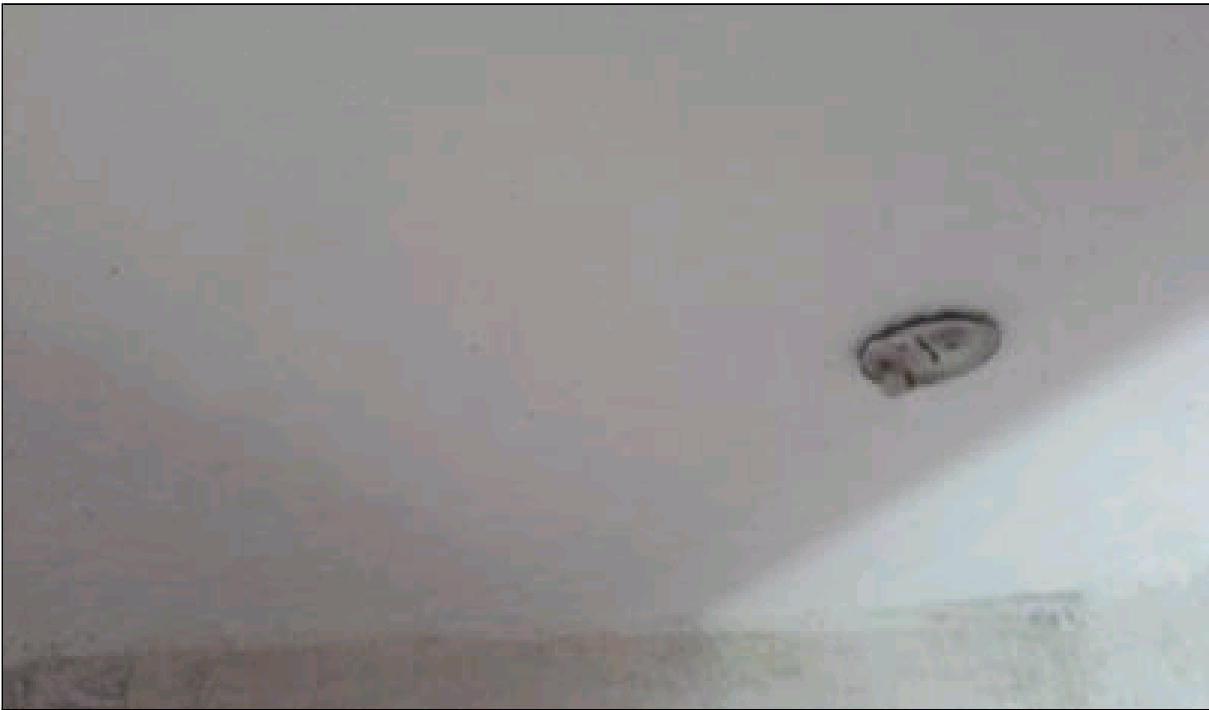
<b>SAMPLE REFERENCE</b>	AE003836	<b>ASBESTOS</b>	<b>YES</b>
<b>PRESUMPTION REFERENCE</b>	N/A	<b>RISK LEVEL</b>	VERY LOW RISK

<b>AREA</b>	Internal	<b>MATERIAL ASSESSMENT</b>	
<b>FLOOR</b>	Ground Floor	<b>PRODUCT TYPE</b>	1 - Decorative plaster
<b>UNIQUE ROOM IDENTIFIER</b>	Dinning Room	<b>DAMAGE</b>	1 - Low Damage
<b>DESCRIPTION OF SAMPLE TAKEN OR PRESUMPTION</b>	textured coating to ceiling	<b>SURFACE TREATMENT</b>	1 - Surface Sealed
<b>EXTENT</b>	12 Sq. m	<b>ASBESTOS TYPE</b>	1 - Chrysotile
<b>ACCESSIBILITY</b>	Low	<b>MATERIAL ASSESSMENT SCORE</b>	4
<b>LEVEL OF IDENTIFICATION</b>	Sampled	<b>POTENTIAL TO RELEASE FIBRES</b>	Very Low Risk
<b>RECOMMENDATIONS</b> <b>C - Removal by Trained Operatives</b>		<b>COMMENTS</b> -

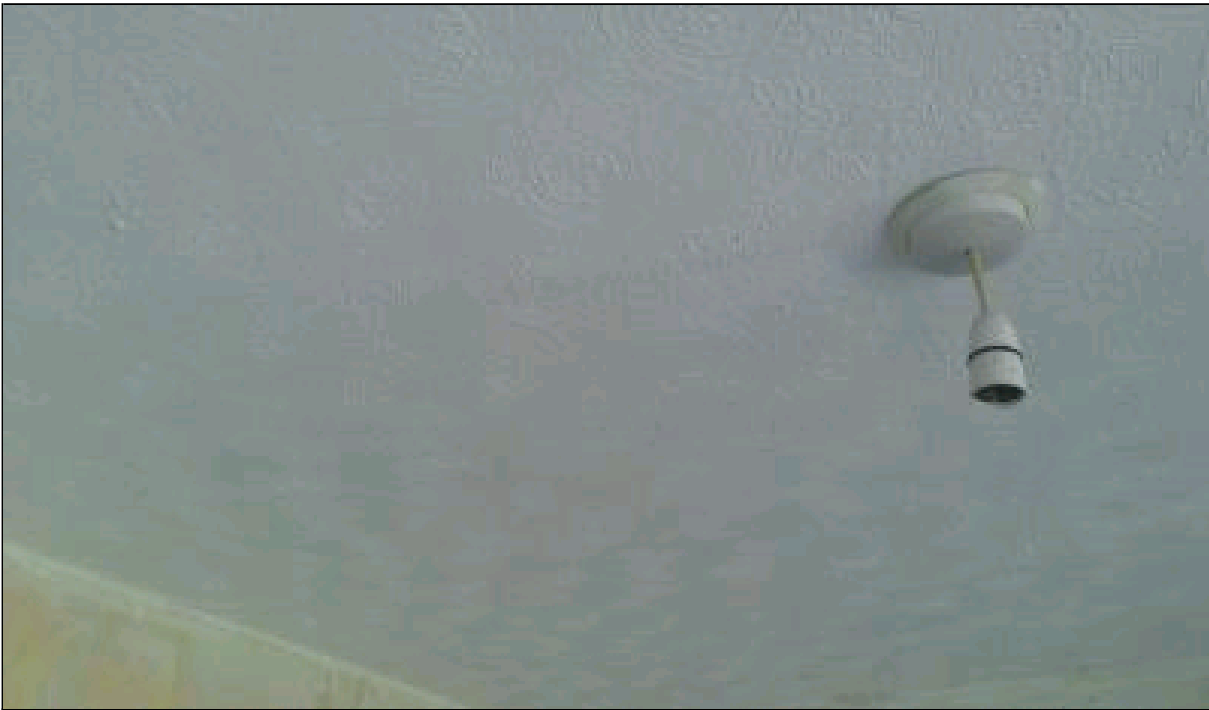
<b>SAMPLE REFERENCE</b>	AE003841	<b>ASBESTOS</b>	<b>YES</b>
<b>PRESUMPTION REFERENCE</b>	N/A	<b>RISK LEVEL</b>	VERY LOW RISK

<b>AREA</b>	Internal	<b>MATERIAL ASSESSMENT</b>	
<b>FLOOR</b>	1st Floor	<b>PRODUCT TYPE</b>	1 - Decorative plaster
<b>UNIQUE ROOM IDENTIFIER</b>	Bedroom 3 and Cpd	<b>DAMAGE</b>	1 - Low Damage
<b>DESCRIPTION OF SAMPLE TAKEN OR PRESUMPTION</b>	textured coating to ceiling	<b>SURFACE TREATMENT</b>	1 - Surface Sealed
<b>EXTENT</b>	8 Sq. m	<b>ASBESTOS TYPE</b>	1 - Chrysotile
<b>ACCESSIBILITY</b>	Low	<b>MATERIAL ASSESSMENT SCORE</b>	4
<b>LEVEL OF IDENTIFICATION</b>	Sampled	<b>POTENTIAL TO RELEASE FIBRES</b>	Very Low Risk
<b>RECOMMENDATIONS</b> <b>C - Removal by Trained Operatives</b>		<b>COMMENTS</b> -

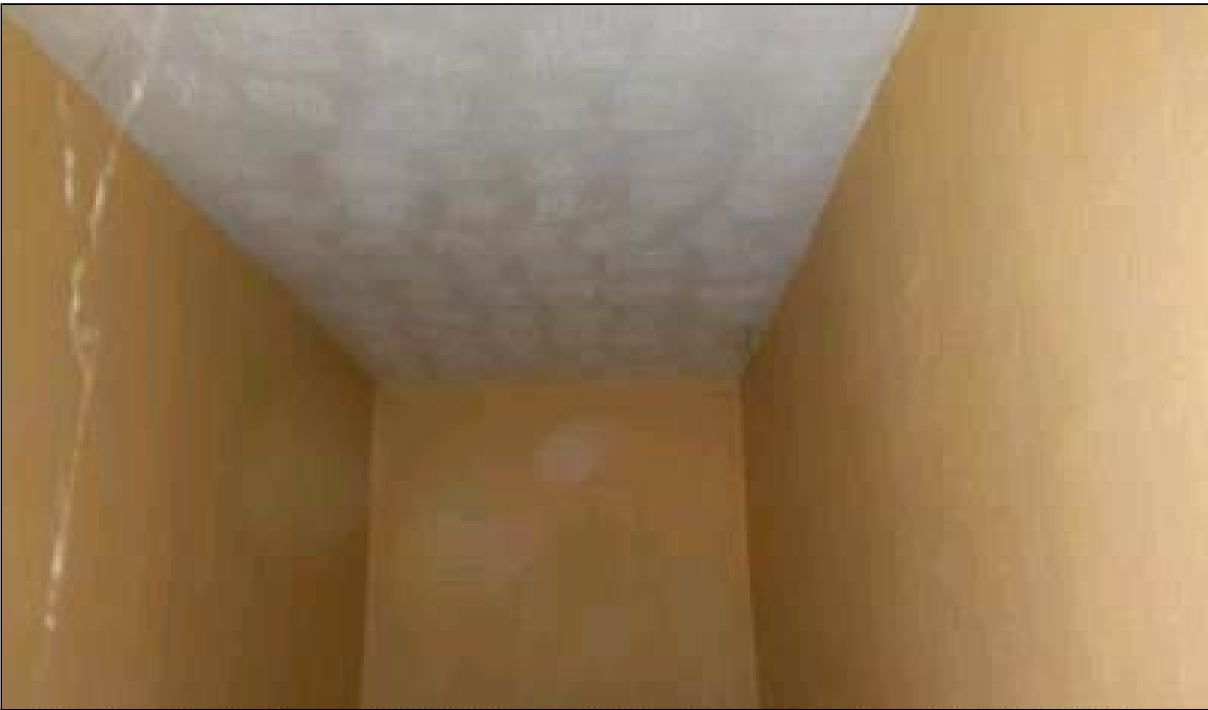
<b>SAMPLE REFERENCE</b>	Item No: 23	<b>ASBESTOS</b>	<b>YES</b>
<b>PRESUMPTION REFERENCE</b>	As Per AE003841	<b>RISK LEVEL</b>	VERY LOW RISK

<b>AREA</b>	Internal	<b>MATERIAL ASSESSMENT</b>	
<b>FLOOR</b>	1st Floor	<b>PRODUCT TYPE</b>	1 - Decorative plaster
<b>UNIQUE ROOM IDENTIFIER</b>	Landing	<b>DAMAGE</b>	1 - Low Damage
<b>DESCRIPTION OF SAMPLE TAKEN OR PRESUMPTION</b>	textured coating to ceiling	<b>SURFACE TREATMENT</b>	1 - Surface Sealed
<b>EXTENT</b>	6 Sq. m	<b>ASBESTOS TYPE</b>	1 - Chrysotile
<b>ACCESSIBILITY</b>	Low	<b>MATERIAL ASSESSMENT SCORE</b>	4
<b>LEVEL OF IDENTIFICATION</b>	Strongly Presumed	<b>POTENTIAL TO RELEASE FIBRES</b>	Very Low Risk
<b>RECOMMENDATIONS</b> <b>C - Removal by Trained Operatives</b>		<b>COMMENTS</b> As per AE003841

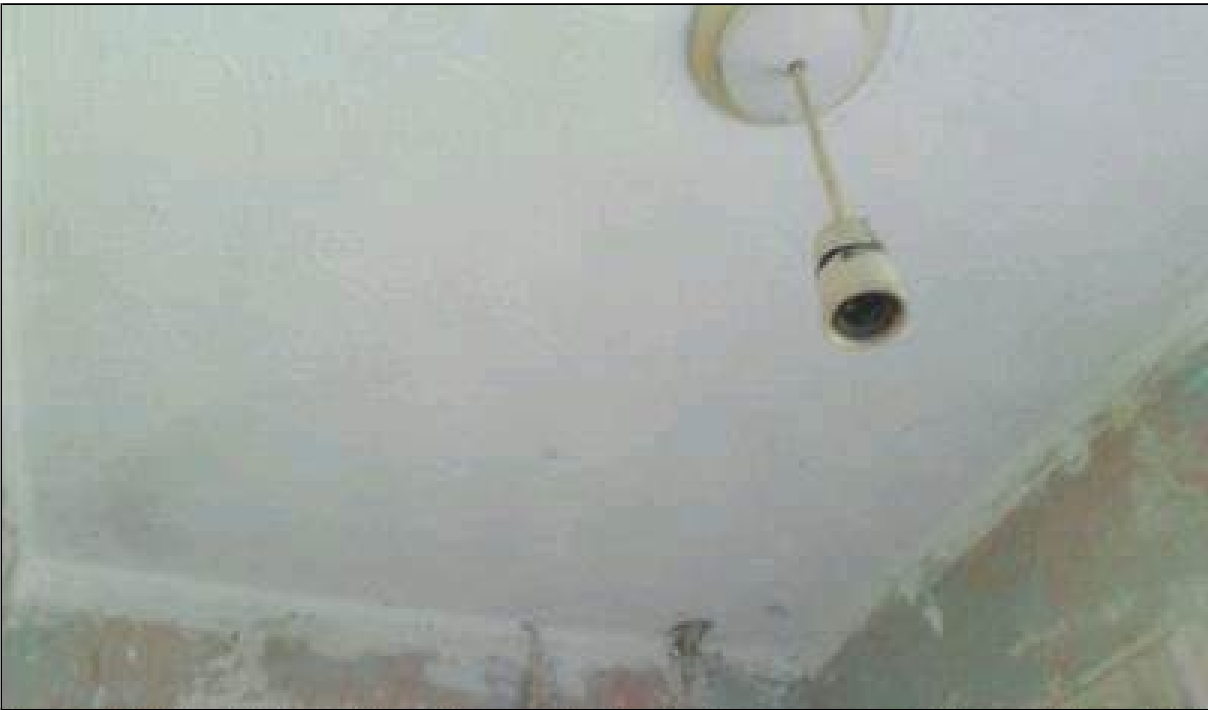
<b>SAMPLE REFERENCE</b>	Item No: 23	<b>ASBESTOS</b>	<b>YES</b>
<b>PRESUMPTION REFERENCE</b>	As Per AE003841	<b>RISK LEVEL</b>	VERY LOW RISK

<b>AREA</b>	Internal	<b>MATERIAL ASSESSMENT</b>	
<b>FLOOR</b>	1st Floor	<b>PRODUCT TYPE</b>	1 - Decorative plaster
<b>UNIQUE ROOM IDENTIFIER</b>	WC 2	<b>DAMAGE</b>	1 - Low Damage
<b>DESCRIPTION OF SAMPLE TAKEN OR PRESUMPTION</b>	textured coating to ceiling	<b>SURFACE TREATMENT</b>	1 - Surface Sealed
<b>EXTENT</b>	2 Sq. m	<b>ASBESTOS TYPE</b>	1 - Chrysotile
<b>ACCESSIBILITY</b>	Low	<b>MATERIAL ASSESSMENT SCORE</b>	4
<b>LEVEL OF IDENTIFICATION</b>	Strongly Presumed	<b>POTENTIAL TO RELEASE FIBRES</b>	Very Low Risk
<b>RECOMMENDATIONS</b> <b>C - Removal by Trained Operatives</b>		<b>COMMENTS</b> As per AE003841

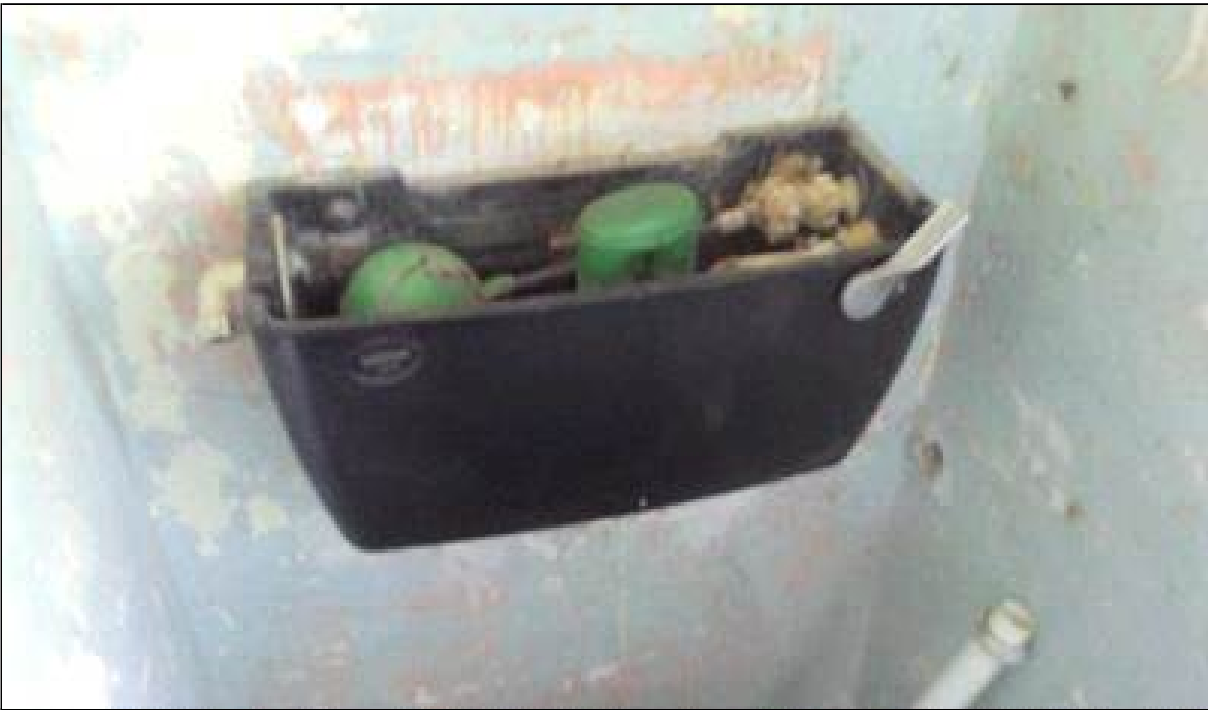
<b>SAMPLE REFERENCE</b>	AE003842	<b>ASBESTOS</b>	<b>YES</b>
<b>PRESUMPTION REFERENCE</b>	N/A	<b>RISK LEVEL</b>	VERY LOW RISK

<b>AREA</b>	Internal	<b>MATERIAL ASSESSMENT</b>	
<b>FLOOR</b>	1st Floor	<b>PRODUCT TYPE</b>	1 - Composite
<b>UNIQUE ROOM IDENTIFIER</b>	WC 2	<b>DAMAGE</b>	1 - Low Damage
<b>DESCRIPTION OF SAMPLE TAKEN OR PRESUMPTION</b>	cistern	<b>SURFACE TREATMENT</b>	0 - Completely Sealed
<b>EXTENT</b>	1no.	<b>ASBESTOS TYPE</b>	2 - Amosite
<b>ACCESSIBILITY</b>	Low	<b>MATERIAL ASSESSMENT SCORE</b>	4
<b>LEVEL OF IDENTIFICATION</b>	Sampled	<b>POTENTIAL TO RELEASE FIBRES</b>	Very Low Risk
<b>RECOMMENDATIONS</b> <b>C - Removal by Trained Operatives</b>		<b>COMMENTS</b> -

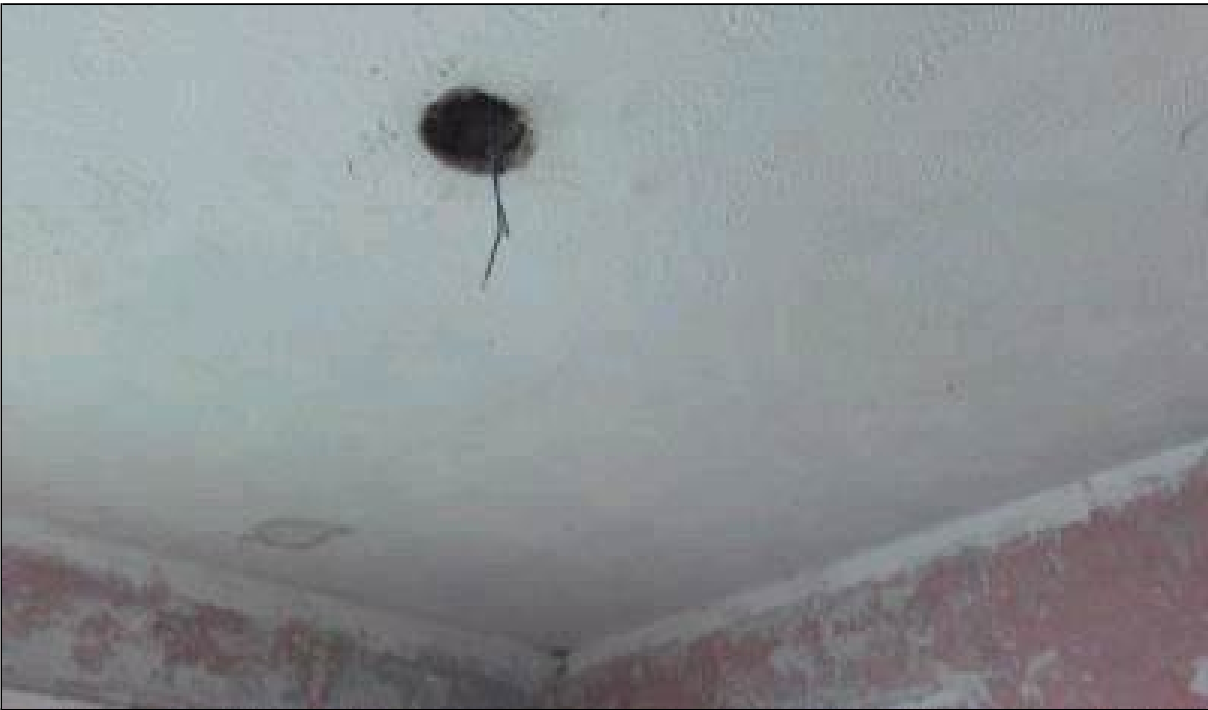
<b>SAMPLE REFERENCE</b>	Item No: 23	<b>ASBESTOS</b>	<b>YES</b>
<b>PRESUMPTION REFERENCE</b>	As Per AE003841	<b>RISK LEVEL</b>	VERY LOW RISK

<b>AREA</b>	Internal	<b>MATERIAL ASSESSMENT</b>	
<b>FLOOR</b>	1st Floor	<b>PRODUCT TYPE</b>	1 - Decorative plaster
<b>UNIQUE ROOM IDENTIFIER</b>	Bathroom	<b>DAMAGE</b>	1 - Low Damage
<b>DESCRIPTION OF SAMPLE TAKEN OR PRESUMPTION</b>	textured coating to ceiling	<b>SURFACE TREATMENT</b>	1 - Surface Sealed
<b>EXTENT</b>	6 Sq. m	<b>ASBESTOS TYPE</b>	1 - Chrysotile
<b>ACCESSIBILITY</b>	Low	<b>MATERIAL ASSESSMENT SCORE</b>	4
<b>LEVEL OF IDENTIFICATION</b>	Strongly Presumed	<b>POTENTIAL TO RELEASE FIBRES</b>	Very Low Risk
<b>RECOMMENDATIONS</b> <b>C - Removal by Trained Operatives</b>		<b>COMMENTS</b> As per AE003841

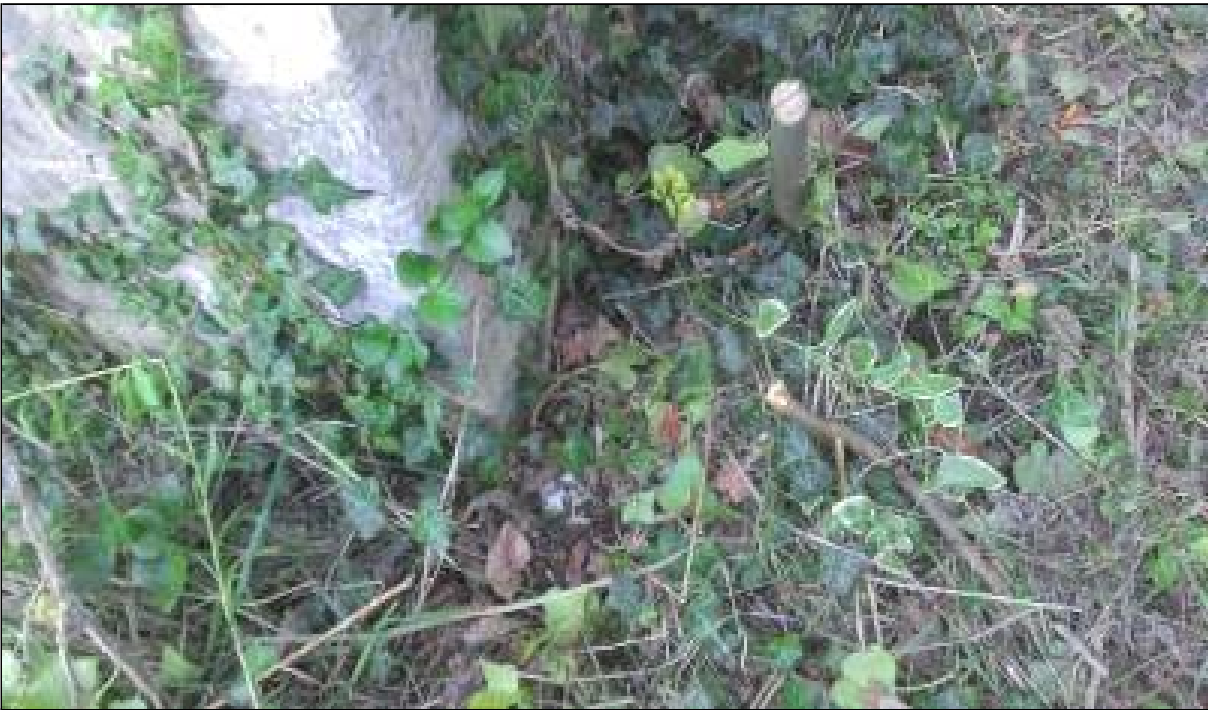
<b>SAMPLE REFERENCE</b>	AE003846	<b>ASBESTOS</b>	<b>YES</b>
<b>PRESUMPTION REFERENCE</b>	N/A	<b>RISK LEVEL</b>	VERY LOW RISK

<b>AREA</b>	External	<b>MATERIAL ASSESSMENT</b>	
<b>FLOOR</b>	External	<b>PRODUCT TYPE</b>	1 - Bitumen product
<b>UNIQUE ROOM IDENTIFIER</b>	External	<b>DAMAGE</b>	1 - Low Damage
<b>DESCRIPTION OF SAMPLE TAKEN OR PRESUMPTION</b>	damp proof course	<b>SURFACE TREATMENT</b>	0 - Completely Sealed
<b>EXTENT</b>	Throughout	<b>ASBESTOS TYPE</b>	1 - Chrysotile
<b>ACCESSIBILITY</b>	Low	<b>MATERIAL ASSESSMENT SCORE</b>	3
<b>LEVEL OF IDENTIFICATION</b>	Sampled	<b>POTENTIAL TO RELEASE FIBRES</b>	Very Low Risk
<b>RECOMMENDATIONS</b> <b>C - Removal by Trained Operatives</b>		<b>COMMENTS</b> -

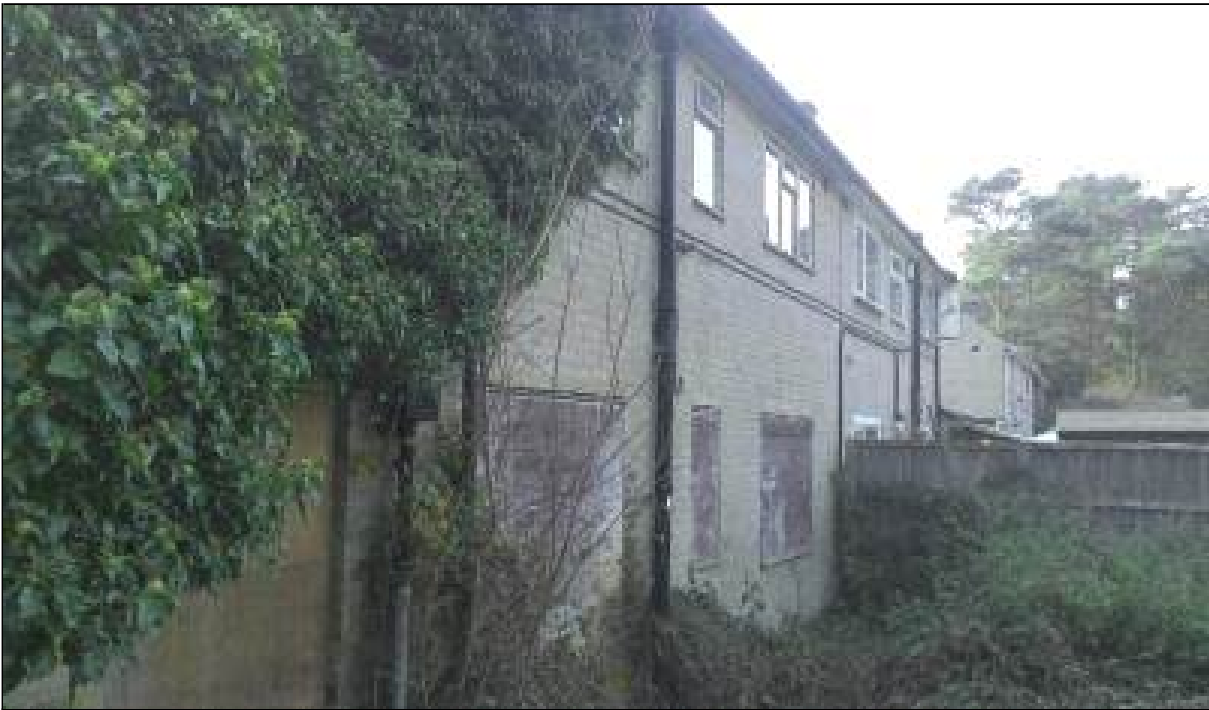
<b>SAMPLE REFERENCE</b>	AE003847	<b>ASBESTOS</b>	<b>YES</b>
<b>PRESUMPTION REFERENCE</b>	N/A	<b>RISK LEVEL</b>	VERY LOW RISK

<b>AREA</b>	External	<b>MATERIAL ASSESSMENT</b>	
<b>FLOOR</b>	External	<b>PRODUCT TYPE</b>	1 - Cement product
<b>UNIQUE ROOM IDENTIFIER</b>	External	<b>DAMAGE</b>	1 - Low Damage
<b>DESCRIPTION OF SAMPLE TAKEN OR PRESUMPTION</b>	cement pipe	<b>SURFACE TREATMENT</b>	1 - Surface Sealed
<b>EXTENT</b>	10 linear metres	<b>ASBESTOS TYPE</b>	1 - Chrysotile
<b>ACCESSIBILITY</b>	Low	<b>MATERIAL ASSESSMENT SCORE</b>	4
<b>LEVEL OF IDENTIFICATION</b>	Sampled	<b>POTENTIAL TO RELEASE FIBRES</b>	Very Low Risk
<b>RECOMMENDATIONS</b> <b>C - Removal by Trained Operatives</b>		<b>COMMENTS</b> -
