ASBESTOS SURVEY REPORT

Management Survey with part Refurbishment/Demolition (MA only)

Report Number	Issue Number	Issue Date	
J025489	1	6 Nov 2017	
Site Address		UPRN	
Park House, Stamford Street, Glenfield, Leicester, LE3 8DL		N/A	
Scope of Survey			
Refurbishment survey to area where stair lift is to be installed, Management survey to all other locations			
Client Specific Requirements			
N/A

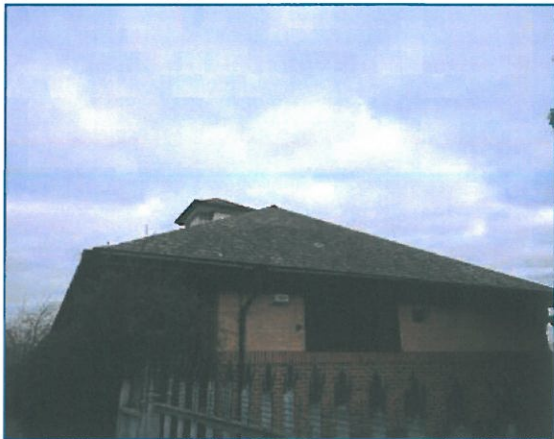
Room Code	Designation/Block	Floor	Ref no.		
E.01	Parish council offices	External	028 - Presumed		
Location	Description	Position	Quantity		
External areas	Cement Tile	Roof	Throughout		
Material Assessment Algorithm					
A-Product Type	B-Extent of Damage	C-Surface Treatment	D-Asbestos Type	Material Score (A+B+C+D)	Potential to Release Fibres
Asbestos Cement (1)	Good Condition(0)	Surface Sealed(1)	Crocidolite (or unknown) (3)	5	Low
Accessibility	Usually inaccessible or unlikely to be disturbed		Action Priority	Longer term	
Photo Ref:	28		Discussion & Recommended Action (in accordance with CAR 2012)

Management Action		
			No action required. Inspect at regular intervals and consider labelling if not already labelled		
			Additional Comments		
			Not applicable		
Who can work with / remove this material		Non-Licensed Materials		Recommended re-inspection in:	
				12 months
