## **Series 9000 Drainage CCTV**

Appendix 90/1      Coded Inspection Report Example

**Project Name**  
DFDE453 Highgate Depot

## Section Inspection - 18/10/2018 - ND074/0235X

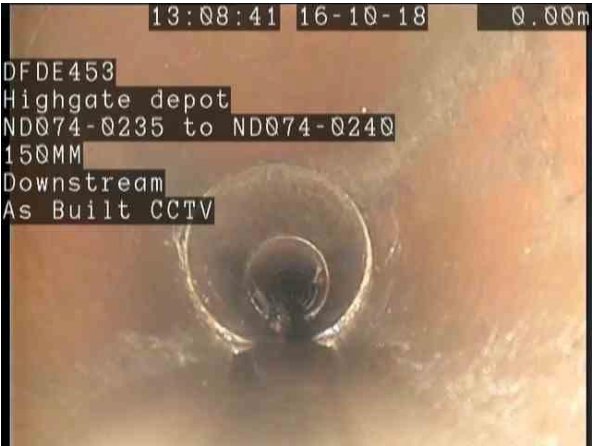
ND074\_0235X\_d34c0cfe-c749-452b-aec0-eca12172fd0a\_20181018\_194939\_249.jpg, 00:00:00, 0.00 m

Start node type, catchpit, reference number: ND074/0235

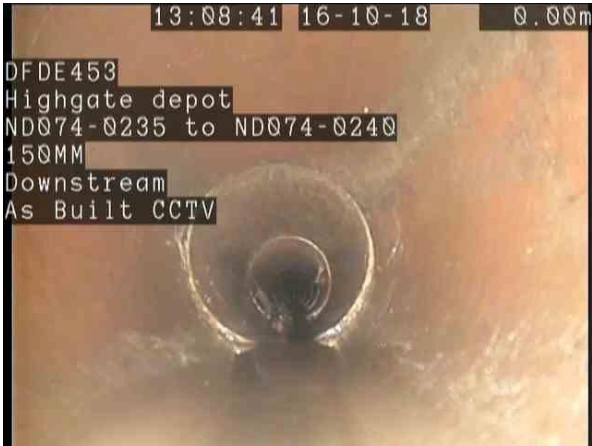
ND074\_0235X\_a38f08cf-8160-4cb4-9b8b-32d74a556471\_20181018\_194945\_087.jpg, 00:00:00, 0.00 m

Water level, 5% of the vertical dimension

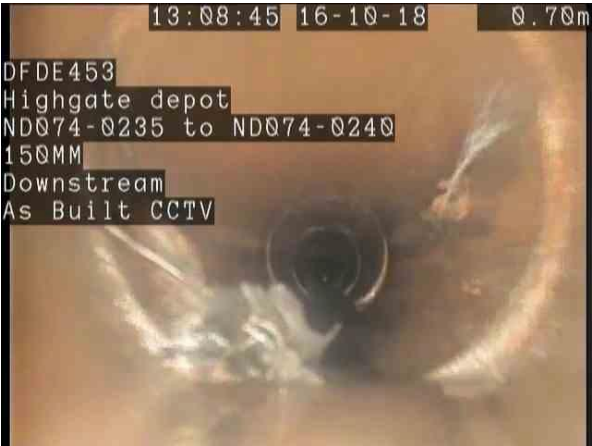
ND074\_0235X\_0e635ae4-788c-4101-af9a-b027c6558970\_20181018\_194959\_477.jpg, 00:00:03, 0.70 m

<table><tr><th>Position [m]</th><th>Code</th><th>Observation</th><th>Grade</th></tr><tr><td>0.70</td><td>RFJ</td><td>Roots, fine at joint</td><td>2</td></tr></table>

Roots, fine at joint

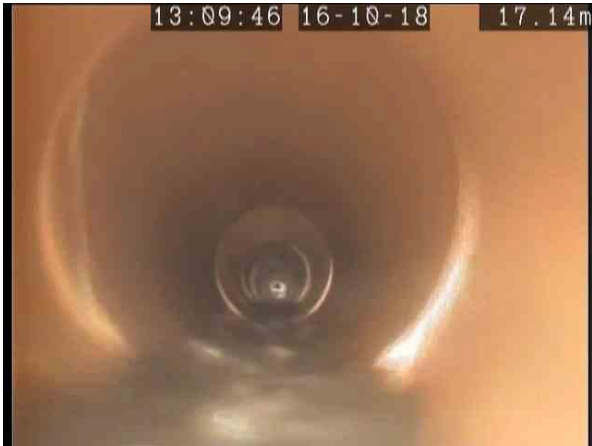
ND074\_0235X\_163291e0-75ac-48ef-95a2-2527c8609293\_20181018\_195117\_299.jpg, 00:01:05, 17.14 m

<table><tr><th>Position [m]</th><th>Code</th><th>Observation</th><th>Grade</th></tr><tr><td>17.14</td><td>FCJ</td><td>Fracture, circumferential at joint from 8 o'clock to 10 o'clock</td><td>3</td></tr></table>

Fracture, circumferential at joint from 8 o'clock to 10 o'clock
