## ASBESTOS REFURBISHMENT SURVEY

RYDE ST THOMAS SQUARE - 6623

St Thomas Square  
Ryde  
PO33 2PL

Date of Survey: 6 Jun 2023

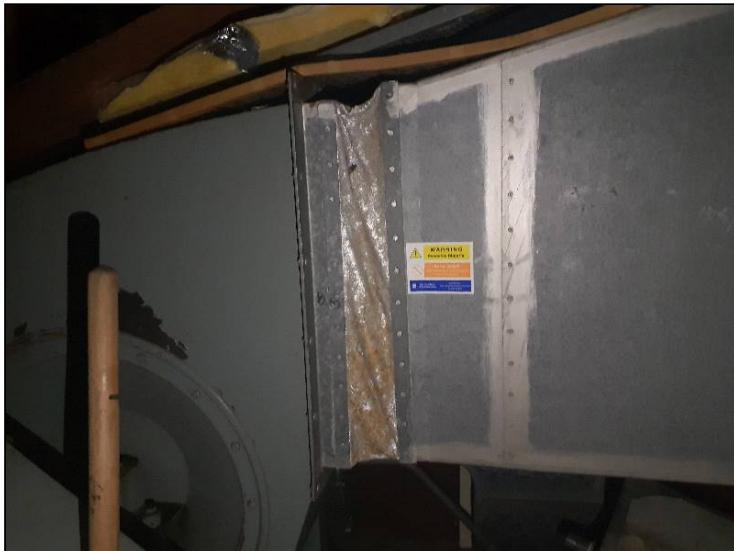
Item No:	1
Site:	RYDE ST THOMAS SQUARE - 6623, St Thomas Square, Ryde, PO33 2PL
Survey Type:	Refurbishment Survey
Surveyor:	Scott Thomas
Survey Date:	6 Jun 2023
Building:	6623 Ryde
Floor:	1st Floor
Area:	Loft tank room 101
Item Description:	Compression gasket to ducting
Approximate Quantity:	1lm
Analysed By and Date:	Andrew West 12/06/2023
Sample No and Type (S,SP, P, As):	FR000278 (S)
Product Type:	Asbestos Textiles/Paper (2)
Extent of Damage/Deterioration:	Low Damage (1)
Surface Treatment:	Unsealed (2)
Asbestos Type	Chrysotile (1)
Material Score:	6

Comments:	Remove if within scope of works
Recommendation:	Remove
Action Date	Not Applicable

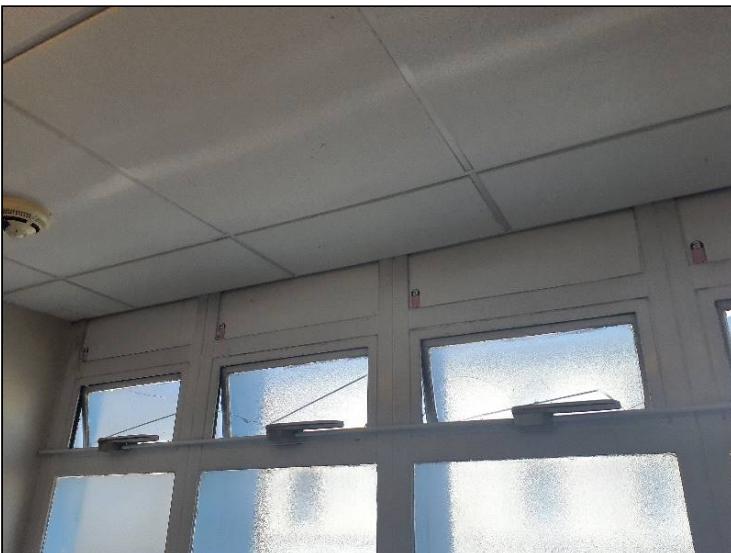
Item No:	3
Site:	RYDE ST THOMAS SQUARE - 6623, St Thomas Square, Ryde, PO33 2PL
Survey Type:	Refurbishment Survey
Surveyor:	Scott Thomas
Survey Date:	6 Jun 2023
Building:	6623 Ryde
Floor:	1st Floor
Area:	Rest room 102
Item Description:	Insulating board panels above window
Approximate Quantity:	2m <sup>2</sup>
Analysed By and Date:	Andrew West 12/06/2023
Sample No and Type (S,SP, P, As):	FR000279 (S)
Product Type:	Asbestos Insulating Board (2)
Extent of Damage/Deterioration:	Good Condition (0)
Surface Treatment:	Surface Sealed (1)
Asbestos Type	Amosite (2)
Material Score:	5

Comments:	Remove if within scope of works
Recommendation:	Remove
Action Date	Not Applicable

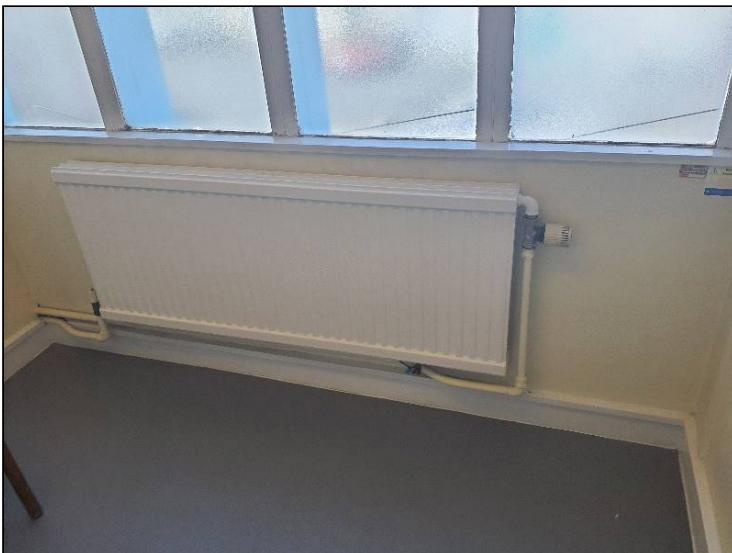
Item No:	4
Site:	RYDE ST THOMAS SQUARE - 6623, St Thomas Square, Ryde, PO33 2PL
Survey Type:	Refurbishment Survey
Surveyor:	Scott Thomas
Survey Date:	6 Jun 2023
Building:	6623 Ryde
Floor:	1st Floor
Area:	Rest room 102
Item Description:	Insulating board panels below window
Approximate Quantity:	2m <sup>2</sup>
Analysed By and Date:	Andrew West 12/06/2023
Sample No and Type (S,SP, P, As):	FR000280 (S)
Product Type:	Asbestos Insulating Board (2)
Extent of Damage/Deterioration:	Good Condition (0)
Surface Treatment:	Surface Sealed (1)
Asbestos Type	Chrysotile + Amosite (2)
Material Score:	5

Comments:	Remove if within scope of works
Recommendation:	Remove
Action Date	Not Applicable

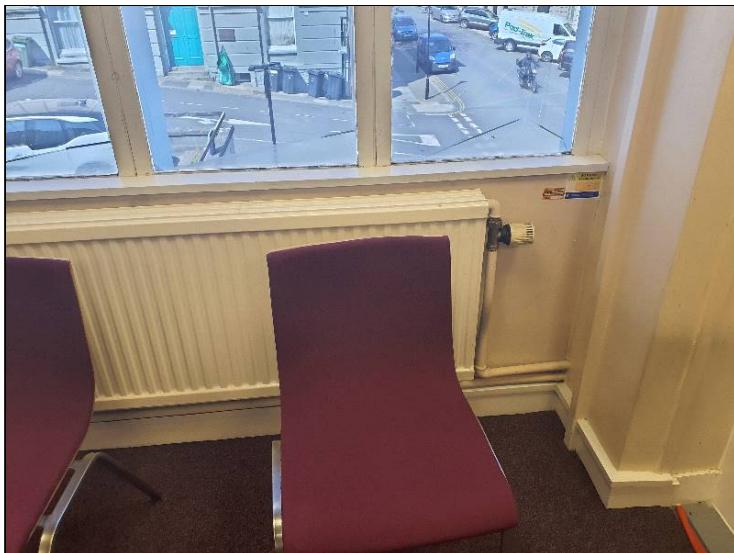
Item No:	7
Site:	RYDE ST THOMAS SQUARE - 6623, St Thomas Square, Ryde, PO33 2PL
Survey Type:	Refurbishment Survey
Surveyor:	Scott Thomas
Survey Date:	6 Jun 2023
Building:	6623 Ryde
Floor:	1st Floor
Area:	Staff room 104
Item Description:	Insulating board panels below window
Approximate Quantity:	2m <sup>2</sup>
Analysed By and Date:	N/A
Sample No and Type (S,SP, P, As):	As FR000280 (SP)
Product Type:	Asbestos Insulating Board (2)
Extent of Damage/Deterioration:	Good Condition (0)
Surface Treatment:	Surface Sealed (1)
Asbestos Type	Chrysotile + Amosite (2)
Material Score:	5

Comments:	Remove if within scope of works
Recommendation:	Remove
Action Date	Not Applicable

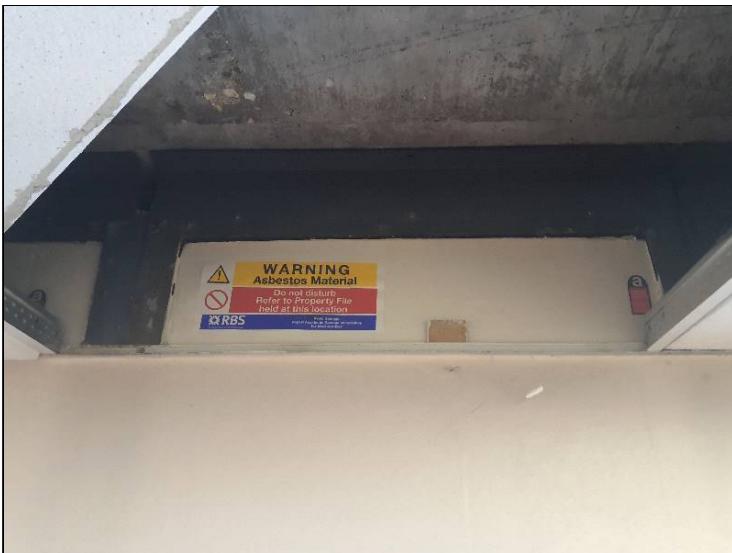
Item No:	8
Site:	RYDE ST THOMAS SQUARE - 6623, St Thomas Square, Ryde, PO33 2PL
Survey Type:	Refurbishment Survey
Surveyor:	Scott Thomas
Survey Date:	6 Jun 2023
Building:	6623 Ryde
Floor:	1st Floor
Area:	Staff room 104
Item Description:	Insulating board panels above window in ceiling void
Approximate Quantity:	2m <sup>2</sup>
Analysed By and Date:	N/A
Sample No and Type (S,SP, P, As):	As FR000279 (SP)
Product Type:	Asbestos Insulating Board (2)
Extent of Damage/Deterioration:	Good Condition (0)
Surface Treatment:	Surface Sealed (1)
Asbestos Type	Amosite (2)
Material Score:	5

Comments:	Remove if within scope of works
Recommendation:	Remove
Action Date	Not Applicable

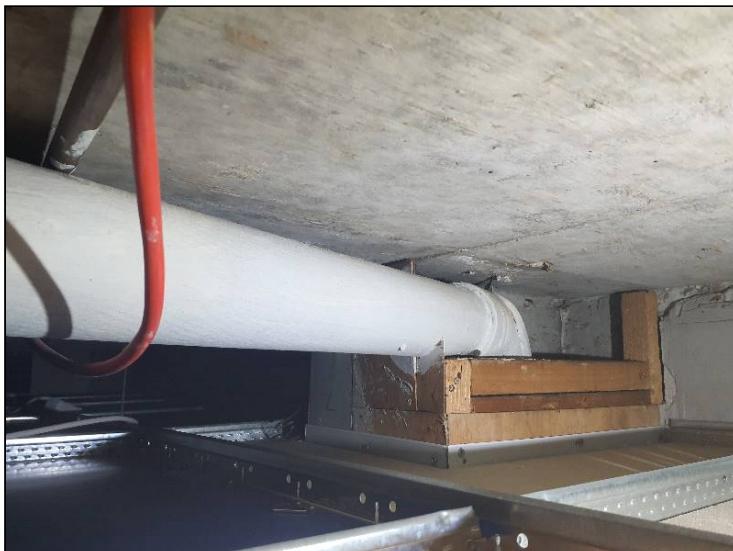
Item No:	9
Site:	RYDE ST THOMAS SQUARE - 6623, St Thomas Square, Ryde, PO33 2PL
Survey Type:	Refurbishment Survey
Surveyor:	Scott Thomas
Survey Date:	6 Jun 2023
Building:	6623 Ryde
Floor:	1st Floor
Area:	Staff room 104
Item Description:	Flue pipe in ceiling void
Approximate Quantity:	5m
Analysed By and Date:	Andrew West 12/06/2023
Sample No and Type (S,SP, P, As):	FR000281 (S)
Product Type:	Asbestos Cement (1)
Extent of Damage/Deterioration:	Good Condition (0)
Surface Treatment:	Surface Sealed (1)
Asbestos Type	Chrysotile (1)
Material Score:	3

Comments:	Remove if within scope of works
Recommendation:	Remove
Action Date	Not Applicable

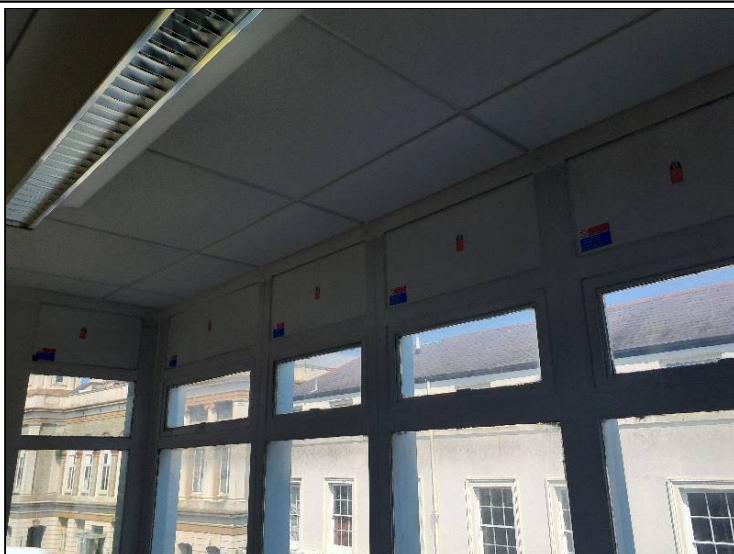
Item No:	10
Site:	RYDE ST THOMAS SQUARE - 6623, St Thomas Square, Ryde, PO33 2PL
Survey Type:	Refurbishment Survey
Surveyor:	Scott Thomas
Survey Date:	6 Jun 2023
Building:	6623 Ryde
Floor:	1st Floor
Area:	Office 105
Item Description:	Insulating board panels above window
Approximate Quantity:	4m <sup>2</sup>
Analysed By and Date:	N/A
Sample No and Type (S,SP, P, As):	As FR000279 (SP)
Product Type:	Asbestos Insulating Board (2)
Extent of Damage/Deterioration:	Good Condition (0)
Surface Treatment:	Surface Sealed (1)
Asbestos Type	Amosite (2)
Material Score:	5

Comments:	Remove if within scope of works
Recommendation:	Remove
Action Date	Not Applicable

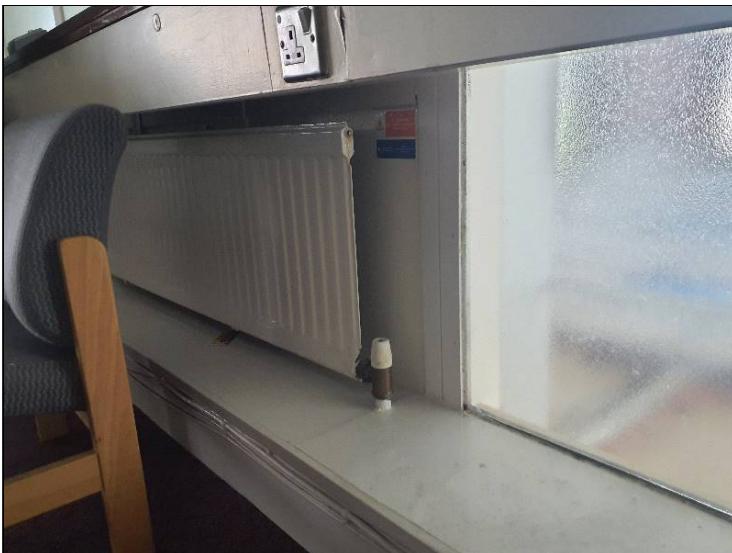
Item No:	11
Site:	RYDE ST THOMAS SQUARE - 6623, St Thomas Square, Ryde, PO33 2PL
Survey Type:	Refurbishment Survey
Surveyor:	Scott Thomas
Survey Date:	6 Jun 2023
Building:	6623 Ryde
Floor:	1st Floor
Area:	Office 105
Item Description:	Insulating board panels behind radiators to bay window and partition to void above banking hall
Approximate Quantity:	10m <sup>2</sup>
Analysed By and Date:	N/A
Sample No and Type (S,SP, P, As):	As FR000280 (SP)
Product Type:	Asbestos Insulating Board (2)
Extent of Damage/Deterioration:	Good Condition (0)
Surface Treatment:	Surface Sealed (1)
Asbestos Type	Chrysotile + Amosite (2)
Material Score:	5

Comments:	Remove if within scope of works
Recommendation:	Remove
Action Date	Not Applicable

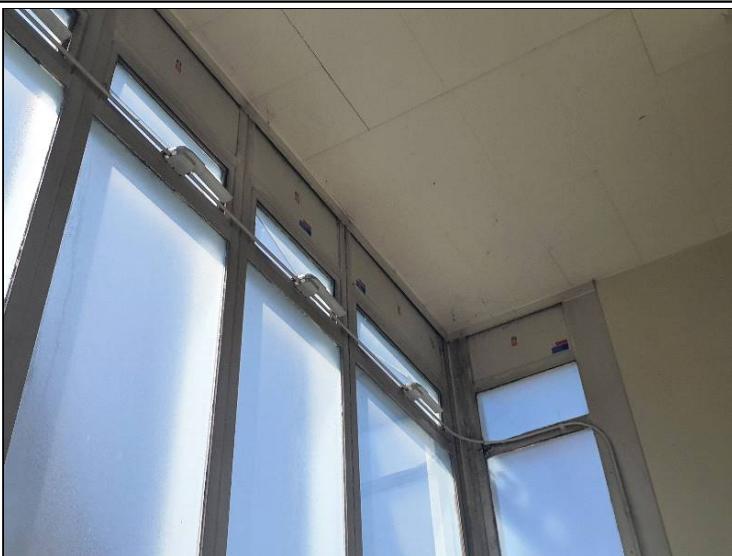
Item No:	15
Site:	RYDE ST THOMAS SQUARE - 6623, St Thomas Square, Ryde, PO33 2PL
Survey Type:	Refurbishment Survey
Surveyor:	Scott Thomas
Survey Date:	6 Jun 2023
Building:	6623 Ryde
Floor:	1st Floor
Area:	Stairs to ground 106
Item Description:	Insulating board panels above windows
Approximate Quantity:	3m <sup>2</sup>
Analysed By and Date:	N/A
Sample No and Type (S,SP, P, As):	As FR000279 (SP)
Product Type:	Asbestos Insulating Board (2)
Extent of Damage/Deterioration:	Good Condition (0)
Surface Treatment:	Surface Sealed (1)
Asbestos Type	Amosite (2)
Material Score:	5

Comments:	Remove if within scope of works
Recommendation:	Remove
Action Date	Not Applicable

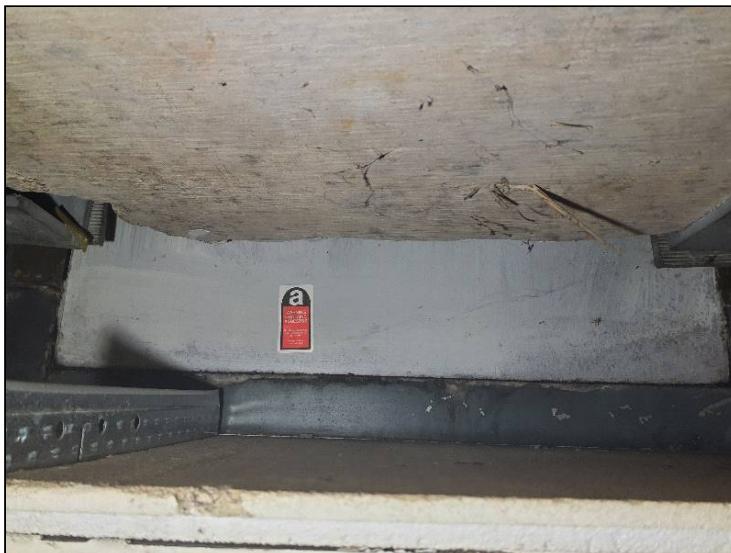
Item No:	26
Site:	RYDE ST THOMAS SQUARE - 6623, St Thomas Square, Ryde, PO33 2PL
Survey Type:	Refurbishment Survey
Surveyor:	Scott Thomas
Survey Date:	6 Jun 2023
Building:	6623 Ryde
Floor:	Ground Floor
Area:	Cashiers and back office G02
Item Description:	Insulating board panels above windows in ceiling void
Approximate Quantity:	4m <sup>2</sup>
Analysed By and Date:	Andrew West 12/06/2023
Sample No and Type (S,SP, P, As):	FR000282 (S)
Product Type:	Asbestos Insulating Board (2)
Extent of Damage/Deterioration:	Good Condition (0)
Surface Treatment:	Surface Sealed (1)
Asbestos Type	Chrysotile + Amosite (2)
Material Score:	5

Comments:	Remove if within scope of works
Recommendation:	Remove
Action Date	Not Applicable

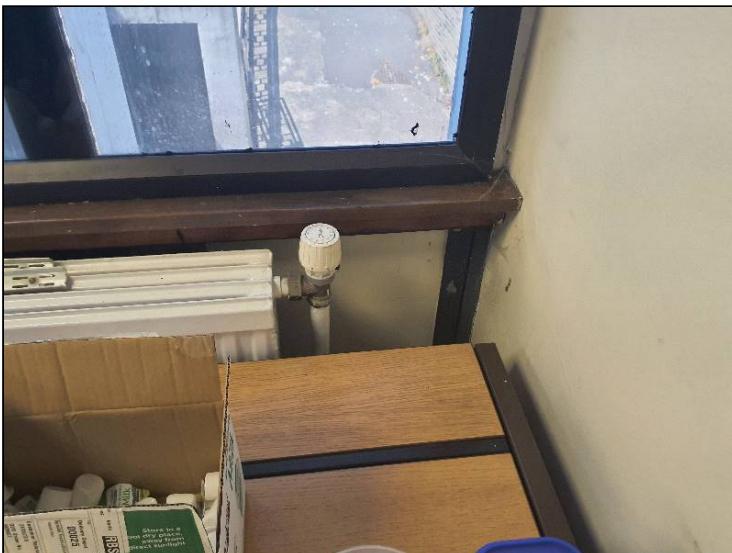
Item No:	27
Site:	RYDE ST THOMAS SQUARE - 6623, St Thomas Square, Ryde, PO33 2PL
Survey Type:	Refurbishment Survey
Surveyor:	Scott Thomas
Survey Date:	6 Jun 2023
Building:	6623 Ryde
Floor:	Ground Floor
Area:	Cashiers and back office G02
Item Description:	Insulating board panel below window
Approximate Quantity:	2m <sup>2</sup>
Analysed By and Date:	Andrew West 12/06/2023
Sample No and Type (S,SP, P, As):	FR000283 (S)
Product Type:	Asbestos Insulating Board (2)
Extent of Damage/Deterioration:	Good Condition (0)
Surface Treatment:	Surface Sealed (1)
Asbestos Type	Chrysotile (1)
Material Score:	4

Comments:	Remove if within scope of works
Recommendation:	Remove
Action Date	Not Applicable

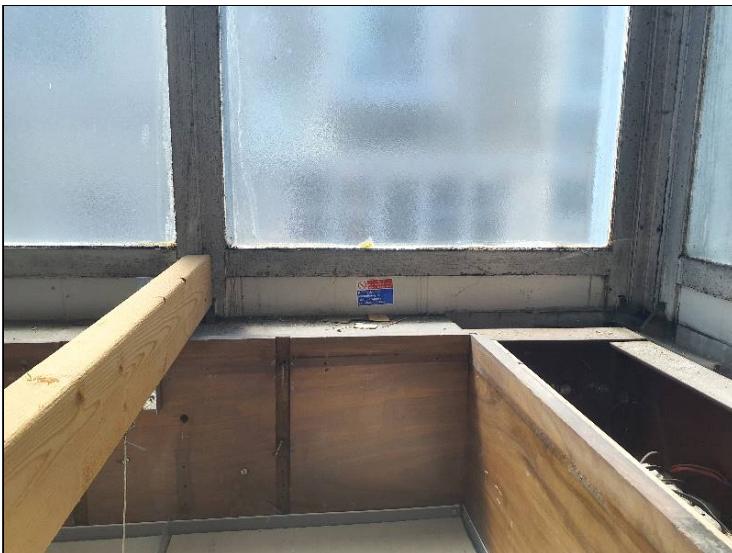
Item No:	29
Site:	RYDE ST THOMAS SQUARE - 6623, St Thomas Square, Ryde, PO33 2PL
Survey Type:	Refurbishment Survey
Surveyor:	Scott Thomas
Survey Date:	6 Jun 2023
Building:	6623 Ryde
Floor:	Ground Floor
Area:	Interview room G04
Item Description:	Insulating board panels above both sets of windows in ceiling void
Approximate Quantity:	3m <sup>2</sup>
Analysed By and Date:	N/A
Sample No and Type (S,SP, P, As):	As FR000282 (SP)
Product Type:	Asbestos Insulating Board (2)
Extent of Damage/Deterioration:	Good Condition (0)
Surface Treatment:	Surface Sealed (1)
Asbestos Type	Chrysotile + Amosite (2)
Material Score:	5

Comments:	Remove if within scope of works
Recommendation:	Remove
Action Date	Not Applicable

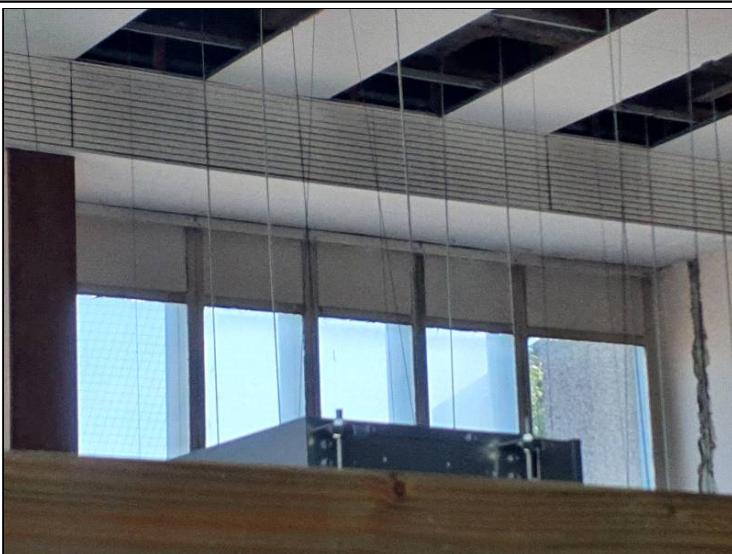
Item No:	30
Site:	RYDE ST THOMAS SQUARE - 6623, St Thomas Square, Ryde, PO33 2PL
Survey Type:	Refurbishment Survey
Surveyor:	Scott Thomas
Survey Date:	6 Jun 2023
Building:	6623 Ryde
Floor:	Ground Floor
Area:	Banking hall G05
Item Description:	Insulating board panels above both sets of windows in ceiling void
Approximate Quantity:	20m <sup>2</sup>
Analysed By and Date:	N/A
Sample No and Type (S,SP, P, As):	As FR000282 (SP)
Product Type:	Asbestos Insulating Board (2)
Extent of Damage/Deterioration:	Good Condition (0)
Surface Treatment:	Surface Sealed (1)
Asbestos Type	Chrysotile + Amosite (2)
Material Score:	5

Comments:	Remove if within scope of works
Recommendation:	Remove
Action Date	Not Applicable

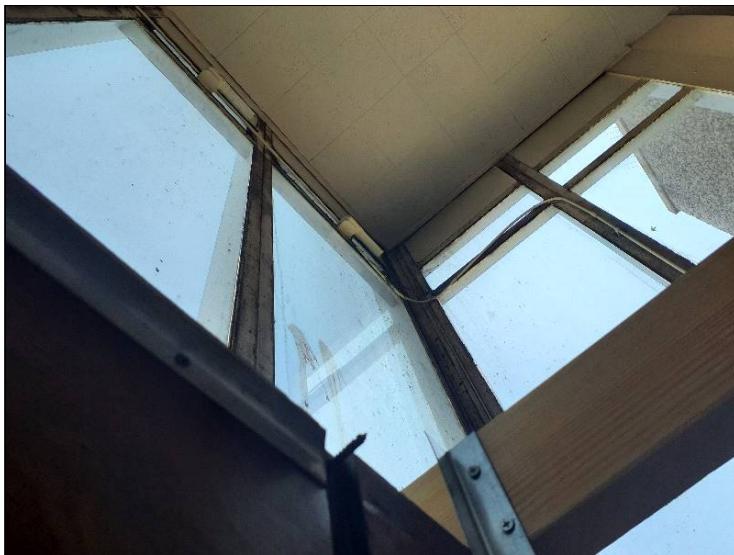
Item No:	31
Site:	RYDE ST THOMAS SQUARE - 6623, St Thomas Square, Ryde, PO33 2PL
Survey Type:	Refurbishment Survey
Surveyor:	Scott Thomas
Survey Date:	6 Jun 2023
Building:	6623 Ryde
Floor:	Ground Floor
Area:	Interview room G06
Item Description:	Insulating board panels above both sets of windows in ceiling void
Approximate Quantity:	6m <sup>2</sup>
Analysed By and Date:	N/A
Sample No and Type (S,SP, P, As):	As FR000282 (SP)
Product Type:	Asbestos Insulating Board (2)
Extent of Damage/Deterioration:	Good Condition (0)
Surface Treatment:	Surface Sealed (1)
Asbestos Type	Chrysotile + Amosite (2)
Material Score:	5

Comments:	Remove if within scope of works
Recommendation:	Remove
Action Date	Not Applicable

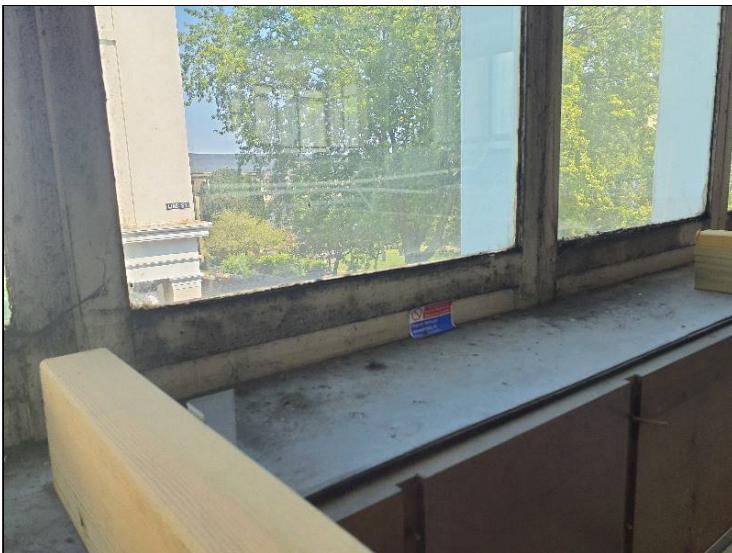
Item No:	32
Site:	RYDE ST THOMAS SQUARE - 6623, St Thomas Square, Ryde, PO33 2PL
Survey Type:	Refurbishment Survey
Surveyor:	Scott Thomas
Survey Date:	6 Jun 2023
Building:	6623 Ryde
Floor:	Ground Floor
Area:	Interview room G07
Item Description:	Insulating board panels above both sets of windows in ceiling void
Approximate Quantity:	6m <sup>2</sup>
Analysed By and Date:	N/A
Sample No and Type (S,SP, P, As):	As FR000282 (SP)
Product Type:	Asbestos Insulating Board (2)
Extent of Damage/Deterioration:	Good Condition (0)
Surface Treatment:	Surface Sealed (1)
Asbestos Type	Chrysotile + Amosite (2)
Material Score:	5

Comments:	Remove if within scope of works
Recommendation:	Remove
Action Date	Not Applicable

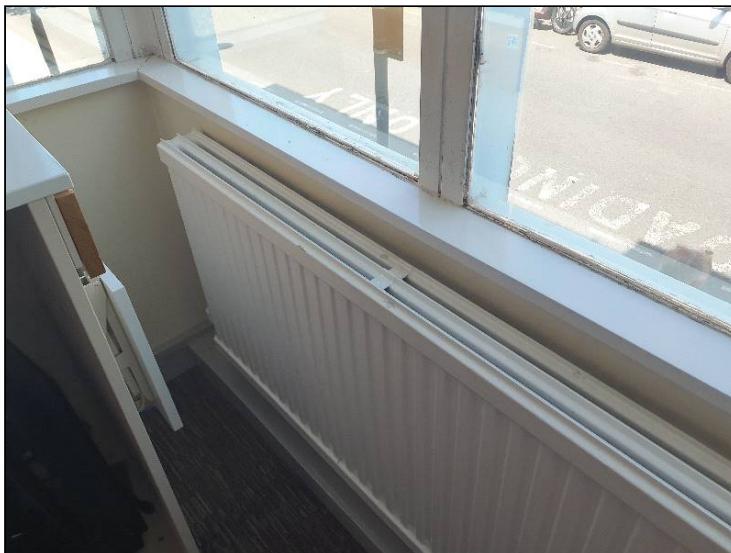
Item No:	33
Site:	RYDE ST THOMAS SQUARE - 6623, St Thomas Square, Ryde, PO33 2PL
Survey Type:	Refurbishment Survey
Surveyor:	Scott Thomas
Survey Date:	6 Jun 2023
Building:	6623 Ryde
Floor:	Ground Floor
Area:	Interview room G07
Item Description:	Insulating board panels below window
Approximate Quantity:	4m <sup>2</sup>
Analysed By and Date:	Andrew West 12/06/2023
Sample No and Type (S,SP, P, As):	FR000284 (S)
Product Type:	Asbestos Insulating Board (2)
Extent of Damage/Deterioration:	Good Condition (0)
Surface Treatment:	Surface Sealed (1)
Asbestos Type	Chrysotile + Amosite (2)
Material Score:	5

Comments:	Remove if within scope of works
Recommendation:	Remove
Action Date	Not Applicable
