Additional Photos (25/10/2023)

ROOF VOIDS

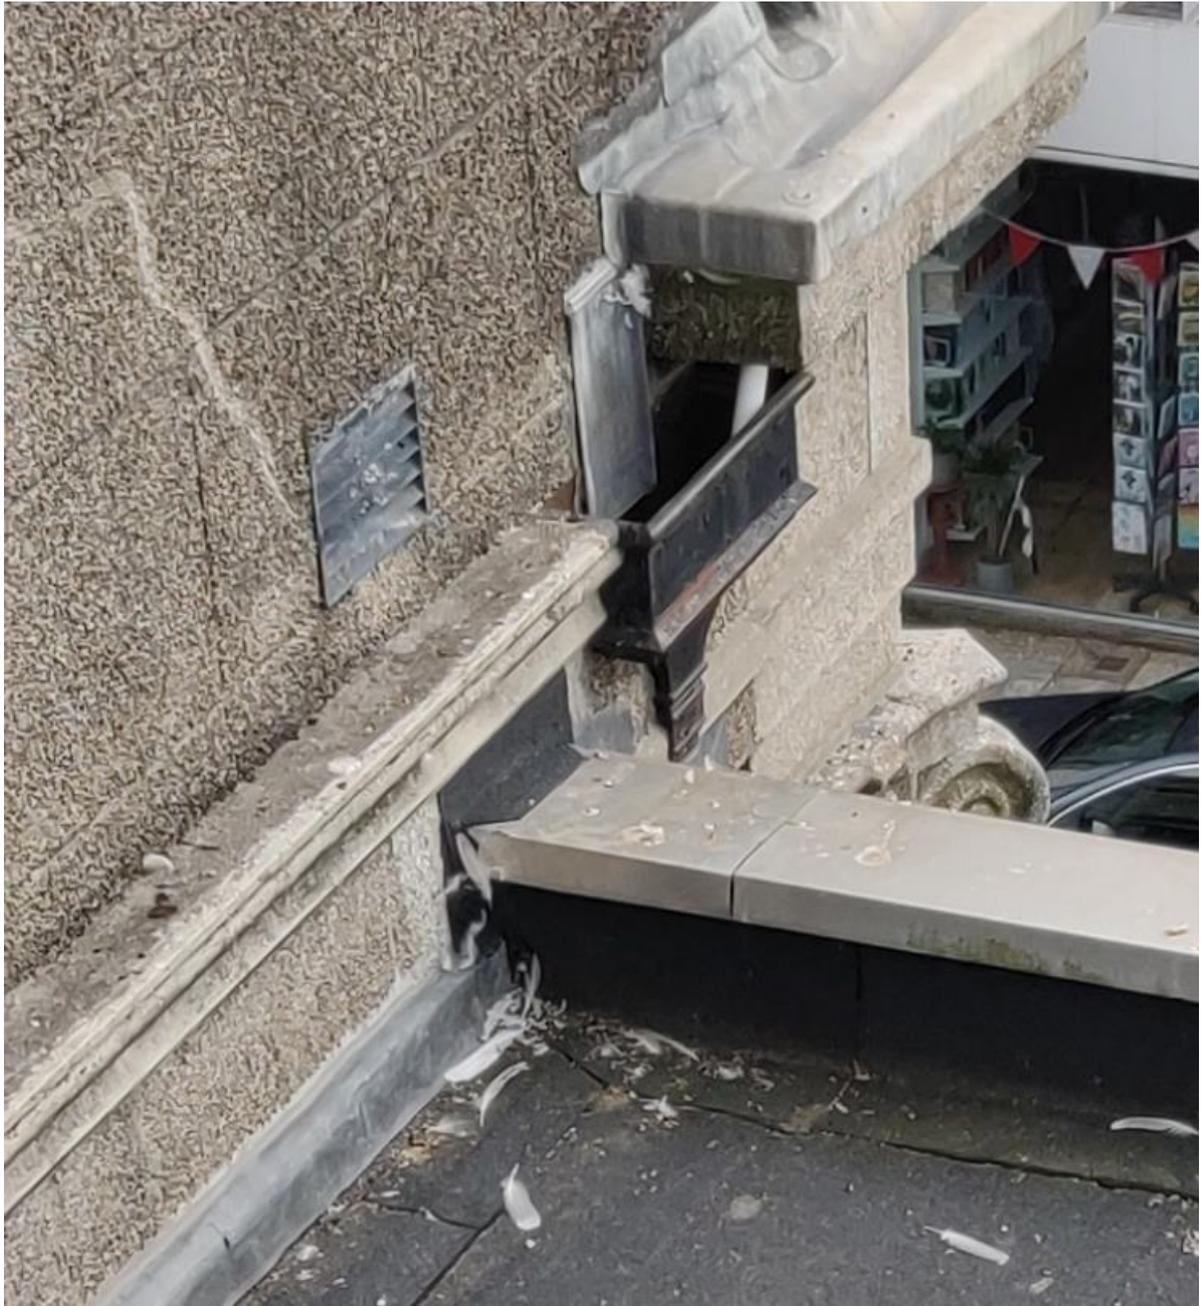
The white outlet seems inadequate so the lead trough will overflow. Same detail on the other end of this main roof (Appendix 2 DSC00107).

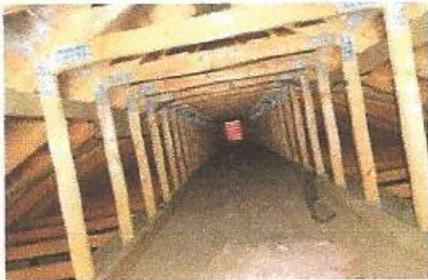
DSC00869

Gang nail plate truss on raised shuttered concrete collar supported on steel framing with ladder strutting across supporting glazing. Later 1990s gang nail plate added, replacing lantern or glazed structure unknown.

Water getting in the corners due to poor detailing at low level. Re-detail behind secondary fascia. Possible condensation. Possible water entry through Chinaman's cap and lead vent to ventilators below (ref. external section of report).

The single image below seems to be the roof above the Philbrick Gallery, roof R2.
