FAAM Asbestos Register May 20

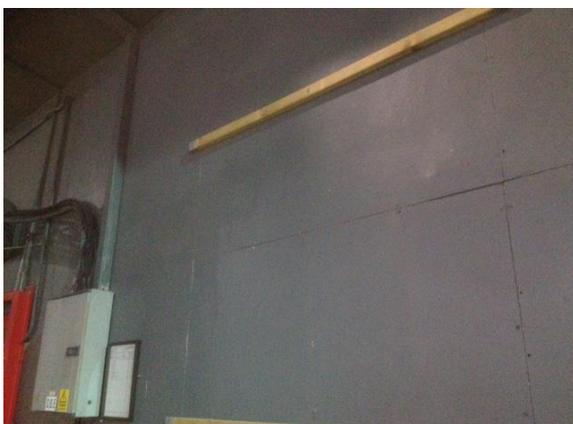
1. Hall 1 & 4 dividing wall – The ACM runs from the front of the building approx. 2 meters back from folding doors to where the link from hall 1 enters hall 4 at the 1st floor level. Beyond this point is plasterboard as it was part of the carrier exhibition project in early 2000. The ACM cladding starts 3.6M (Approx.) from floor and goes up to the eaves. Below this level is normal blockwork.

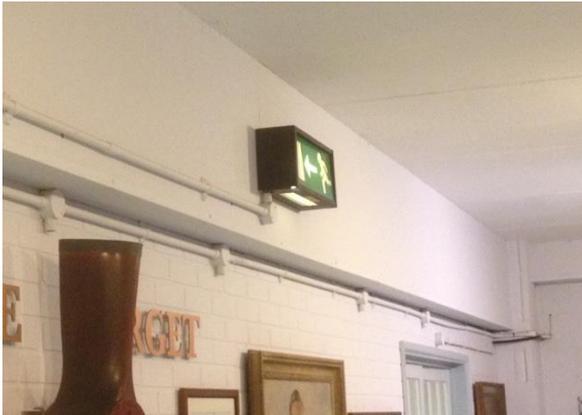
3. Outside education centre – Around this area most of the load bearing structural steel has been clad in ACM. The ACM can be identified as it has metal angled cover strip. Some areas are clad in modern fire retardant materials in 2000 and do not have this cover strip.

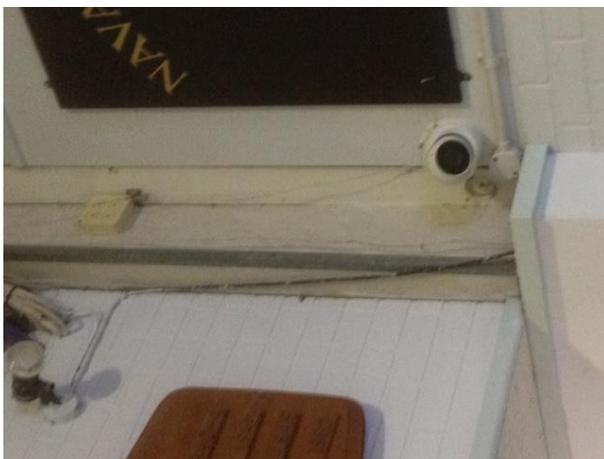
4. Front offices – The pillar between doors 4 & 10 is clad in ACM as are a number of the steel beams along this office facing the road. There is also a mixture of modern and old materials in this area so caution is recommended.

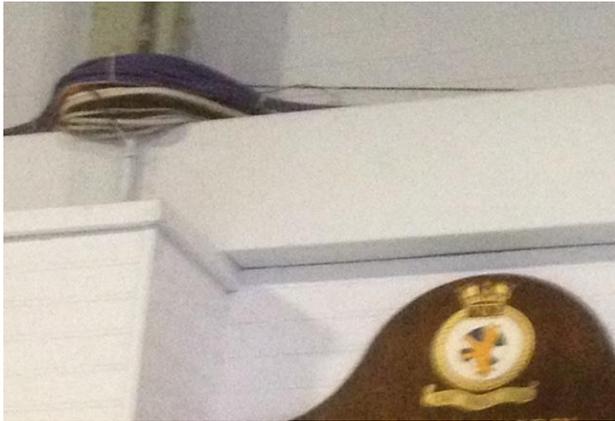
5. Above auditorium – There is a strip of ACM lying across the gap above the auditorium wall and below the level of the marketing office floor. It forms the fire break between hall 1 and the area above the shop and runs the full length of the auditorium.

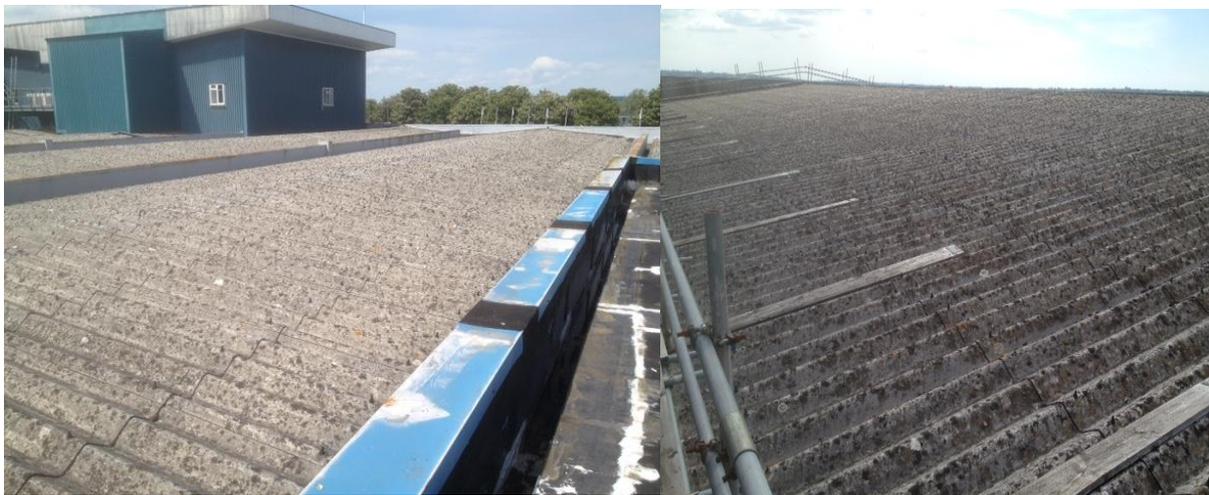
- Hall 1, 2 and 4 AND Bld 221 have asbestos cement roof panels.

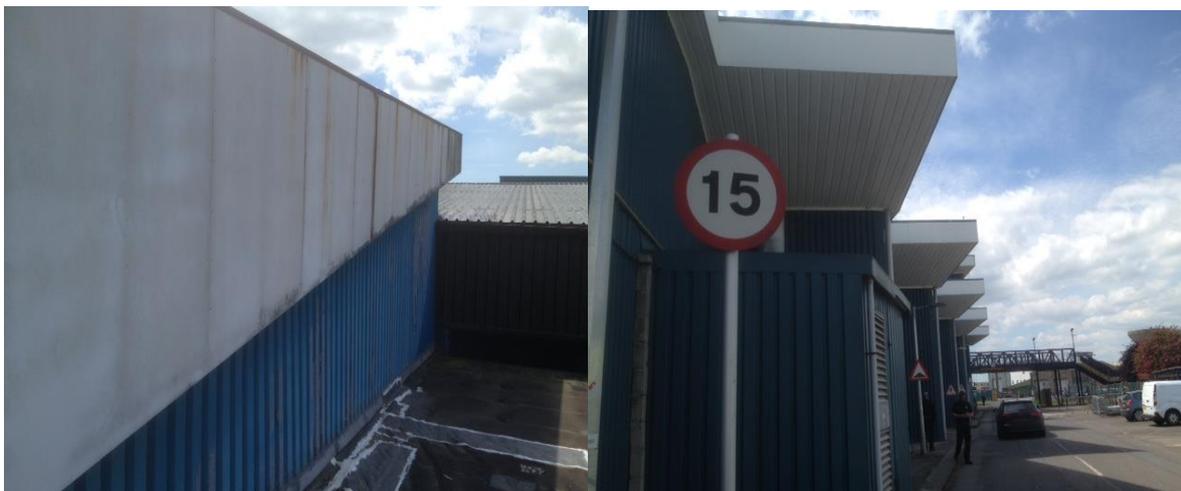
- Halls 1, 2 and 4 have sections of asbestos cement soffit cladding at roof level.

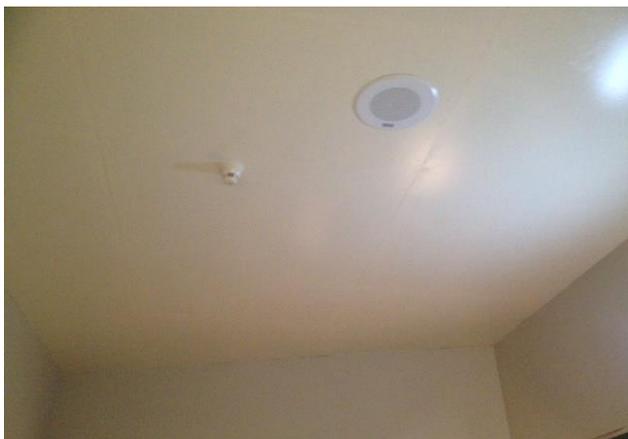
- Ceiling panels in barrack area exhibition roof.
