Peter Moore - Head of Environment  
Dorset Property • Technical Services • County Hall • Colliton Park • Dorchester • DT1 1XJ  
Phone: (01305 225258) Direct Line: (01305) 221907/8

**ASBESTOS MANAGEMENT SURVEY**  
**FOR**  
**SWANAGE TOWN COUNCIL OFFICE AND ANNEXE**  
**AUGUST 2016**

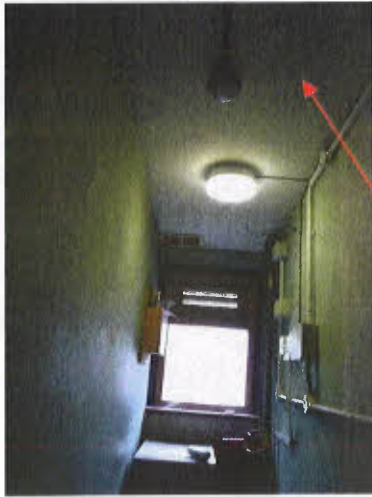
AIB ceiling panel in boiler room B15

1	Create an Asbestos Management Plan and manage asbestos installations as per the plan.
2	Remove small amount of AIB debris from basement boiler room B15.
3	Consider labelling accessible asbestos installations as detailed in this report

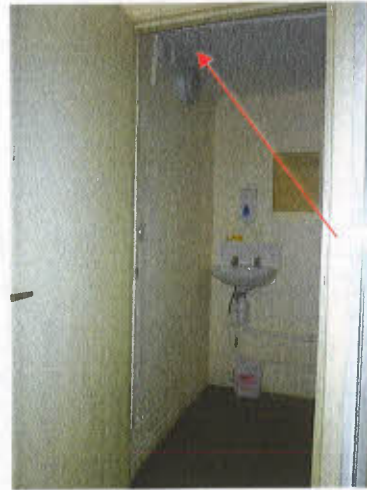
AIB ceiling panels within shower room and WC

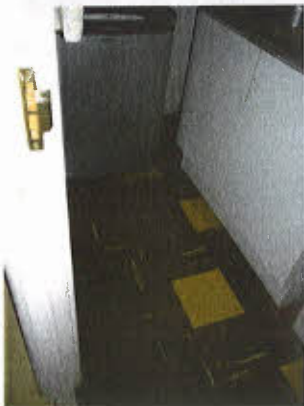
Asbestos floor tiles within basement kitchenette B16

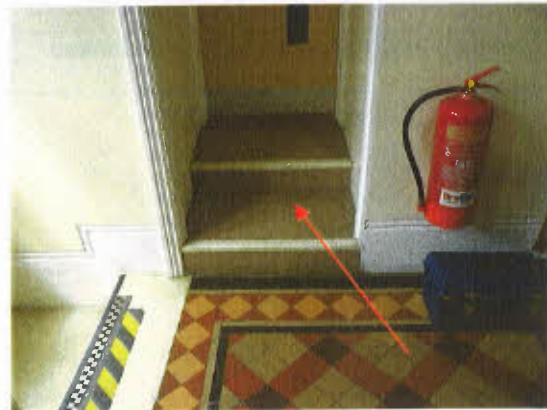
Asbestos floor tiles on steps leading to annexe Rm 9

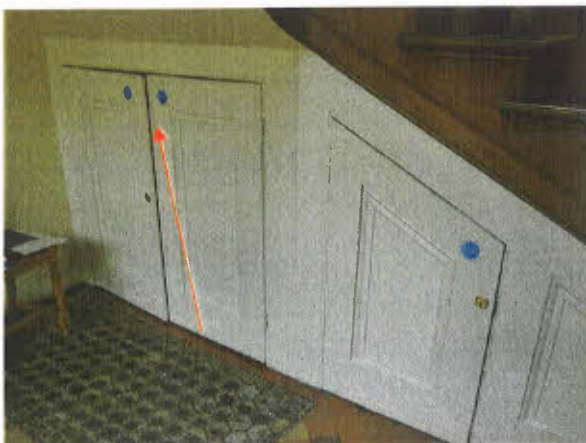
Non asbestos lining found in various locations throughout the building (under stair stores, fuse boxes, risers etc.)

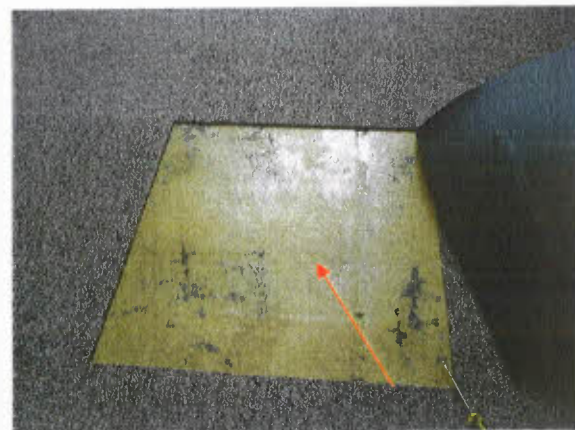
Non asbestos floor lino found beneath floor coverings in some rooms.
