Understanding the forces and energy in the electrification system during dewirements

Written by: Steven Conway, Current Collection Solutions Ltd

Published: October 2015

Understanding the forces and energy in the electrification system during de-wirements

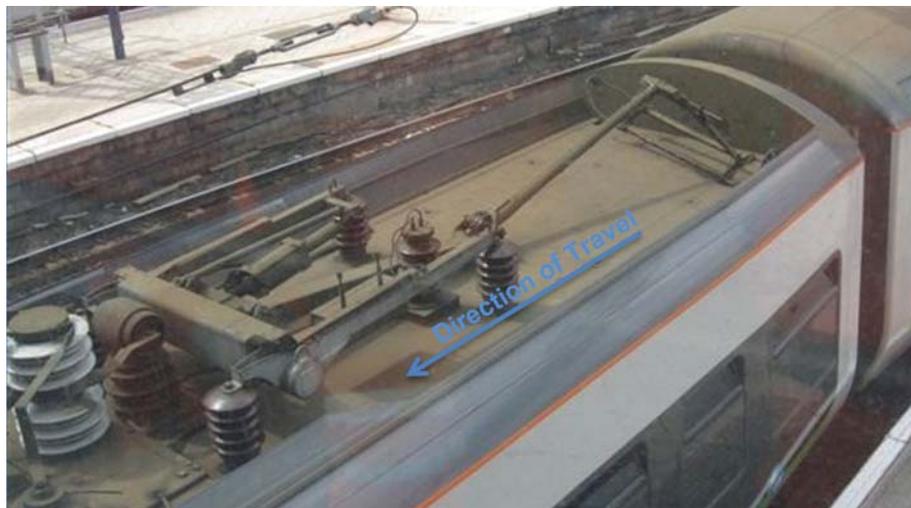
Although in 'Trend 2' the 'pantograph pulled backwards with upper and lower arms close to the horizontal' results in the pantograph being severely damaged it also minimizes any further damage to the OLE. Figure 1 shows the outcome of a typical incident where the pantograph ended up in this position.

Figure 1 - 'Trend 2' pantograph pulled backwards with upper and lower arms close to the horizontal.

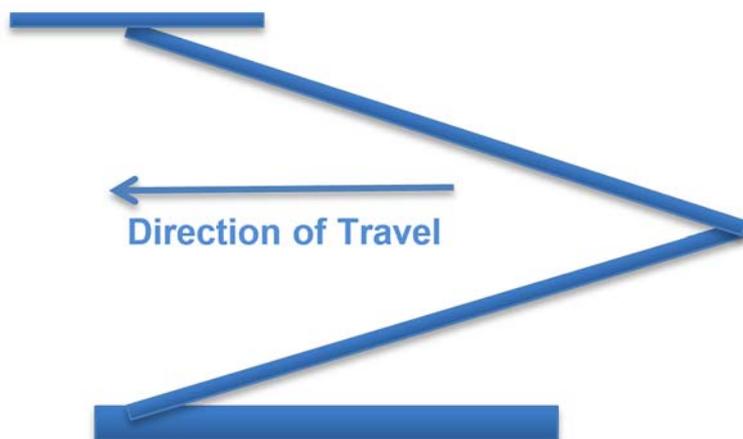
All pantographs in 'Trend 2' were operating in the KT direction as in Figure 2.

Figure 2 - Pantograph operating in the knuckle trailing (KT) position

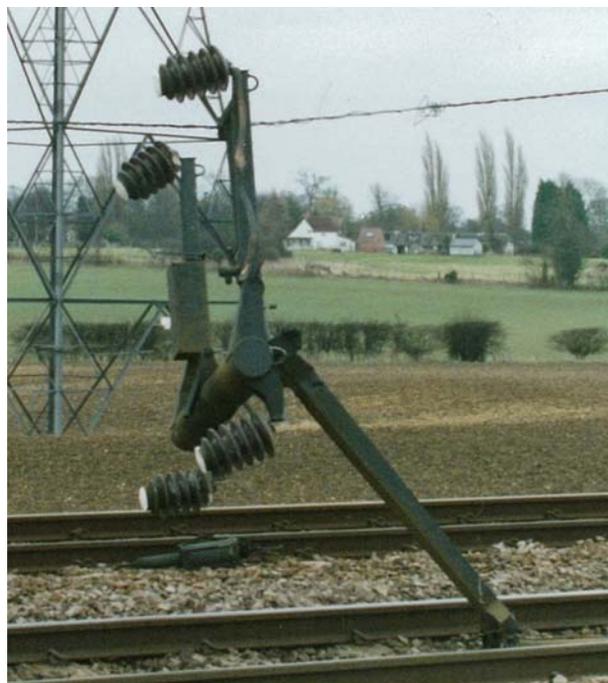
The pantograph being pulled off the roof of the vehicle, as in 'Trend 3', can only occur when ceramic foot insulators are fitted. An example of this incident can be seen in Figure 4.

Figure 4 - Example of a pantograph pulled off the roof (Trend 3).

The Alexandra Palace and Littleport incidents had the pantograph ripped of the roof, which ended up in the cess or hanging from the OLE as in Figure 4; all pantographs in these incidents were fitted with ceramic foot insulators.

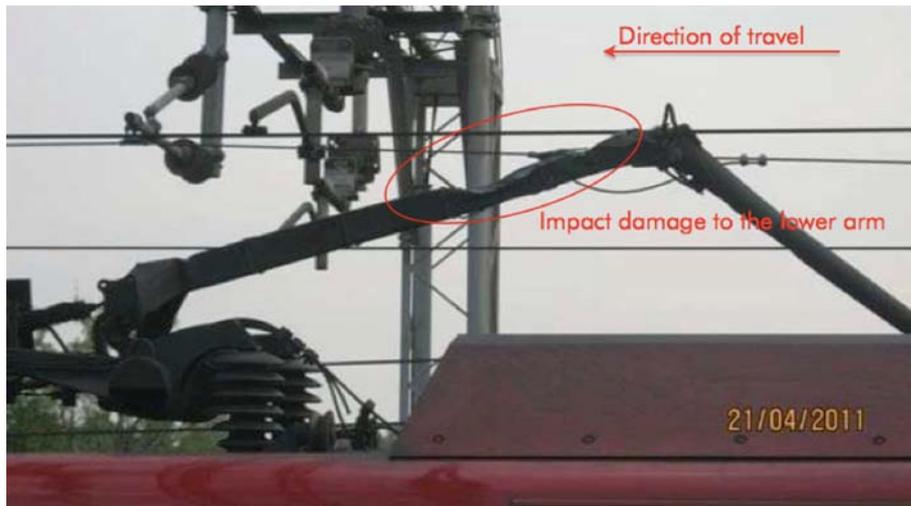
In 'Trend 4' the 'Pantograph with knuckle uppermost' the pantograph is in the most 'dangerous' position, as it will result in further damage to the OLE. An example of such an incident can be seen in Figure 5.

Figure 5 - Example of a 'pantograph with knuckle uppermost'.

The impact damage to the lower arm should be noted, where it has struck OLE components.

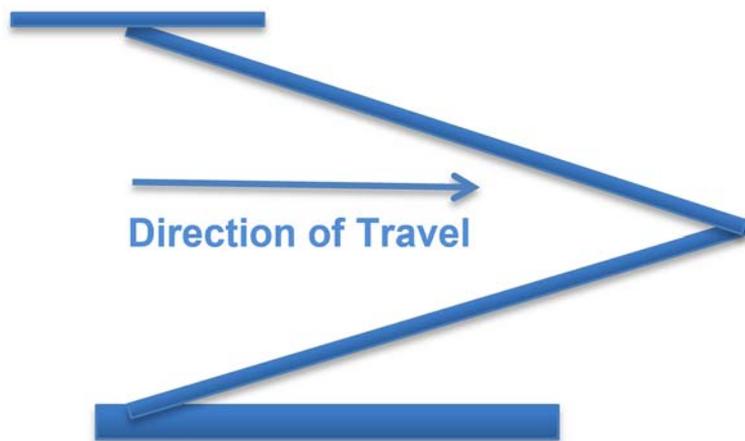
All pantographs in 'Trend 4' were operating in the KL direction as in Figure 6.

Figure 6 - Pantograph operating in the knuckle leading (KL) position.

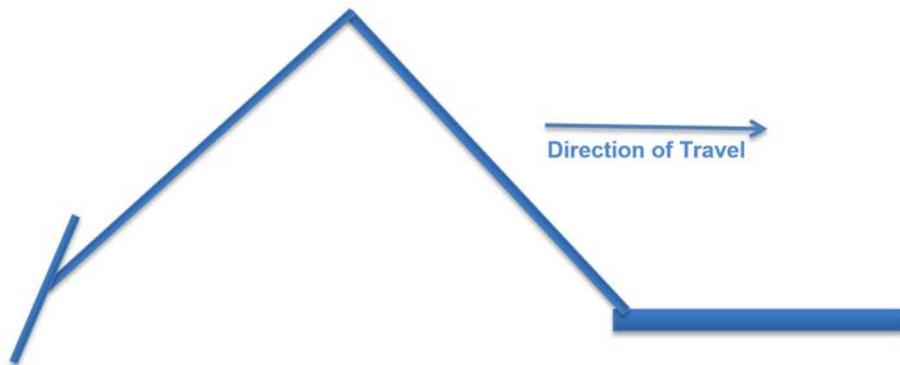
- 1 'Snag' the contact wire and pull the pantograph over as in Figure 7 with knuckle uppermost

Figure 7 - Pantograph pulled after over after 'snagging the contact wire' with knuckle uppermost.

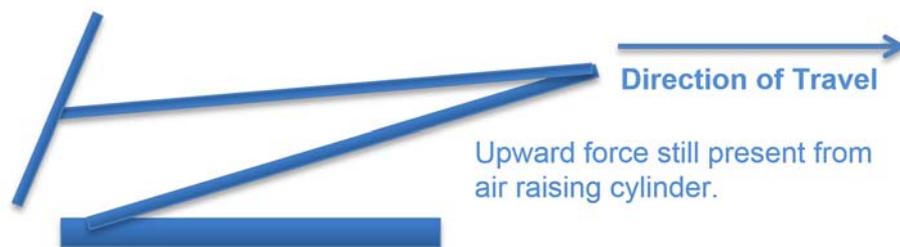
- 2 The outer chains would fail, which transfer the upward force from the lower arm to the upper arm, the upper arm then would fall as in Figure 8 due to the force applied by the air raising cylinder.

Figure 8 - Outer chains would fail and upper arm would drop.

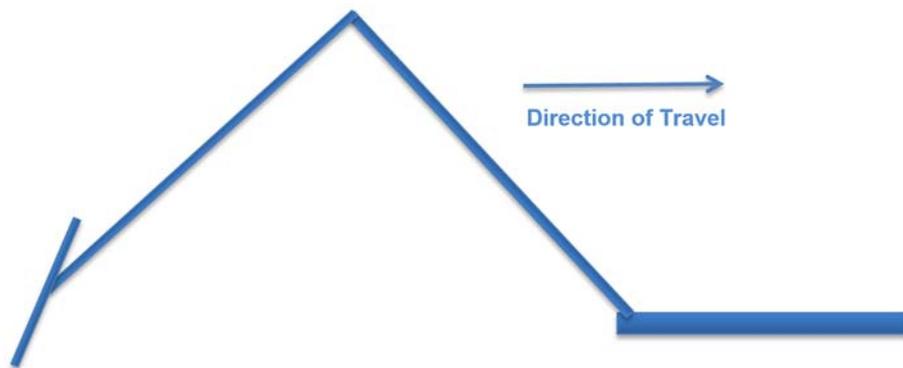
The lower arm would raise because of the upward force still present from the air raising cylinder or springs resulting in the knuckle being uppermost.

Figure 9 - Lower arm raised, due to upward force still present, resulting in the pantograph being 'knuckle uppermost'.

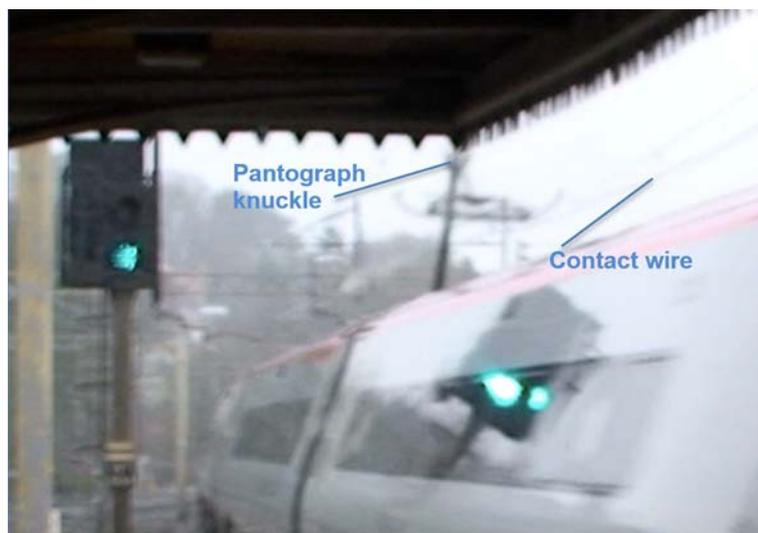
The Berkhamstead incident occurred with polymeric foot insulators fitted to the pantograph and in a location where these type of insulators were also fitted to the infrastructure. The pantograph with knuckle uppermost, as Figure 10, had been previously damaged and the vehicle was travelling at 110mph; it should be noted that the knuckle was above the contact wire.

Figure 10 - Screen shot taken from a video of a 390 travelling at 110mph with knuckle uppermost.

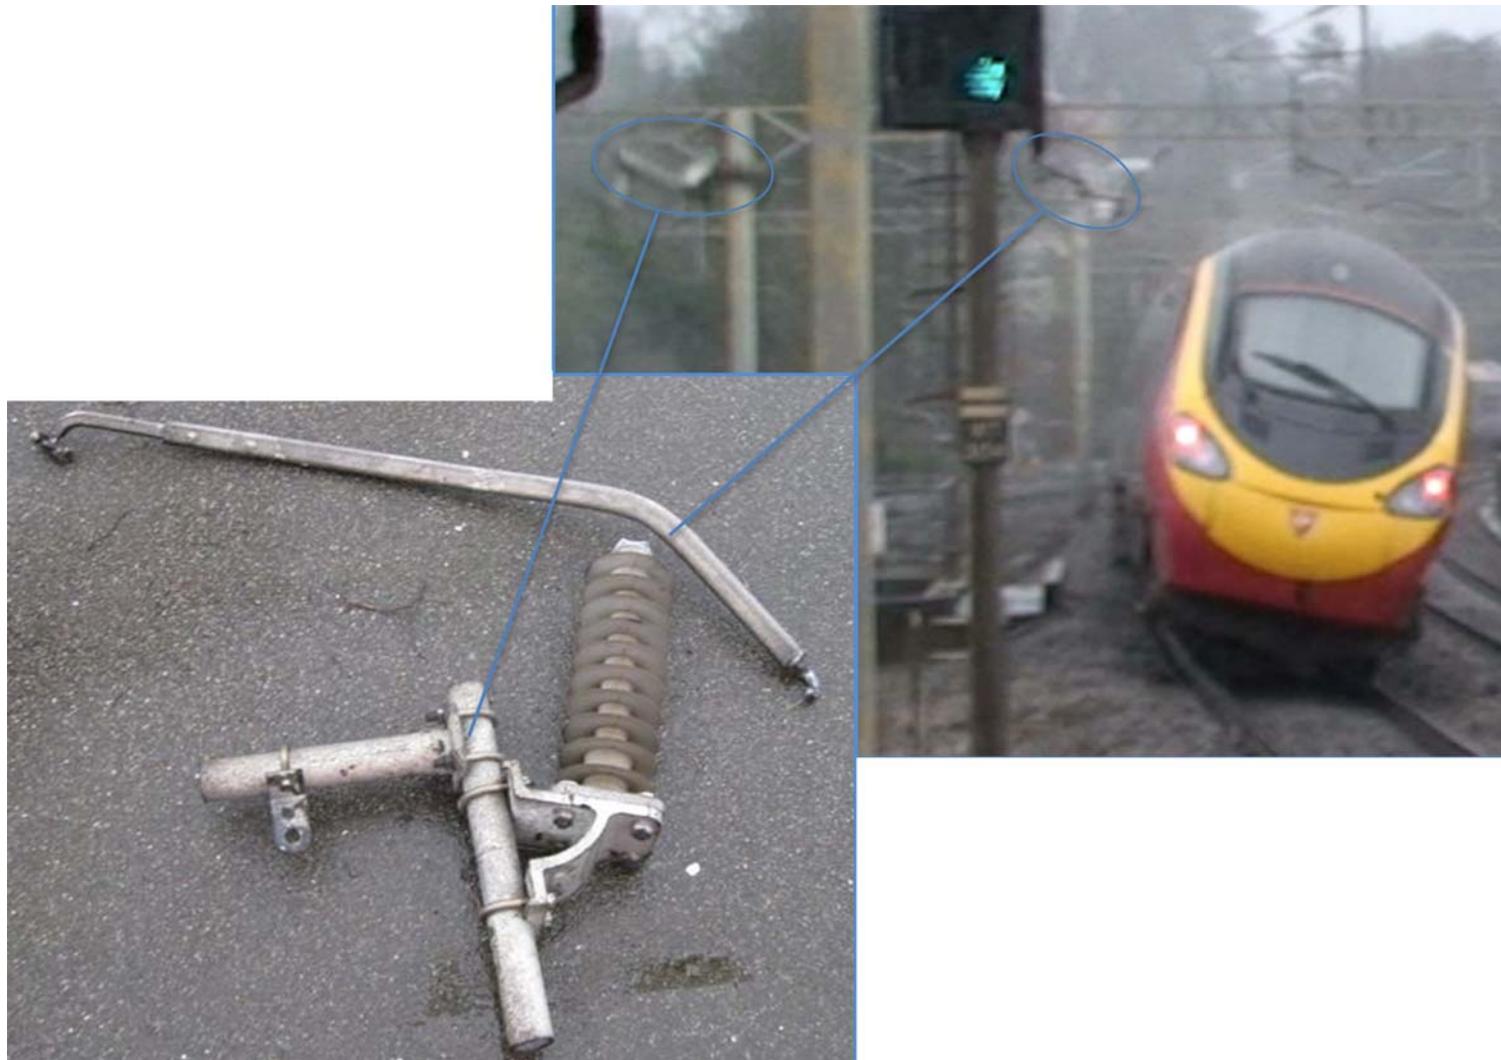
This resulted in the pantograph striking the infrastructure and causing further damage as in Figures 11 and 12.

Figure 11 - Screen shot taken from a video of a 390 travelling at 110mph just after it struck a portal structure and the 'debris' recovered from site

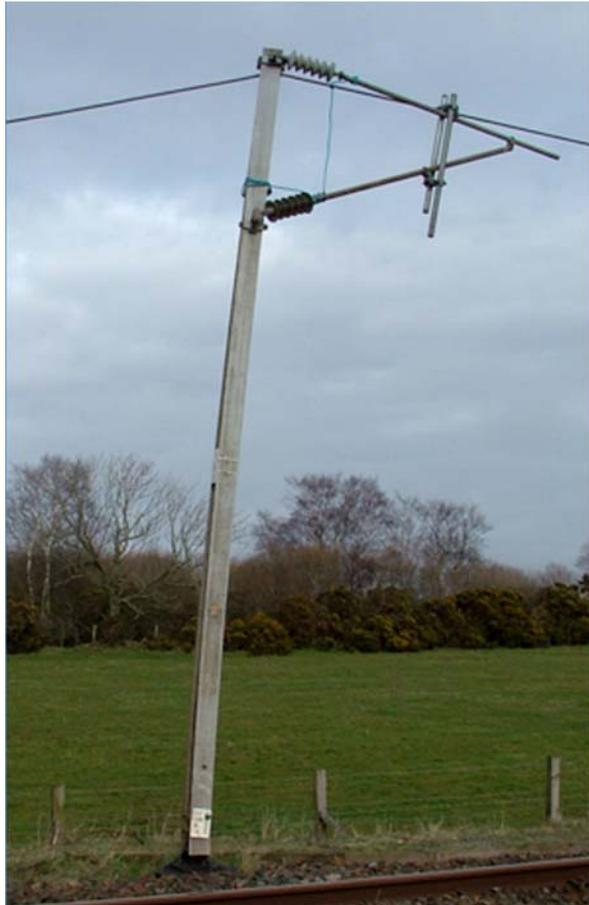
Figure 12 - Distorted mast after being struck by the pantograph on 390 053

The most concerning and serious of the trends is 'Trend 3' 'Pantograph pulled of the vehicle roof and 'Trend 5' 'Pantograph with knuckle uppermost'. Both of these trends could have resulted in injury to passengers or staff by 'flying' OLE or pantograph debris. Also of concern was the distorted mast (Incident 28, Berkhamstead).
