Refurbishment and Demolition Survey

Chinley and Buxworth Youth and Community Centre

A & L Reference : 20421

21 Lower Lane
High Peak
Derbyshire
SK23 6BE

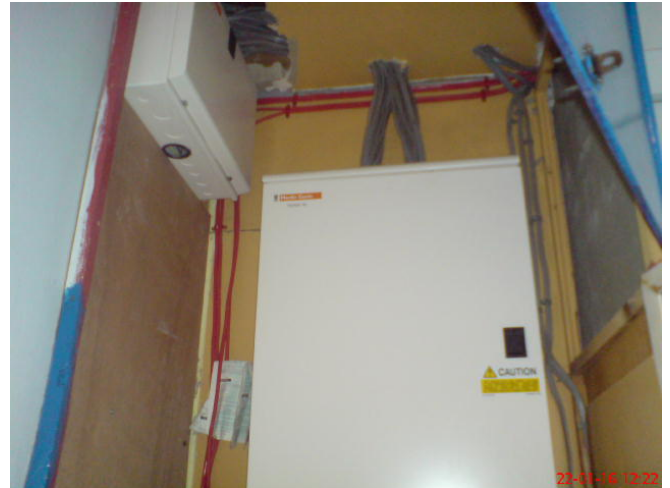
Room ID: 0-001
Room Ref: Entrance Lobby
Sample No: Negative Electrics
Asbestos Detected: No Asbestos Detected

Comment: The electrical system within the area was seen to be of a type non conducive to containing asbestos containing materials.

Recommendation: No further action required.

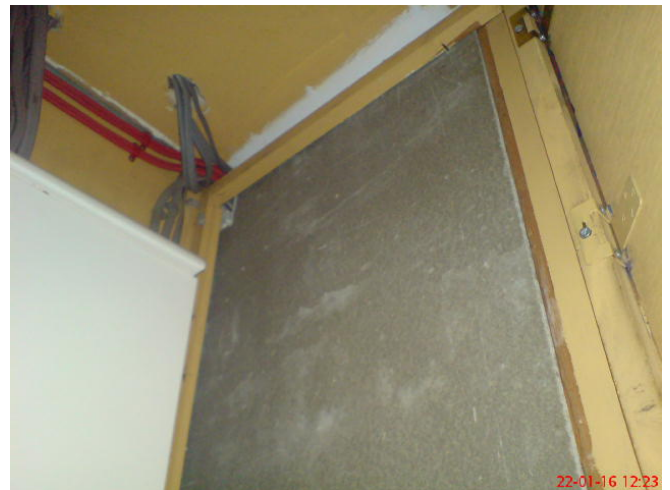
Room ID: 0-001
Room Ref: Entrance Lobby
Sample No: 001
Asbestos Detected: No Asbestos Detected

Comment: No asbestos was detected in the sample of cement panels to the right hand side of the electric cupboard ref: 20421/001.

Recommendation: No further action required.

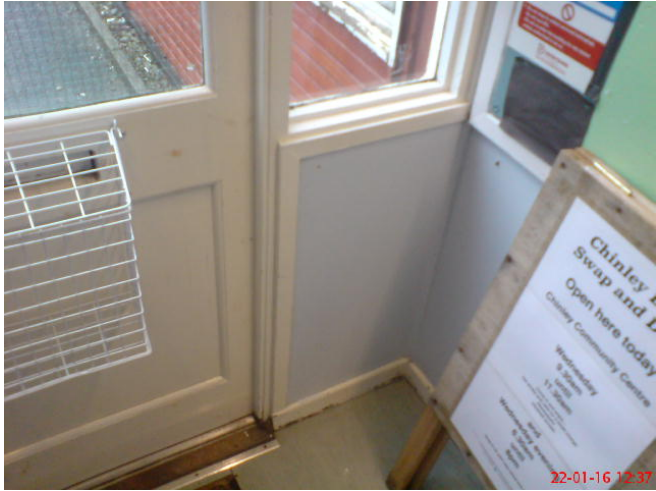
<p>Comment: No asbestos was detected in the sample of the low level cement panels to either side of doors ref: 20421/002.</p>

<p>Recommendation: No further action required.</p>

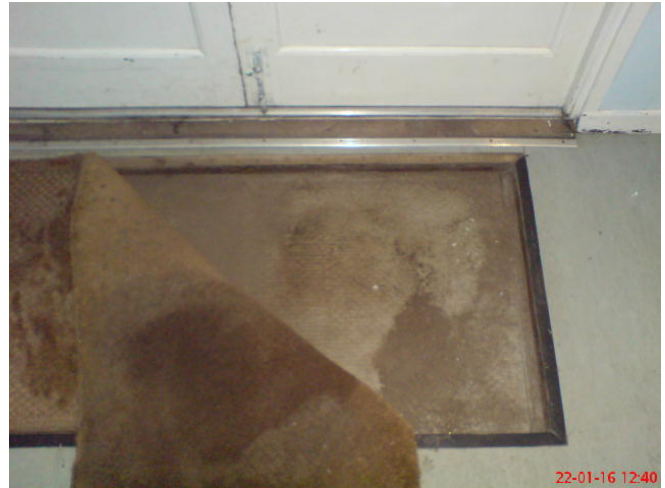
Comment: No asbestos was detected in the sample of the vinyl floor covering beneath the door mat ref: 20421/003.

Recommendation: No further action required.

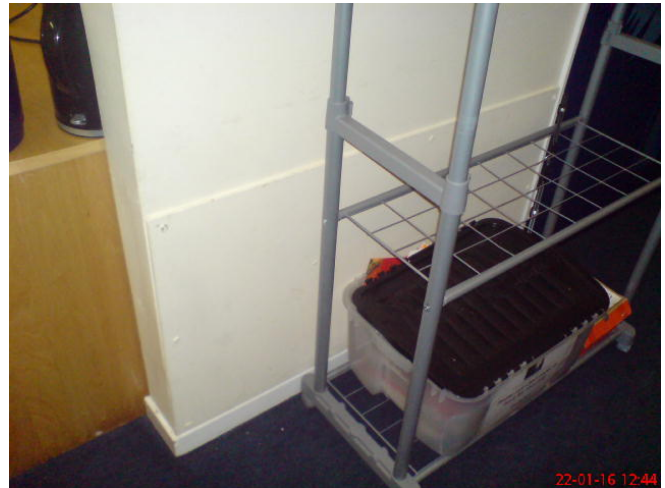
Comment: No asbestos was detected in the sample of the cement panel to the wall of the Office at low level ref: 20421/001.

Recommendation: No further action required.

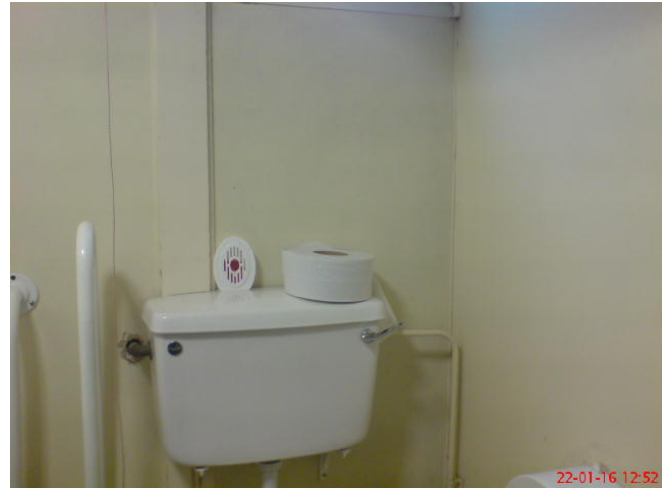
Comment: No asbestos was detected in the sample of the cement panels to the wall behind the cistern ref: 20421/004.

Recommendation: No further action required.

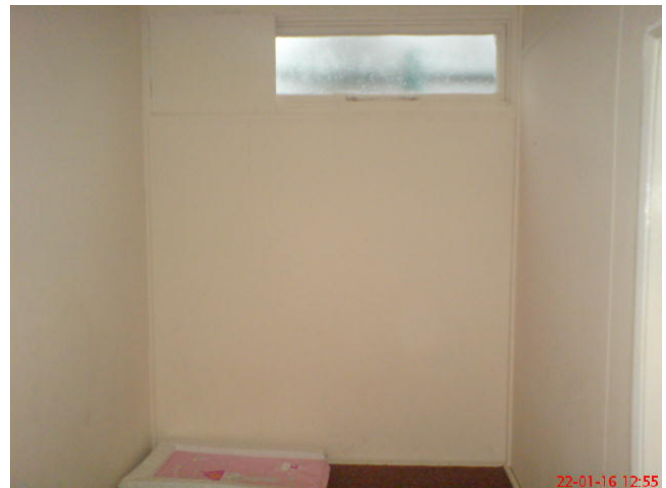
Comment: No asbestos was detected in the sample of cement panels to the wall below the window ref: 20421/004.

Recommendation: No further action required.

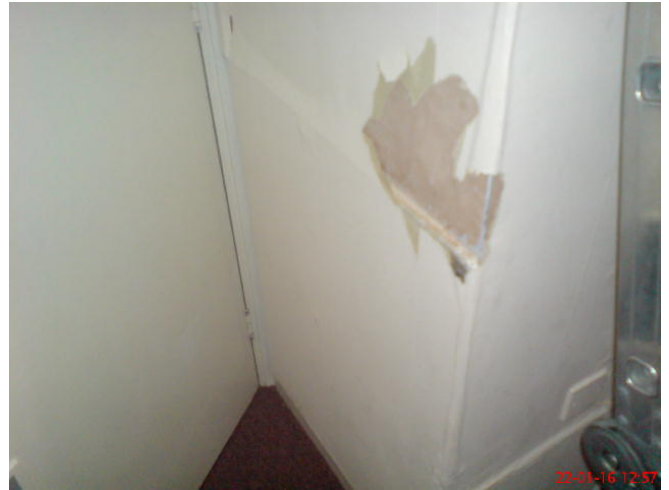
Comment: No asbestos was detected in the sample of cement panel to the wall at low level behind the door ref: 20421/001.

Recommendation: No further action required.

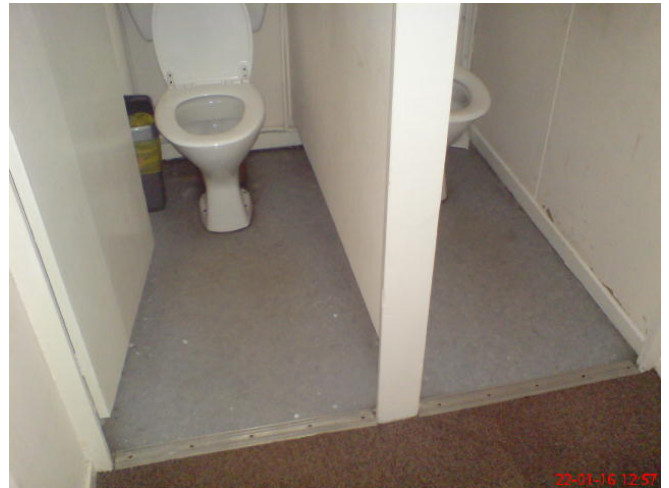
Comment: No asbestos was detected in the sample of the vinyl floor covering to floor ref: 20421/003.

Recommendation: No further action required.

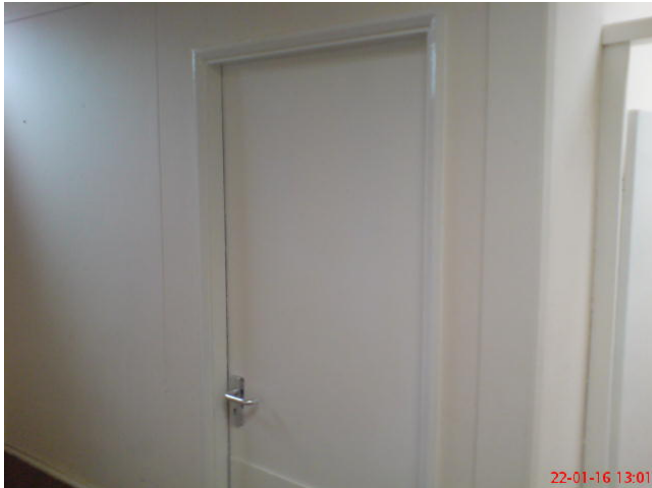
<p>Room ID: 0-007 Room Ref: Side Entrance Sample No: No Access Asbestos Detected: No Access</p> <p>(£)Budget Cost: 0 Asbestos Type: Product Type: Extent: Surface Treatment: Condition: Location: Access: Human Exposure: Frequency of Use: Time In use: Risk Score: 0</p>

<p>Comment: No Access was possible into the area as no keys were made available at the time of the survey.</p>	
<p>Recommendation: Works in the area should proceed with caution, if suspect asbestos containing materials are seen all works should stop and further sampling / investigation should be carried out.</p>	
<p>Room ID: 0-008 Room Ref: Female Changing Sample No: No Access Asbestos Detected: No Access</p> <p>(£)Budget Cost: 0 Asbestos Type: Product Type: Extent: Surface Treatment: Condition: Location: Access: Human Exposure: Frequency of Use: Time In use: Risk Score: 0</p>

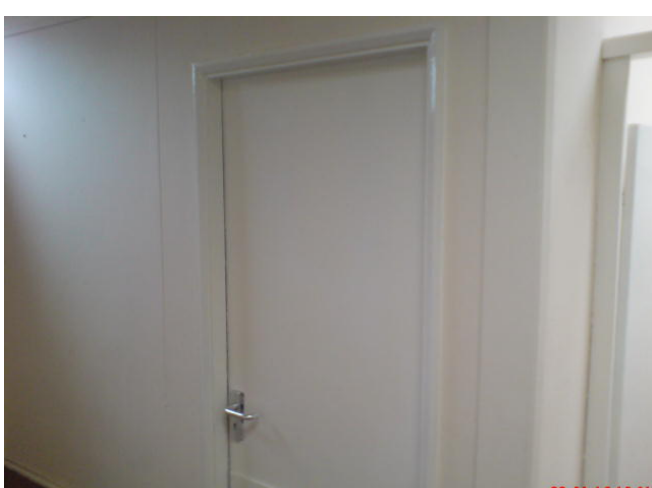
<p>Comment: No Access was possible into the area as no keys were made available at the time of the survey.</p>

<p>Recommendation: Works in the area should proceed with caution, if suspect asbestos containing materials are seen all works should stop and further sampling / investigation should be carried out.</p>

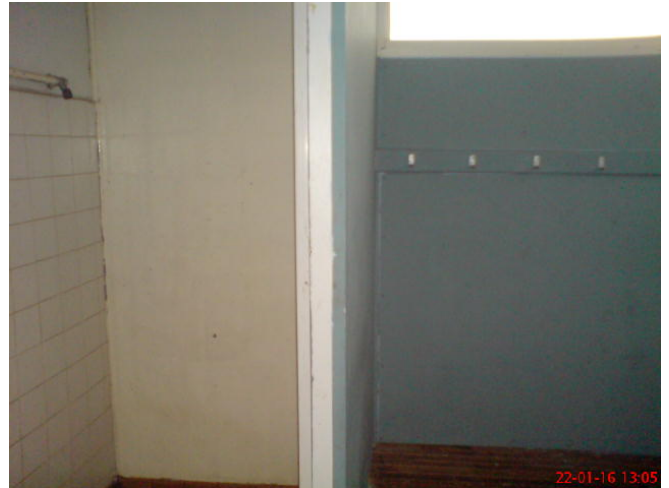
Comment: No asbestos was detected in the sample of the cement panels to the walls ref: 20421/005.

Recommendation: No further action required.

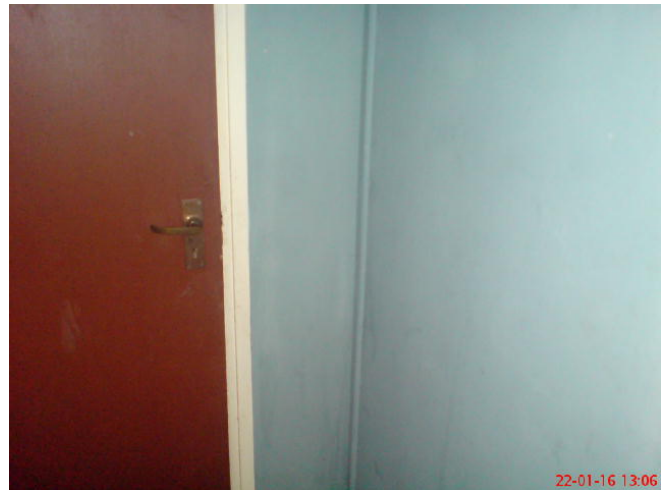
Comment: No asbestos was detected in the sample of the cement panel to the wall to the side of the door ref: 20421/002.

Recommendation: No further action required.

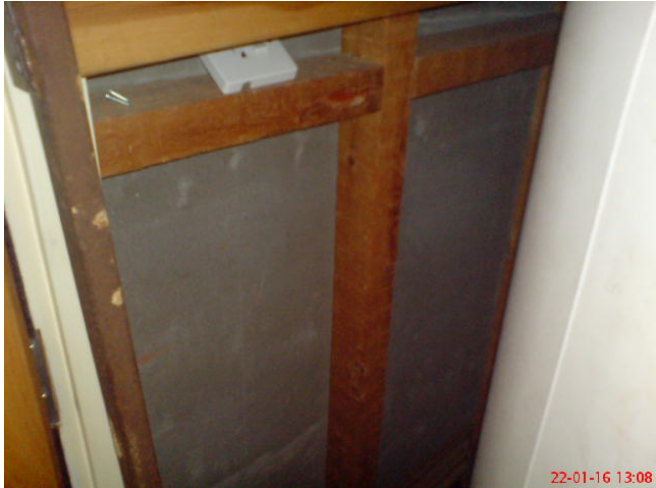
<p>Comment: No asbestos was detected in the sample of the cement panels to the front and side walls ref: 20421/006.</p>	
<p>Recommendation: No further action required.</p>

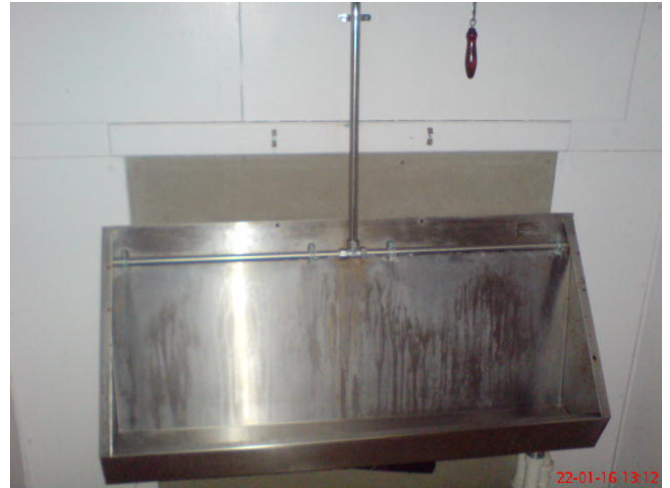
Room ID: 0-012
Room Ref: Gents Toilet
Sample No: As006
Asbestos Detected: No Asbestos Detected

Comment: No asbestos was detected in the sample of the cement panels to the wall behind the urinal ref: 20421/006.

Recommendation: No further action required.

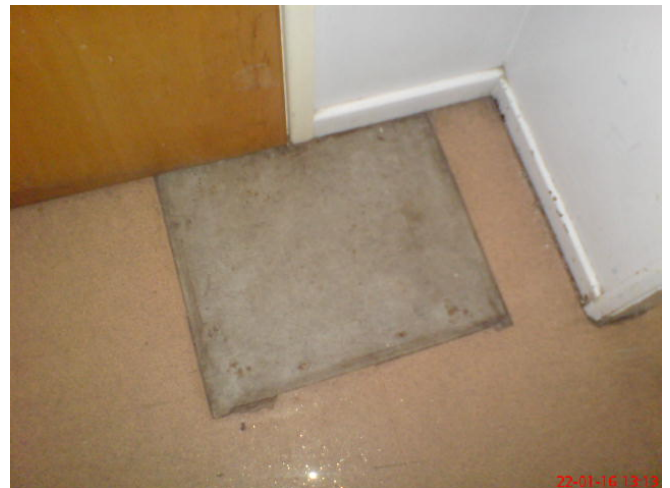
Comment: No asbestos was detected in the sample of the vinyl floor covering ref: 20421/003.

Recommendation: No further action required.

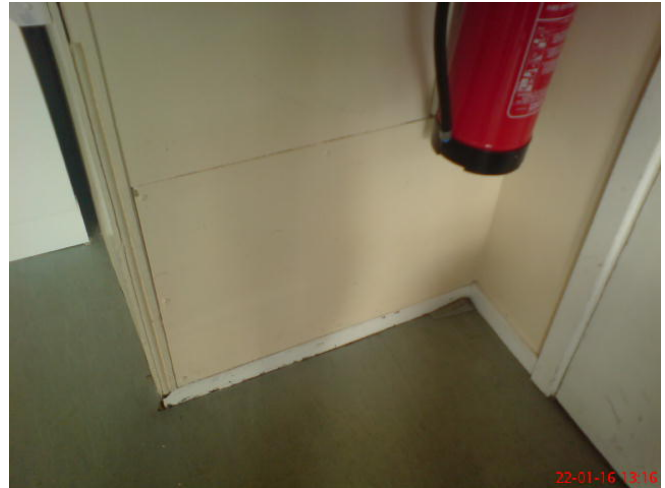
Comment: No asbestos was detected in the sample of the cement panel to the wall at low level behind the door ref: 20421/001.

Recommendation: No further action required.

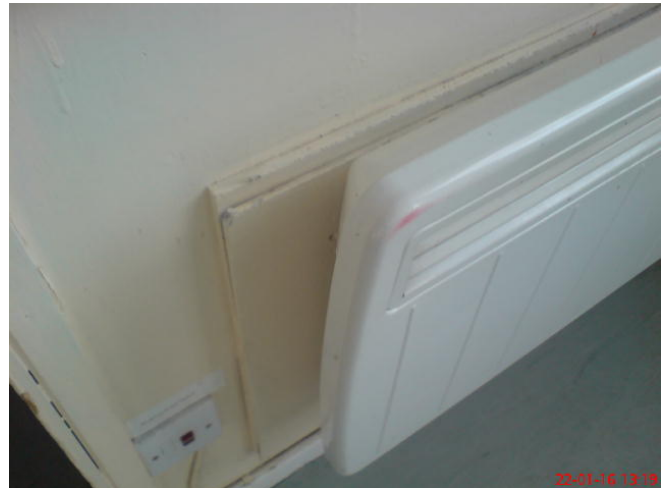
Comment: No asbestos was detected in the sample of the insulating board panel behind the radiator ref: 20421/007.

Recommendation: No further action required.

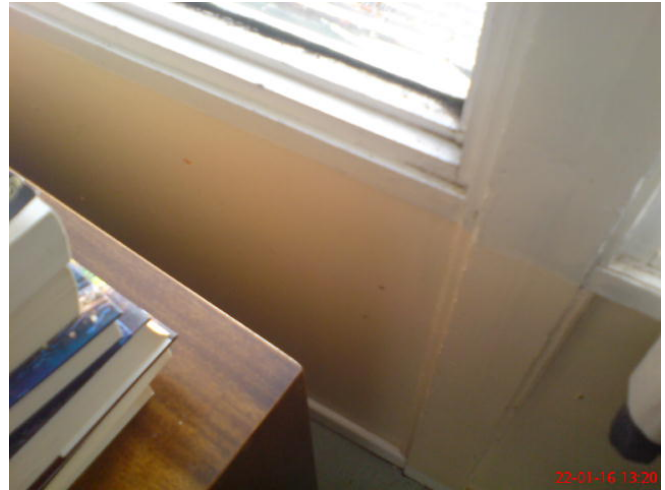
Comment: No asbestos was detected in the sample of the cement panels to the wall behind book case under the window ref: 20421/008.

Recommendation: No further action required.

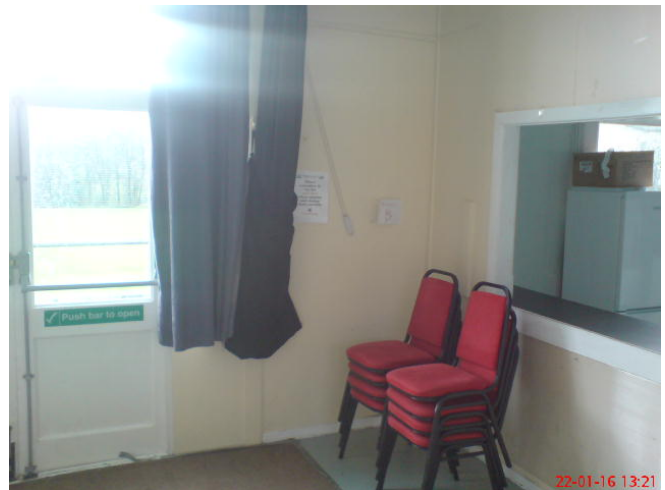
Comment: No asbestos was detected in the sample of the cement panels to the wall to the right hand side of the fire exit ref: 20421/008.

Recommendation: No further action required.

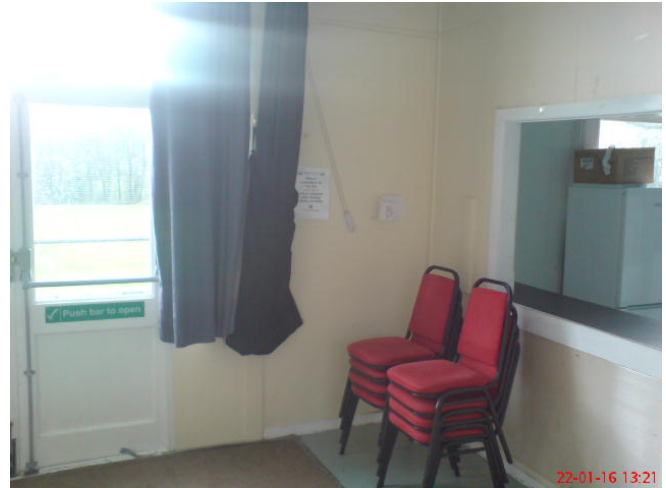
Comment: No asbestos was detected in the sample of the cement panel to wall on the right hand side of fire exit ref:20421/008.

Recommendation: No further action required.

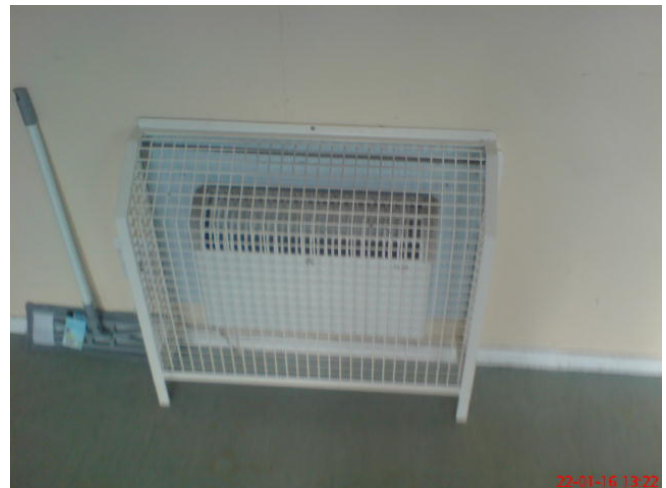
Comment: No asbestos was detected in the sample of the insulating board panel behind the radiator ref: 20421/007.

Recommendation: No further action required.

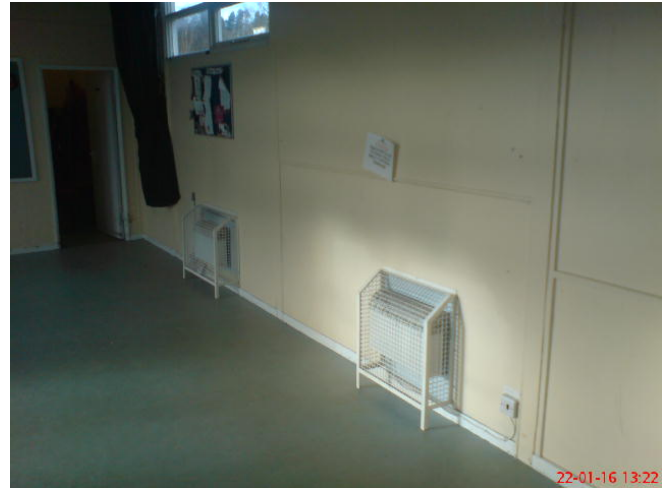
Comment: No asbestos was detected in the sample of the cement panels to the front wall ref: 20421/008.

Recommendation: No further action required.

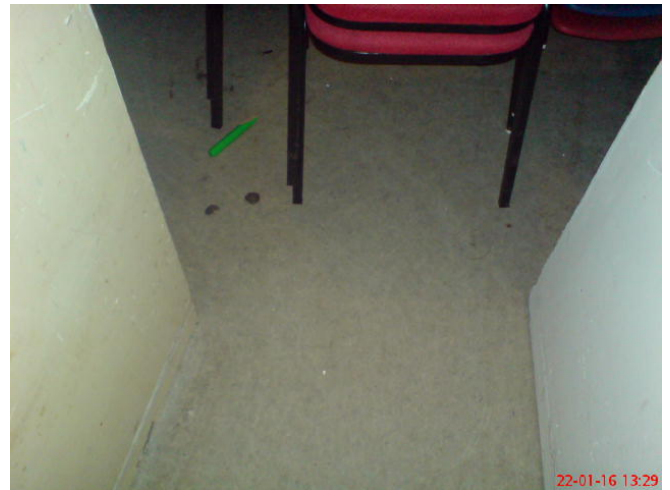
Comment: No asbestos was detected in the sample of the vinyl floor covering ref: 20421/003.

Recommendation: No further action required.

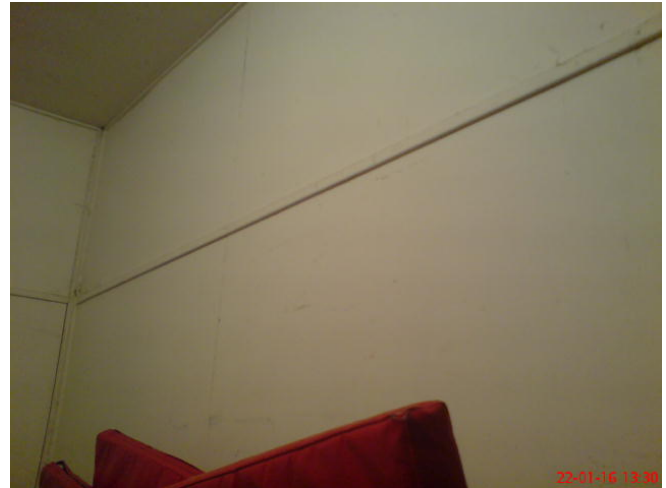
Comment: No asbestos was detected in the sample of the cement panels to the walls ref: 20421/008.

Recommendation: No further action required.

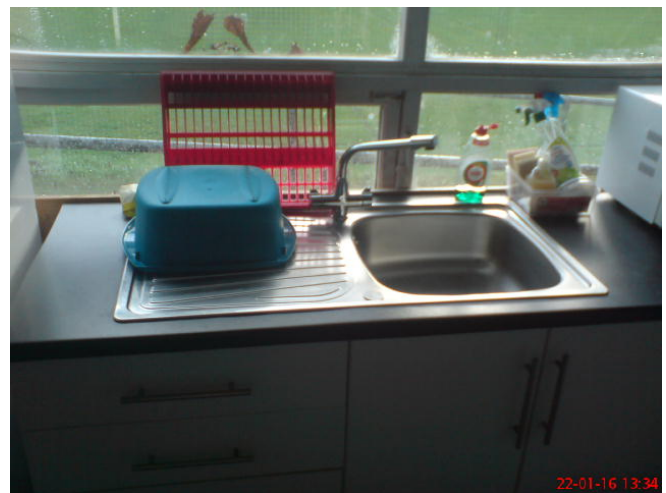
Comment: No asbestos was detected in the sample of the bitumen sink pad to the underside of the sink unit ref: 20421/009.

Recommendation: No further action required.

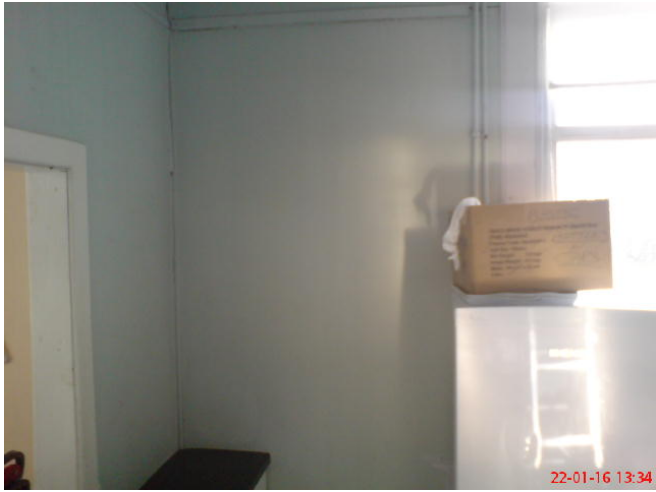
<p>Room ID: 0-015 Room Ref: Kitchen Sample No: As008 Asbestos Detected: No Asbestos Detected</p> <p>(£)Budget Cost: 0 Asbestos Type: Product Type: Cement Panel(s) Extent: 5-10m² Surface Treatment: Condition: Location: Access: Human Exposure: Frequency of Use: Time In use: Risk Score: 0</p>

<p>Comment: No asbestos was detected in the sample of the cement panels to the wall ref: 20421/008.</p>	
<p>Recommendation: No further action required.</p>	
<p>Room ID: 0-016 Room Ref: Store Sample No: 010 Asbestos Detected: No Asbestos Detected</p> <p>(£)Budget Cost: 0 Asbestos Type: Product Type: Roofing Felt Extent: 25-30m² Surface Treatment: Condition: Location: Access: Human Exposure: Frequency of Use: Time In use: Risk Score: 0</p>

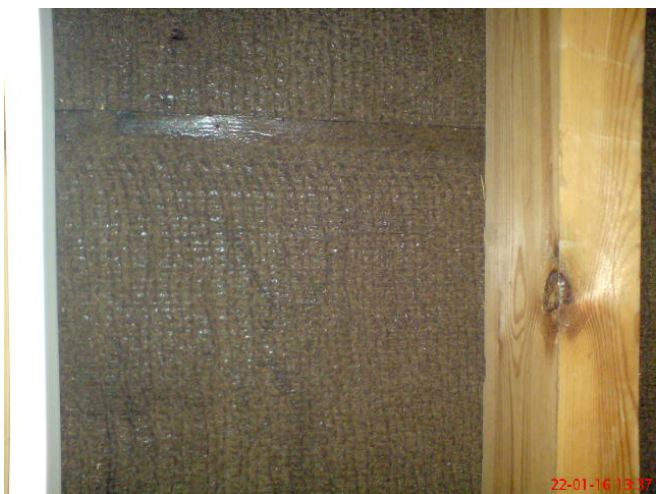
<p>Comment: No asbestos was detected in the sample of the felt lining to walls ref: 20421/010.</p>	
<p>Recommendation: No further action required.</p>

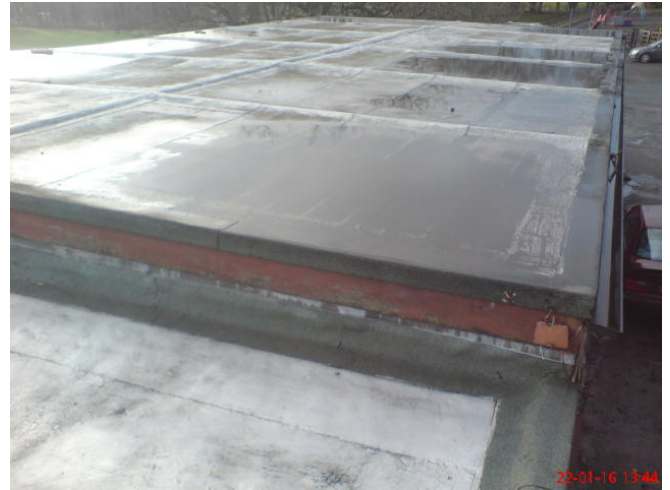
Room ID: External
Room Ref: Roof
Sample No: 011
Asbestos Detected: No Asbestos Detected

Comment: No asbestos was detected in the sample of roofing felt to the whole of the flat roof ref: 20421/011.

Recommendation: No further action required.

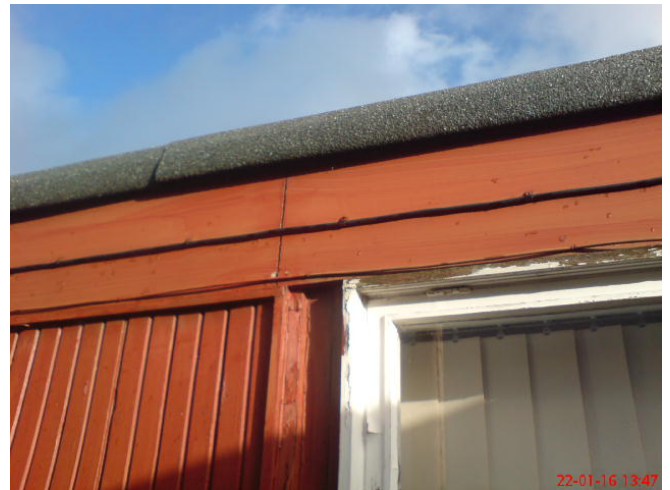
Comment: No asbestos was detected in the sample of the cement panels to the high level fascias to the perimeter of the building ref: 20421/012.

Recommendation: No further action required.

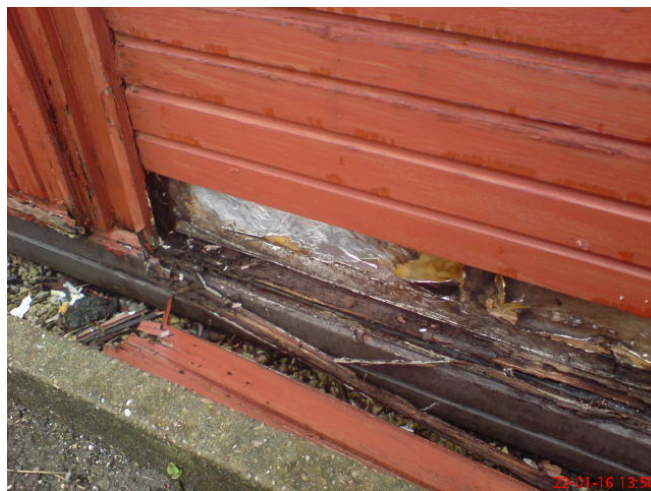
Comment: No asbestos was detected in the sample of the bitumen felt lining behind the timber panels to the perimeter of the building ref: 20421/013.

Recommendation: No further action required.
