# Electrical Services Report

Public Toilet Block – High Street, Westbury, BA13 3BW

Prepared for: Information and Refurbishment Recommendations

Prepared by: James Liston Building services

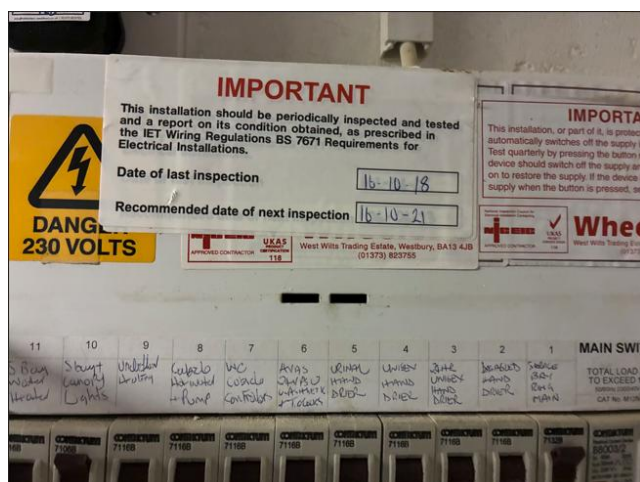
Ref 1.

The next inspection date was 16/10/2021, which is now over four years overdue. A full Electrical Installation Condition Report (EICR) is strongly recommended as soon as possible as it represents a compliance failure, Periodic Inspections are required under BS7671, Part 6. (Photo(s) Ref 1)

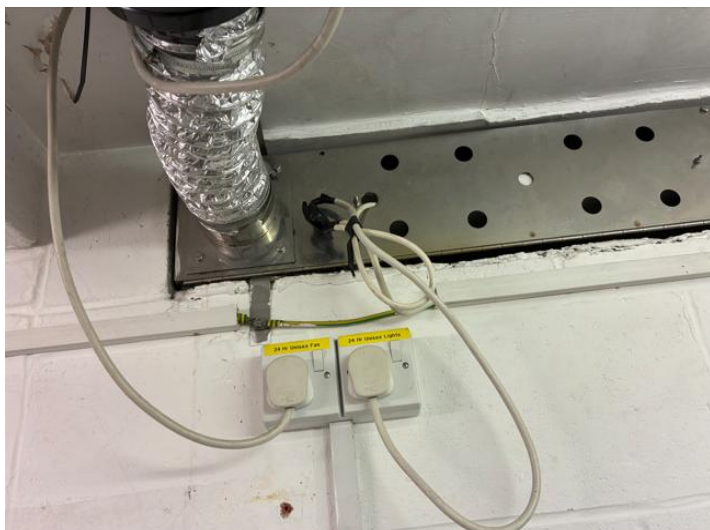
Ref 4.

Some cables enter light fittings without protective grommets or sleeving. Additionally, single insulated conductors are visible, and connector block joints have been used inappropriately, such practices contravene BS7671 requirements for mechanical protection and secure terminals, specifically regulations 526.5 & 526.8. (Photo(s) Ref 4)

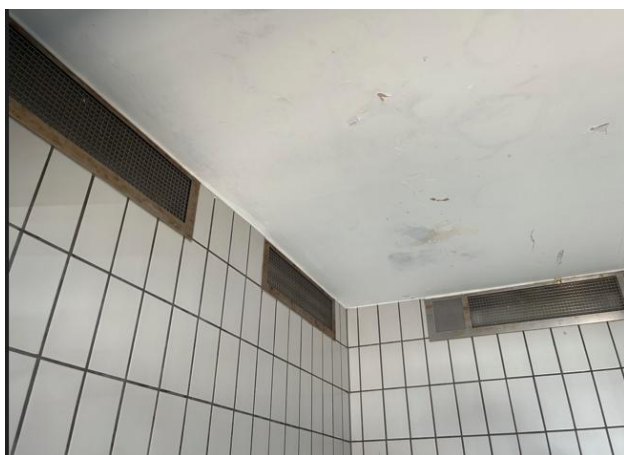
Ref 5.

Internal and external light fittings are mainly fluorescent, and several are not operational. We recommend replacing all fittings with LED luminaires for greater energy efficiency, improved lighting quality and extended lifespan. (Photo(s) Ref 5 & 6)

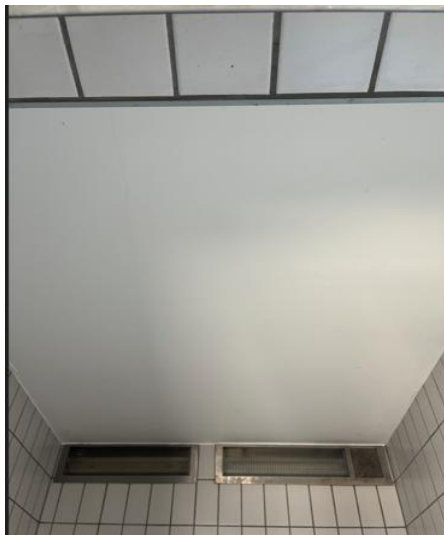
Ref 8.

No fire detection systems are installed, while the toilet block may be considered a low risk environment for fire, a fire risk assessment should determine whether heat or smoke detection is required, particularly in service areas where electrical equipment is concentrated. At a minimum, installation of a standalone heat detector in the service area where cleaners' products and the electrical intake area should be considered. (Photo(s) Ref 8)

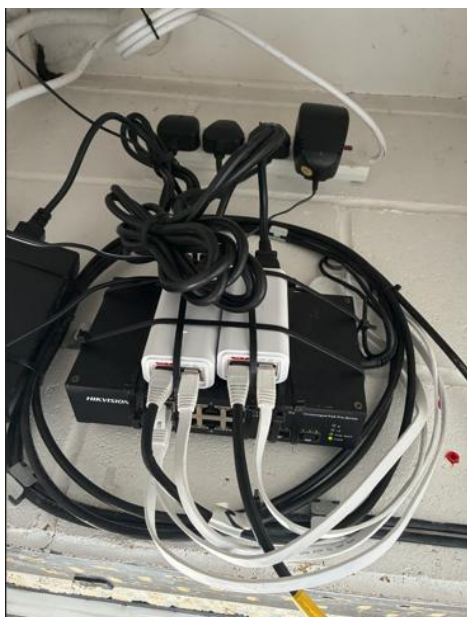
Ref 9.

Hikvision cameras and associated equipment are installed but not tested during the survey. The system should undergo functional testing to verify image quality, coverage and recording functionality. Given the public nature of the premises, CCTV should comply with GDPR and local authority guidance on surveillance in public spaces. (Photo(s) Ref 9 & 10)

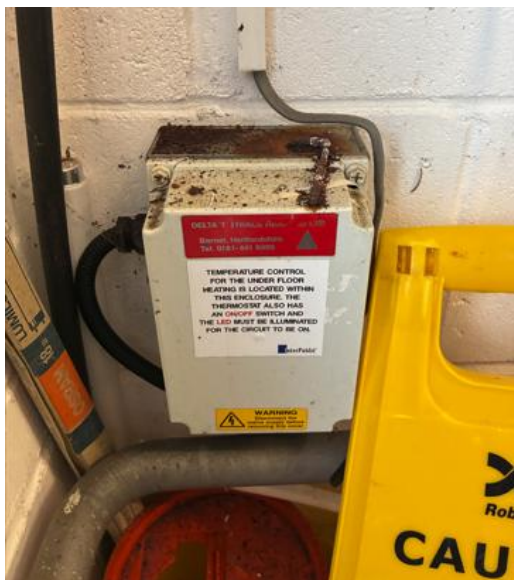
Ref 11.

Underfloor heating is present but not tested during the survey, electrical heating systems require suitable RCD which are in place under Regulation 701.753. The age and condition of the system should be reviewed and tested. (Photo(s) Ref 11)

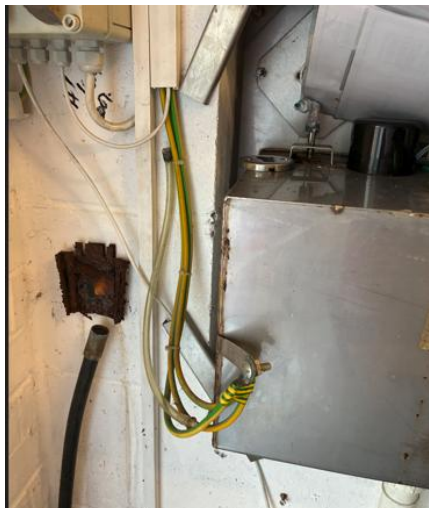
Ref 12.

The majority of equipment and accessories had supplementary bonding in place. However, confirmation of compliance with BS7671 Part 5, Chapter 54 is recommended. Bonding conductors need to be tested for continuity and adequate sizing, and any missing could create dangerous potential differences under fault conditions especially on the metallic pipework and stainless steel sanitaryware that is in place. (Photo(s) Ref 12)

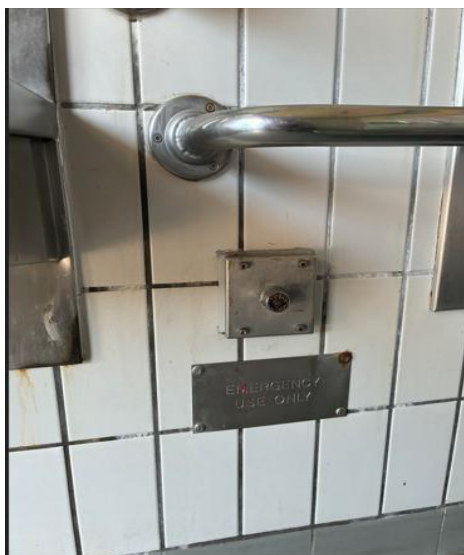
Ref 13.

A disabled assistance alarm system is installed with a beacon located outside to provide alert. This was assumed to be functional but not tested during this survey. (Photo(s) Ref 13 & 14)
