# BUILDING SURVEY

Radford House,  
18-20 Effingham Street,  
Ramsgate,  
Kent,  
CT11 9AT.

**Working DRAFT**

Ramsgate Town Council

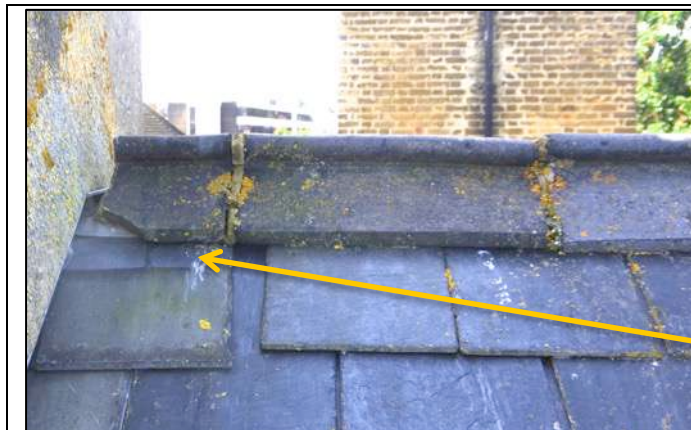
Example of a slipped slate at ridge tile on the rear pile, to the left

Note;  
the ridge tile will need to be removed to replace this slate

There are about 25 broken/ slipped slates, which need to be replaced now.

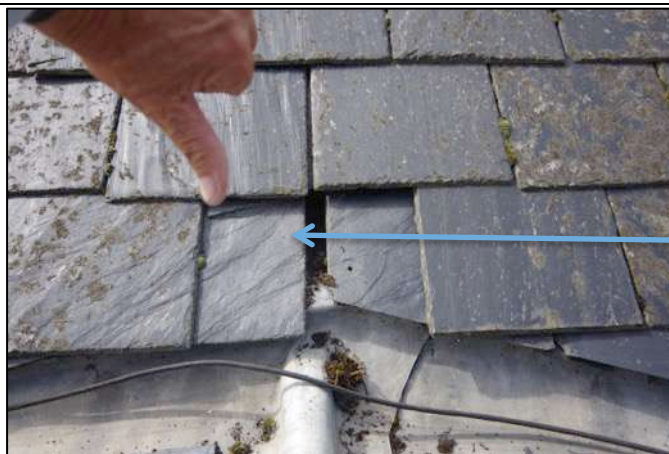
Missing slate at the centre of the front pitch of the rear pile

The surveyor slipped a slate back in for temporary covering repair

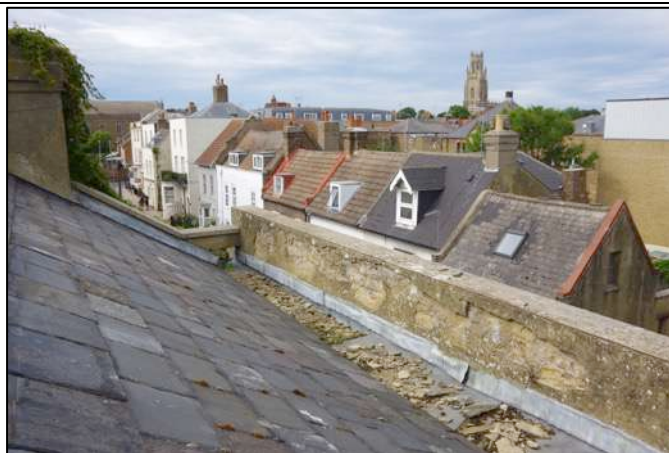
The lead flashing at the front parapet has come away from the wall, this will need to be clipped/wedged back in to the wall and a temporary NHL2 mortar mix used for a repair now as there are signs of (historic) rainwater ingress internally below. Note the surveyor pushed back the flashing in to the mortar joint as best as possible.

Failed cement work and flashing at the front parapet

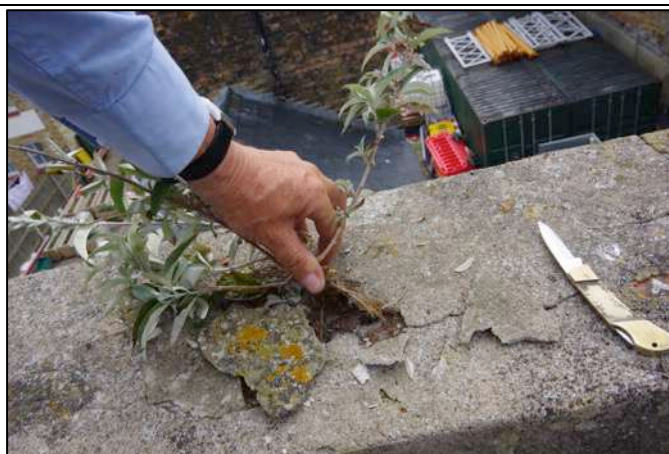
Foliage (Buddleia) has exploited the defective mortars at the front and rear parapets.

Buddleia growing at the top the rear parapet

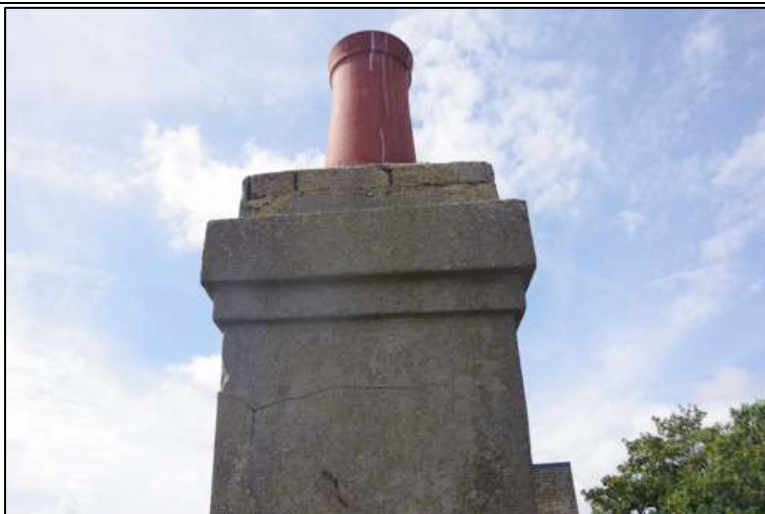
The remaining chimney pot

Note;  
Cracked and failing OPC mortars

The OPC mortars at the crown areas of the chimney stacks and the flaunching have failed, particularly at the flaunching. The failed mortars need removing and redoing with a specified lime mortar. The flashings under the OPC mortars will need attention or replacement.

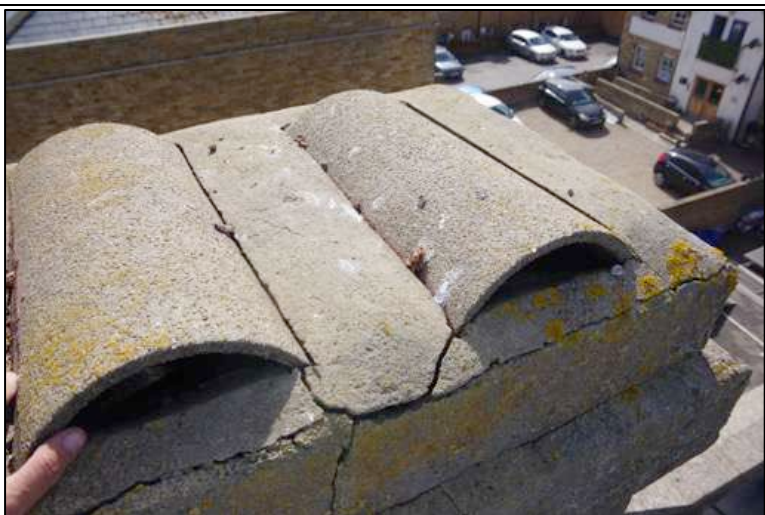
Current flue capping's

Note;  
Cracked and failing OPC mortars

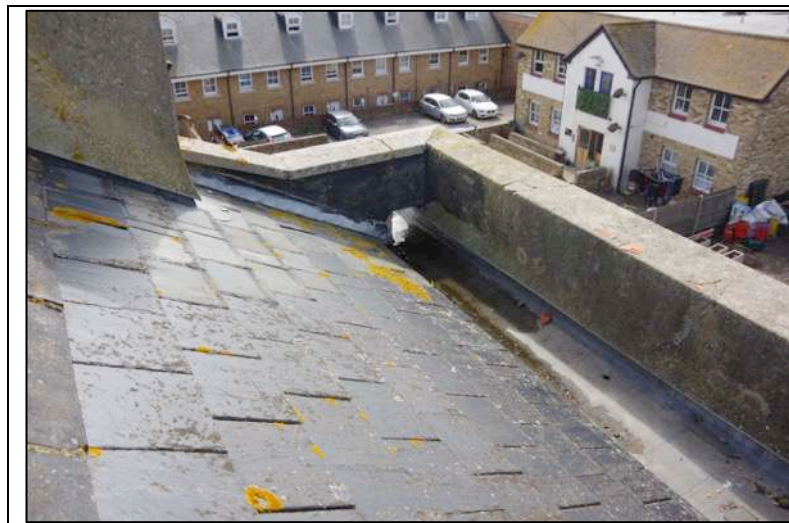
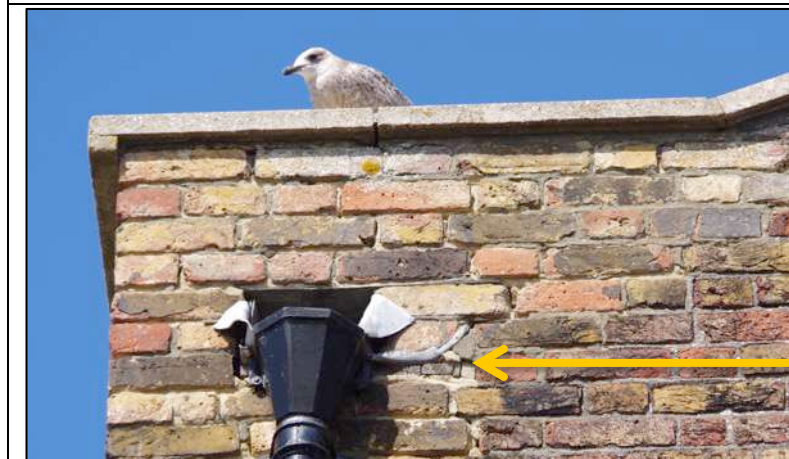
**The left-hand side of the rear gutter**

Water was seen to be ponding at the left-hand end of the back gutter. Rainwater should discharge completely from a roof. The lead work to the gutter outlet has been poorly dressed in and there are exposed timbers on show. Repairs to the corner brickwork here and at the front have been carried out using OPC mortars. Further accessed inspection is required to define what repair work needs to be done.

- Water ponding at the gutter outlet

- Poorly dressed leadwork
- Cement mortars used in brickwork
- Exposed timbers

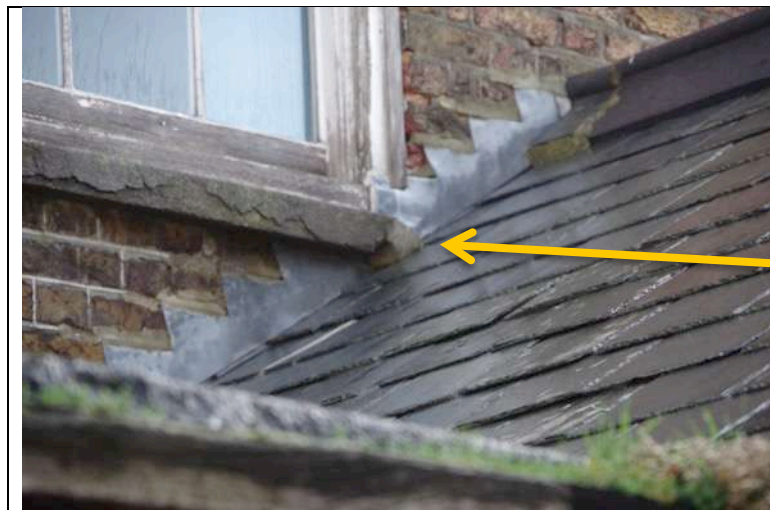
There is some poor detailing where the right-hand pitch meets the building. The roof line is too high, this has led to the flashing clashing with the window cill and attempts to repair/ get over this have been made using OPC mortars. It should be noted that a defective window sill can soak a building's wall; the wall internally has been dry-lined with a plastic sheet incorporated, indicating rainwater penetration. The OPC mortars will need to be stripped from the flashing and the window sill, the lead work inspected and an on-site remedy/ developed.

**Poor detailing at the right-hand pitch where it meets the main building**

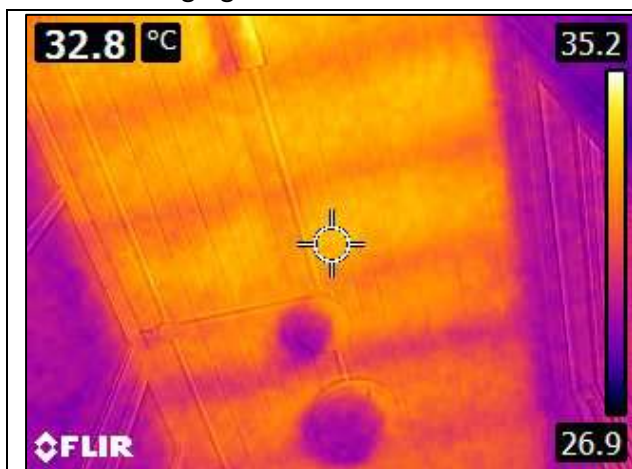
- Excessive heat gain during the summer seen by the bright colours in the image will translate to excessive heat loss in the winter
- Condensation will be forming on the building fabric inside the roof space

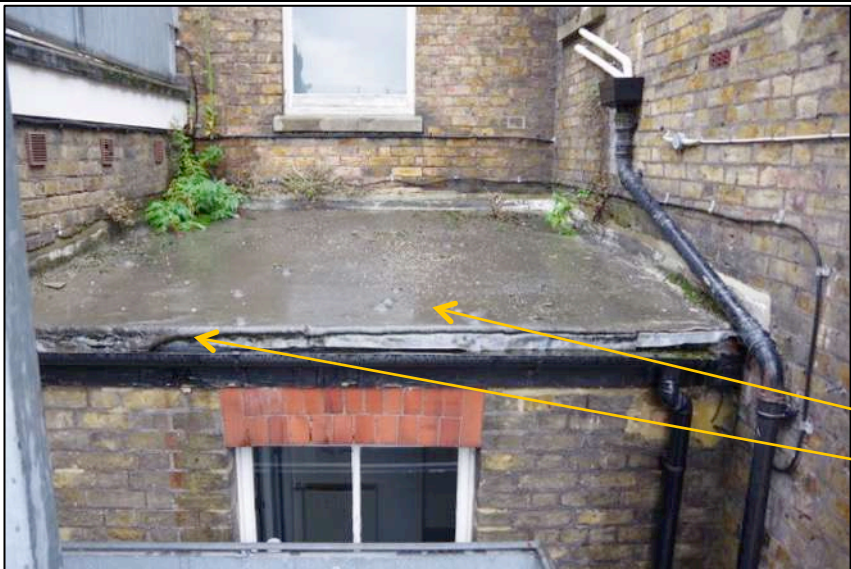
<p><b>Flat Roof Areas</b></p> <p><u>Roof over the toilet</u> <u>/shower</u></p> <p>Notes:</p> <ul style="list-style-type: none"> <li>• Foliage growing in the up-stands</li> <li>• Cement used in the mortar joints</li> <li>• Blistering asphalt</li> <li>• Melted asphalt</li> </ul>

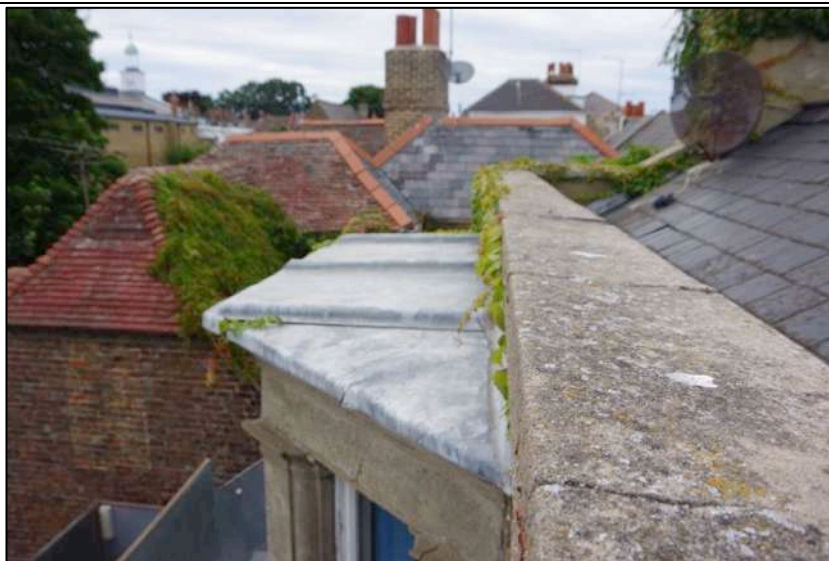
Roof over the rear bay

The roof over the rear bay has been covered with lead; this is for all intent purposes an unventilated cold deck roof. The lead work hasn't been properly detailed at the drip; the lead hasn't been returned on itself, the lead at the central roll is lifting because of this and there is a split at the left right-hand edge where the material has folded on its own. However the lead is doing its job of shedding rainwater and just for now only needs some maintenance at the flashings. The condition of the roofs timbers need to be established, this will require opening up works. The lead roof (along with insulation) should be recovered.

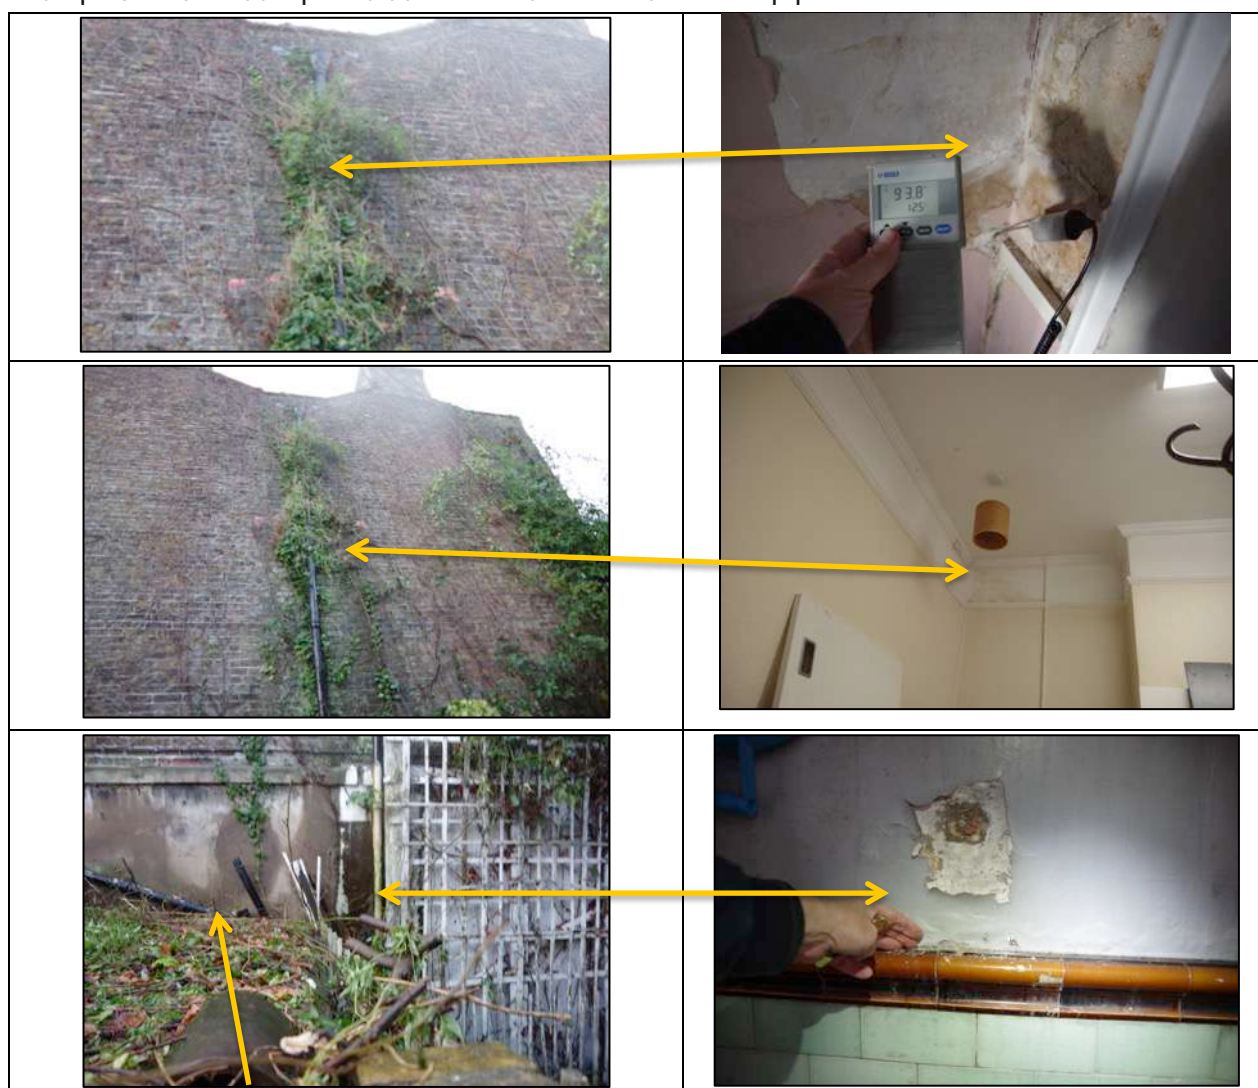
### Examples of rainwater penetration form the defective downpipe

Note; arrows indicate where the pipe is blocked and leaking and how it relates to the internal wall

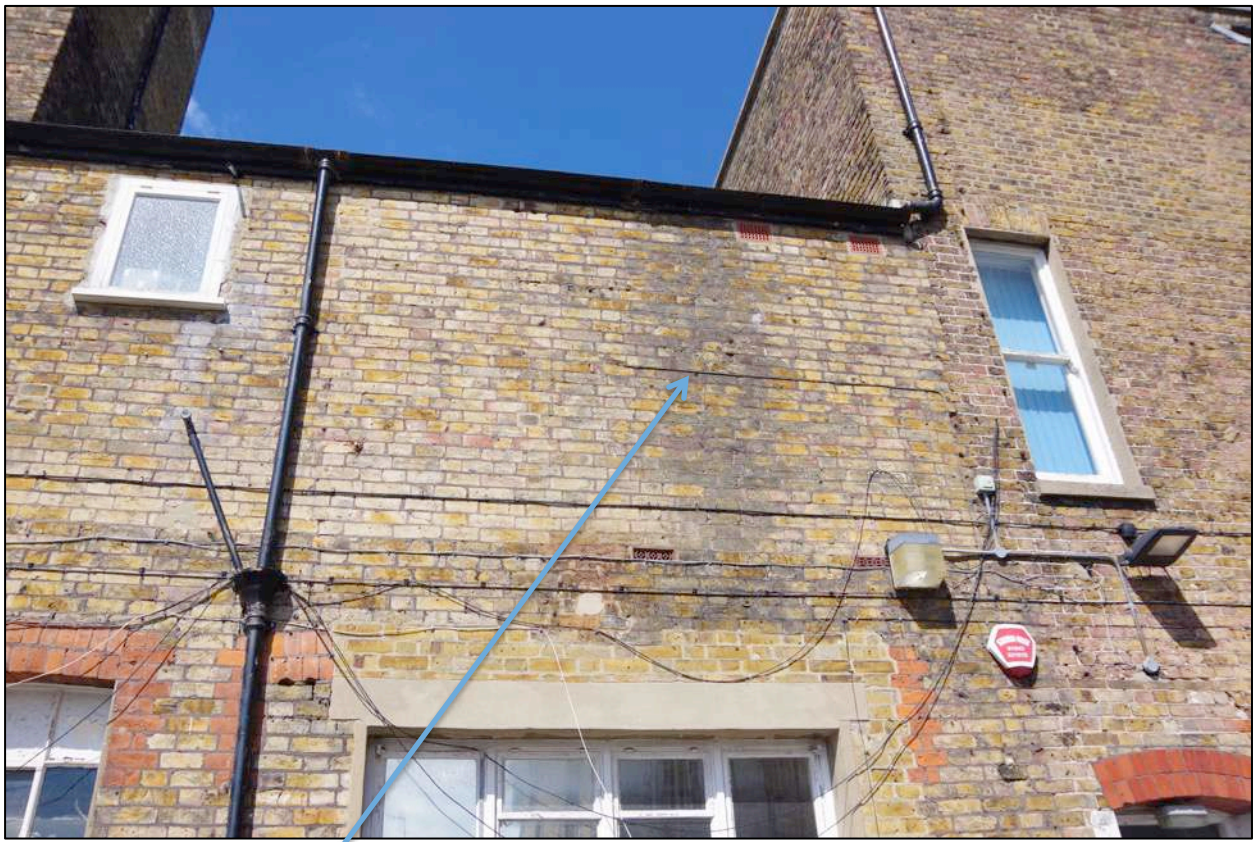
#### Rainwater runs from the rear boxed gutter and the Rear Wing

Note; water staining under gutter

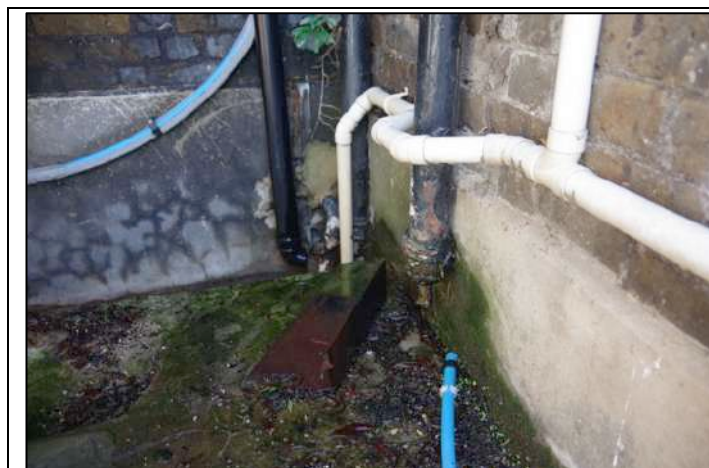
The downpipe that services the right-hand pitch of the rear wing and tower roof discharging on the ground away from the drain

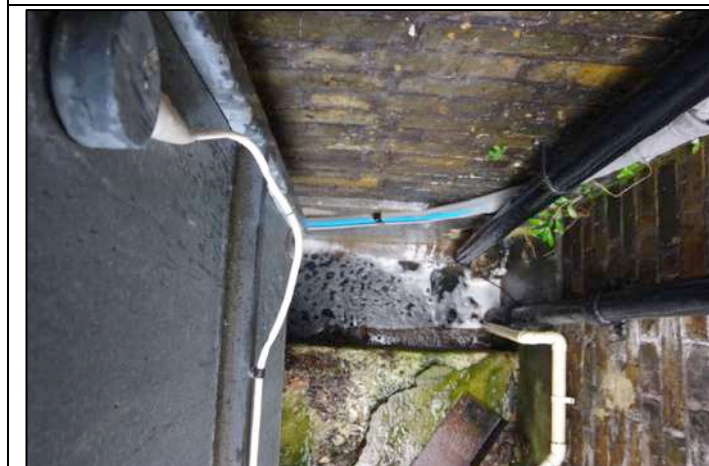
The downpipe that services the rainwater from the flat roofs and domestic wastes discharging over a blocked drain

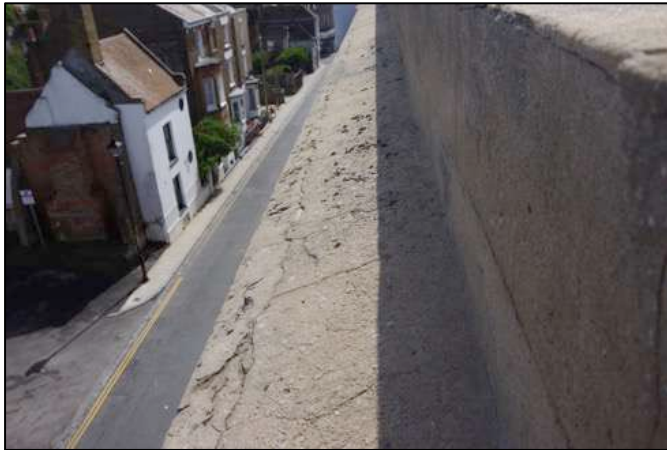
Extensive cracking in the render at the parapet and the top of the cornice

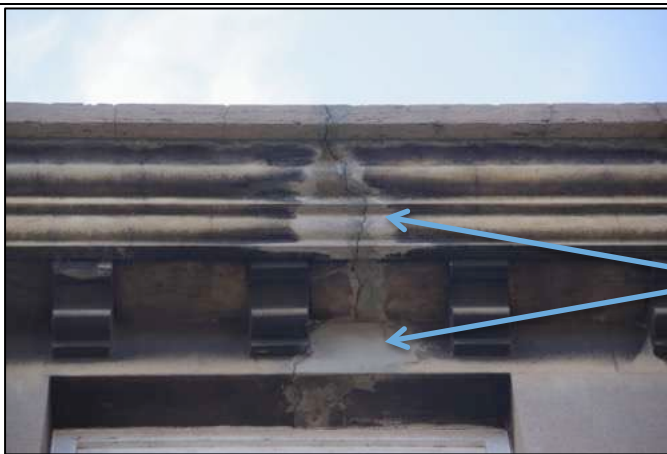
Expansion crack in cornice above the central window

Note crude OPC repairs

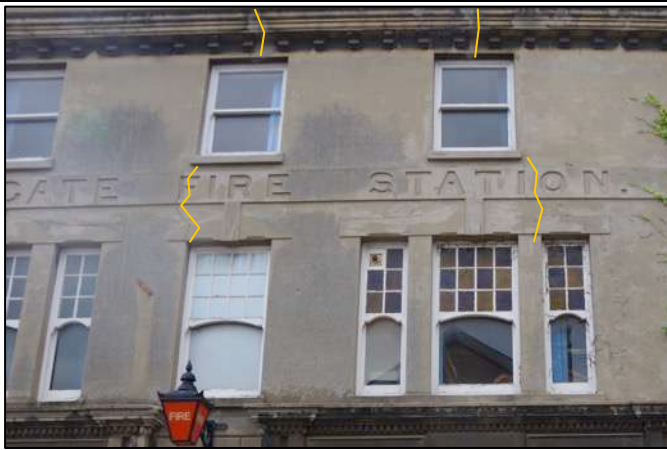
Example of expansion cracks in masonry

Note; yellow lines indicate the cracks

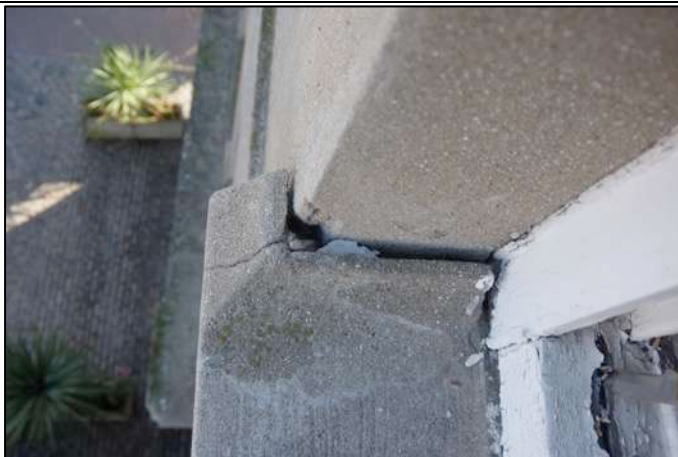
Cracking/ movement at an OPC repair at the top central window

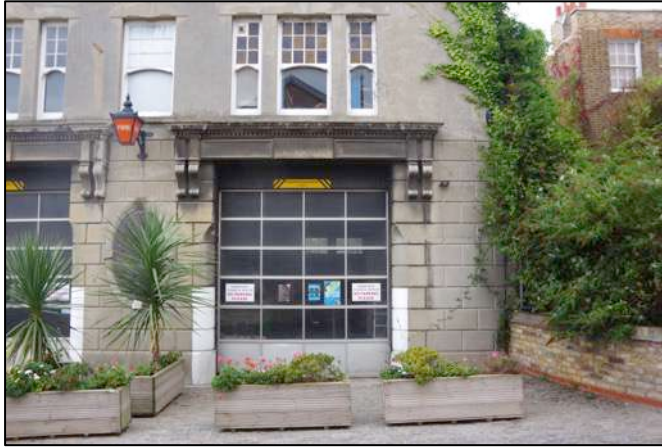
There is heavy soiling under the masonry overhangs at the main entrance doors and at the cornice. The soiling is from the exhausts of just over a century of motorised fire engine use.

**Example of heavy soiling from the motorised fire engines**

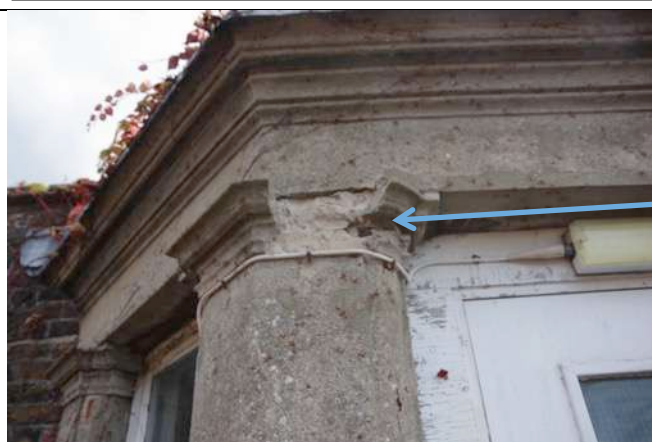
Close up of damaged moulding;  
note embedded metal

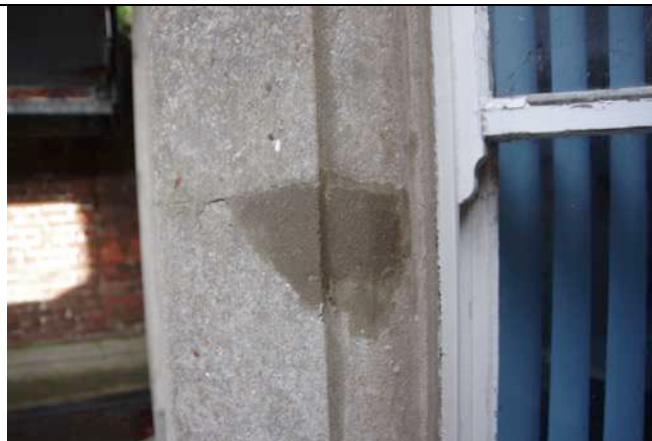
OPC repair over blown cement

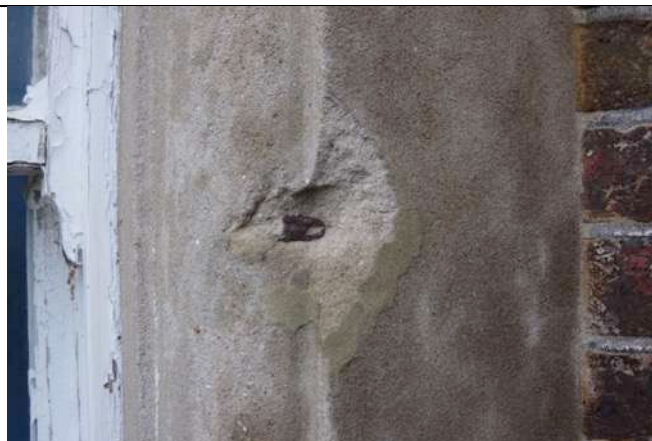
Example of OPC repair that has been blown  
off by embedded metal

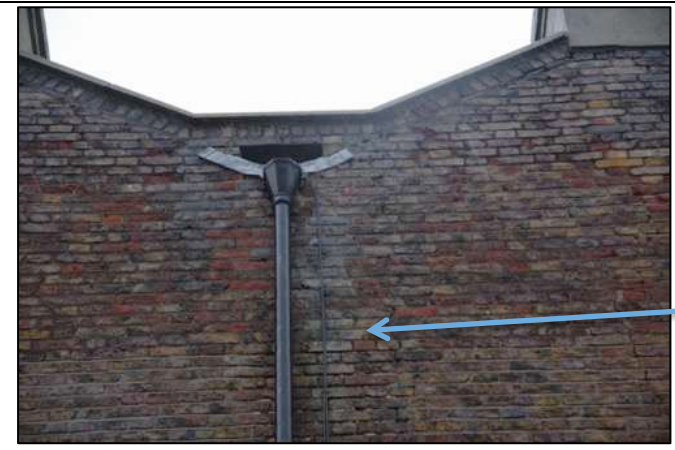
<p>Rain water bypassing the hopper downpipe at the central boxed gutter</p> <p>Notes</p> <ul style="list-style-type: none"> <li>• Water run off from the copings</li> <li>• Mortars washed away here</li> </ul>

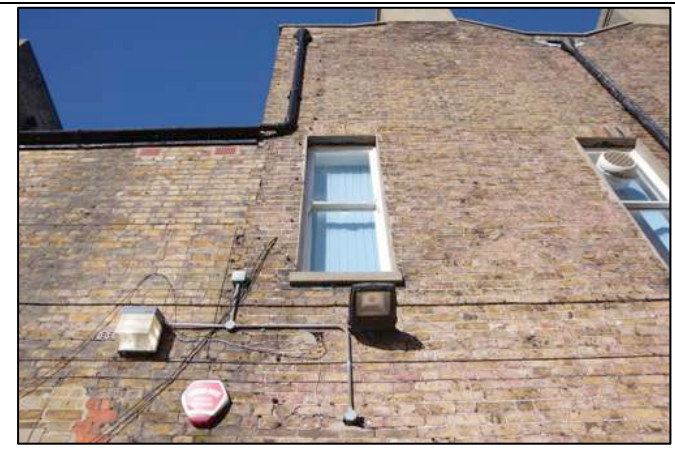
<p>Left hand wall where it meets the rear wing</p> <p>Note; crude bonding where the masonry has been built up</p>

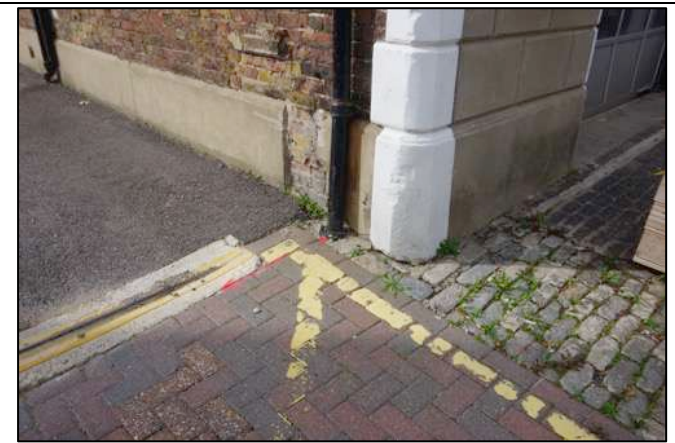
<p>Example of inappropriate cement plinth work</p>

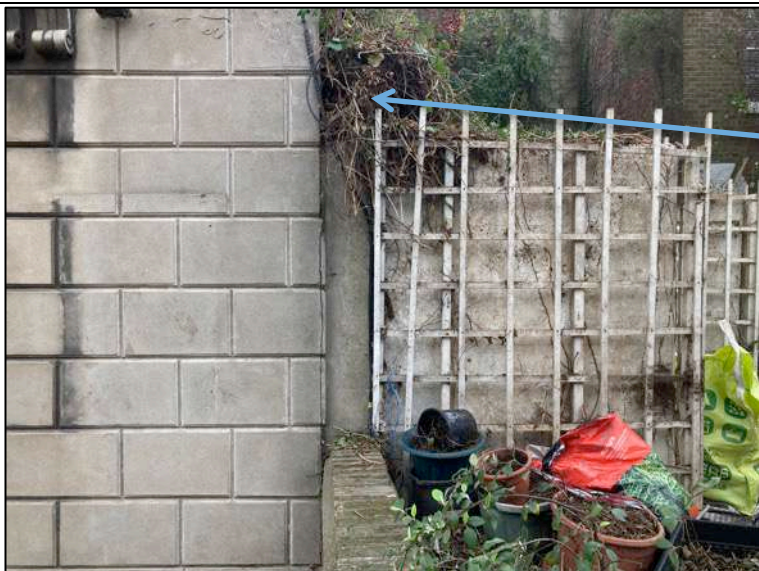
Note;  
foliage has exploited the joint here

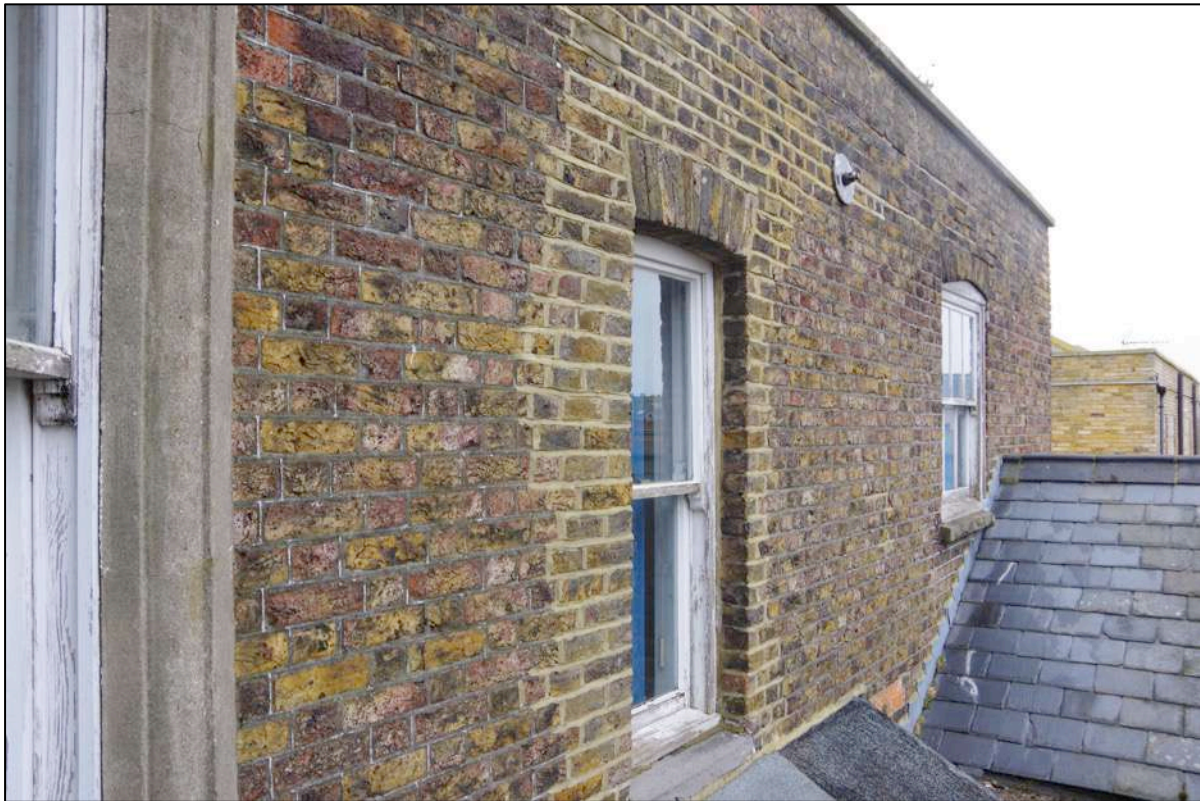
**Rear Elevation at the second floor**

Note; Crudely built window opening

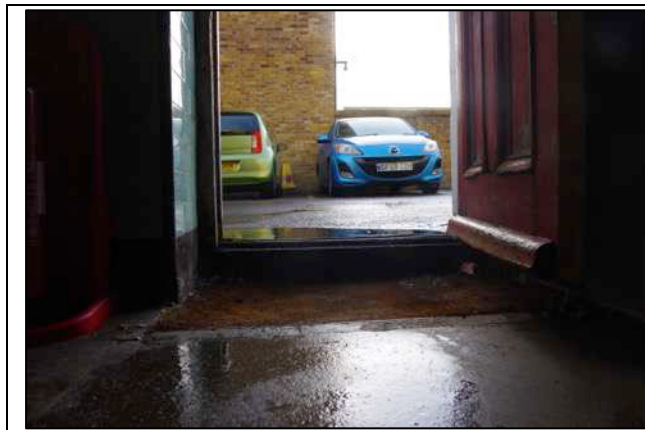
Rainwater ponding at the side entry door

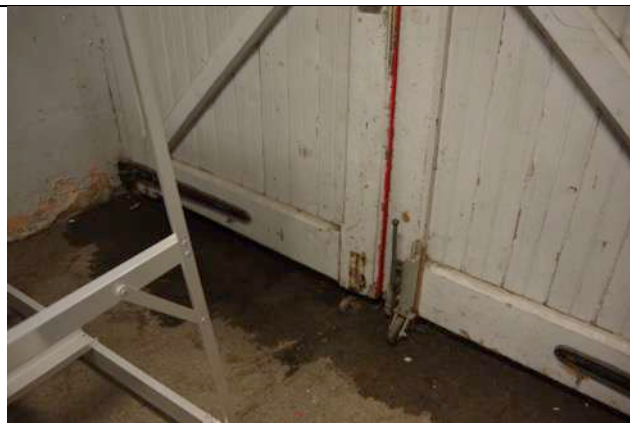
Rainwater penetrating into the carriage entry

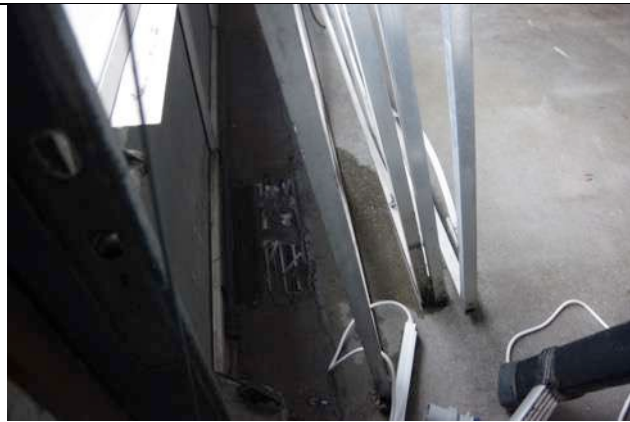
Rainwater penetrating into the appliance bay

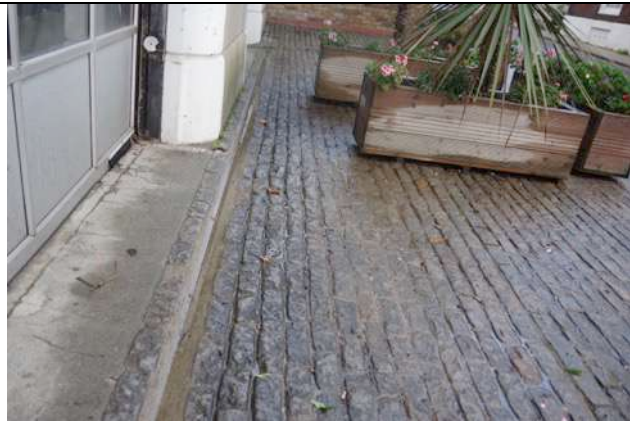
Gully formed at the front to the roller shutter doors

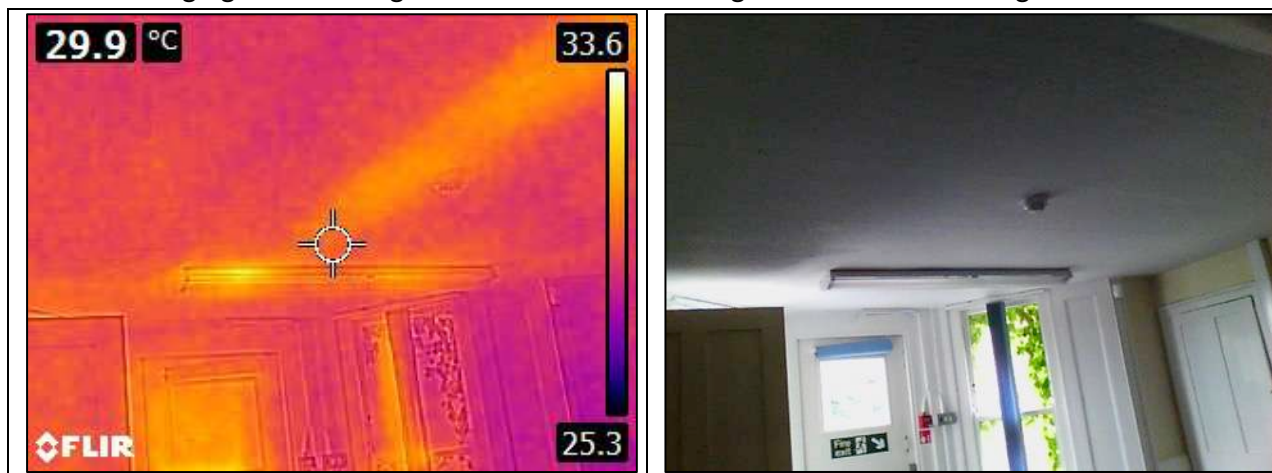
Thermal imaging of the ceiling at the back room to the right of the main building

Note; the brighter colours in the ceiling shows an area where there is no insulation at all

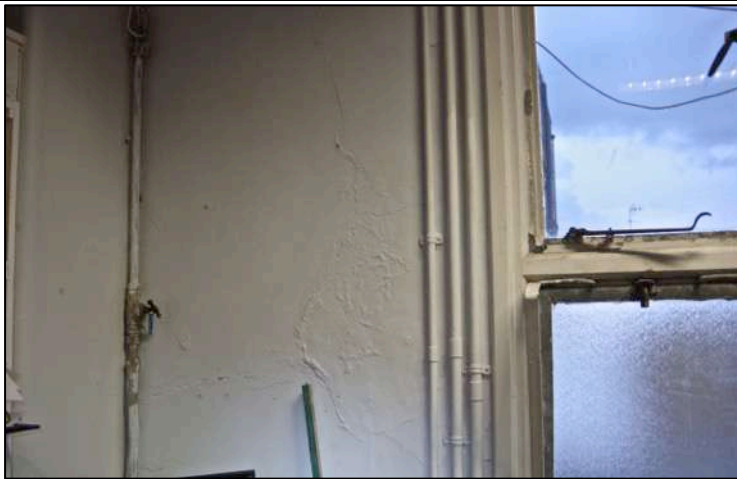
Hydrostatic pressure blowing the impermeable materials off of the wall in the front Watch Room

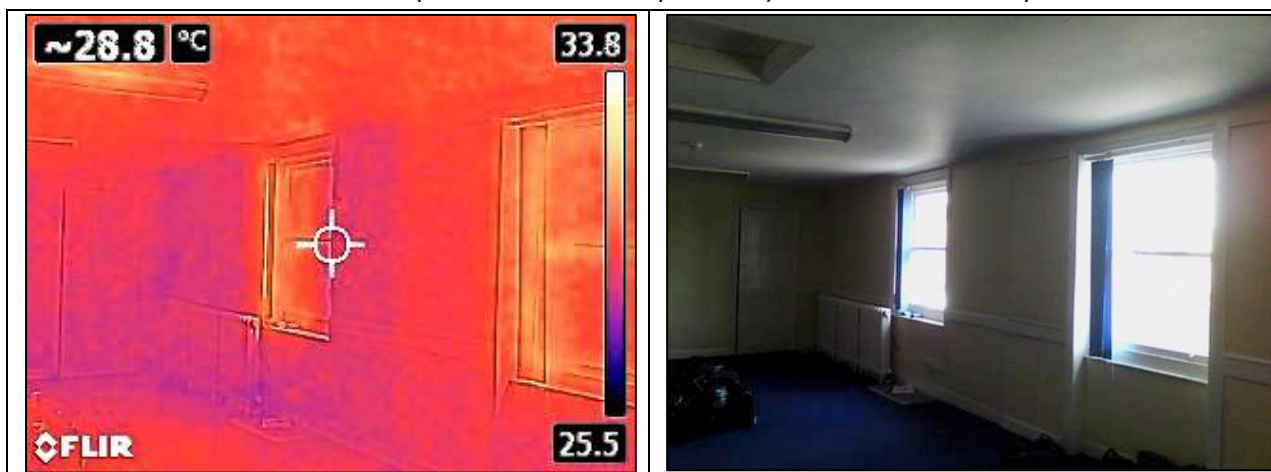
Second floor were the lath and plaster has been replaced by cementitious solid plaster

Note; temperature difference between the two sets of materials; solid plaster to the left, lath and plaster to the right. The imaging was done in the summer months when the building was near equilibrium with its environment. The solid plaster needs to be stripped and the lath and plaster reinstated.
