Survey of
Asbestos Materials
at

HELLESDON
COMMUNITY CENTRE
Norwich

Survey completed on : 08 April 2016

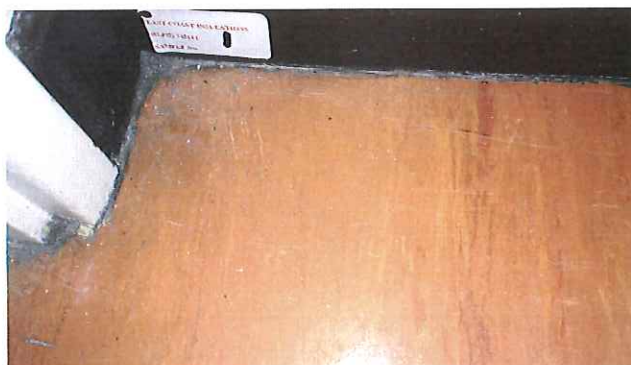
Location:	Type:	Inspection Type:		
Bush Room, flooring	A.I.B. 4

Friability	LOW 1	MEDIUM 2	HIGH 4	Amount - Square Metres: 54.0		
General Condition	GOOD 0	FAIR 2	POOR 4	Laboratory Results Vinyl & adhesive		
Algorithm Rating		Recommended Action:	High	Chrysotile		
			Medium	Amosite		
			Low	Crocidolite

Photograph No:- 01	Sample No:- HCC-01
-------------------------------------	-------------------------------------

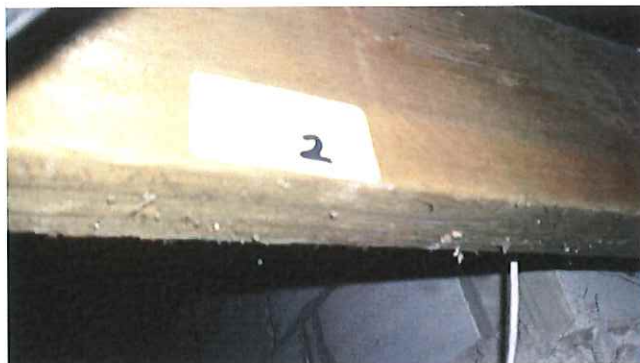
Site Name: HELLESDON COMMUNITY CENTRE, NORWICH		Surveyor: KEITH YELLOP		Date: 08.04.16	
Location:	Type:		Inspection Type:		
Front corridor, debris on joists above false ceiling	A.I.B.	4

Friability	LOW 1		MEDIUM 2		HIGH 4		Amount - Square Metres: MINOR		
General Condition	GOOD 0		FAIR 2		POOR 4		Laboratory Results Insulating board		
Algorithm Rating			Recommended Action:	High		Chrysotile			
				Medium		Amosite			
				Low		Crocidolite			
Photograph No:- 02					Sample No:- HCC-02

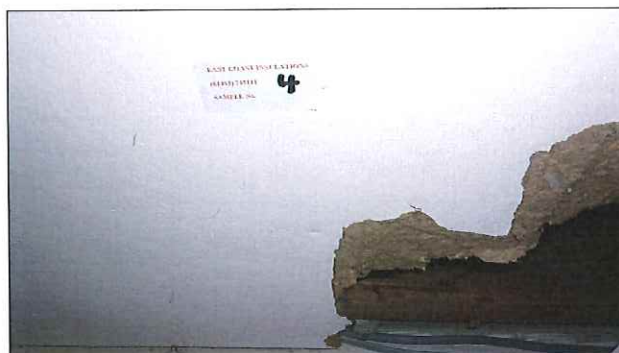
Site Name: HELLESDON COMMUNITY CENTRE, NORWICH		Surveyor: KEITH YELLOP		Date: 08.04.16	
Location:	Type:	Inspection Type:			
Front corridor, old fibreboard ceiling above ceiling tiles	A.I.B. 4	<div style="display: flex; justify-content: space-around;"> <div style="text-align: center;"> <input checked="" type="checkbox"/> Management </div> <div style="text-align: center;"> <input type="checkbox"/> Refurbishment/ Demolition </div> </div>			
	Spray 6				
	Insulation 5				
	Textured Coating 1				
	Cement 2				
	Other 1

Accessibility	DIFFICULT 0		MEDIUM 2		EASY 6		Asbestos	Yes	No
Damaged	NO 0		MINOR 2		SEVERE 4				<input checked="" type="checkbox"/>
Friability	LOW 1		MEDIUM 2		HIGH 4		Amount - Square Metres: EXTENSIVE		
General Condition	GOOD 0		FAIR 2		POOR 4		Laboratory Results Fibreboard		
Algorithm Rating			Recommended Action:	High		Chrysotile			
				Medium		Amosite			
				Low		Crocidolite			
Photograph No:- 04						Sample No:- HCC-04

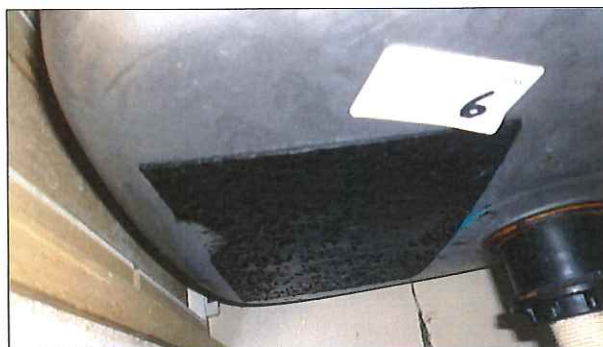
Photograph No:-
06

HCC-06 Doctor's room, acoustic pad beneath sink: Bitumen, Chrysotile

Site Name: HELLESDON COMMUNITY CENTRE, NORWICH		Surveyor: KEITH YELLOP		Date: 08.04.16																					
Location: Doctors Room, acoustic pad beneath sink		Type: <table border="1" style="width: 100%; border-collapse: collapse;"> <tr><td>A.I.B.</td><td style="text-align: center;">4</td><td></td></tr> <tr><td>Spray</td><td style="text-align: center;">6</td><td></td></tr> <tr><td>Insulation</td><td style="text-align: center;">5</td><td></td></tr> <tr><td>Textured Coating</td><td style="text-align: center;">1</td><td></td></tr> <tr><td>Cement</td><td style="text-align: center;">2</td><td></td></tr> <tr><td>Other</td><td style="text-align: center;">1</td><td style="text-align: center;"><input checked="" type="checkbox"/></td></tr> </table>		A.I.B.	4		Spray	6		Insulation	5		Textured Coating	1		Cement	2		Other	1	<input checked="" type="checkbox"/>	Inspection Type: <table border="1" style="width: 100%; border-collapse: collapse;"> <tr> <td style="text-align: center; vertical-align: middle;"> <input checked="" type="checkbox"/> Management </td> <td style="text-align: center; vertical-align: middle;"> <input type="checkbox"/> Refurbishment/ Demolition </td> </tr> </table>		<input checked="" type="checkbox"/> Management	<input type="checkbox"/> Refurbishment/ Demolition

Accessibility	DIFFICULT 0	<input checked="" type="checkbox"/>	MEDIUM 2		EASY 6		Asbestos	Yes	No
Damaged	NO 0	<input checked="" type="checkbox"/>	MINOR 2		SEVERE 4			<input checked="" type="checkbox"/>	
Friability	LOW 1	<input checked="" type="checkbox"/>	MEDIUM 2		HIGH 4		Amount - Square Metres: MINOR		
General Condition	GOOD 0	<input checked="" type="checkbox"/>	FAIR 2		POOR 4		Laboratory Results Bitumen		
Algorithm Rating	2	Recommended Action: LABEL & MANAGE	High			Chrysotile	<input checked="" type="checkbox"/>		
			Medium			Amosite			
			Low		<input checked="" type="checkbox"/>	Crocidolite

Sample Ref.	Description	Date Checked	Comments	Recommended Action	Signed
HCC-06	Doctors room, acoustic pad beneath sink	08.04.16	Bitumen – Chrysotile (white) asbestos	LABEL & MANAGE

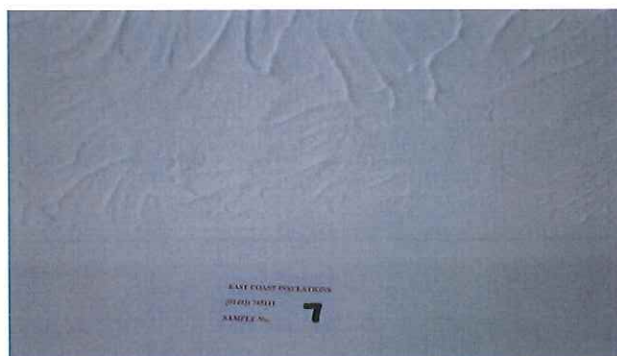
Photograph No:-
07

Site Name: HELLESDON COMMUNITY CENTRE, NORWICH		Surveyor: KEITH YELLOP		Date: 08.04.16															
Location: Kitchen, ceiling textured coating		Type: <table border="1" style="width: 100%; border-collapse: collapse;"> <tr><td>A.I.B.</td><td style="text-align: center;">4</td></tr> <tr><td>Spray</td><td style="text-align: center;">6</td></tr> <tr><td>Insulation</td><td style="text-align: center;">5</td></tr> <tr><td>Textured Coating</td><td style="text-align: center;">1</td></tr> <tr><td>Cement</td><td style="text-align: center;">2</td></tr> <tr><td>Other</td><td style="text-align: center;">1</td></tr> </table>		A.I.B.	4	Spray	6	Insulation	5	Textured Coating	1	Cement	2	Other	1	Inspection Type: <table border="1" style="width: 100%; border-collapse: collapse;"> <tr> <td style="text-align: center; vertical-align: middle;">   Management </td> <td style="text-align: center; vertical-align: middle;">   Refurbishment/ Demolition </td> </tr> </table>		  Management	  Refurbishment/ Demolition

Friability	LOW 1		MEDIUM 2		HIGH 4		Amount - Square Metres: 35.0		
General Condition	GOOD 0		FAIR 2		POOR 4		Laboratory Results Textured coating		
Algorithm Rating	Recommended Action:		High			Chrysotile			
			Medium			Amosite			
			Low			Crocidolite

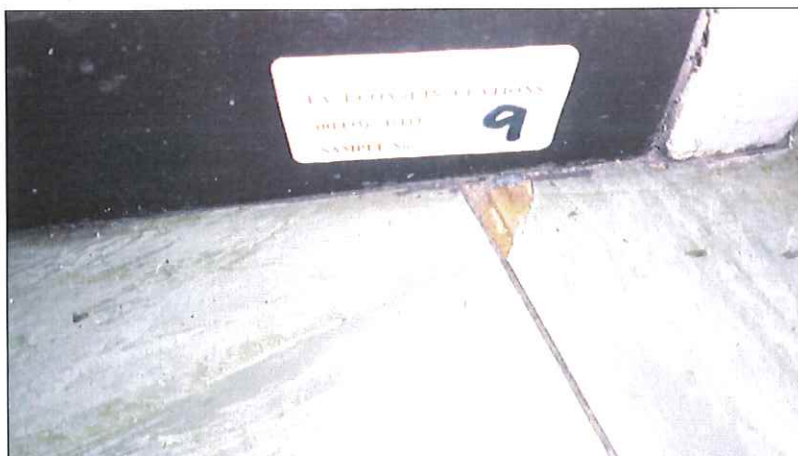
Site Name: HELLESDON COMMUNITY CENTRE, NORWICH		Surveyor: KEITH YELLOP		Date: 08.04.16	
Location: Caretaker's office, green floor tiles	Type:		Inspection Type:		
	A.I.B.	4	<input checked="" type="checkbox"/> Management	<input type="checkbox"/> Refurbishment/ Demolition	
	Spray	6			
	Insulation	5			
	Textured Coating	1			
	Cement	2			
	Other	1

Accessibility	DIFFICULT 0		MEDIUM 2		EASY 6		Asbestos	Yes	No
Damaged	NO 0		MINOR 2		SEVERE 4				<input checked="" type="checkbox"/>
Friability	LOW 1		MEDIUM 2		HIGH 4		Amount - Square Metres: 12.0		
General Condition	GOOD 0		FAIR 2		POOR 4		Laboratory Results Floor tile & adhesive		
Algorithm Rating		Recommended Action:	High			Chrysotile			
			Medium			Amosite			
			Low			Crocidolite			
Photograph No:- 09					Sample No:- HCC-09

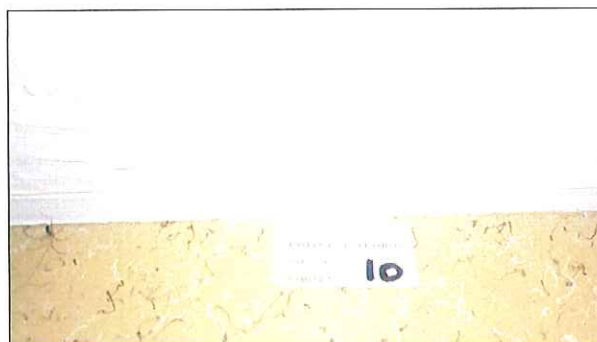
Site Name: HELLESDON COMMUNITY CENTRE, NORWICH		Surveyor: KEITH YELLOP		Date: 08.04.16	
Location:	Type:	Inspection Type:			
Corridor to fire exit, ceiling textured coating	A.I.B. 4	<input checked="" type="checkbox"/>

Accessibility	DIFFICULT 0		MEDIUM 2		EASY 6		Asbestos	Yes	No
Damaged	NO 0		MINOR 2		SEVERE 4				<input checked="" type="checkbox"/>
Friability	LOW 1		MEDIUM 2		HIGH 4		Amount - Square Metres: 24.0		
General Condition	GOOD 0		FAIR 2		POOR 4		Laboratory Results Textured coating		
Algorithm Rating		Recommended Action:	High		Chrysotile				
			Medium		Amosite				
			Low		Crocidolite				
Photograph No:- 10						Sample No:- HCC-10

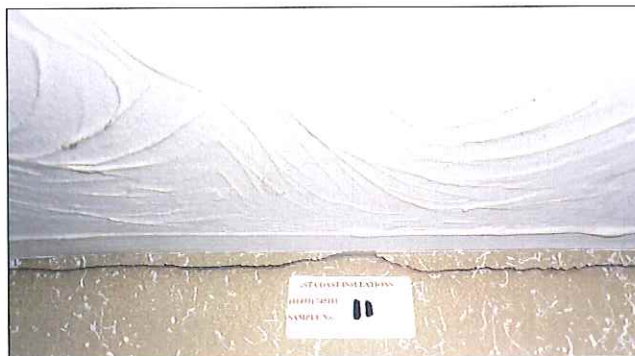
Site Name: HELLESDON COMMUNITY CENTRE, NORWICH		Surveyor: KEITH YELLOP		Date: 08.04.16															
Location: Changing room & disabled wc, ceiling textured coating		Type: <table border="1" style="width: 100%; border-collapse: collapse;"> <tr><td>A.I.B.</td><td style="text-align: center;">4</td></tr> <tr><td>Spray</td><td style="text-align: center;">6</td></tr> <tr><td>Insulation</td><td style="text-align: center;">5</td></tr> <tr><td>Textured Coating</td><td style="text-align: center;">1</td></tr> <tr><td>Cement</td><td style="text-align: center;">2</td></tr> <tr><td>Other</td><td style="text-align: center;">1</td></tr> </table>		A.I.B.	4	Spray	6	Insulation	5	Textured Coating	1	Cement	2	Other	1	Inspection Type: <table border="1" style="width: 100%; border-collapse: collapse;"> <tr> <td style="text-align: center; vertical-align: middle;"> <input checked="" type="checkbox"/> Management </td> <td style="text-align: center; vertical-align: middle;"> <input type="checkbox"/> Refurbishment/ Demolition </td> </tr> </table>		<input checked="" type="checkbox"/> Management	<input type="checkbox"/> Refurbishment/ Demolition

Accessibility	DIFFICULT 0		MEDIUM 2		EASY 6		Asbestos	Yes	No
Damaged	NO 0		MINOR 2		SEVERE 4				<input checked="" type="checkbox"/>
Friability	LOW 1		MEDIUM 2		HIGH 4		Amount - Square Metres: 46.0		
General Condition	GOOD 0		FAIR 2		POOR 4		Laboratory Results Textured coating		
Algorithm Rating		Recommended Action:	High		Chrysotile				
			Medium		Amosite				
			Low		Crocidolite				
Photograph No:- 11						Sample No:- HCC-11

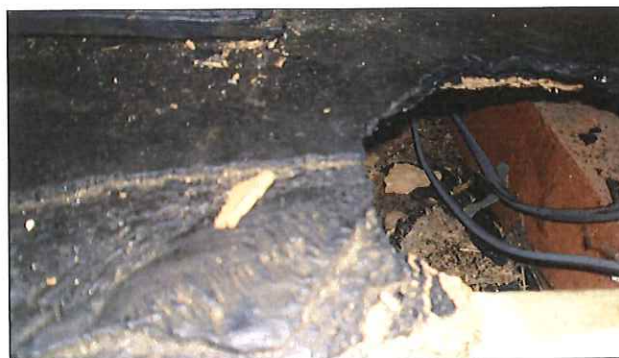
Site Name: HELLESDON COMMUNITY CENTRE, NORWICH		Surveyor: KEITH YELLOP		Date: 08.04.16	
Location:	Type:	Inspection Type:			
Roof void, original flat roof, roofing felt, bitumen	A.I.B.	4	<div style="display: flex; justify-content: space-around;"> <div style="text-align: center;"> <input checked="" type="checkbox"/> Management </div> <div style="text-align: center;"> <input type="checkbox"/> Refurbishment/ Demolition </div> </div>		
	Spray	6			
	Insulation	5			
	Textured Coating	1			
	Cement	2			
	Other	1

Accessibility	DIFFICULT 0		MEDIUM 2		EASY 6		Asbestos	Yes	No
Damaged	NO 0		MINOR 2		SEVERE 4				<input checked="" type="checkbox"/>
Friability	LOW 1		MEDIUM 2		HIGH 4		Amount - Square Metres: EXTENSIVE		
General Condition	GOOD 0		FAIR 2		POOR 4		Laboratory Results Bitumen felt		
Algorithm Rating			Recommended Action:	High			Chrysotile		
				Medium			Amosite		
				Low			Crocidolite		
Photograph No:- 13						Sample No:- HCC-13

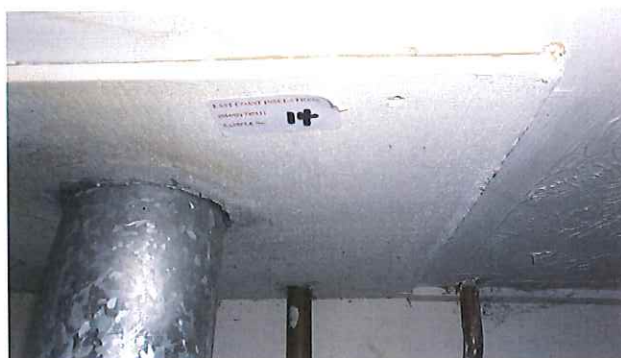
Site Name: HELLESDON COMMUNITY CENTRE, NORWICH		Surveyor: KEITH YELLOP	Date: 08.04.16
Location:	Type:	Inspection Type:	
Store room, boarding above boiler	A.I.B. 4	<input checked="" type="checkbox"/> Management	<input type="checkbox"/> Refurbishment/ Demolition
	Spray 6		
	Insulation 5		
	Textured Coating 1		
	Cement 2		
	Other 1

Accessibility	DIFFICULT 0		MEDIUM 2		EASY 6		Asbestos	Yes	No
Damaged	NO 0		MINOR 2		SEVERE 4				<input checked="" type="checkbox"/>
Friability	LOW 1		MEDIUM 2		HIGH 4		Amount - Square Metres: 1.0		
General Condition	GOOD 0		FAIR 2		POOR 4		Laboratory Results Insulating board		
Algorithm Rating		Recommended Action:	High			Chrysotile			
			Medium			Amosite			
			Low			Crocidolite			
Photograph No:- 14						Sample No:- HCC-14

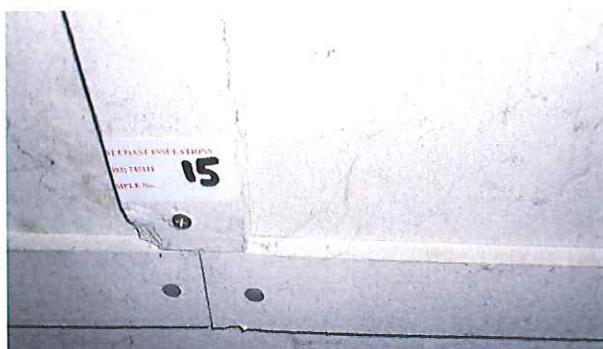
Site Name: HELLESDON COMMUNITY CENTRE, NORWICH		Surveyor: KEITH YELLOP		Date: 08.04.16															
Location: Boiler room, ceiling boards		Type: <table border="1" style="width: 100%; border-collapse: collapse;"> <tr><td>A.I.B.</td><td style="text-align: center;">4</td></tr> <tr><td>Spray</td><td style="text-align: center;">6</td></tr> <tr><td>Insulation</td><td style="text-align: center;">5</td></tr> <tr><td>Textured Coating</td><td style="text-align: center;">1</td></tr> <tr><td>Cement</td><td style="text-align: center;">2</td></tr> <tr><td>Other</td><td style="text-align: center;">1</td></tr> </table>		A.I.B.	4	Spray	6	Insulation	5	Textured Coating	1	Cement	2	Other	1	Inspection Type: <table border="1" style="width: 100%; border-collapse: collapse;"> <tr> <td style="text-align: center; vertical-align: middle;"> <input checked="" type="checkbox"/> Management </td> <td style="text-align: center; vertical-align: middle;"> <input type="checkbox"/> Refurbishment/ Demolition </td> </tr> </table>		<input checked="" type="checkbox"/> Management	<input type="checkbox"/> Refurbishment/ Demolition

Accessibility	DIFFICULT 0		MEDIUM 2		EASY 6		Asbestos	Yes	No
Damaged	NO 0		MINOR 2		SEVERE 4				<input checked="" type="checkbox"/>
Friability	LOW 1		MEDIUM 2		HIGH 4		Amount - Square Metres: 12.0		
General Condition	GOOD 0		FAIR 2		POOR 4		Laboratory Results Insulating board		
Algorithm Rating	Recommended Action:		High			Chrysotile			
			Medium			Amosite			
			Low			Crocidolite			
Photograph No:- 15					Sample No:- HCC-15

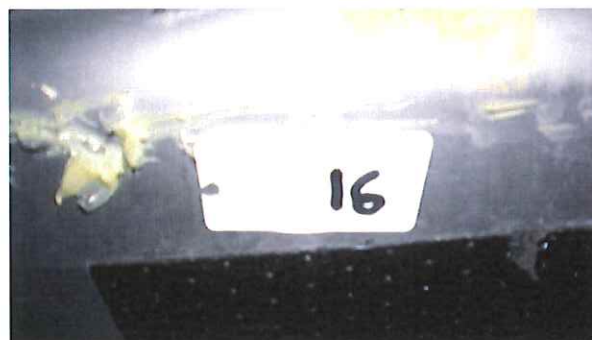
Site Name: HELLESDON COMMUNITY CENTRE, NORWICH			Surveyor: KEITH YELLOP		Date: 08.04.16	
Location: Bar, acoustic pad beneath sink		Type:		Inspection Type:		
		A.I.B.	4			
		Spray	6			
		Insulation	5			
		Textured Coating	1			
		Cement	2			
		Other	1

Accessibility	DIFFICULT 0		MEDIUM 2		EASY 6		Asbestos	Yes	No
Damaged	NO 0		MINOR 2		SEVERE 4				<input checked="" type="checkbox"/>
Friability	LOW 1		MEDIUM 2		HIGH 4		Amount - Square Metres: MINOR		
General Condition	GOOD 0		FAIR 2		POOR 4		Laboratory Results Bitumen		
Algorithm Rating		Recommended Action:	High			Chrysotile			
			Medium			Amosite			
			Low			Crocidolite			
Photograph No:- 16					Sample No:- HCC-16
