Asbestos Register including Completed Management Action Plan

Revised Asbestos Register

Project Ref: Re-inspection 2013

Oakham Castle
Market Place
Oakham
Rutland
LE15 6DR

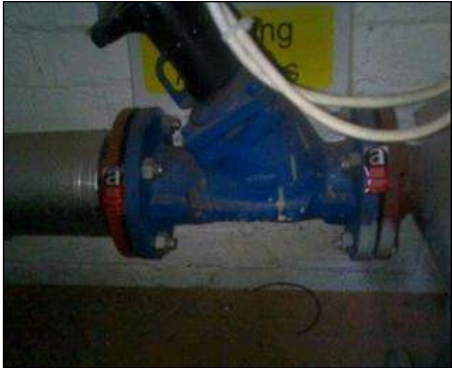
Floor/Room ID		Sample Description						
Ground 15		Gaskets to pipework.						
Room Description								
Boiler Room / Sump Room								
Element								
Pipework								
Record ID	3506426	Asbestos Analysis		Sample No.	003/334	Quantity	1	4
Survey ID	208030	Chrysotile		Ref Sample		Unit	m	
Survey Type	Type 2

Material Risk Assessment		Priority Risk Assessment				Total Risk Score		Management Plan & Timescales
Gaskets	2	Low disturbance	1	1 to 4	1	Material Score	4	Re-inspect condition of material within 12 months.
Low Damage-few scratches on surface,broken edges	1	Low disturbance	1	Infrequently	0	Priority Risk Score	2	
Composite materials reinforced plastic,resins etc	0	Rooms up to 100m2	2	<1/Hr	0	Total Risk Score	6	
Chrysotile	1	Usually inaccessible	0	Minor disturbance possible	0			
		<10m2 or <10m run	1	Unlikely to be disturbed	0
