Refurbishment Survey

Martello Toilets, Martello Tower, Seaford, BN25 1JH
Seaford Town Council
J023994
15th November 2022
17th November 2022
Colin Van Son
Report Reviewed By:

Asbestos Survey of Martello Toilets, Martello Tower, Seaford

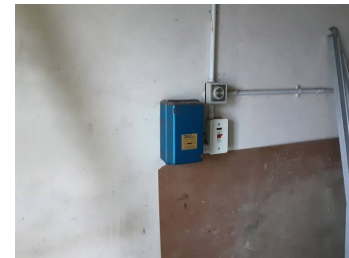
<p>Picture 4</p>
Visual	Martello Toilets, Seaford	Ground Floor	Textiles	Attendants room, To electrics	Small amou	Bonded	Metal	Chrysotile	
Recommendations					Assessment Scores			Risk Code	
					Material	Priority	Total		
Remove, repair or encapsulate by a licenced asbestos contractor under controlled conditions. Work on this material requires a license & is notifiable to the appropriate enforcing authority. Disposal of asbestos waste by a licensed contractor only. All work must conform to the 'Control of Asbestos Regulations 2012'.					5	-	5	C	
Reinspection Due		12 months	Actions Taken	N/A	Time Scale			Action Completed Sign & Date

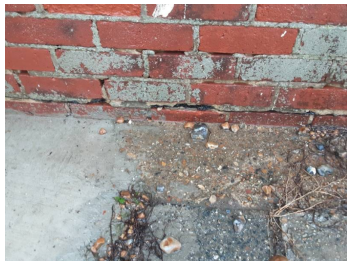
Picture 6
AJ002465	Martello Toilets, Seaford	External	Bitumen	External Elements, Damp proof course	10lm	Bonded	Brick	Chrysotile	
Recommendations					Assessment Scores			Risk Code	
					Material	Priority	Total		
Low risk ACM (bound in matrix) remove, repair or encapsulate under controlled conditions. Work on this material does not require a license. Work on this material may be notifiable to the appropriate enforcing authority. Disposal of asbestos waste by a licensed contractor only. All work must conform to the 'Control of Asbestos Regulations 2012'.					3	-	3	D	
Reinspection Due		12 months	Actions Taken	N/A	Time Scale			Action Completed Sign & Date

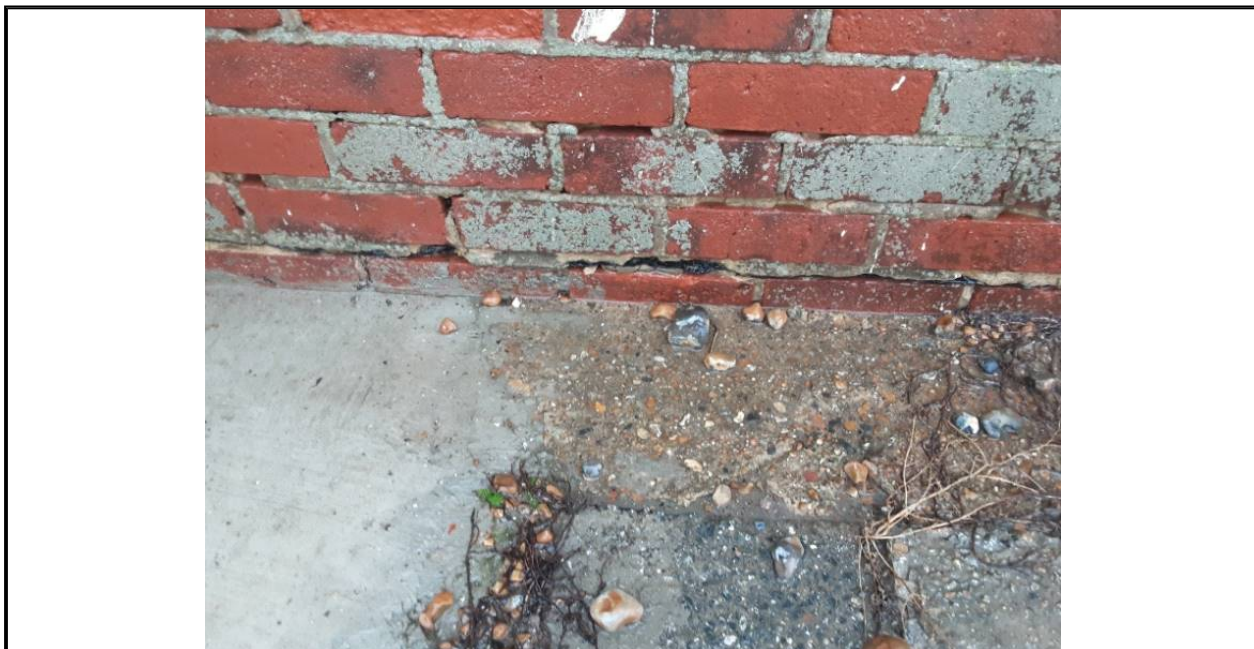
Sample No:	AJ002465
Item No:	6
Survey Date:	15/11/22
Building:	Martello Toilets, Seaford
Floor:	External
Room No:	External Elements
Position:	Damp proof course - Bitumen
Extent:	10lm
Substrate:	Bonded, Brick
Material:	(1) Well Bound Material
Accessibility:	(1) Occasionally likely to be disturbed
Asbestos Type:	Chrysotile
Risk Category:	D
Recommended Action:	Low risk ACM (bound in matrix) remove, repair or encapsulate under controlled conditions. Work on this material does not require a license. Work on this material may be notifiable to the appropriate enforcing authority. Disposal of asbestos waste by a licensed contractor only. All work must conform to the 'Control of Asbestos Regulations 2012'.

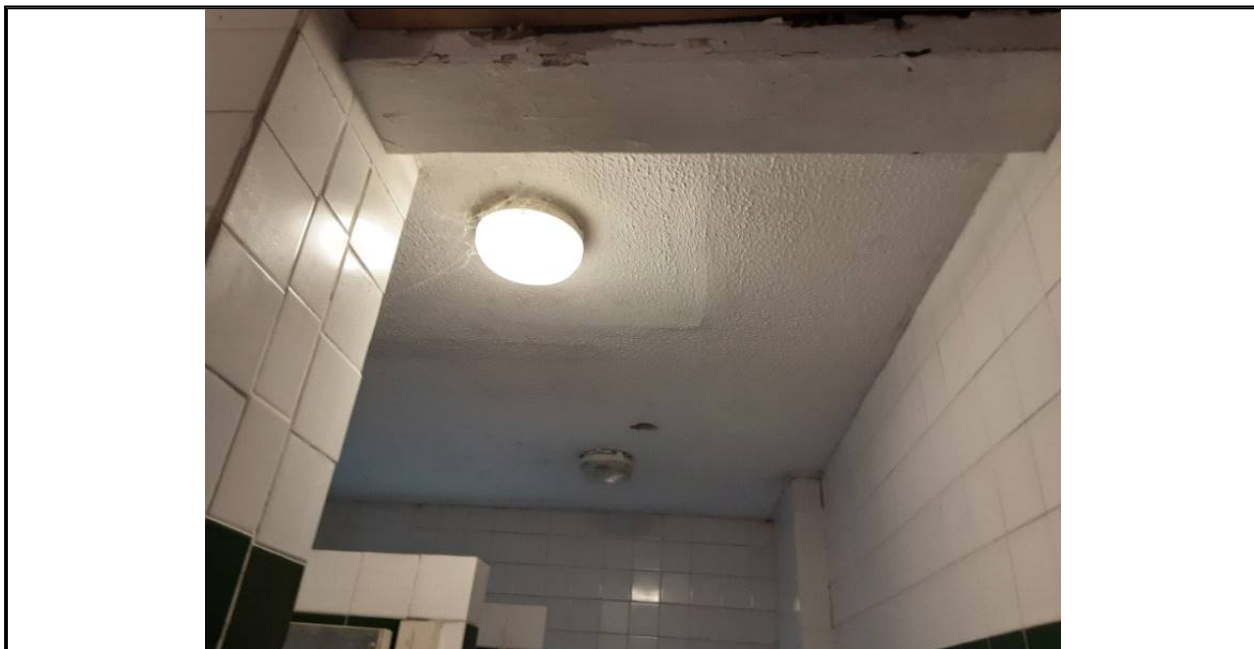
<p>Picture 2</p>
AJ002464	Martello Toilets, Seaford	Ground Floor	Textured Coating	Ladies toilets, Ceiling	12m ²	Bonded	Lathe and Plaster	Chrysotile	
Recommendations					Assessment Scores			Risk Code	
					Material	Priority	Total		
Low risk ACM (bound in matrix) remove, repair or encapsulate under controlled conditions. Work on this material does not require a license. Work on this material may be notifiable to the appropriate enforcing authority. Disposal of asbestos waste by a licensed contractor only. All work must conform to the 'Control of Asbestos Regulations 2012'.					4	-	4	D	
Reinspection Due		12 months	Actions Taken	N/A	Time Scale			Action Completed Sign & Date

Sample No:	AJ002464
Item No:	2
Survey Date:	15/11/22
Building:	Martello Toilets, Seaford
Floor:	Ground Floor
Room No:	Ladies toilets
Position:	Ceiling - Textured Coating
Extent:	12m ²
Substrate:	Bonded, Lathe and Plaster
Material:	(1) Textured Coating
Accessibility:	(1) Occasionally likely to be disturbed
Asbestos Type:	Chrysotile
Risk Category:	D
Recommended Action:	Low risk ACM (bound in matrix) remove, repair or encapsulate under controlled conditions. Work on this material does not require a license. Work on this material may be notifiable to the appropriate enforcing authority. Disposal of asbestos waste by a licensed contractor only. All work must conform to the 'Control of Asbestos Regulations 2012'.

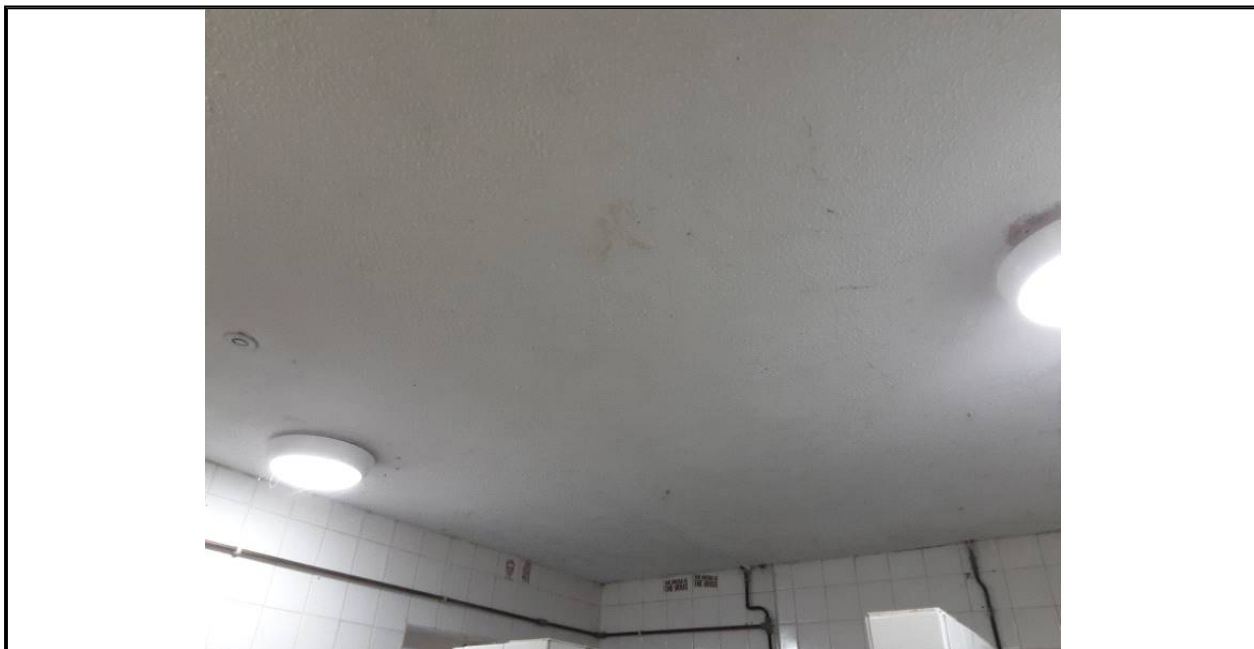
<p>Picture 3</p>
As AJ002464	Martello Toilets, Seaford	Ground Floor	Textured Coating	Gents toilets, Ceiling	15m ²	Bonded	Lathe and Plaster	Chrysotile	
Recommendations					Assessment Scores			Risk Code	
					Material	Priority	Total		
Low risk ACM (bound in matrix) remove, repair or encapsulate under controlled conditions. Work on this material does not require a license. Work on this material may be notifiable to the appropriate enforcing authority. Disposal of asbestos waste by a licensed contractor only. All work must conform to the 'Control of Asbestos Regulations 2012'.					4	-	4	D	
Reinspection Due		12 months	Actions Taken	N/A	Time Scale			Action Completed Sign & Date

3	As AJ002464	Martello Toilets, Seaford	Ground Floor	2	Gents toilets	Ceiling - Textured Coating	15m ²	Bonded, Lathe and Plaster	(1) Textured Coating	Low Damage	1	Chrysotile	(1) Occasionally likely to be disturbed	4	D
Gents toilets: Lathe and plaster ceiling with stipple pattern textured coating, solid rendered walls with ceramic tiles, bare metal pipework, ceiling and wall vents with metal ductwork, timber framed windows, timber doors and frames, metal panels to cubicle doors, ceramic and plastic toilet cisterns with plastic soil pipes, metal sink unit with void behind housing plastic soil pipe and metal and plastic pipework, ceramic tiled concrete floor															
4	Presumed	Martello Toilets, Seaford	Ground Floor	3	Attendants room	To electrics - Textiles	Small amou	Bonded, Metal	(2) Bonded, Metal	Good Condition	2	Chrysotile	(1) Occasionally likely to be disturbed	5	C
Attendants room: Plasterboard ceiling, solid rendered walls, timber door and frame, metal ductwork, bare metal pipework, wall mounted electric unit with presumed textiles, concrete floor

Sample No:	As AJ002464
Item No:	3
Survey Date:	15/11/22
Building:	Martello Toilets, Seaford
Floor:	Ground Floor
Room No:	Gents toilets
Position:	Ceiling - Textured Coating
Extent:	15m ²
Substrate:	Bonded, Lathe and Plaster
Material:	(1) Textured Coating
Accessibility:	(1) Occasionally likely to be disturbed
Asbestos Type:	Chrysotile
Risk Category:	D
Recommended Action:	Low risk ACM (bound in matrix) remove, repair or encapsulate under controlled conditions. Work on this material does not require a license. Work on this material may be notifiable to the appropriate enforcing authority. Disposal of asbestos waste by a licensed contractor only. All work must conform to the 'Control of Asbestos Regulations 2012'.

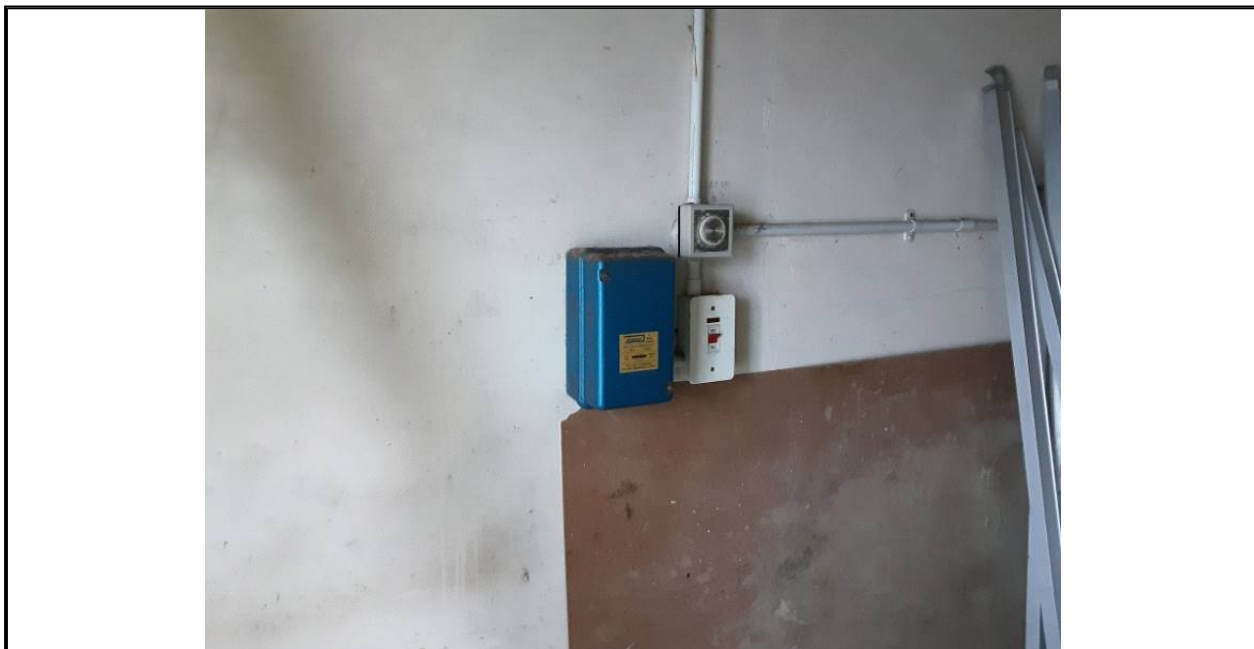
Sample No:	Presumed
Item No:	4
Survey Date:	15/11/22
Building:	Martello Toilets, Seaford
Floor:	Ground Floor
Room No:	Attendants room
Position:	To electrics - Textiles
Extent:	Small amou
Substrate:	Bonded, Metal
Material:	(2) Bonded, Metal
Accessibility:	(1) Occasionally likely to be disturbed
Asbestos Type:	Chrysotile
Risk Category:	C
Recommended Action:	Remove, repair or encapsulate by a licenced asbestos contractor under controlled conditions. Work on this material requires a license & is notifiable to the appropriate enforcing authority. Disposal of asbestos waste by a licensed contractor only. All work must conform to the 'Control of Asbestos Regulations 2012'.

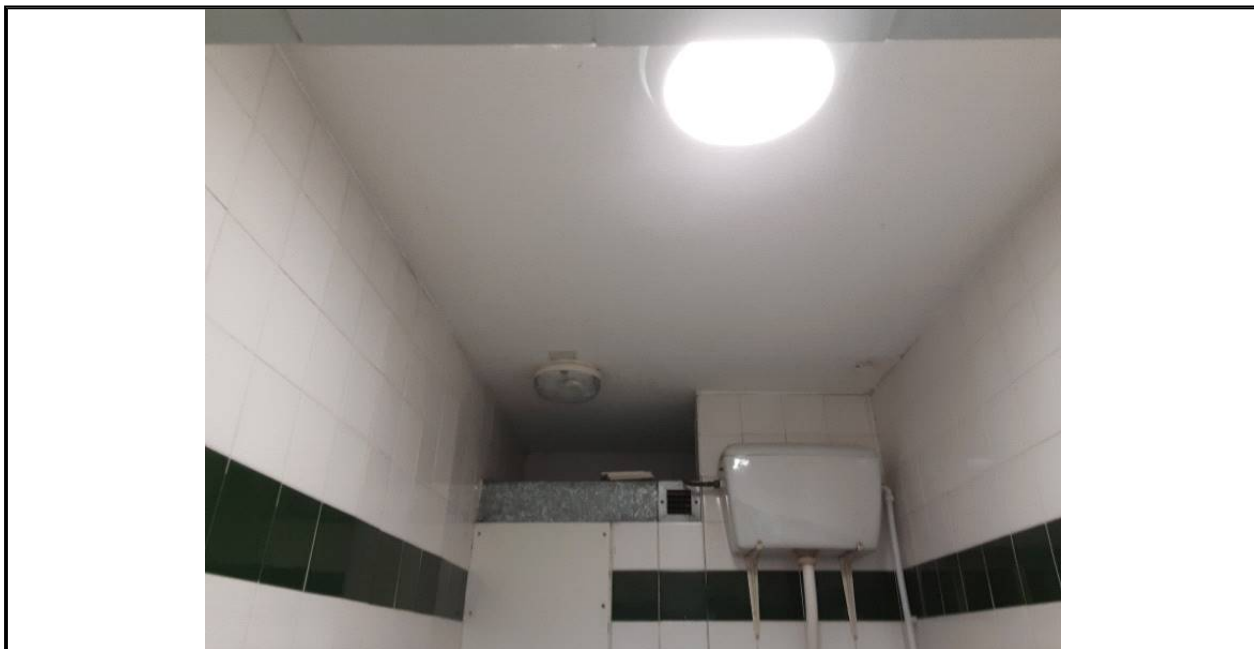
<p>Picture 5</p>
As AJ002464	Martello Toilets, Seaford	Ground Floor	Textured Coating	Disabled WC, Ceiling	8m²	Bonded	Lathe and Plaster	Chrysotile	
Recommendations					Assessment Scores			Risk Code	
					Material	Priority	Total		
Low risk ACM (bound in matrix) remove, repair or encapsulate under controlled conditions. Work on this material does not require a license. Work on this material may be notifiable to the appropriate enforcing authority. Disposal of asbestos waste by a licensed contractor only. All work must conform to the 'Control of Asbestos Regulations 2012'.					4	-	4	D	
Reinspection Due		12 months	Actions Taken	N/A	Time Scale			Action Completed Sign & Date

5	As AJ002464	Martello Toilets, Seaford	Ground Floor	4	Disabled WC	Ceiling - Textured Coating	8m ²	Bonded, Lathe and Plaster	(1) Textured Coating	Low Damage	1	Chrysotile	(1) Occasionally likely to be disturbed	4	D
Disabled WC: Lathe and plaster ceiling with stipple pattern textured coating, solid rendered walls with ceramic tiles, bare metal and plastic pipework, timber door and frame, ceramic toilet cistern with plastic soil pipes, void housing plastic soil pipe and metal and plastic pipework, ceramic tiled concrete floor. Limited access due to biological hazard

Sample No:	As AJ002464
Item No:	5
Survey Date:	15/11/22
Building:	Martello Toilets, Seaford
Floor:	Ground Floor
Room No:	Disabled WC
Position:	Ceiling - Textured Coating
Extent:	8m ²
Substrate:	Bonded, Lathe and Plaster
Material:	(1) Textured Coating
Accessibility:	(1) Occasionally likely to be disturbed
Asbestos Type:	Chrysotile
Risk Category:	D
Recommended Action:	Low risk ACM (bound in matrix) remove, repair or encapsulate under controlled conditions. Work on this material does not require a license. Work on this material may be notifiable to the appropriate enforcing authority. Disposal of asbestos waste by a licensed contractor only. All work must conform to the 'Control of Asbestos Regulations 2012'.
