**Asbestos Re-Inspection Report and Register**

<b>Site:</b>	Chesham House, 53 - 59 Lower Street, Kettering, Northamptonshire, NN16 8BH
<b>Contract:</b>	C07437
<b>Surveyor:</b>	Mr John Myers
<b>Re-Inspection Date:</b>	6 <sup>th</sup> June 2017
<b>Report Date:</b>	22 <sup>nd</sup> June 2017
<b>Re-Inspection Due:</b>	6 <sup>th</sup> June 2018
<b>Client:</b>	<b>Kettering Borough Council</b> 4 Robinson Way, Telford Industrial Estate, Kettering, NN16 8PP

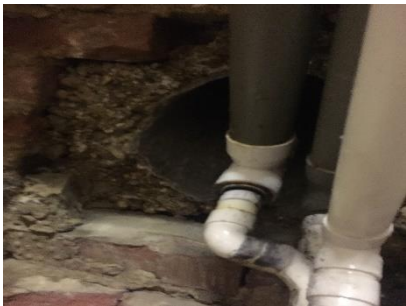
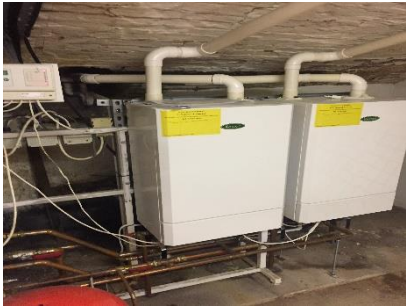
<b>Contract No:</b> C07437	<b>Client:</b> Kettering Borough Council	<b>Location Ref OSL:</b> 001	
<b>Site:</b> Chesham House, 53 – 59 Lower Street, Kettering, Northamptonshire, NN16 8BH		<b>Inspection Date:</b> 06/06/17	
<b>Building:</b>	Main

<b>Floor:</b>	Basement		
<b>Room Area:</b>	Basement		
<b>Description:</b>	Redundant Cement Flue Pipe		
<b>Quantity:</b>	2 lm		
<b>Accessibility:</b>	Easy		
<b>Product Type:</b>	(Score 1,2,3 = 1) Cement		
<b>Damage Extent:</b>	(Score 0,1,2,3 = 2) Medium		
<b>Surface Treatment:</b>	(Score 0,1,2,3 = 1) Unsealed	<b>Re-inspection Due:</b>	06/06/18
<b>Asbestos Type:</b>	(Score 1,2,3 = 1) Chrysotile (White)	<b>Sample Ref:</b>	Sampled - S01
<b>Material Assessment:</b>		<b>Risk Score = 5</b> <b>Low</b>	
<b>Comments:</b> - Same condition, pipes from boiler exit through flue pipe.			
<b>Recommendations:</b> - The identified asbestos containing material should be managed in accordance with current legislation. For adequate management asbestos materials must be in a good condition and products other than cement and composite materials should be sealed and or protected. As such should the identified asbestos containing material be damaged then it will require repair and for materials other than cement and composites it will require encapsulation and or protection. Where asbestos materials are beyond repair they should be removed. Although labelling and or signage is not a legal requirement it should be considered to avoid accidental damage.

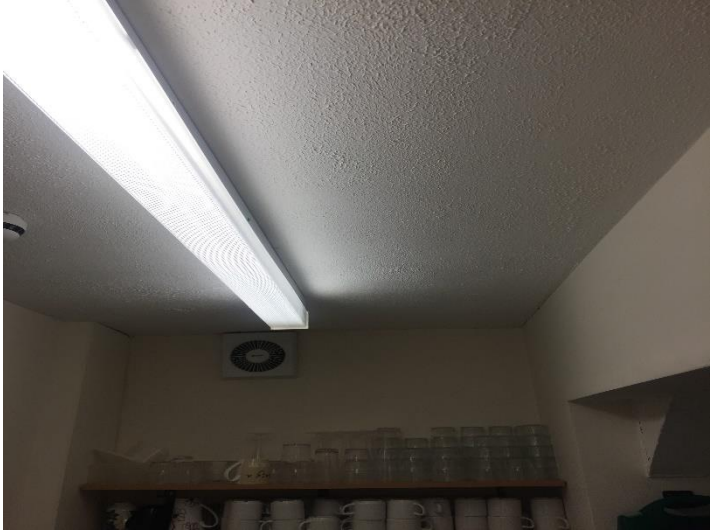
<b>Contract No:</b> C07437	<b>Client:</b> Kettering Borough Council	<b>Location Ref OSL:</b> 003	
<b>Site:</b> Chesham House, 53 – 59 Lower Street, Kettering, Northamptonshire, NN16 8BH		<b>Inspection Date:</b> 06/06/17	
<b>Building:</b>	Main

<b>Floor:</b>	Ground		
<b>Room Area:</b>	Kitchenette 11		
<b>Description:</b>	Textured Coating		
<b>Quantity:</b>	4 m <sup>2</sup>		
<b>Accessibility:</b>	Easy		
<b>Product Type:</b>	(Score 1,2,3 = 1) Textured Coating		
<b>Damage Extent:</b>	(Score 0,1,2,3 = 1) Low		
<b>Surface Treatment:</b>	(Score 0,1,2,3 = 0) Composite	<b>Re-inspection Due:</b>	06/06/18
<b>Asbestos Type:</b>	(Score 1,2,3 = 1) Chrysotile (White)	<b>Sample Ref:</b>	Sampled - S03
<b>Material Assessment:</b>		<b>Risk Score = 3</b> Very Low	
<b>Comments:</b> - The textured coating was onto plasterboard.			
<b>Recommendations:</b> - The identified asbestos containing material should be managed in accordance with current legislation. For adequate management asbestos materials must be in a good condition and products other than cement and composite materials should be sealed and or protected. As such should the identified asbestos containing material be damaged then it will require repair and for materials other than cement and composites it will require encapsulation and or protection. Where asbestos materials are beyond repair they should be removed. Although labelling and or signage is not a legal requirement it should be considered to avoid accidental damage.

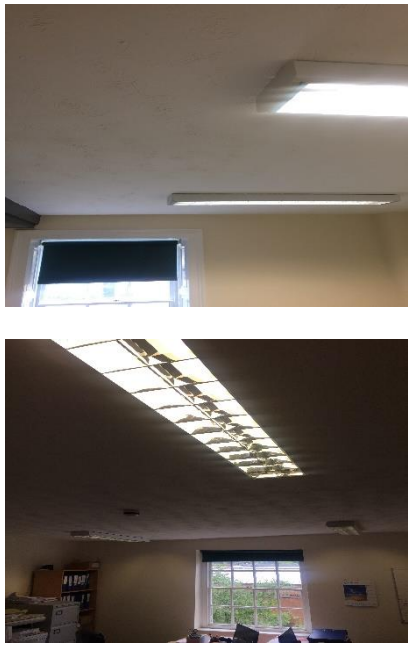
<b>Contract No:</b> C07437	<b>Client:</b> Kettering Borough Council	<b>Location Ref OSL:</b> 004	
<b>Site:</b> Chesham House, 53 – 59 Lower Street, Kettering, Northamptonshire, NN16 8BH		<b>Inspection Date:</b> 06/06/17	
<b>Building:</b>	Main

<b>Floor:</b>	First		
<b>Room Area:</b>	Corridor 8		
<b>Description:</b>	Textured Coating		
<b>Quantity:</b>	157 m <sup>2</sup>		
<b>Accessibility:</b>	Easy		
<b>Product Type:</b>	(Score 1,2,3 = 1) Textured Coating		
<b>Damage Extent:</b>	(Score 0,1,2,3 = 1) Low		
<b>Surface Treatment:</b>	(Score 0,1,2,3 = 0) Composite	<b>Re-inspection Due:</b>	06/06/18
<b>Asbestos Type:</b>	(Score 1,2,3 = 1) Chrysotile (White)	<b>Sample Ref:</b>	Sampled - S04
<b>Material Assessment:</b>		<b>Risk Score = 3</b> <b>Very Low</b>	
<p><b>Comments:</b> - The textured coating was onto plasterboard. The area by the stairs had been plastered over and damage to the plaster finish exposes textured coating.</p>

<p><b>Recommendations:</b> - The identified asbestos containing material should be managed in accordance with current legislation. For adequate management asbestos materials must be in a good condition and products other than cement and composite materials should be sealed and or protected. As such should the identified asbestos containing material be damaged then it will require repair and for materials other than cement and composites it will require encapsulation and or protection. Where asbestos materials are beyond repair they should be removed. Although labelling and or signage is not a legal requirement it should be considered to avoid accidental damage.</p>

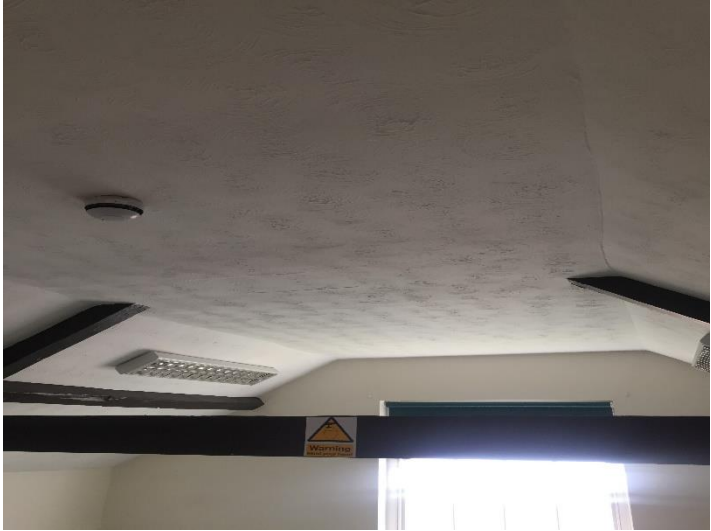
<b>Contract No:</b> C07437	<b>Client:</b> Kettering Borough Council	<b>Location Ref OSL:</b> 005	
<b>Site:</b> Chesham House, 53 – 59 Lower Street, Kettering, Northamptonshire, NN16 8BH		<b>Inspection Date:</b> 06/06/17	
<b>Building:</b>	Main

<b>Floor:</b>	Second		
<b>Room Area:</b>	Rooms 11, 9, 10, 12, 6, 4, 3, 5, 1 & 2		
<b>Description:</b>	Textured Coating		
<b>Quantity:</b>	55 m <sup>2</sup>		
<b>Accessibility:</b>	Easy		
<b>Product Type:</b>	(Score 1,2,3 = 1) Textured Coating		
<b>Damage Extent:</b>	(Score 0,1,2,3 = 1) Low		
<b>Surface Treatment:</b>	(Score 0,1,2,3 = 0) Composite	<b>Re-inspection Due:</b>	06/06/18
<b>Asbestos Type:</b>	(Score 1,2,3 = 1) Chrysotile (White)	<b>Sample Ref:</b>	Sampled - S05
<b>Material Assessment:</b>		<b>Risk Score = 3</b> <b>Very Low</b>	
<b>Comments:</b> - The textured coating was onto plasterboard.			
<b>Recommendations:</b> - The identified asbestos containing material should be managed in accordance with current legislation. For adequate management asbestos materials must be in a good condition and products other than cement and composite materials should be sealed and or protected. As such should the identified asbestos containing material be damaged then it will require repair and for materials other than cement and composites it will require encapsulation and or protection. Where asbestos materials are beyond repair they should be removed. Although labelling and or signage is not a legal requirement it should be considered to avoid accidental damage.
