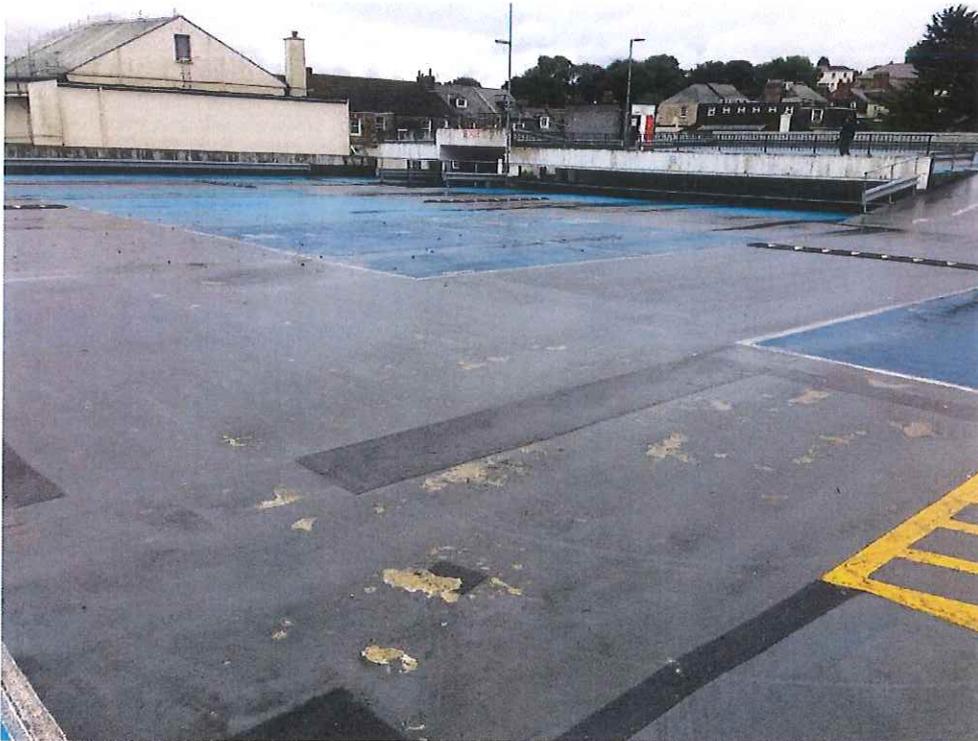
Photograph 3: Debonding and deterioration of upper level deck waterproofing.

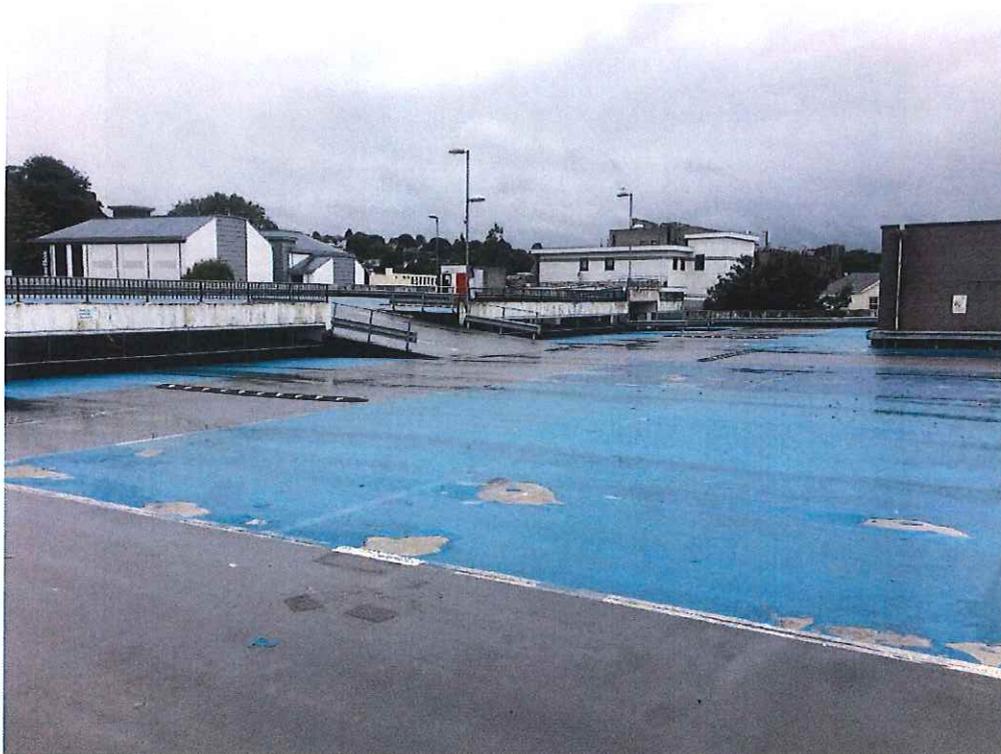
Photograph 4: Missing areas of waterproofing on upper levels.

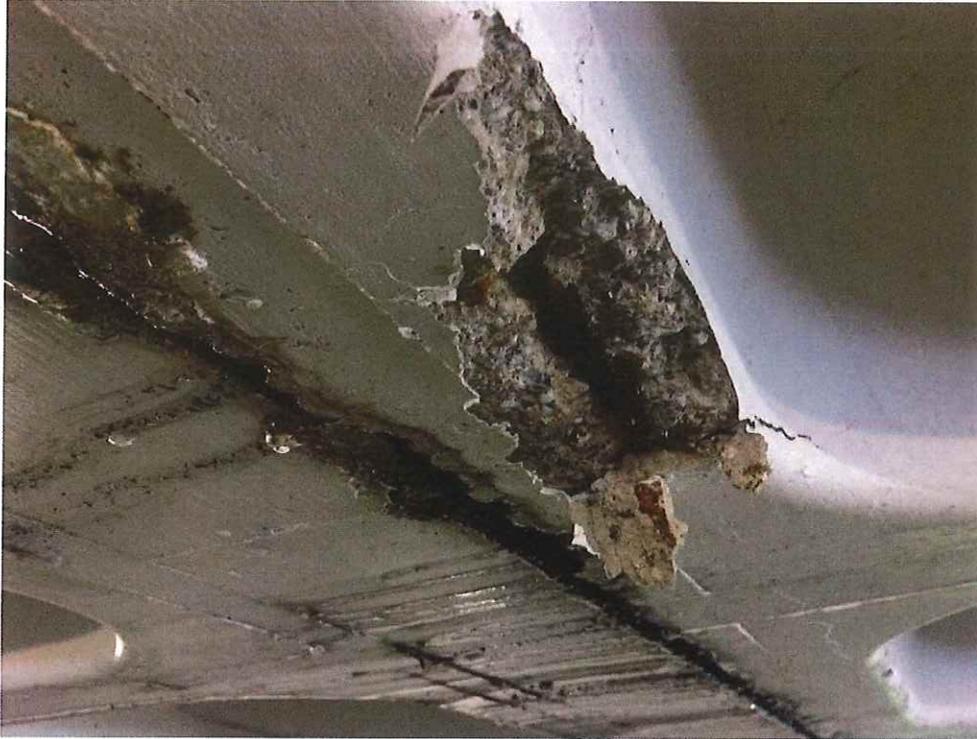
Photograph 5: Water penetration and spalling of reinforcement at level 7 ramp joint.

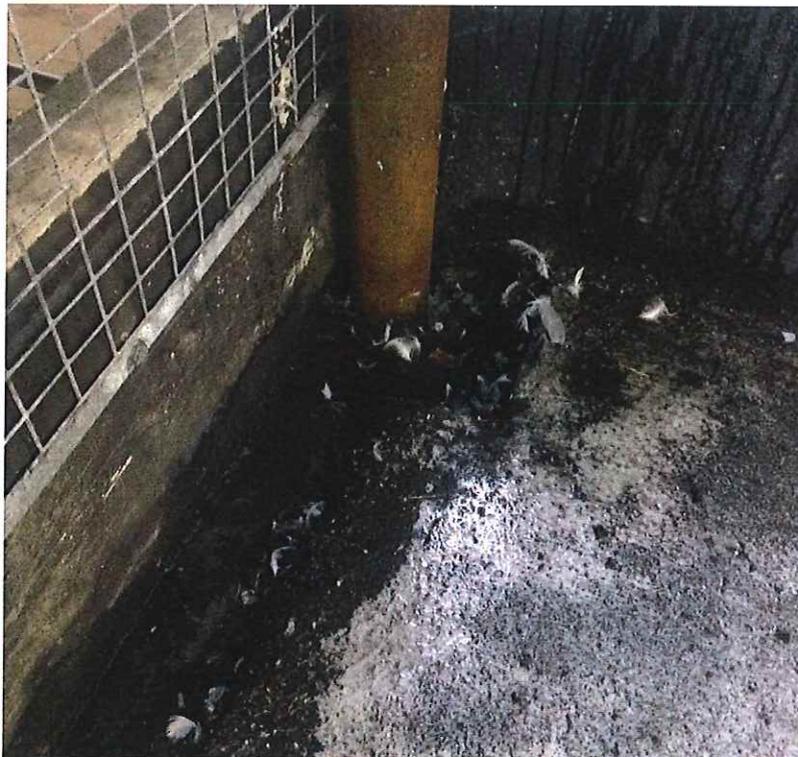
Photograph 6: Partially blocked internal drains.

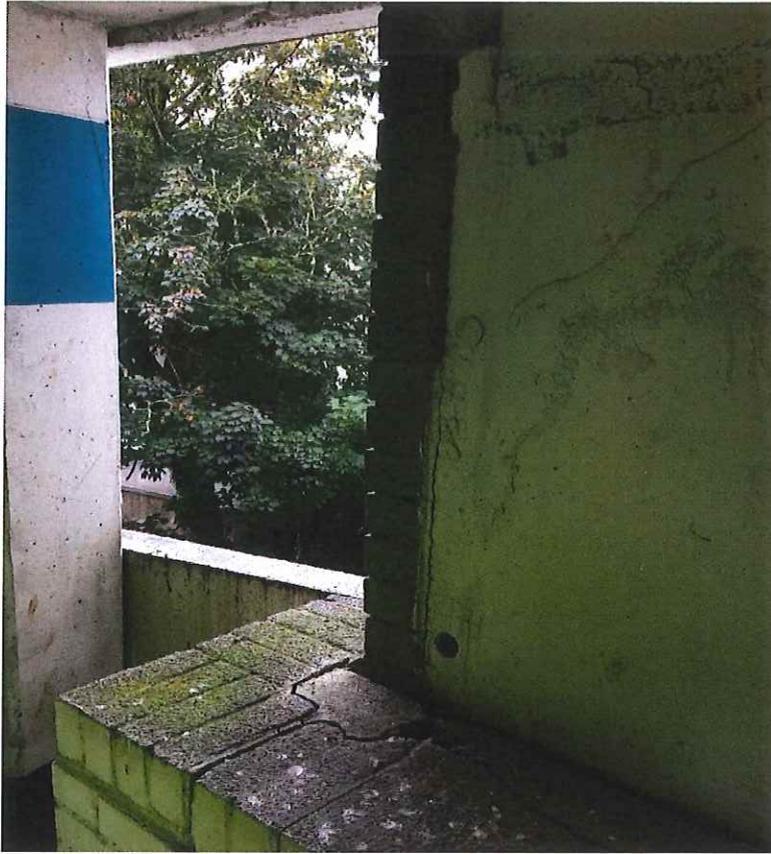
Photograph 7: Local cracking of block facing at level 6.

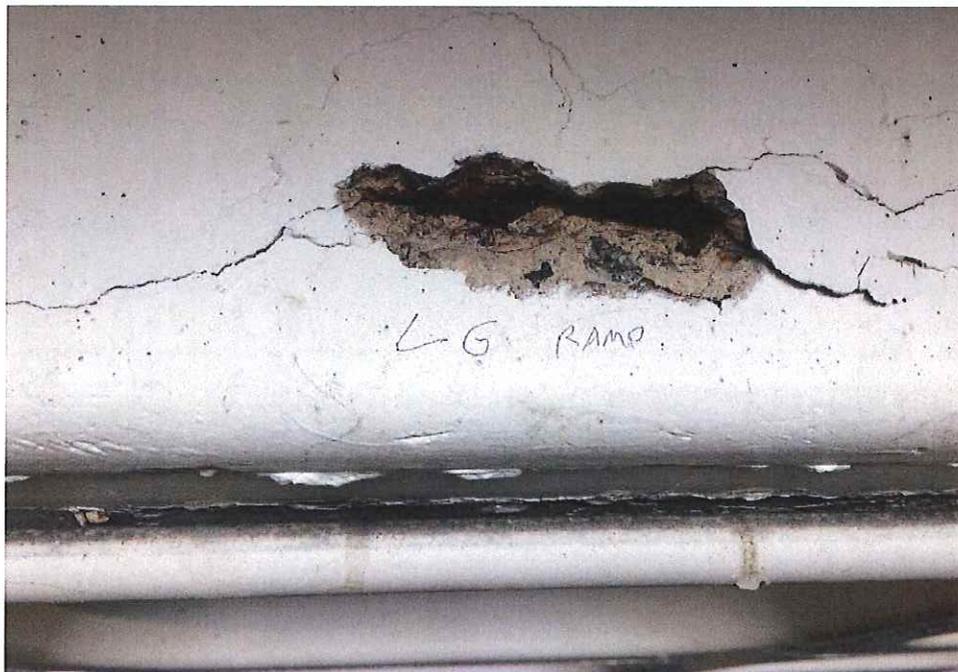
Photograph 8: Spalling at ramp soffit level 6.

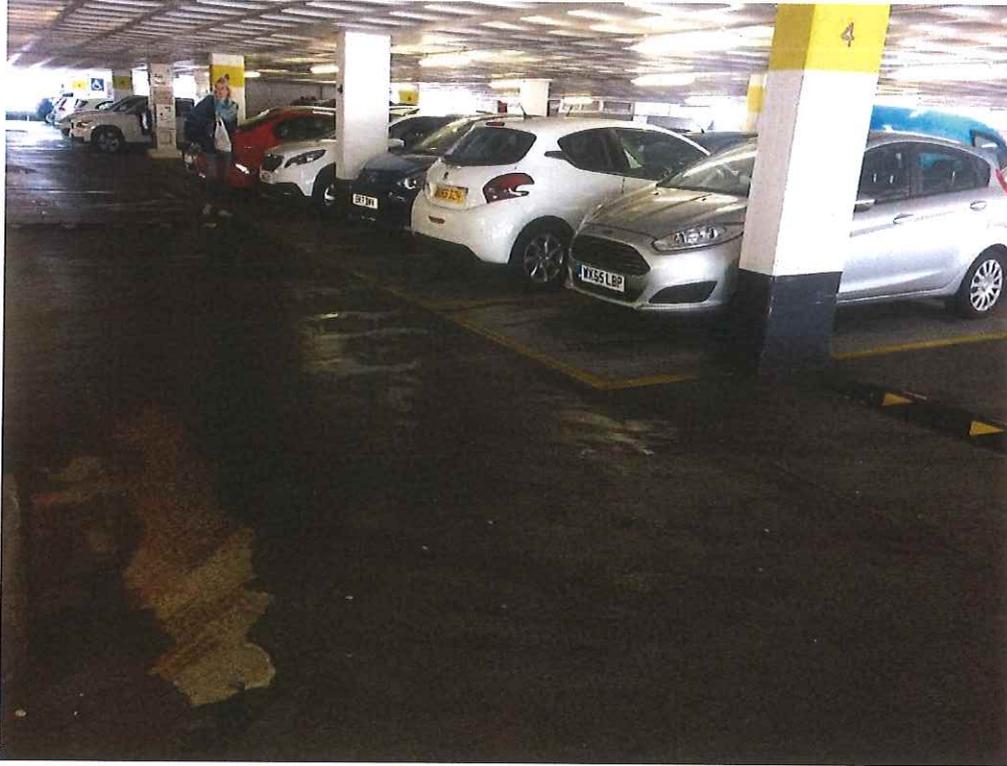
Photograph 9: Missing waterproofing near ramp on level 4.

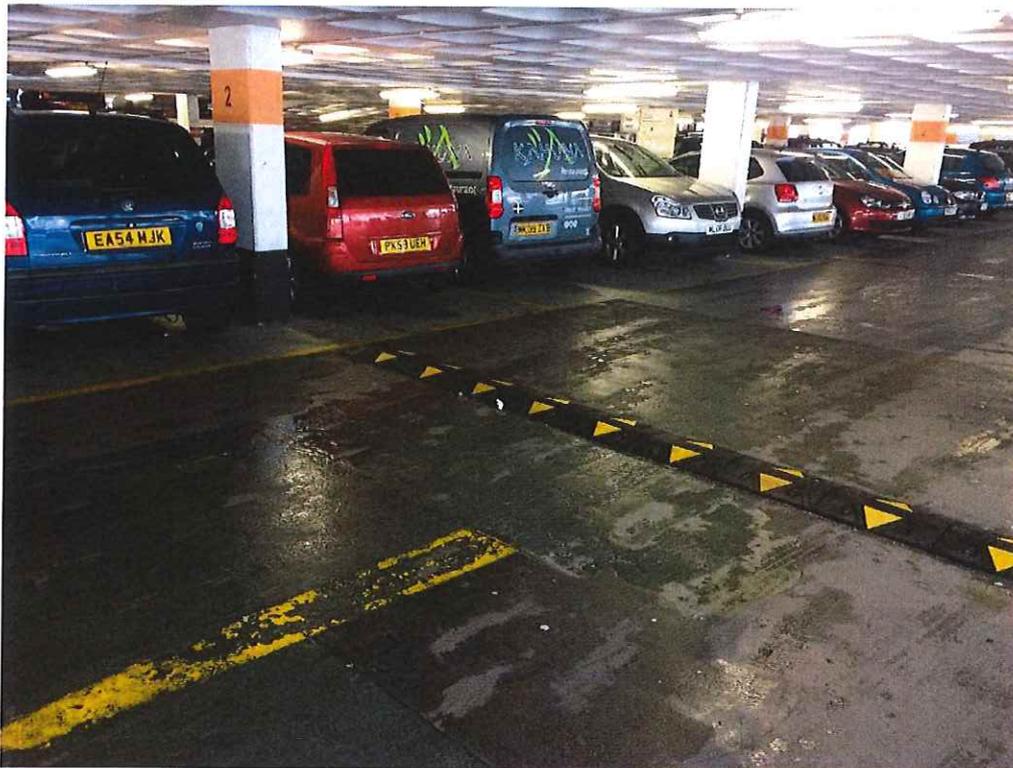
Photograph 10: Damaged waterproofing entrance on level 2.

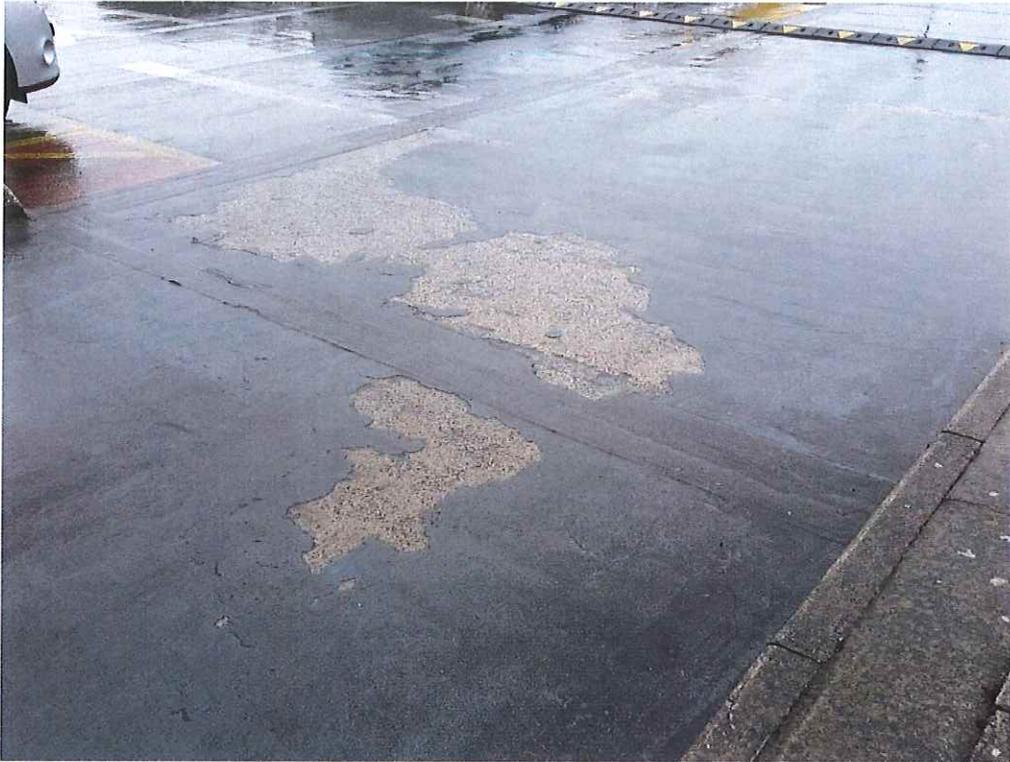
Photograph 7: Missing waterproofing on exit ramp to level 2.

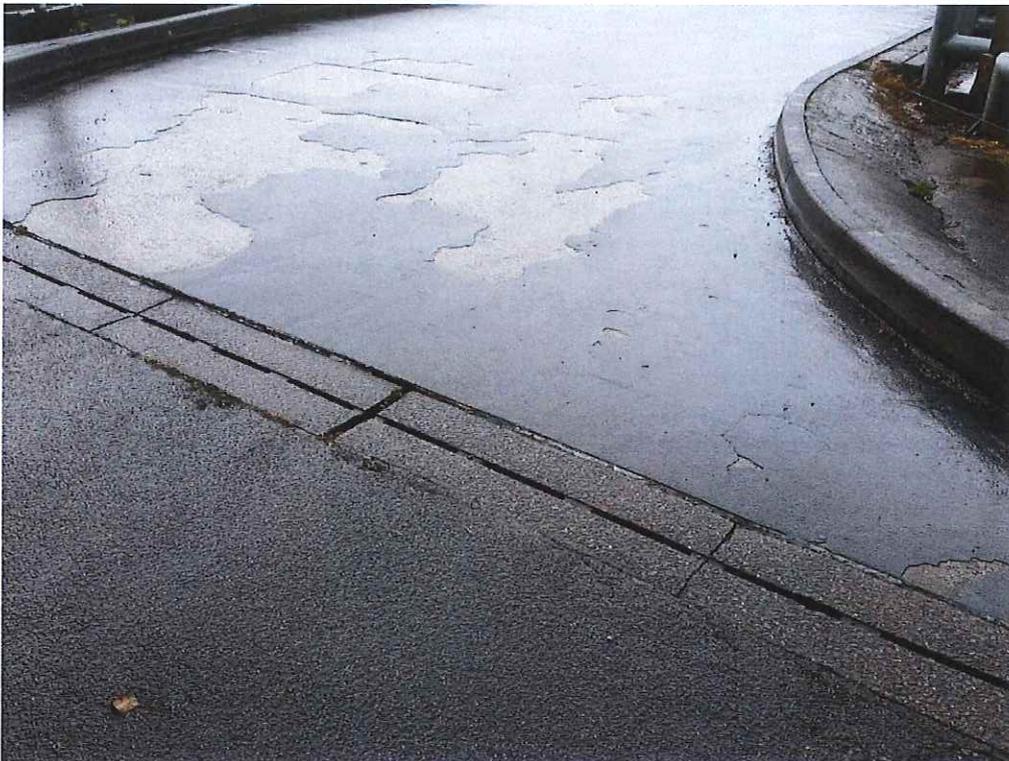
Photograph 8: Missing waterproofing on entrance ramp to level 2.

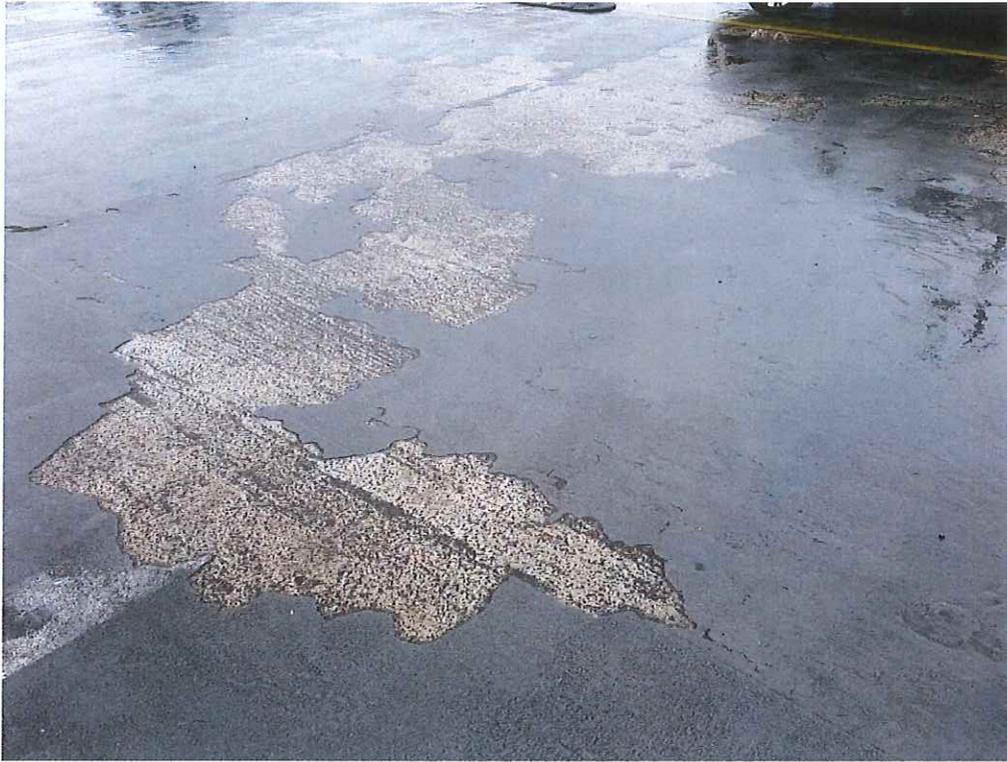
Photograph 9: Missing waterproofing around entrance on level 2.

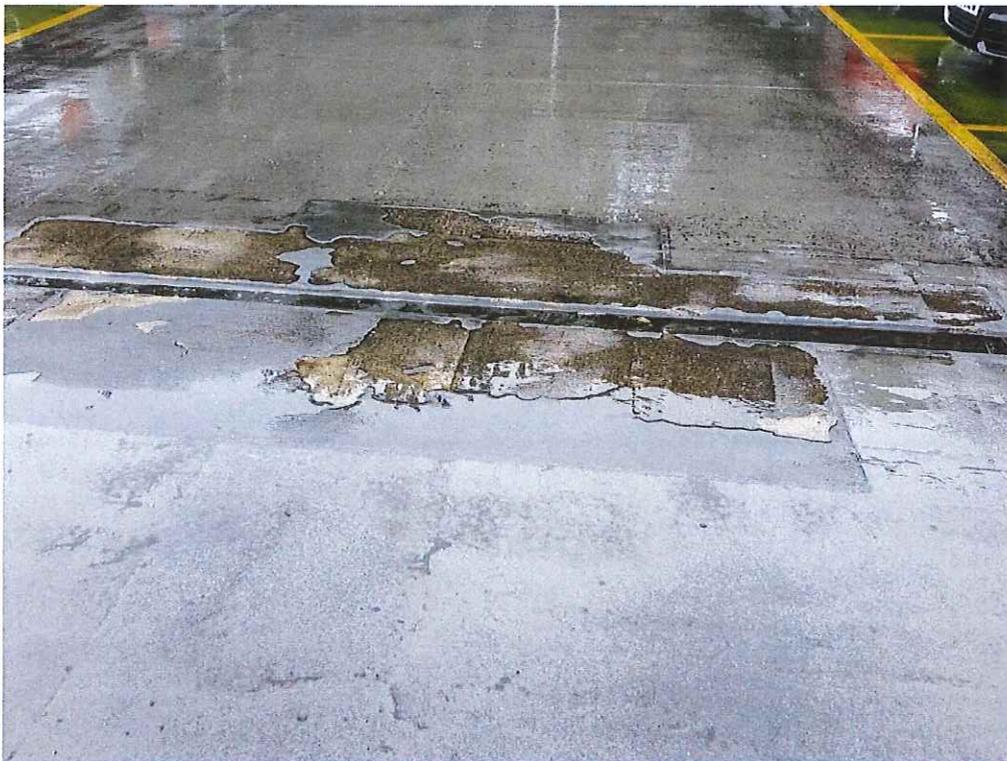
Photograph 10: Damaged waterproofing around drainage gully on level 2.

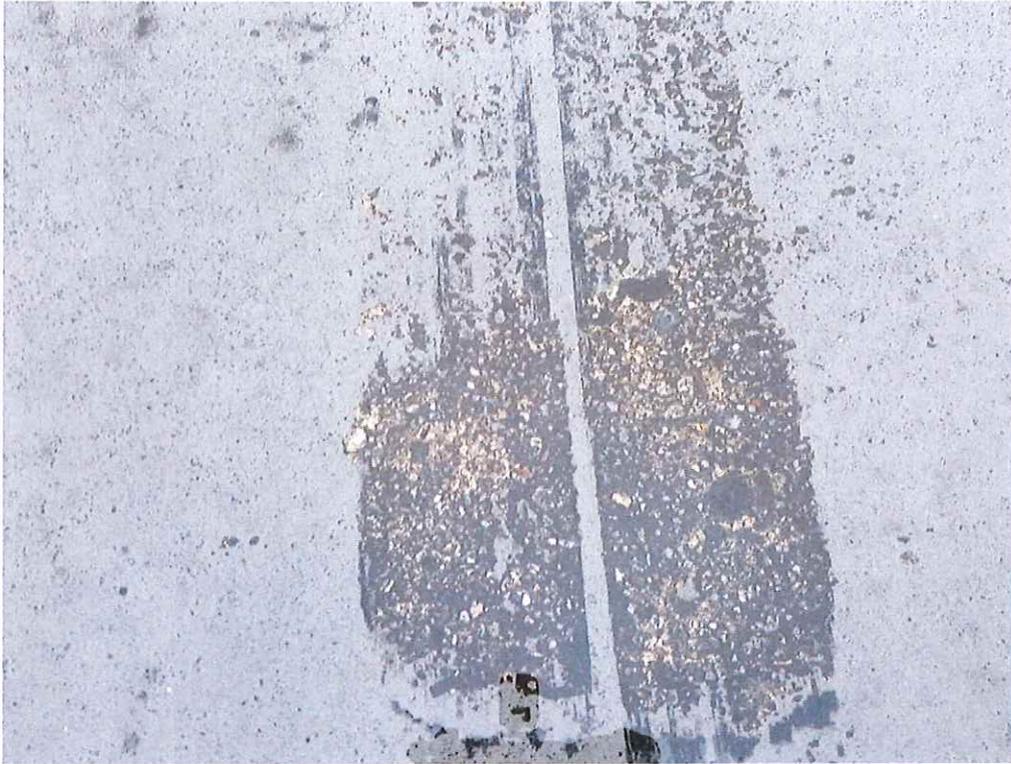
Photograph 11: Worn waterproofing showing exposed aggregate on level 2 main vehicle route.

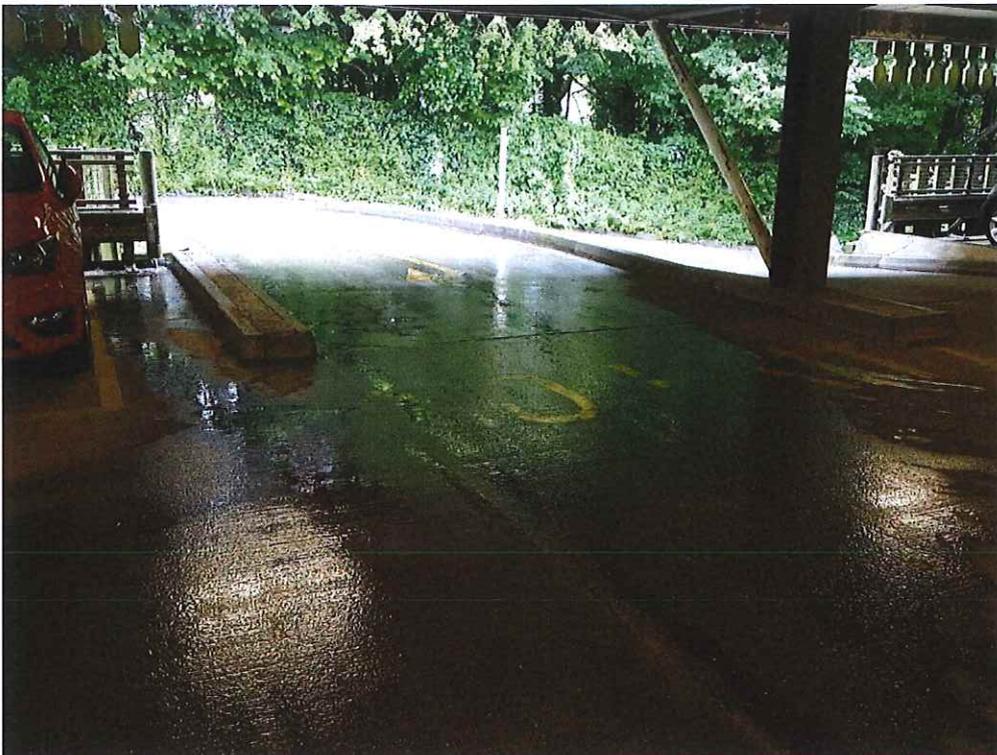
Photograph 12: Water runoff from entrance ramp into level 1.
