## General Visual Investigation Report

### WaveHub / Seatricty Moorings KML-10-

Client: WaveHub				
Title: Seatricty device mooring General Visual Investigation Report				
Project Number: WaveHub			Document No: KML-WaveHub-GVIR	
Prepared By: SH			Checked By:	
Approved By: SH			Date of Issue: 06/10/20	
00	06/10/20	Issued to client	SH	SH
REV	DATE	ISSUE DESCRIPTION	BY	APP'D

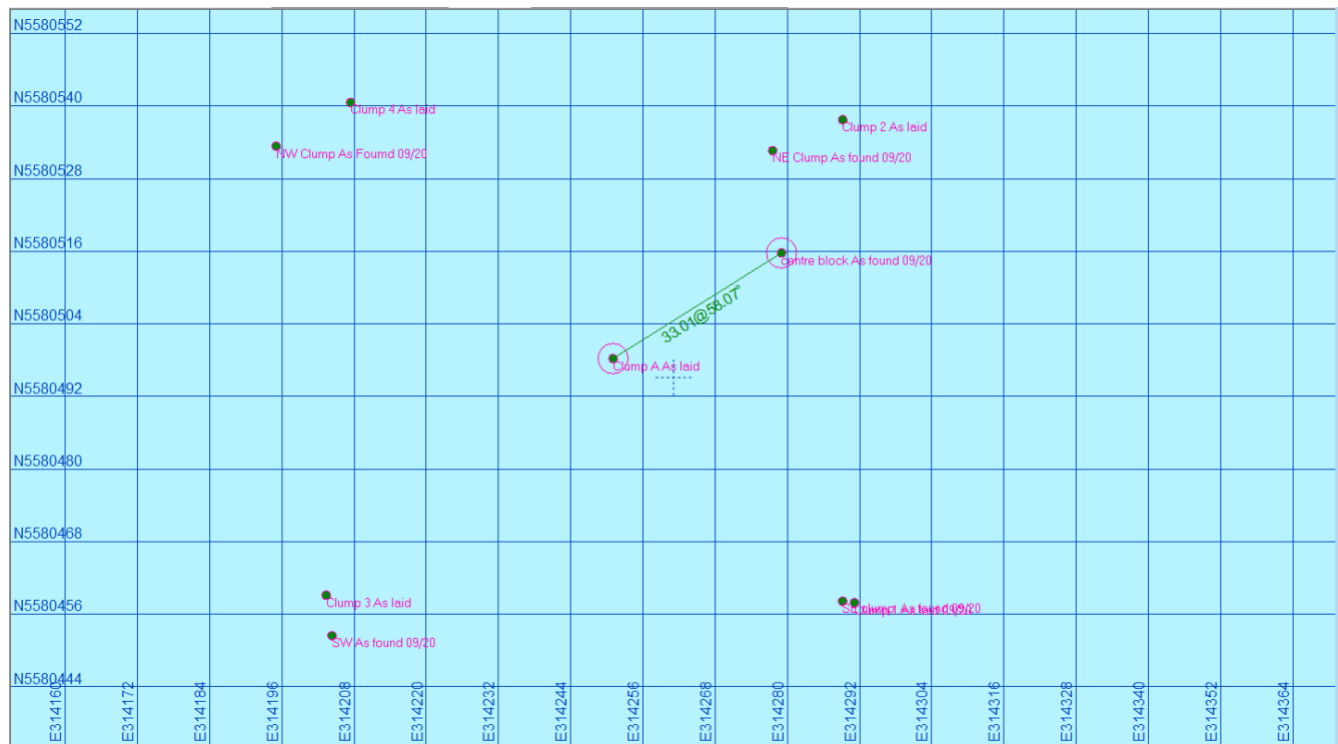
Moorings clump positions were recorded as below. Note that basis the as laid co-ordinates provided and those below, the centre clump appears to off centre compared to the as-laid positions.

(i) Mooring clump as laid and plotted positions 17.09.20

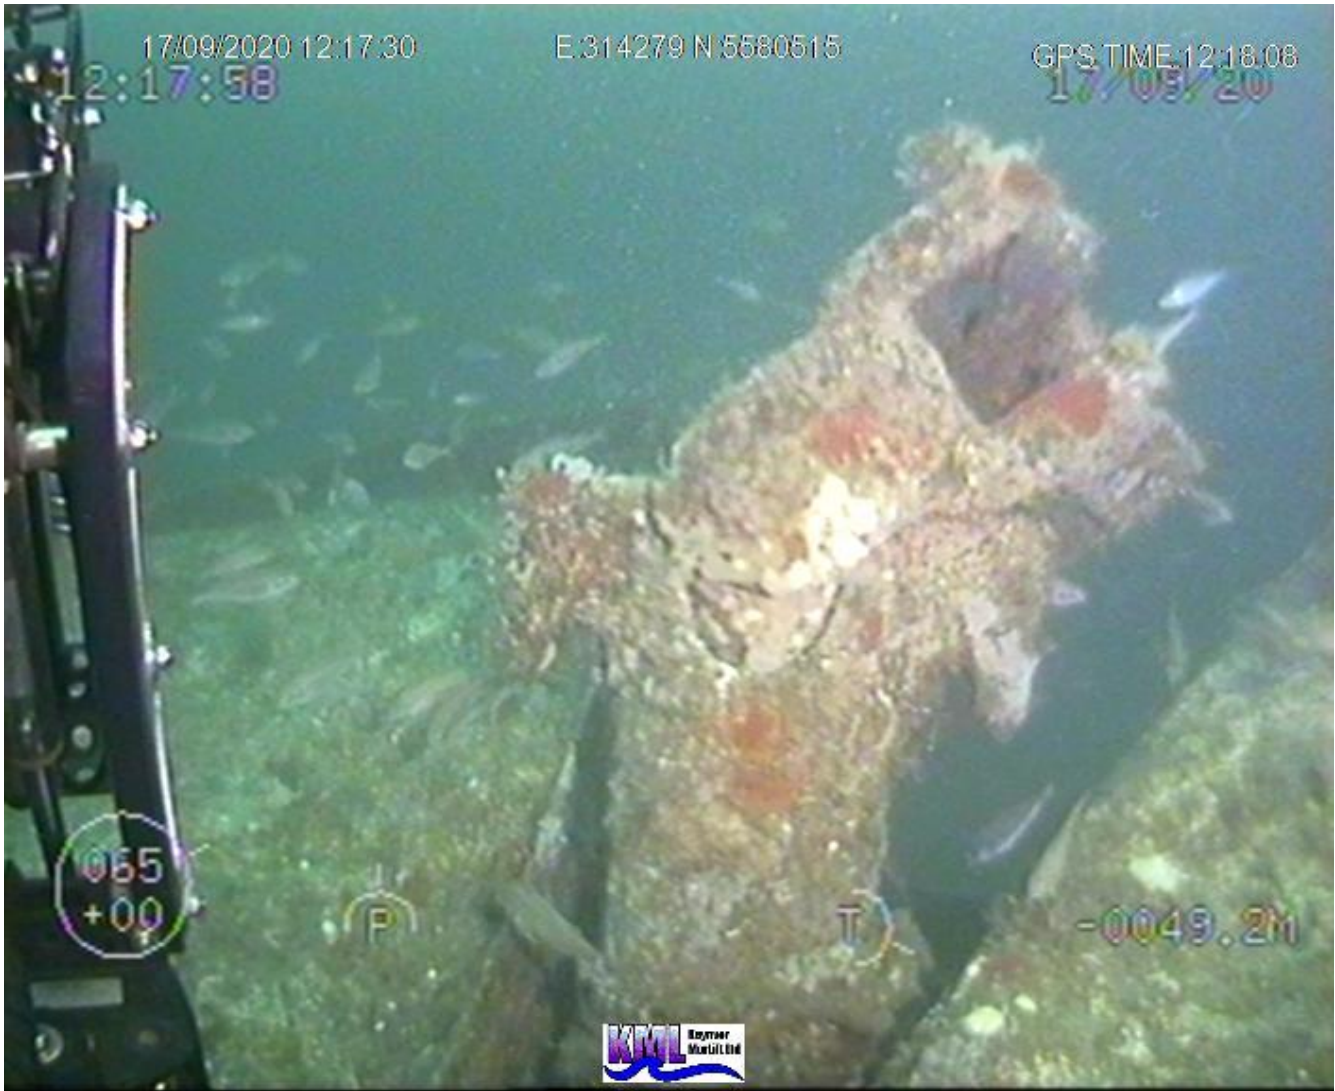
**Centre Clump**

(ii) Centre clump mooring connection

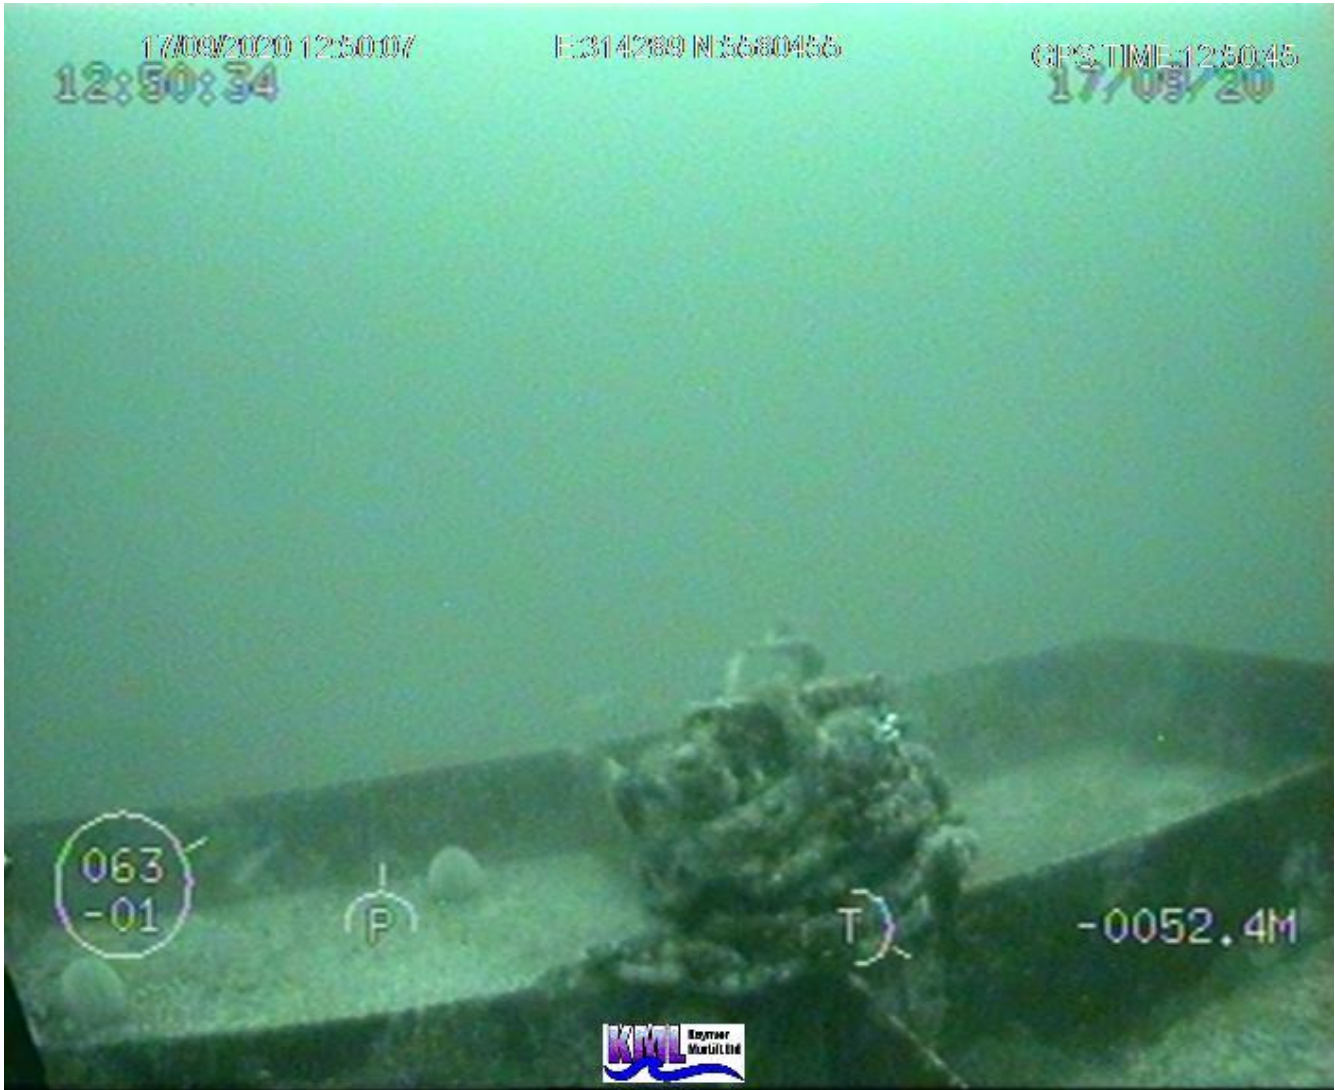
**SE Clump**

(iii) SE mooring clump top connection. Some dyneema remaining.

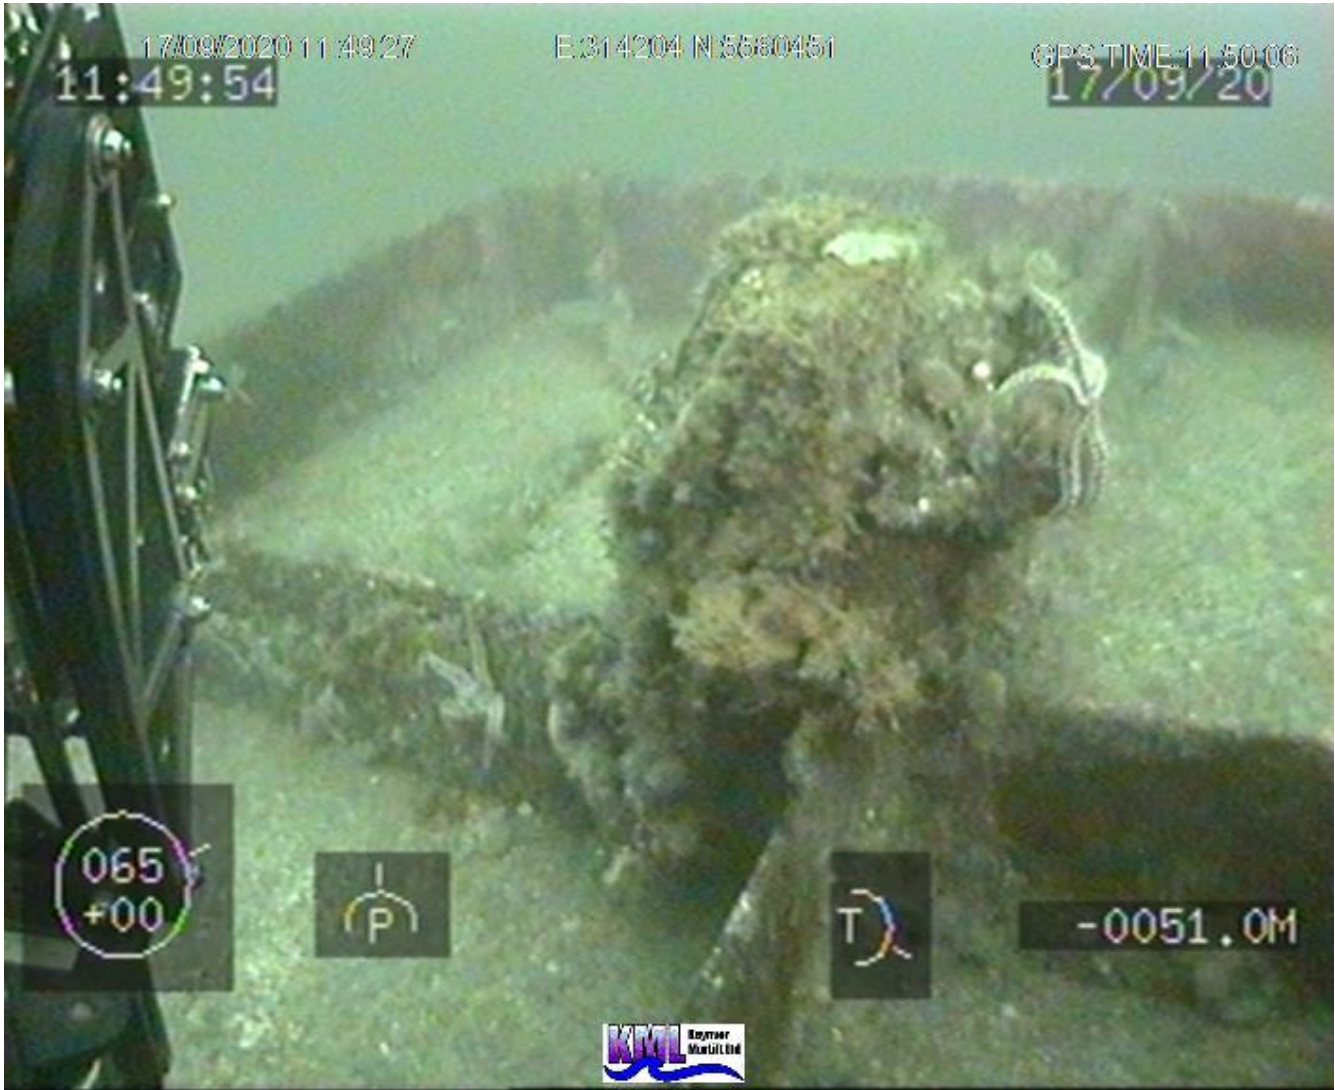
**SW Clump**

(iv) SW mooring clump top conenction

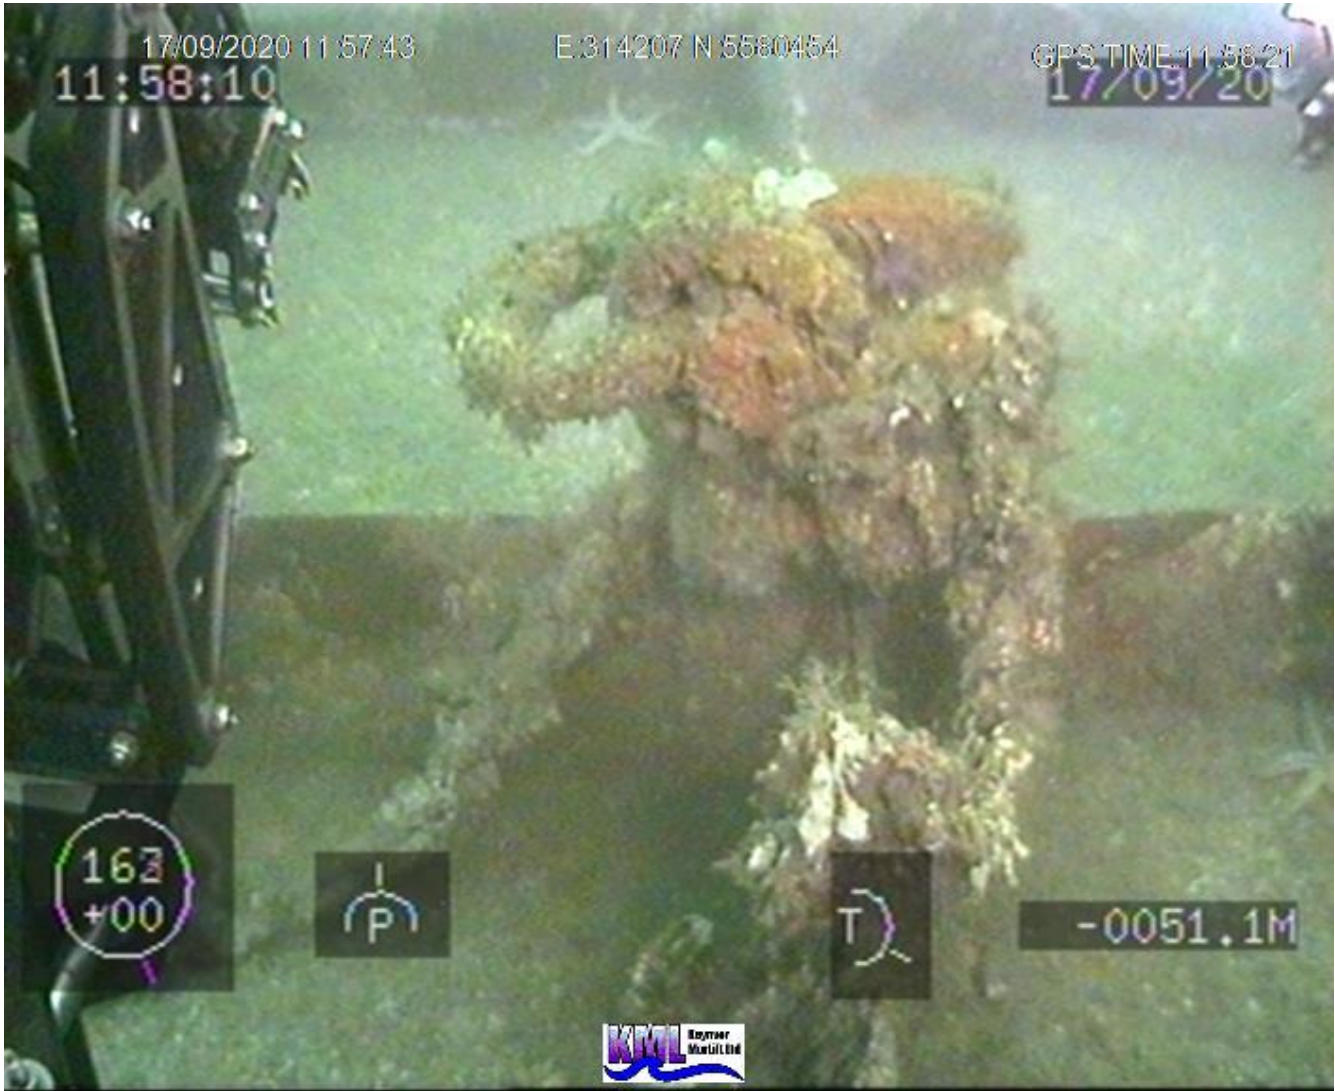
(v) SW mooring clump top connection opposite angle

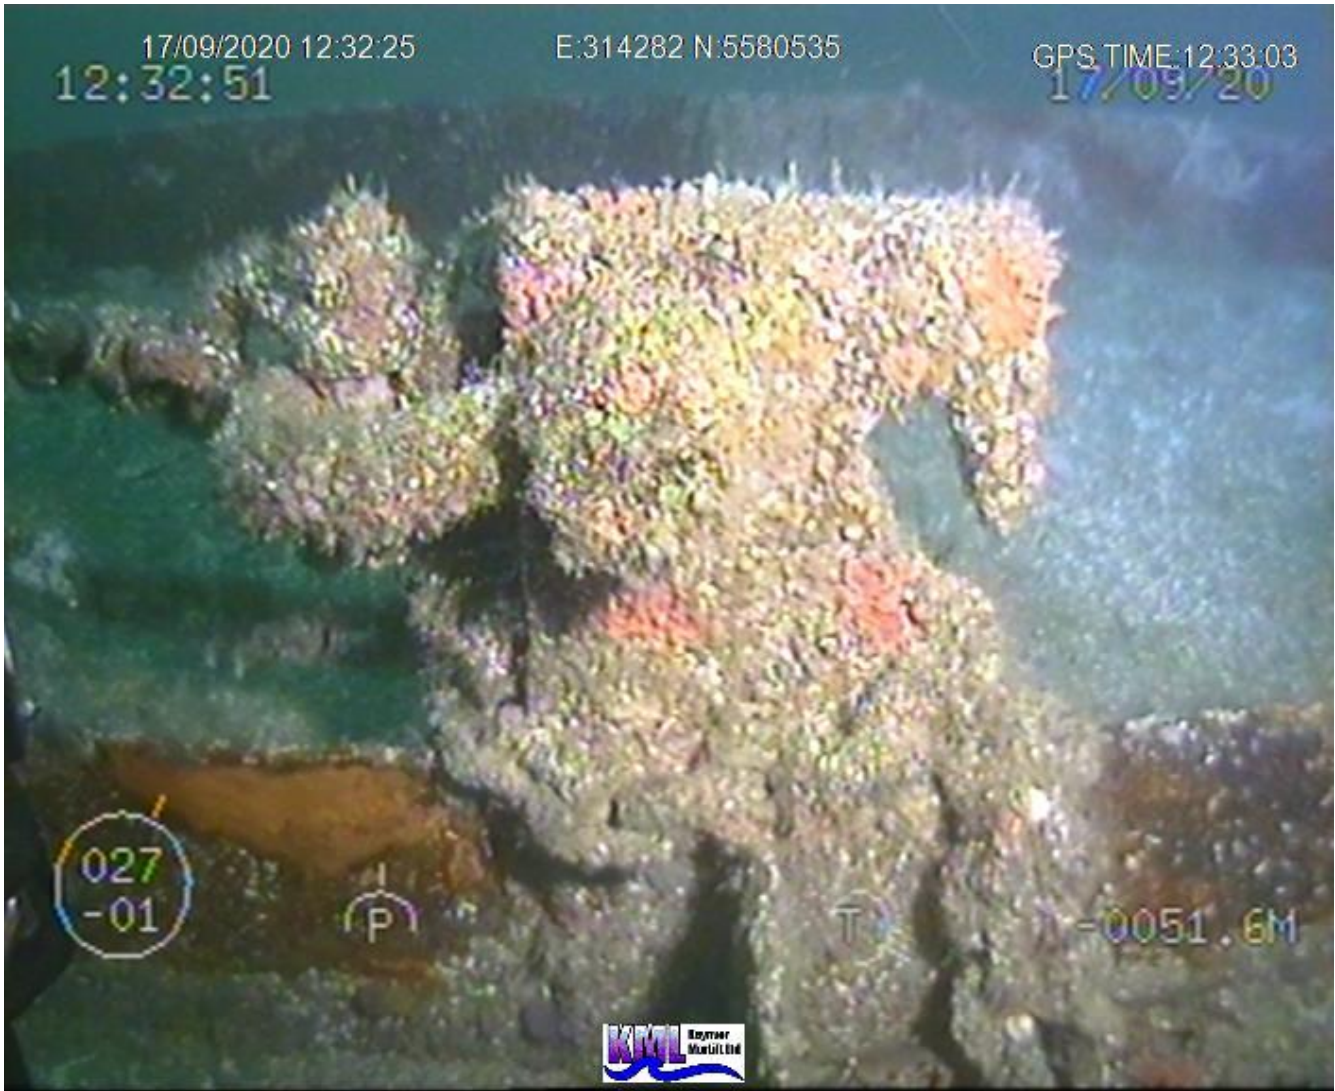
**NE Clump**

(vi) NE clump top connection

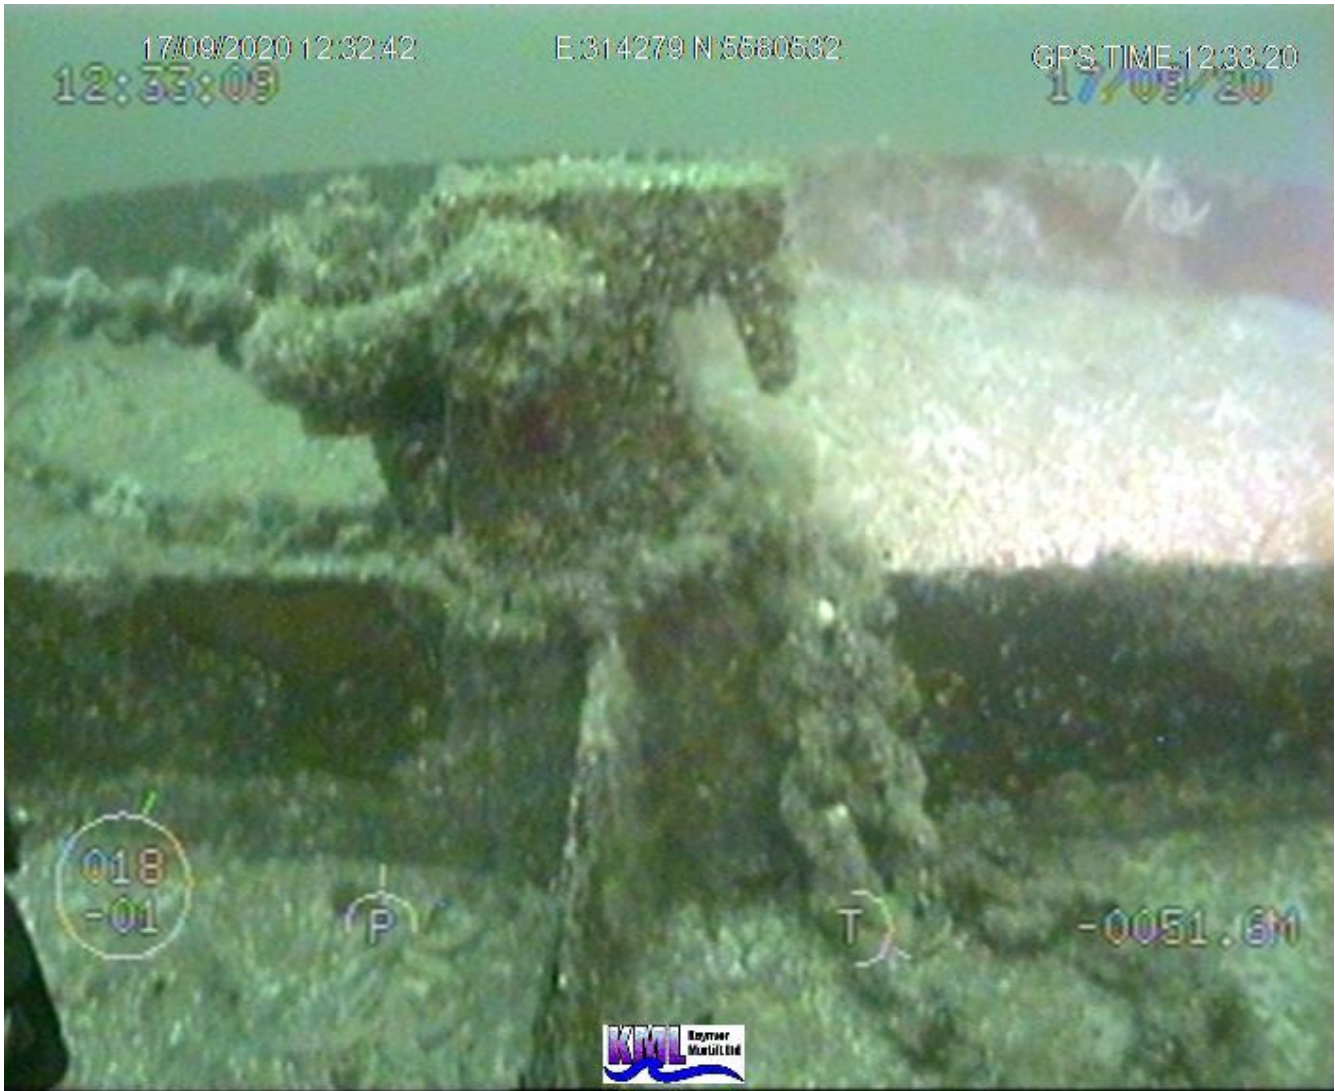
(vii) NE mooring clump top connection opposite angle

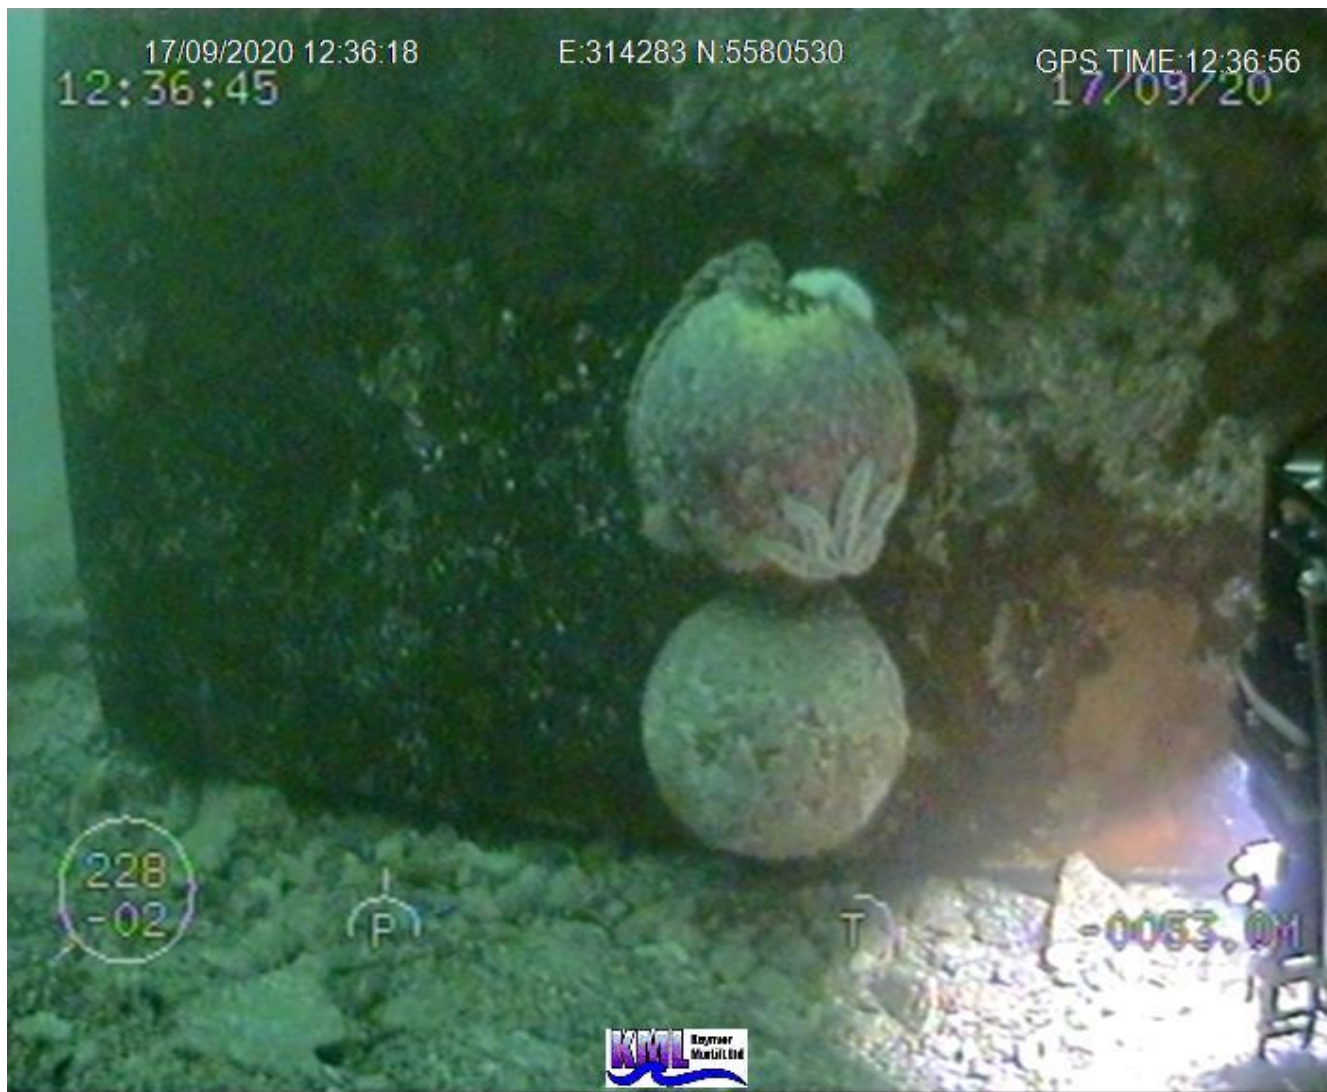
Expected marine growth was found on all mooring clumps. No significant fouling by external items (e.g. fishing gear) observed. Some dyneema (NW clump) and pellet buoys (NE clump) and various lengths of chain from previous mooring/deployment operations sighted on and beside the clumps.

(viii) Pellet buoys entangled in NE clump

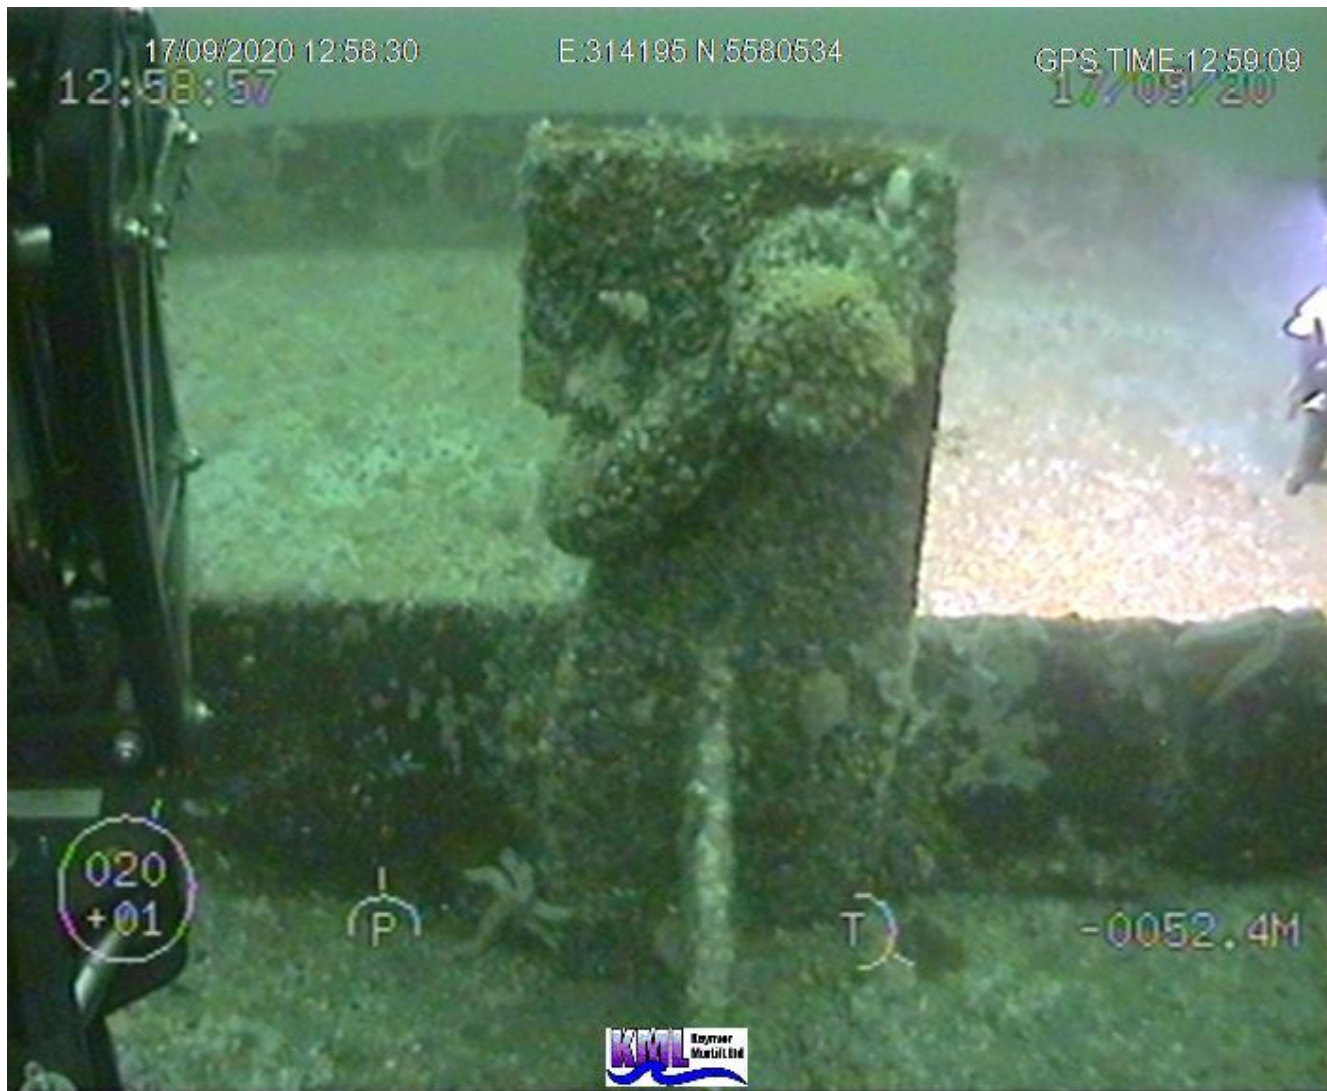
NW Clump

(ix) NW mooring clump top connection

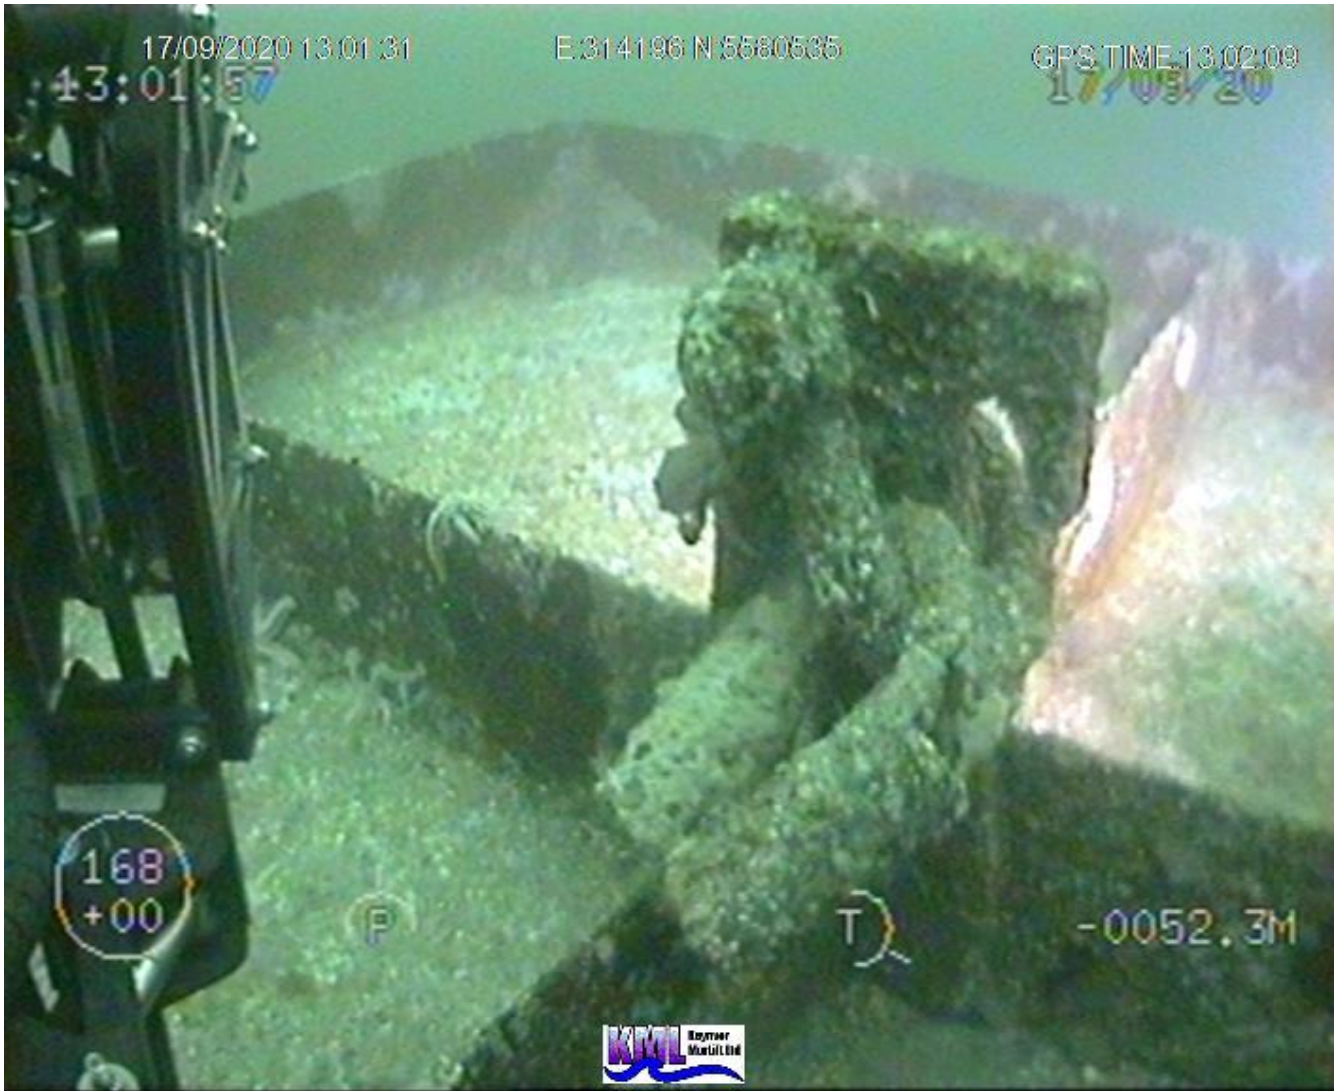
(x) NW mooring clump opposite angle

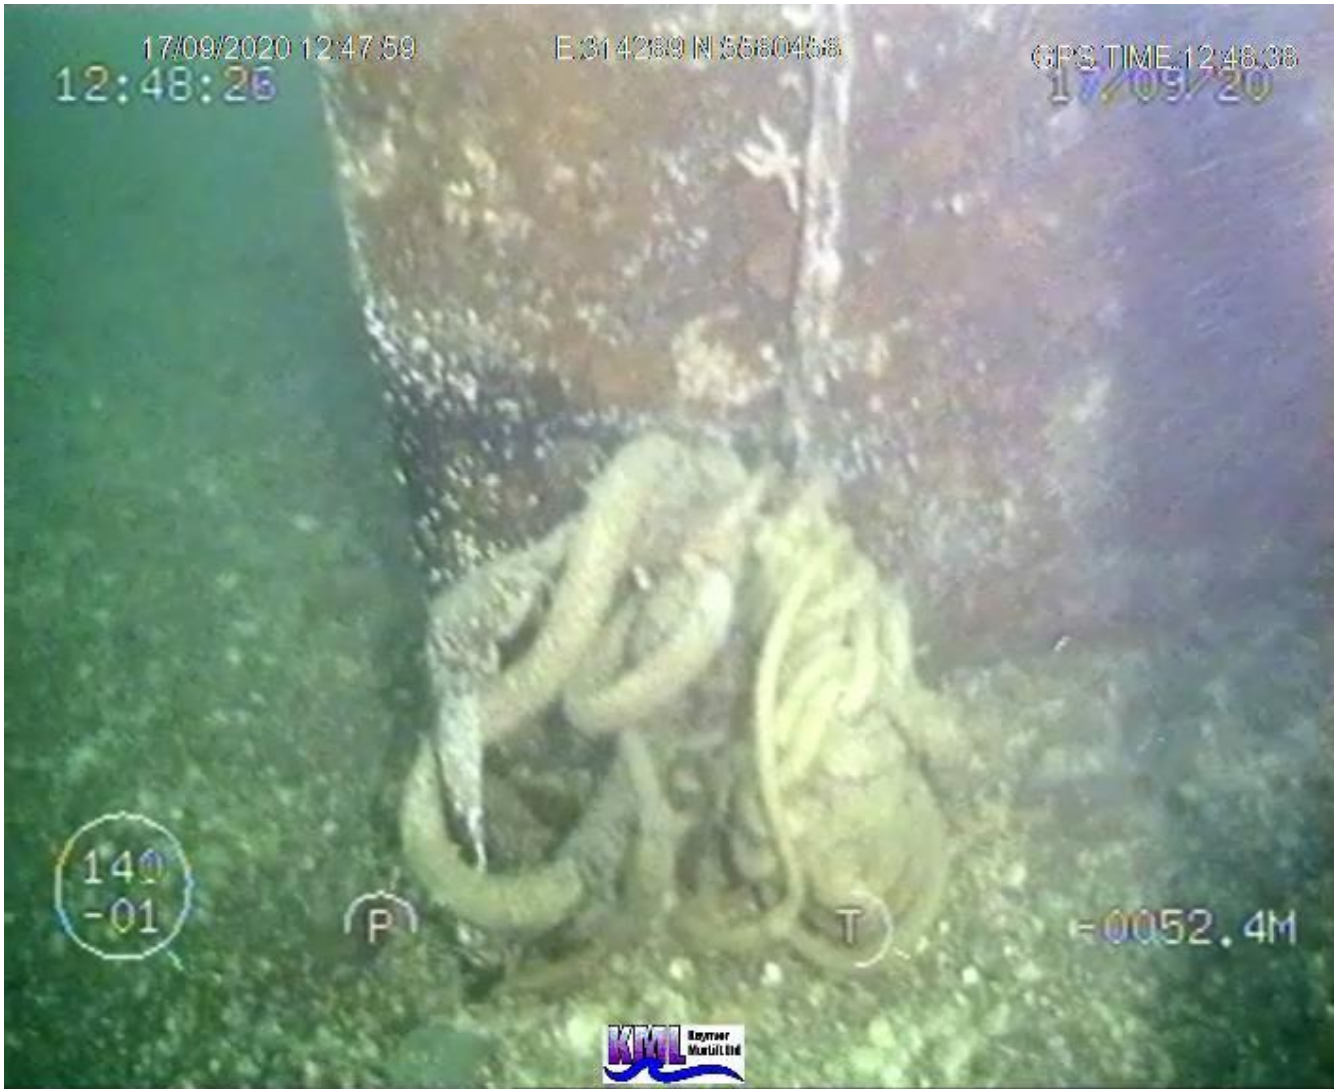
(xi) NW mooring clump - dyneema bundle alongside
