# Repairs 1

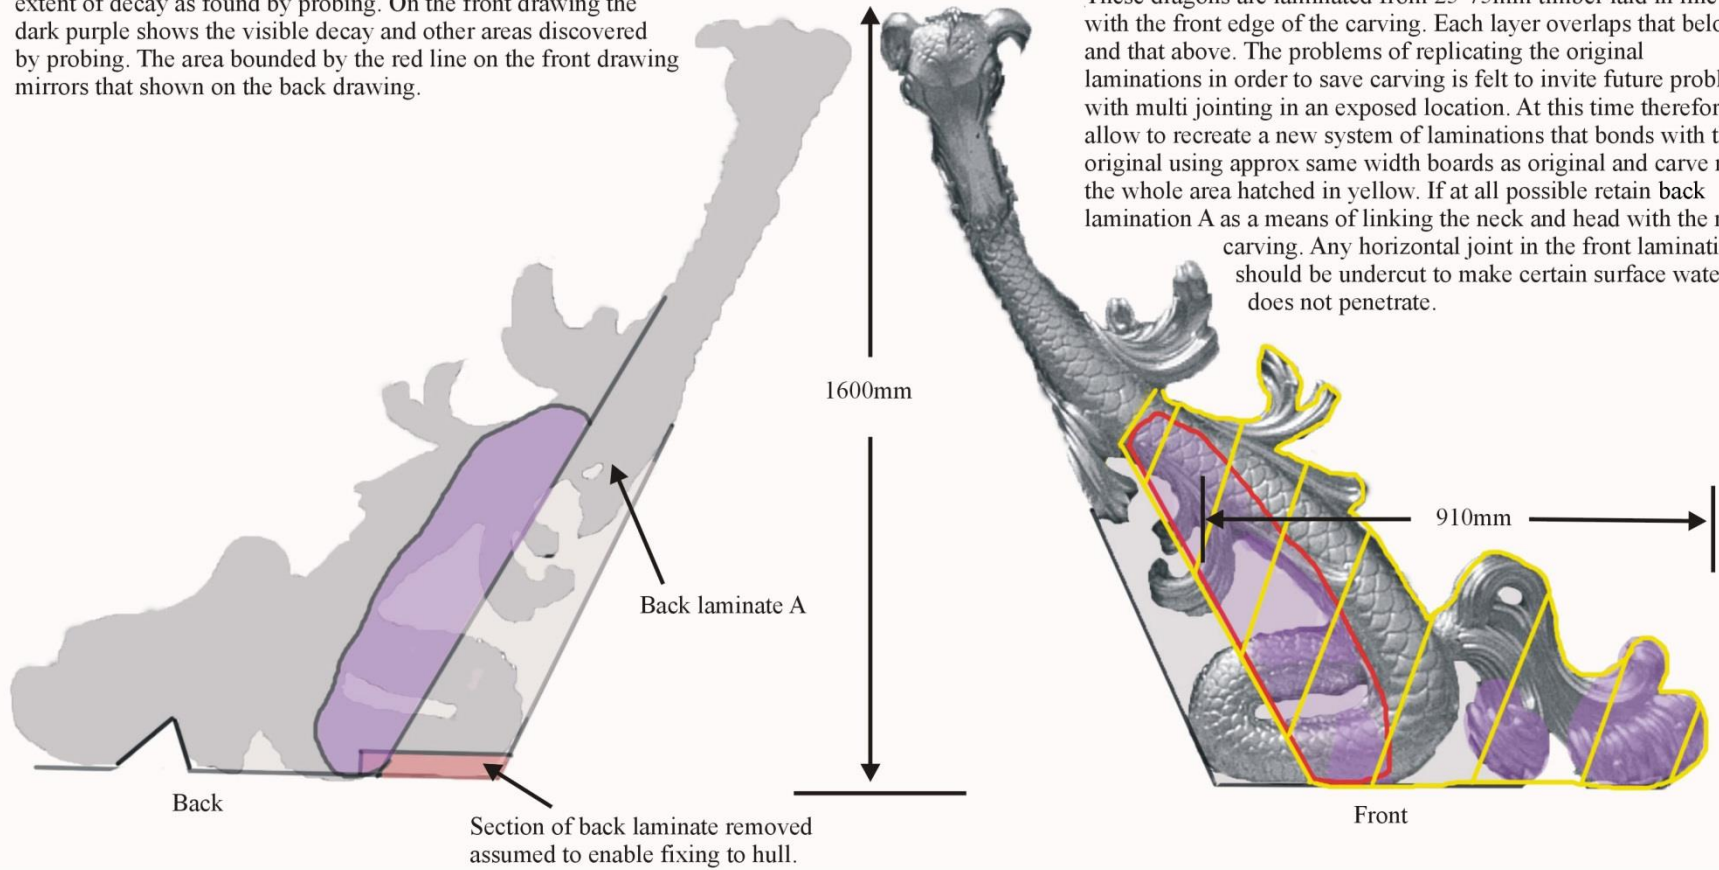
The pale purple on the back elevation indicates the apparent extent of decay as found by probing. On the front drawing the dark purple shows the visible decay and other areas discovered by probing. The area bounded by the red line on the front drawing mirrors that shown on the back drawing.

These dragons are laminated from 25-75mm timber laid in line with the front edge of the carving. Each layer overlaps that below and that above. The problems of replicating the original laminations in order to save carving is felt to invite future problems with multi jointing in an exposed location. At this time therefore, allow to recreate a new system of laminations that bonds with the original using approx same width boards as original and carve new the whole area hatched in yellow. If at all possible retain back lamination A as a means of linking the neck and head with the new carving. Any horizontal joint in the front lamination should be undercut to make certain surface water does not penetrate.

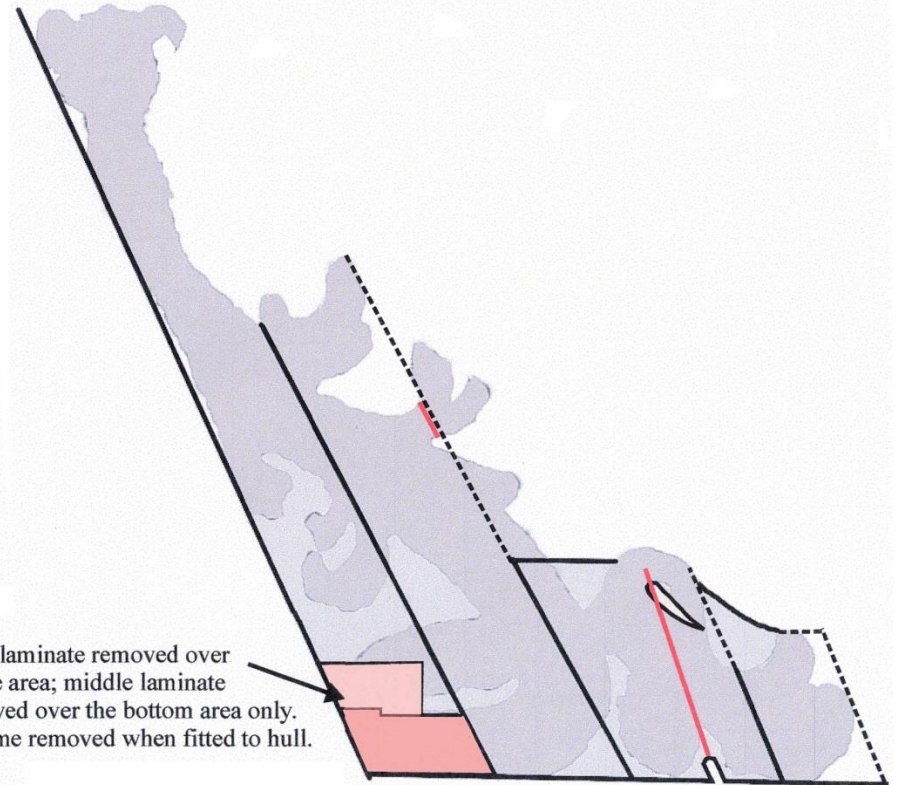
Back laminate removed over whole area; middle laminate removed over the bottom area only. Assume removed when fitted to hull.

Port sea dragon, showing approximate layout of back layer of laminates. The light grey shows where the back layer of laminates is continuous.

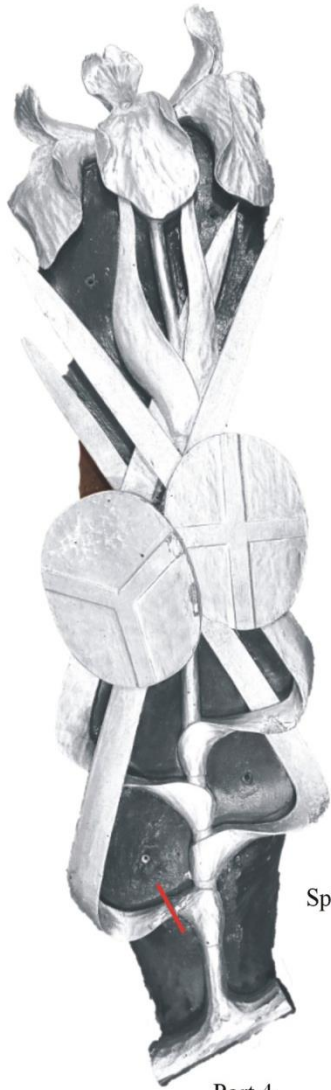
Port 4

Split in carving, reglue

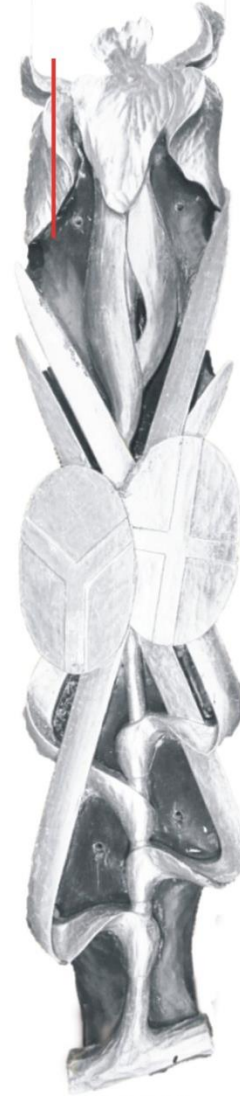
Port 1 Aft

Split in carving, reglue
