# Asbestos Survey Report Refurbishment Survey

## **The Pavillion Meadowcroft, Swindon, England, SN4 9JF**

Job Number: M179226/1

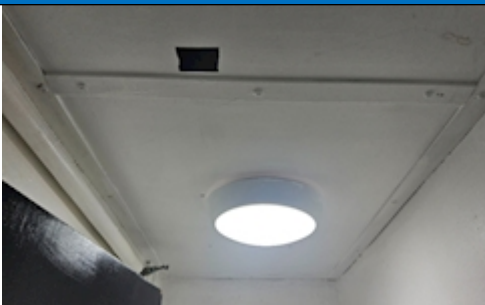
<b>Building</b>	The Pavillion			<b>Floor</b>	0		
<b>Location Description</b>	002: WC (Male)			<b>Record Origin Report</b>	M179226		
<b>Item</b>	Ceiling

<b>Level of Identification (ID)</b>	Sample (S)	<b>Sample No.</b>	S0003				
<b>Material</b>	Insulating Board	<b>Extent</b>	1 m <sup>2</sup>				
<b>Accessibility</b>							
<b>Identification</b>	No Asbestos Detected						
<b>Material Assessment</b>							
<b>Product Type</b>	0	<b>Condition</b>	0	<b>Surface Treatment</b>	0	<b>Asbestos Type</b>	0
<b>Scoring Summary</b>							
<b>Material Score</b>	0				<b>Material Hazard</b>	N/A	
<b>Recommended Action</b>	No Recommendation Required						
<b>Further Information</b>	Insulating board panels to ceiling

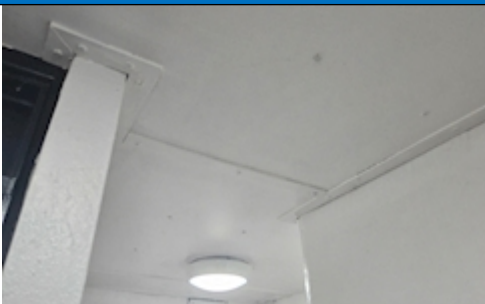
<b>Building</b>	The Pavillion			<b>Floor</b>	0		
<b>Location Description</b>	003: WC (Male)			<b>Record Origin Report</b>	M179226		
<b>Item</b>	Ceiling

<b>Level of Identification (ID)</b>	Cross Reference (X)	<b>Sample No.</b>	X0003				
<b>Material</b>	Insulating Board	<b>Extent</b>	3 m <sup>2</sup>				
<b>Accessibility</b>							
<b>Identification</b>	No Asbestos Detected						
<b>Material Assessment</b>							
<b>Product Type</b>	0	<b>Condition</b>	0	<b>Surface Treatment</b>	0	<b>Asbestos Type</b>	0
<b>Scoring Summary</b>							
<b>Material Score</b>	0				<b>Material Hazard</b>	N/A	
<b>Recommended Action</b>	No Recommendation Required						
<b>Further Information</b>	Insulating board panels to ceiling

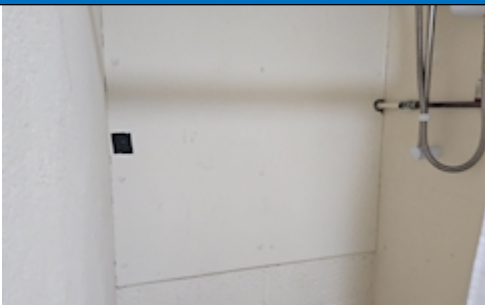
<b>Building</b>	The Pavillion			<b>Floor</b>	0		
<b>Location Description</b>	004: Changing Room			<b>Record Origin Report</b>	M179226		
<b>Item</b>	Wall

<b>Level of Identification (ID)</b>	Sample (S)	<b>Sample No.</b>	S0004				
<b>Material</b>	Insulating Board	<b>Extent</b>	1 m <sup>2</sup>				
<b>Accessibility</b>							
<b>Identification</b>	No Asbestos Detected						
<b>Material Assessment</b>							
<b>Product Type</b>	0	<b>Condition</b>	0	<b>Surface Treatment</b>	0	<b>Asbestos Type</b>	0
<b>Scoring Summary</b>							
<b>Material Score</b>	0					<b>Material Hazard</b>	N/A
<b>Recommended Action</b>	No Recommendation Required						
<b>Further Information</b>	Insulating board panels to wall adjacent to shower unit

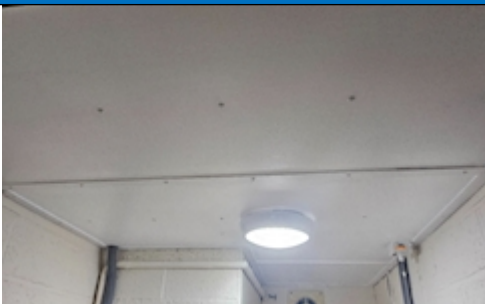
<b>Building</b>	The Pavillion			<b>Floor</b>	0		
<b>Location Description</b>	004: Changing Room			<b>Record Origin Report</b>	M179226		
<b>Item</b>	Ceiling

<b>Level of Identification (ID)</b>	Cross Reference (X)	<b>Sample No.</b>	X0003				
<b>Material</b>	Insulating Board	<b>Extent</b>	2 m <sup>2</sup>				
<b>Accessibility</b>							
<b>Identification</b>	No Asbestos Detected						
<b>Material Assessment</b>							
<b>Product Type</b>	0	<b>Condition</b>	0	<b>Surface Treatment</b>	0	<b>Asbestos Type</b>	0
<b>Scoring Summary</b>							
<b>Material Score</b>	0					<b>Material Hazard</b>	N/A
<b>Recommended Action</b>	No Recommendation Required						
<b>Further Information</b>	Insulating board panels to ceiling

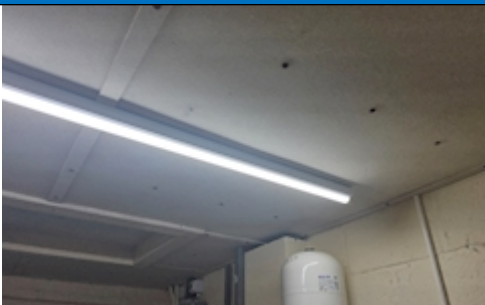
<b>Building</b>	The Pavillion			<b>Floor</b>	0		
<b>Location Description</b>	005: Plant Room			<b>Record Origin Report</b>	M179226		
<b>Item</b>	Ceiling

<b>Level of Identification (ID)</b>	Cross Reference (X)	<b>Sample No.</b>	X0003				
<b>Material</b>	Insulating Board	<b>Extent</b>	3 m²				
<b>Accessibility</b>							
<b>Identification</b>	No Asbestos Detected						
<b>Material Assessment</b>							
<b>Product Type</b>	0	<b>Condition</b>	0	<b>Surface Treatment</b>	0	<b>Asbestos Type</b>	0
<b>Scoring Summary</b>							
<b>Material Score</b>	0					<b>Material Hazard</b>	N/A
<b>Recommended Action</b>	No Recommendation Required						
<b>Further Information</b>	Insulating board panels to ceiling

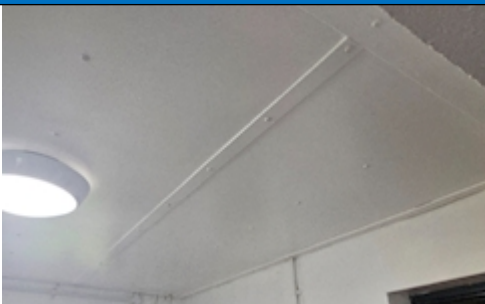
<b>Building</b>	The Pavillion			<b>Floor</b>	0		
<b>Location Description</b>	006: Corridor			<b>Record Origin Report</b>	M179226		
<b>Item</b>	Ceiling

<b>Level of Identification (ID)</b>	Cross Reference (X)	<b>Sample No.</b>	X0003				
<b>Material</b>	Insulating Board	<b>Extent</b>	12 m²				
<b>Accessibility</b>							
<b>Identification</b>	No Asbestos Detected						
<b>Material Assessment</b>							
<b>Product Type</b>	0	<b>Condition</b>	0	<b>Surface Treatment</b>	0	<b>Asbestos Type</b>	0
<b>Scoring Summary</b>							
<b>Material Score</b>	0					<b>Material Hazard</b>	N/A
<b>Recommended Action</b>	No Recommendation Required						
<b>Further Information</b>	Insulating board panels to ceiling

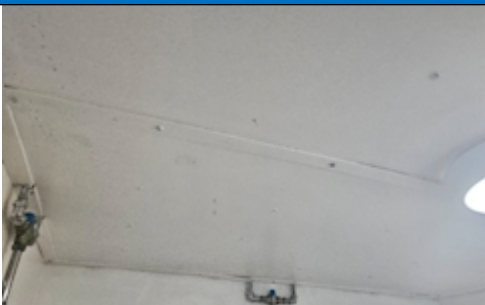
<b>Building</b>	The Pavillion			<b>Floor</b>	0		
<b>Location Description</b>	007: Shower Room			<b>Record Origin Report</b>	M179226		
<b>Item</b>	Ceiling

<b>Level of Identification (ID)</b>	Sample (S)	<b>Sample No.</b>	S0005				
<b>Material</b>	Insulating Board	<b>Extent</b>	4 m²				
<b>Accessibility</b>							
<b>Identification</b>	No Asbestos Detected						
<b>Material Assessment</b>							
<b>Product Type</b>	0	<b>Condition</b>	0	<b>Surface Treatment</b>	0	<b>Asbestos Type</b>	0
<b>Scoring Summary</b>							
<b>Material Score</b>	0					<b>Material Hazard</b>	N/A
<b>Recommended Action</b>	No Recommendation Required						
<b>Further Information</b>	Insulating board panels to ceiling

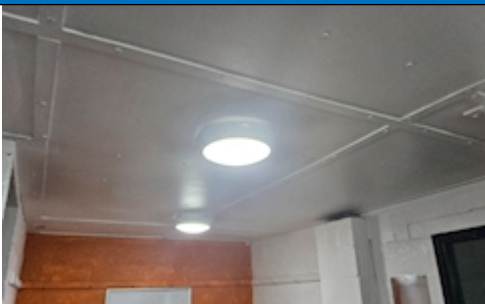
<b>Building</b>	The Pavillion			<b>Floor</b>	0		
<b>Location Description</b>	008: Changing Room			<b>Record Origin Report</b>	M179226		
<b>Item</b>	Ceiling

<b>Level of Identification (ID)</b>	Cross Reference (X)	<b>Sample No.</b>	X0005				
<b>Material</b>	Insulating Board	<b>Extent</b>	20 m²				
<b>Accessibility</b>							
<b>Identification</b>	No Asbestos Detected						
<b>Material Assessment</b>							
<b>Product Type</b>	0	<b>Condition</b>	0	<b>Surface Treatment</b>	0	<b>Asbestos Type</b>	0
<b>Scoring Summary</b>							
<b>Material Score</b>	0					<b>Material Hazard</b>	N/A
<b>Recommended Action</b>	No Recommendation Required						
<b>Further Information</b>	Insulating board panels to ceiling

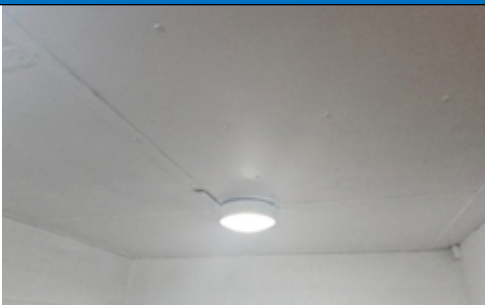
<b>Building</b>	The Pavillion			<b>Floor</b>	0		
<b>Location Description</b>	009: Changing Room			<b>Record Origin Report</b>	M179226		
<b>Item</b>	Ceiling

<b>Level of Identification (ID)</b>	Sample (S)	<b>Sample No.</b>	S0006				
<b>Material</b>	Insulating Board	<b>Extent</b>	20 m <sup>2</sup>				
<b>Accessibility</b>							
<b>Identification</b>	No Asbestos Detected						
<b>Material Assessment</b>							
<b>Product Type</b>	0	<b>Condition</b>	0	<b>Surface Treatment</b>	0	<b>Asbestos Type</b>	0
<b>Scoring Summary</b>							
<b>Material Score</b>	0					<b>Material Hazard</b>	N/A
<b>Recommended Action</b>	No Recommendation Required						
<b>Further Information</b>	Insulating board panels to ceiling

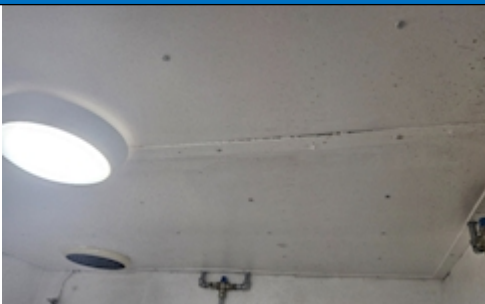
<b>Building</b>	The Pavillion			<b>Floor</b>	0		
<b>Location Description</b>	010: Shower Room			<b>Record Origin Report</b>	M179226		
<b>Item</b>	Ceiling

<b>Level of Identification (ID)</b>	Cross Reference (X)	<b>Sample No.</b>	X0006				
<b>Material</b>	Insulating Board	<b>Extent</b>	4 m <sup>2</sup>				
<b>Accessibility</b>							
<b>Identification</b>	No Asbestos Detected						
<b>Material Assessment</b>							
<b>Product Type</b>	0	<b>Condition</b>	0	<b>Surface Treatment</b>	0	<b>Asbestos Type</b>	0
<b>Scoring Summary</b>							
<b>Material Score</b>	0					<b>Material Hazard</b>	N/A
<b>Recommended Action</b>	No Recommendation Required						
<b>Further Information</b>	Insulating board panels to ceiling

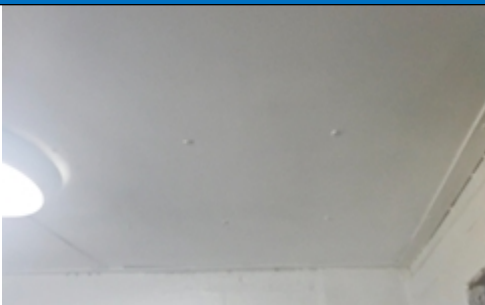
<b>Building</b>	The Pavillion			<b>Floor</b>	0		
<b>Location Description</b>	011: Lobby			<b>Record Origin Report</b>	M179226		
<b>Item</b>	Ceiling

<b>Level of Identification (ID)</b>	Sample (S)	<b>Sample No.</b>	S0007				
<b>Material</b>	Insulating Board	<b>Extent</b>	4 m²				
<b>Accessibility</b>							
<b>Identification</b>	No Asbestos Detected						
<b>Material Assessment</b>							
<b>Product Type</b>	0	<b>Condition</b>	0	<b>Surface Treatment</b>	0	<b>Asbestos Type</b>	0
<b>Scoring Summary</b>							
<b>Material Score</b>	0					<b>Material Hazard</b>	N/A
<b>Recommended Action</b>	No Recommendation Required						
<b>Further Information</b>	Insulating board panels to ceiling

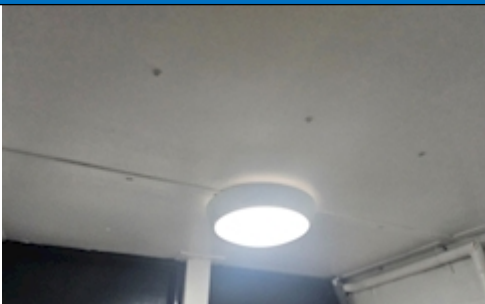
<b>Building</b>	The Pavillion			<b>Floor</b>	0		
<b>Location Description</b>	012: WC (Female)			<b>Record Origin Report</b>	M179226		
<b>Item</b>	Ceiling

<b>Level of Identification (ID)</b>	Cross Reference (X)	<b>Sample No.</b>	X0007				
<b>Material</b>	Insulating Board	<b>Extent</b>	5 m²				
<b>Accessibility</b>							
<b>Identification</b>	No Asbestos Detected						
<b>Material Assessment</b>							
<b>Product Type</b>	0	<b>Condition</b>	0	<b>Surface Treatment</b>	0	<b>Asbestos Type</b>	0
<b>Scoring Summary</b>							
<b>Material Score</b>	0					<b>Material Hazard</b>	N/A
<b>Recommended Action</b>	No Recommendation Required						
<b>Further Information</b>	Insulating board panels to ceiling

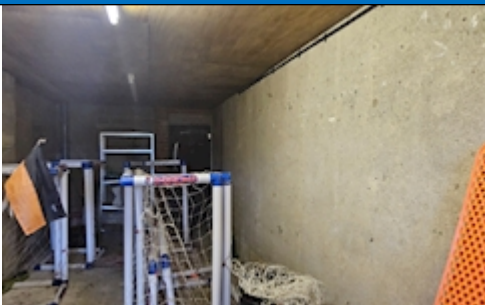
<b>Building</b>	The Pavillion			<b>Floor</b>	0		
<b>Location Description</b>	013: Store			<b>Record Origin Report</b>	M179226		
<b>Item</b>	Store

<b>Level of Identification (ID)</b>	Inspected Area (IA)	<b>Sample No.</b>					
<b>Material</b>		<b>Extent</b>					
<b>Accessibility</b>							
<b>Identification</b>							
<b>Material Assessment</b>							
<b>Product Type</b>		<b>Condition</b>		<b>Surface Treatment</b>		<b>Asbestos Type</b>	
<b>Scoring Summary</b>							
<b>Material Score</b>					<b>Material Hazard</b>		
<b>Recommended Action</b>	<b>No Recommendation Required</b>						
<b>Further Information</b>	All areas within scope inspected, no suspect ACM's detected.

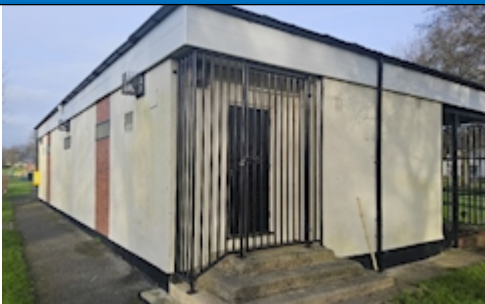
<b>Building</b>	The Pavillion			<b>Floor</b>	Ext		
<b>Location Description</b>	014: External			<b>Record Origin Report</b>	M179226		
<b>Item</b>	External

<b>Level of Identification (ID)</b>	Inspected Area (IA)	<b>Sample No.</b>					
<b>Material</b>		<b>Extent</b>					
<b>Accessibility</b>							
<b>Identification</b>							
<b>Material Assessment</b>							
<b>Product Type</b>		<b>Condition</b>		<b>Surface Treatment</b>		<b>Asbestos Type</b>	
<b>Scoring Summary</b>							
<b>Material Score</b>					<b>Material Hazard</b>		
<b>Recommended Action</b>	<b>No Recommendation Required</b>						
<b>Further Information</b>	All areas within scope inspected, no suspect ACM's detected.

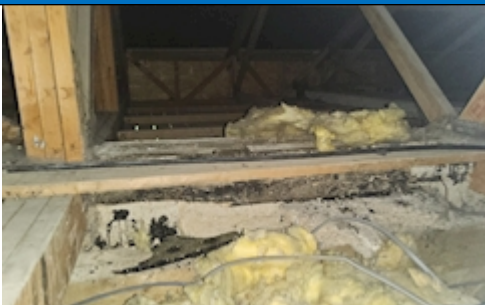
<b>Building</b>	The Pavillion			<b>Floor</b>	Roof		
<b>Location Description</b>	001: Roof Space			<b>Record Origin Report</b>	M179226		
<b>Item</b>	Brickwork

<b>Level of Identification (ID)</b>	Sample (S)	<b>Sample No.</b>	S0001				
<b>Material</b>	Bitumen Product	<b>Extent</b>	20 m²				
<b>Accessibility</b>							
<b>Identification</b>	No Asbestos Detected						
<b>Material Assessment</b>							
<b>Product Type</b>	0	<b>Condition</b>	0	<b>Surface Treatment</b>	0	<b>Asbestos Type</b>	0
<b>Scoring Summary</b>							
<b>Material Score</b>	0					<b>Material Hazard</b>	N/A
<b>Recommended Action</b>	No Recommendation Required						
<b>Further Information</b>	Sarking felt to tops of wall brickwork
