## Roof Survey Report

Imperial War Museum, Duxford  
Duxford Airfield, CAMBRIDGE  
CB22 4QR, England

5th September 2017  
Project Reference: B172642/1

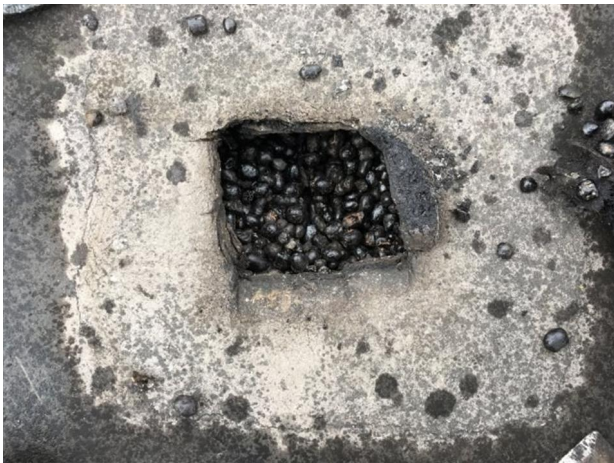
| <b>Condition of core sample:</b> | The deck is dry. |

Image of core sample

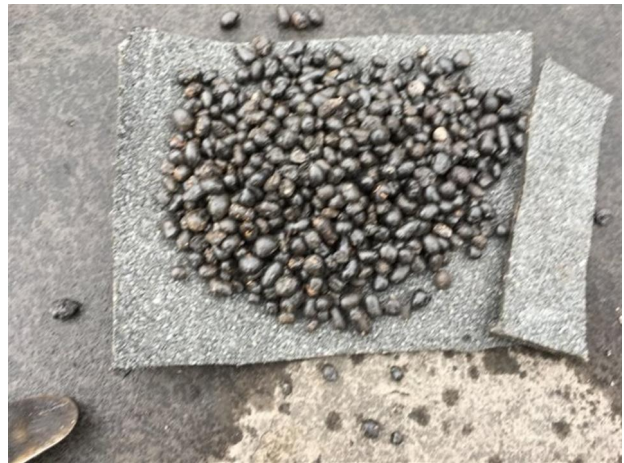
| <b>Screed:</b> | Bitag screed (Expanded clay/ bitumen binder) |

Close up image of lightweight screed

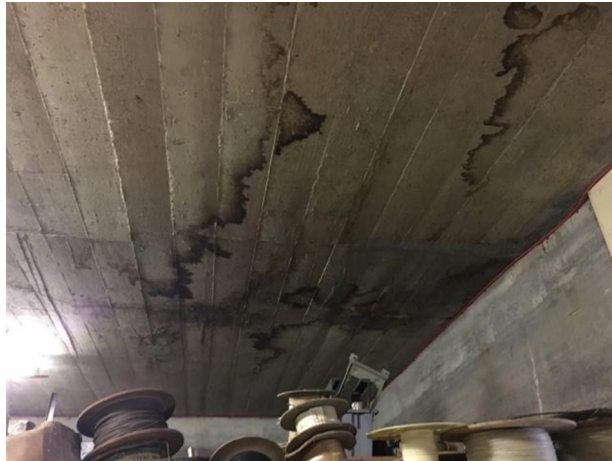
**Image of the underside of the deck shows a number of leaks**

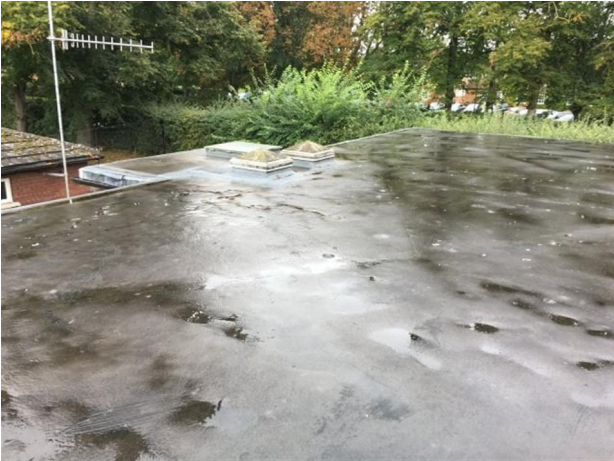
**Overview of roof area**

The condition of the existing waterproofing is of concern. The material covering is coming to the end of its serviceable life and demonstrating signs of age, fatigue and fragility that could lead to serious failure.

The asphalt is showing all the typical defects consistent with a covering of this age including; surface oxidisation, cracks, splits, blows, slumping and signs of repair.

- The existing deck is to be re-used.
- The condition of the existing waterproofing is considered suitable for receiving an overlay system.
- The external rainwater system is in poor condition and should be completely replaced as part of the roof refurbishment works.
- We propose that a new free-standing guard rail system is installed to provide and meet safe access and egress requirements for this roof. We would suggest specialist advice is obtained to provide a suitable specification for these items.

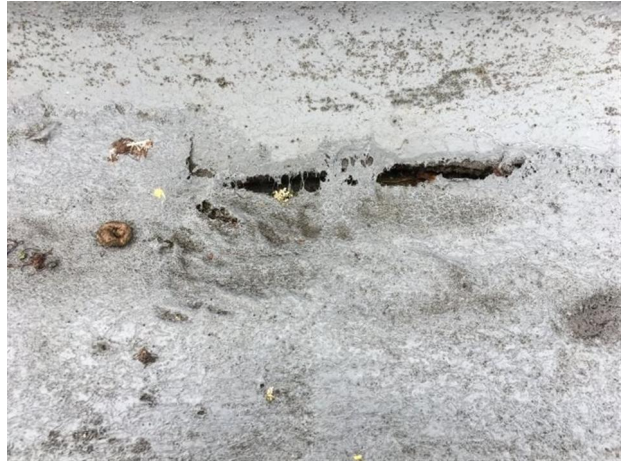
**Evidence of splits in the asphalt at the upstand to rooflight**

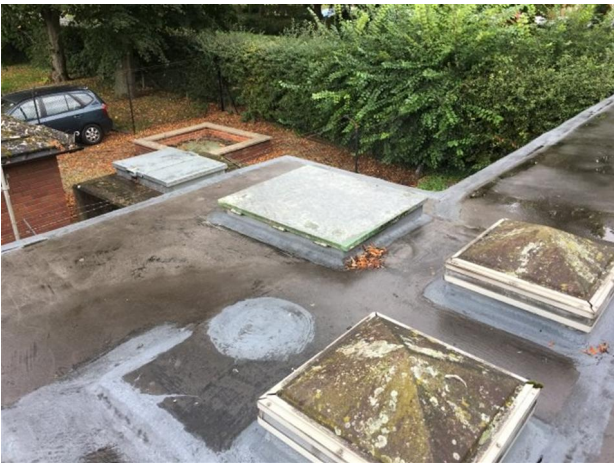
**Extensive liquid repairs show an evidence of water ingress**

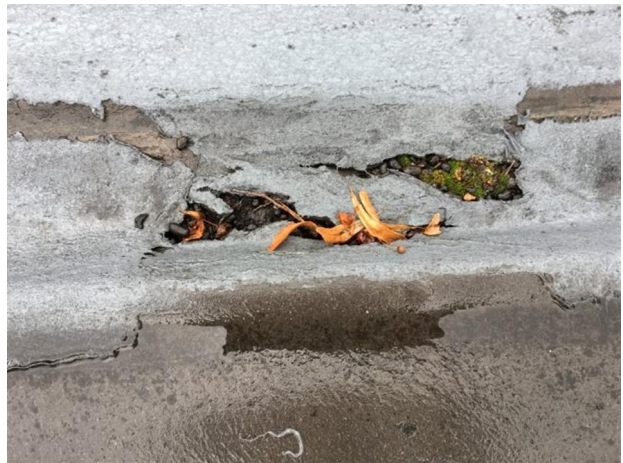
**Further evidence of damaged waterproofing to the perimeter detail**

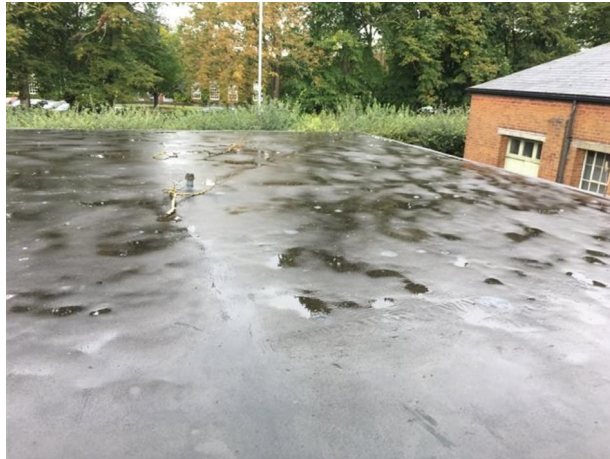
**Overview image of roof shows falls are minimal so some standing water does occur**

Current roof falls are minimal, but appear to be generally functional. Should ponding water be deemed undesirable there is an opportunity whilst re-waterproofing to enhance the existing falls utilising tapered insulation.

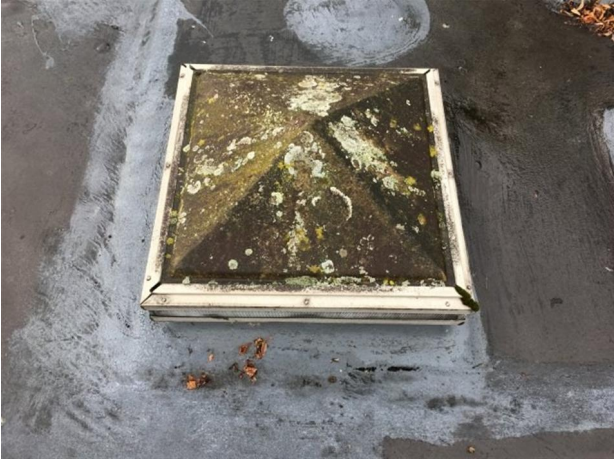
**The existing rooflights are aged and should be replaced or removed all together**

Rooflights designated by the client being redundant should be removed as part of the roof refurbishment works and the openings in-filled as part of the roof refurbishment work. Please be aware that these units may contain asbestos in the internal linings, rope seals or glazing putty.

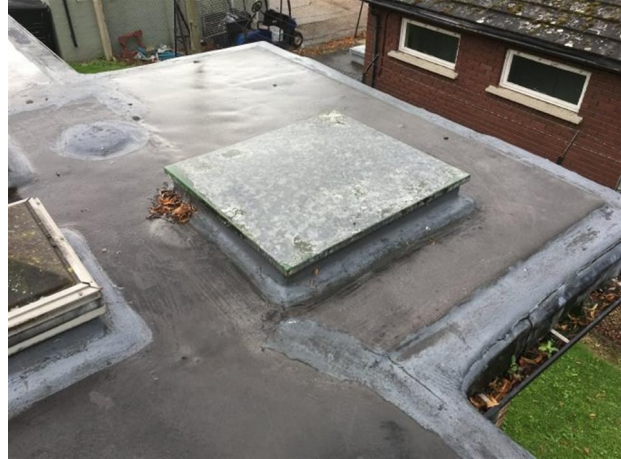
**Access hatch covers a manhole cover and therefore must be retained. The kerbs must be dressed in new waterproofing.**

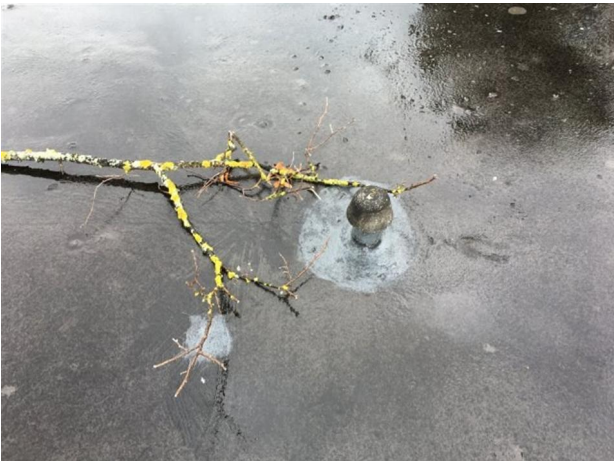
**Screed vent to be removed**
