Asbestos Refurbishment & Demolition Survey Report

**Cockercombe
Over Stowey
Bridgwater
Somerset
TA5 1HJ**

Survey Ref: 9616

Site I.D:	9616	Name of Client:	Forestry Commission	Date of Survey:	05 Dec 2017
Lead Surveyor:	Henry Parkin	Name of Property:	Cockercombe

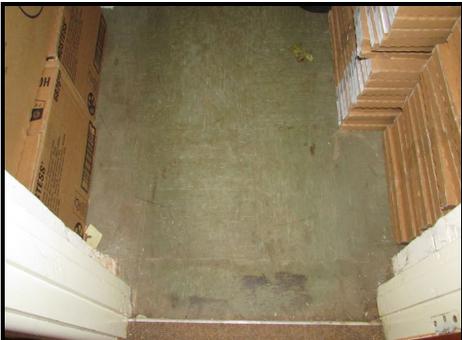
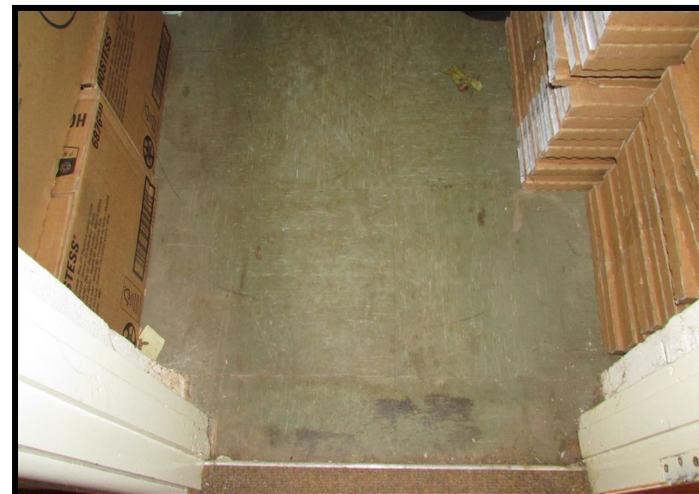
Sample No.	005	Building (Floor)	Cockercombe (Ground floor)	Comments

Room Area	Store cupboard	Description of Location	Floor tile	The green floor tiles and the tile adhesive in the store cupboard are asbestos containing.	
Product Description	Floor Tiles & Adhesive	Asbestos Type	Chrysotile		
Approx Quantity	3.00m2	HSE Notifiable	No

The green floor tiles and the tile adhesive in the store cupboard are asbestos containing.

Asbestos detected in Sample

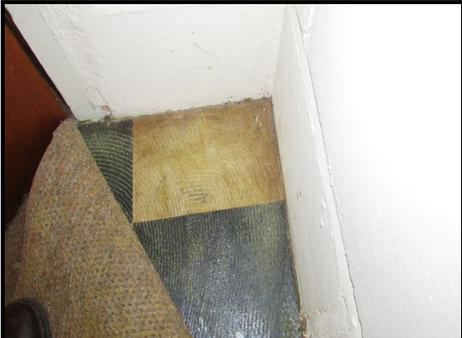
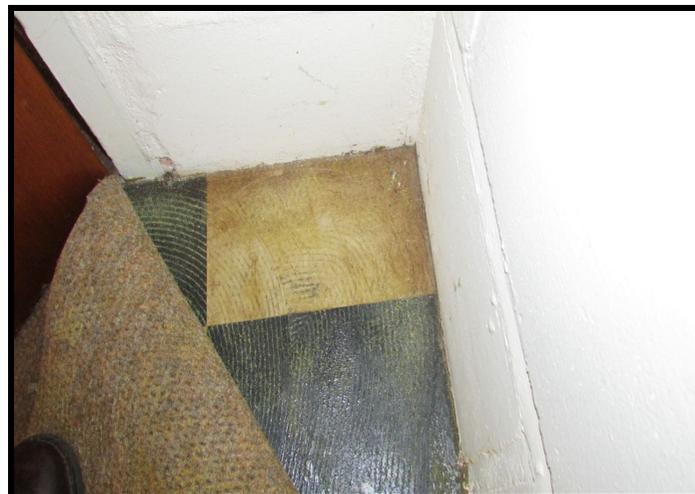
Sample No.	006	Building (Floor)	Cockercombe (Ground floor)	Comments

Room Area	Corridor	Description of Location	Floor tile	The black floor tiles and the floor tile adhesive in the corridor are asbestos containing.	
Product Description	Floor Tiles & Adhesive	Asbestos Type	Chrysotile		
Approx Quantity	10.00m2	HSE Notifiable	No

The black floor tiles and the floor tile adhesive in the corridor are asbestos containing.

Asbestos detected in Sample

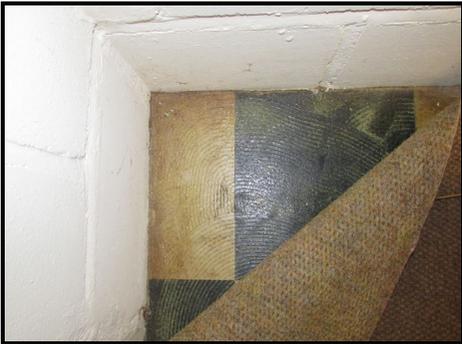
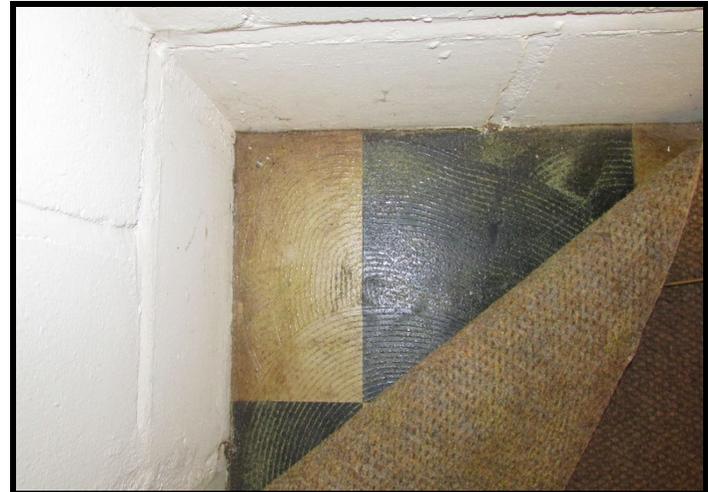
Sample No.	007	Building (Floor)	Cockercombe (Ground floor)	Comments

Room Area	Corridor	Description of Location	Floor tile	<p>The cream floor tiles and the floor tile adhesive in the corridor are asbestos containing.</p>	
Product Description	Floor Tiles & Adhesive	Asbestos Type	Chrysotile		
Approx Quantity	10.00m2	HSE Notifiable	No		
Sample No.	009	Building (Floor)	Cockercombe (Ground floor)	Comments

The cream floor tiles and the floor tile adhesive in the corridor are asbestos containing.

Asbestos detected in Sample

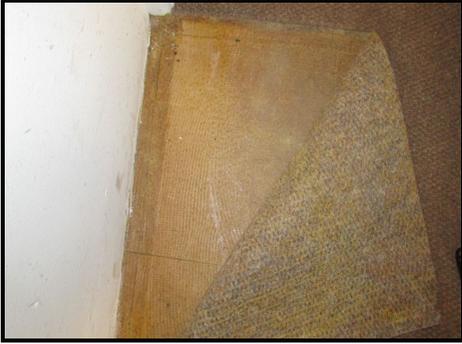
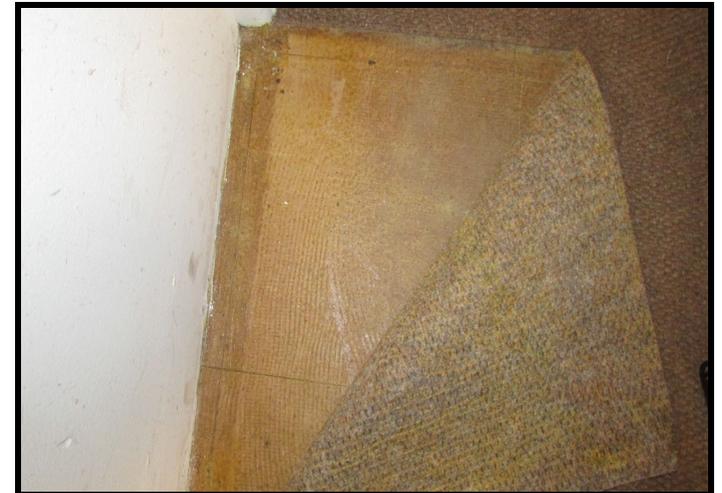
Room Area	Main Office	Description of Location	Floor tile	<p>The pink floor tiles in the main office are asbestos containing.</p>	
Product Description	Floor Tiles	Asbestos Type	Chrysotile		
Approx Quantity	20.00m2	HSE Notifiable	No		
Sample No.	010	Building (Floor)	Cockercombe (Ground floor)	Comments

The pink floor tiles in the main office are asbestos containing.

Asbestos detected in Sample

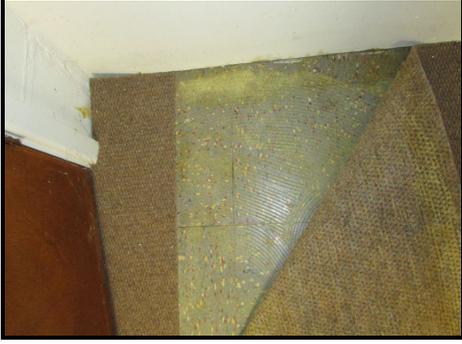
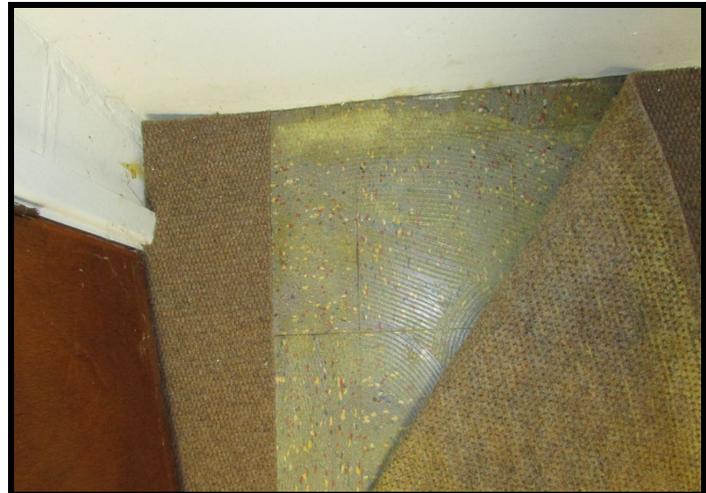
Room Area	Rear Office	Description of Location	Floor tile	<p>The grey floor tiles in the rear office are asbestos containing.</p>	
Product Description	Floor Tiles	Asbestos Type	Chrysotile		
Approx Quantity	15.00m2	HSE Notifiable	No

The grey floor tiles in the rear office are asbestos containing.

Asbestos detected in Sample

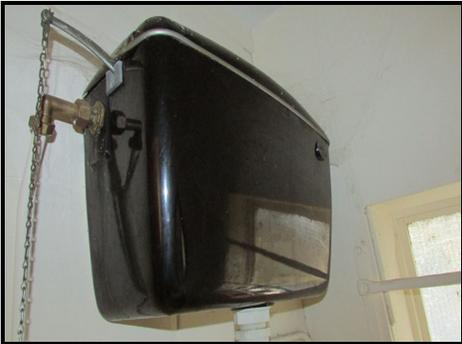
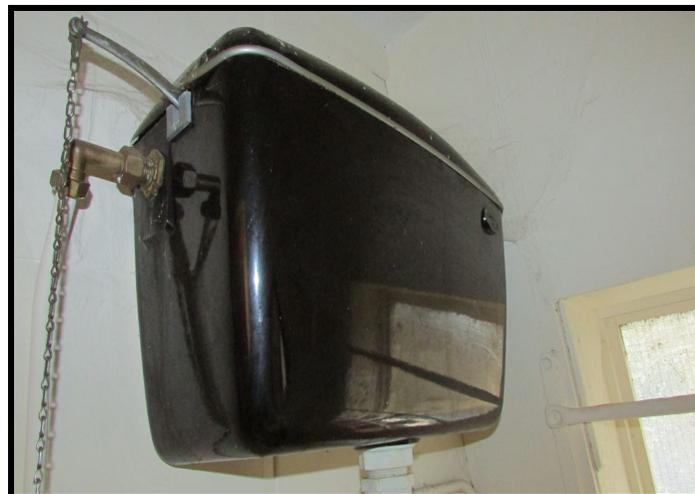
Sample No.	003	Building (Floor)	Cockercombe (Ground floor)	Comments The toilet cistern in the Ladies Toilet is presumed to contain asbestos.

Room Area	Ladies Toilet	Description of Location	Toilet Cistern		
Product Description	Toilet Cistern	Asbestos Type	Amosite		
Approx Quantity	N/A	HSE Notifiable	No

The toilet cistern in the Ladies Toilet is presumed to contain asbestos.

Asbestos Presumed in Sample

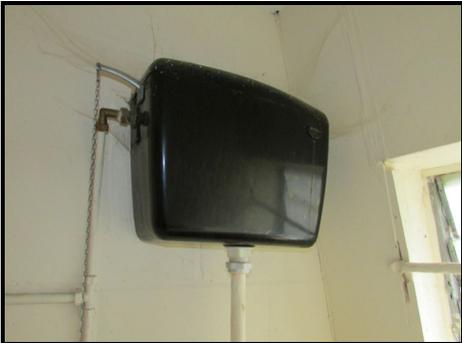
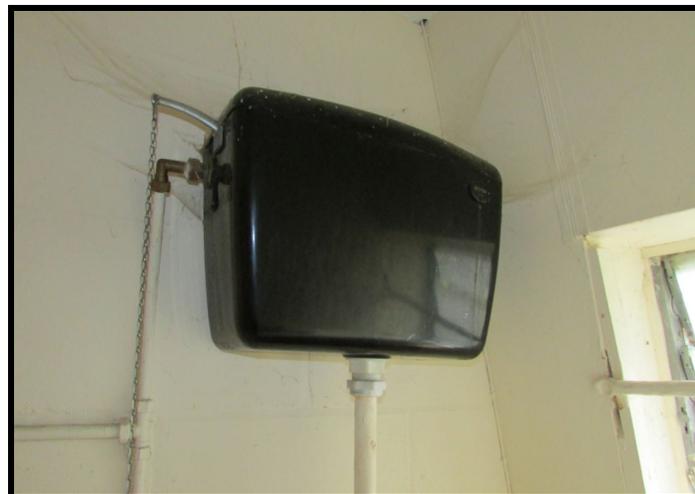
Sample No.	004	Building (Floor)	Cockercombe (Ground floor)	Comments The toilet cistern in the Gents toilet is presumed to contain asbestos.

Room Area	Gents Toilet	Description of Location	Toilet Cistern		
Product Description	Toilet Cistern	Asbestos Type	Amosite		
Approx Quantity	N/A	HSE Notifiable	No

The toilet cistern in the Gents toilet is presumed to contain asbestos.

Asbestos Presumed in Sample

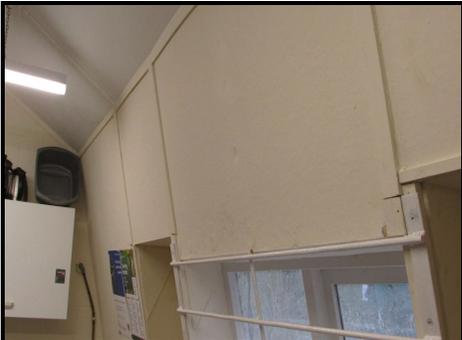
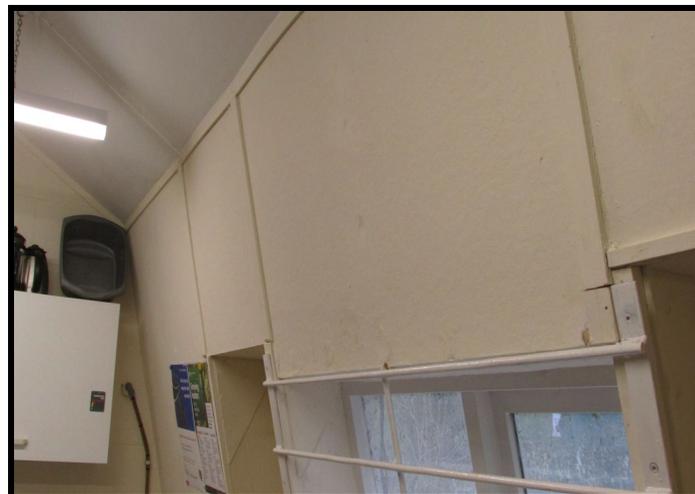
Sample No.	001	Building (Floor)	Cockercombe (Ground floor)	Comments

Room Area	Kitchen	Description of Location	Wall lining	The wall lining to the kitchen is asbestos free. The same asbestos free boarding has been used extensively throughout the property.	
Product Description	No ACMs	Asbestos Type	Not Applicable		
Approx Quantity	N/A	HSE Notifiable	N/A

The wall lining to the kitchen is asbestos free. The same asbestos free boarding has been used extensively throughout the property.

Asbestos not detected in Sample

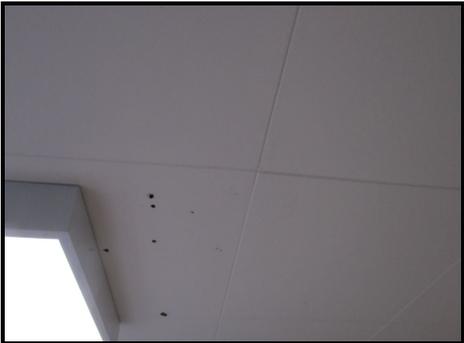
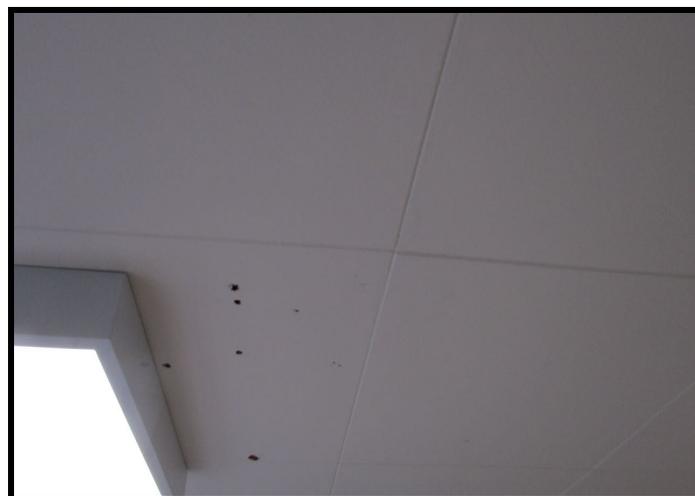
Sample No.	008	Building (Floor)	Cockercombe (Ground floor)	Comments The ceiling tiles on part of the office ceiling are asbestos free.

Room Area	Main Office	Description of Location	Ceiling Panel		
Product Description	No ACMs	Asbestos Type	Not Applicable		
Approx Quantity	N/A	HSE Notifiable	N/A

The ceiling tiles on part of the office ceiling are asbestos free.

Asbestos not detected in Sample
