Cornwall Drains Ltd

Penzance Council Penlee House Gallery & Museum 280125

12 February 2025

## GRADE 3,4 & 5 Summary

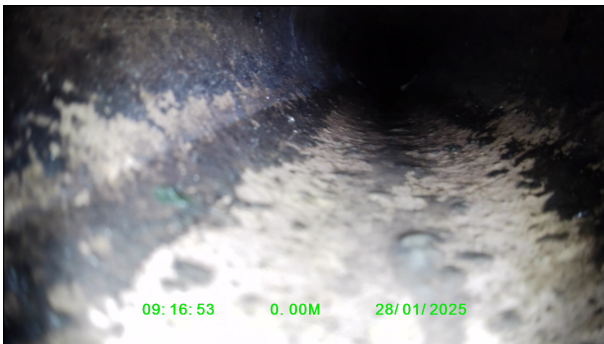
Photo: 1\_1\_5\_A.jpg

0m, Attached deposits, fouling, from 12 to 12 o'clock, 5%  
 cross-sectional area loss, Start Remarks: vision obscured

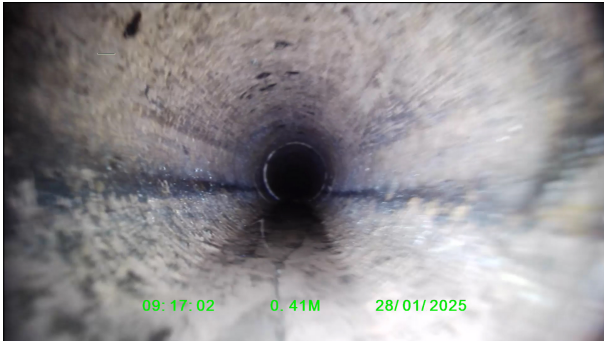
Photo: 1\_1\_7\_A.jpg  
0.5m, Fracture, longitudinal at joint, at 6 o'clock, Start

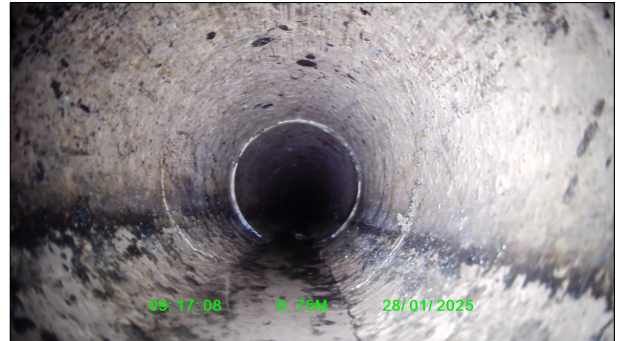
Photo: 1\_1\_8\_A.jpg  
0.8m, Crack, circumferential, from 4 to 10 o'clock

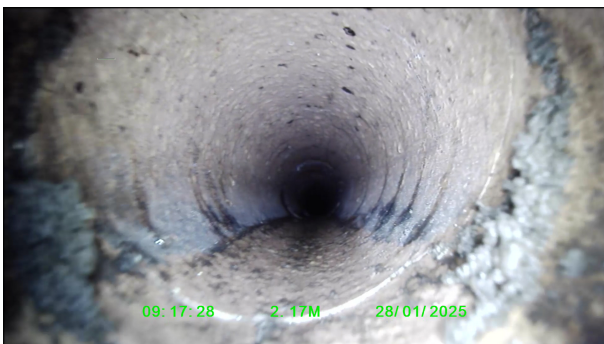
Photo: 1\_1\_10\_A.jpg  
2.2m, Fracture, circumferential at joint, from 2 to 7 o'clock

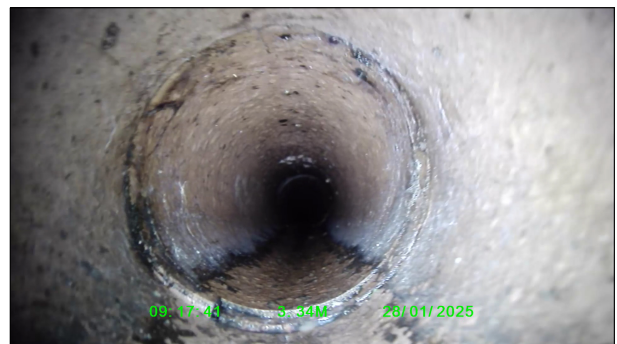
Photo: 1\_1\_11\_A.jpg  
3.4m, Fracture, circumferential at joint, from 3 to 9 o'clock

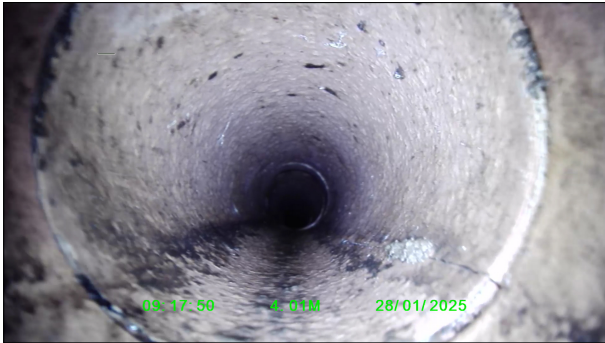
Photo: 1\_1\_12\_A.jpg  
4m, Fracture, longitudinal at joint, at 4 o'clock, Start

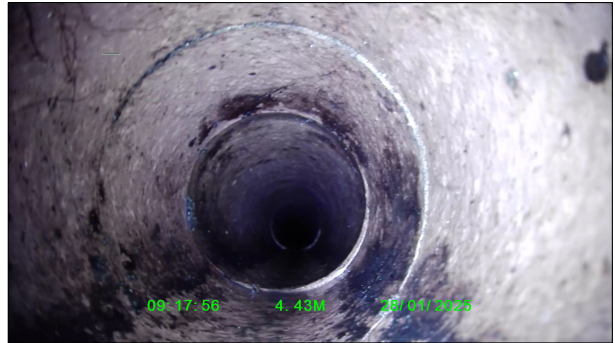
| Structural defects | | | |
|---|---|---|---|
| 1 | CWMH01 X | 3 | Multiple defects at 4.5m |

Photo: 1\_1\_14\_A.jpg  
4.5m, Fracture, circumferential, from 12 to 12 o'clock

Grade 3; Best practice suggests consideration be given to repair in the medium term

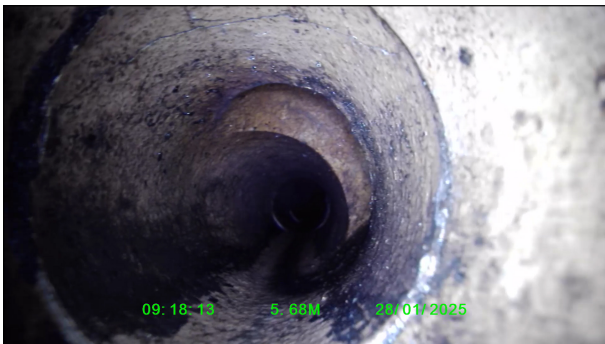
Photo: 1\_1\_15\_A.jpg  
5.7m, Crack, circumferential at joint, from 10 to 2 o'clock

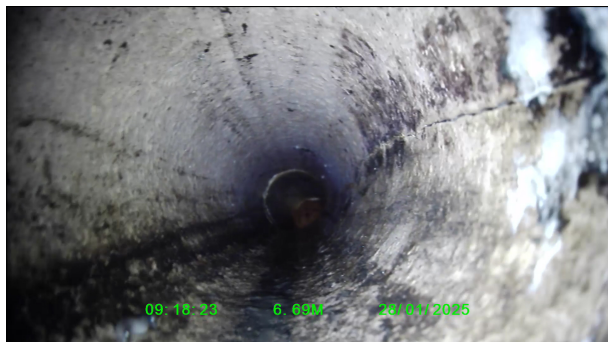
Photo: 1\_1\_17\_A.jpg  
6.7m, Fracture, longitudinal at joint, at 3 o'clock, Start

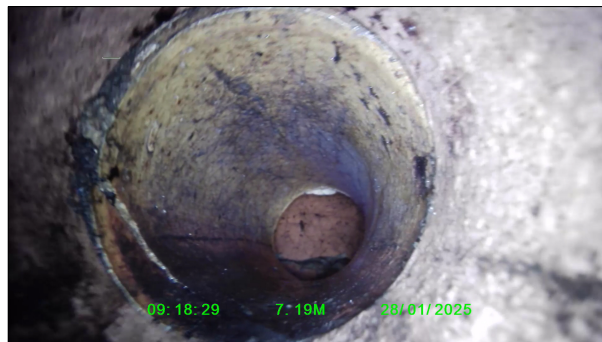
Photo: 1\_1\_19\_A.jpg  
7.2m, Fracture, circumferential at joint, from 6 to 9 o'clock

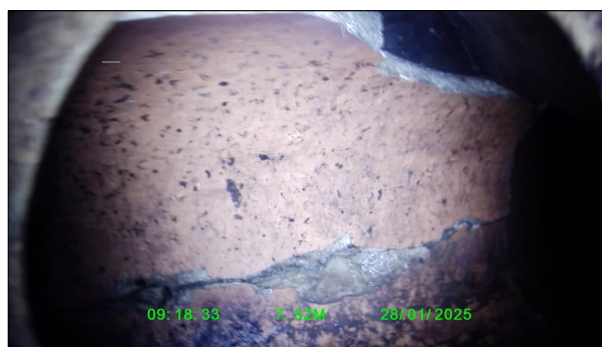
| Service defects | | | |
|---|---|---|---|
| 1 | CWMH01 X | 3 | Multiple defects at 7.6m |

Photo: 1\_1\_21\_A.jpg  
7.6m, Attached deposits, fouling, from 12 to 12 o'clock, 5% cross-sectional area loss, End Remarks: vision obscured

Grade 3; Best practice suggests consideration be given to maintenance activities in the medium term

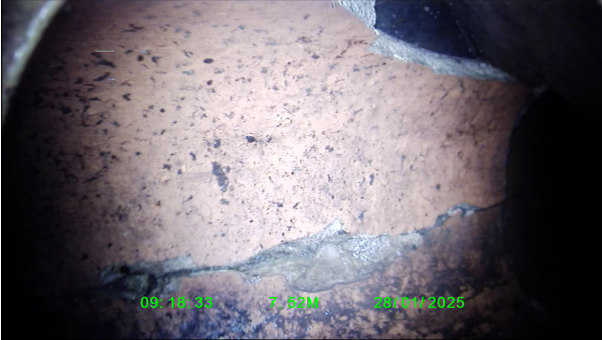
Photo: 1\_1\_73\_A.jpg

7.6m, General photograph taken at this point Remarks: haff  
channel damaged in CWMH02

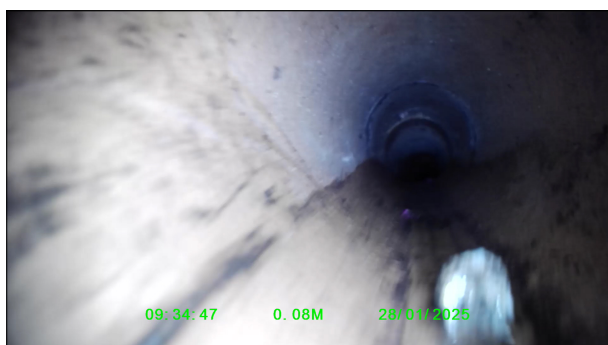
Photo: 3\_3\_26\_A.jpg

| Service defects | | | |
|---|---|---|---|
| 2 | CWMH02 X | 5 | Multiple defects at 0.1m |

0.1m, Other obstacles, other object in invert, from 5 to 6 o'clock, 5% cross-sectional area loss Remarks: stone

Grade 5; Best practice suggests this pipe is at immediate risk of backing up / causing flooding

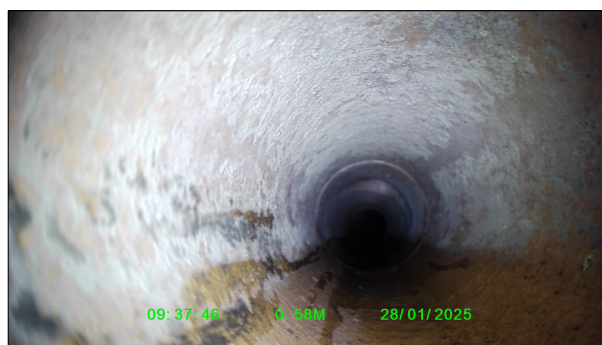
Photo: 3\_3\_34\_A.jpg

0.1m, Attached deposits, fouling, from 12 to 12 o'clock, 5% cross-sectional area loss Remarks: vision obscured

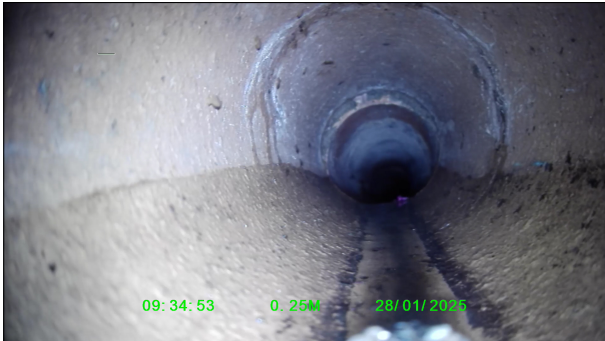
| Structural defects | | | |
|---|---|---|---|
| 2 | CWMH02 X | 3 | Fracture, circumferential, from 12 to 12 o'clock |

Photo: 3\_3\_27\_A.jpg  
0.4m, Fracture, circumferential, from 12 to 12 o'clock

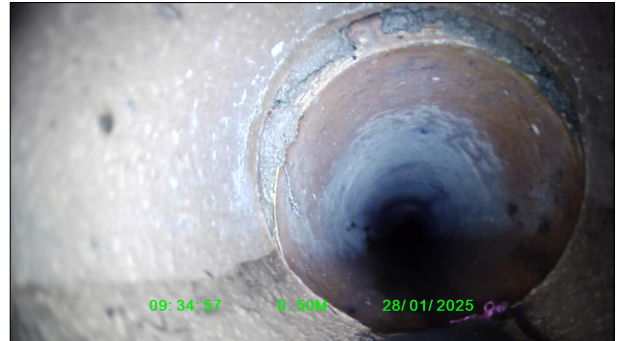
Photo: 3\_3\_28\_A.jpg  
0.6m, Joint displaced, medium Remarks: with flow

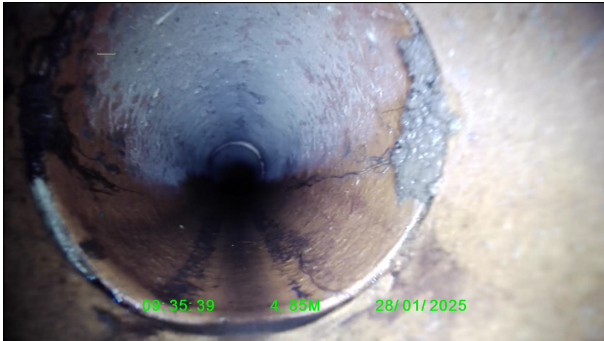
Photo: 3\_3\_31\_A.jpg  
4.9m, Roots, fine at joint

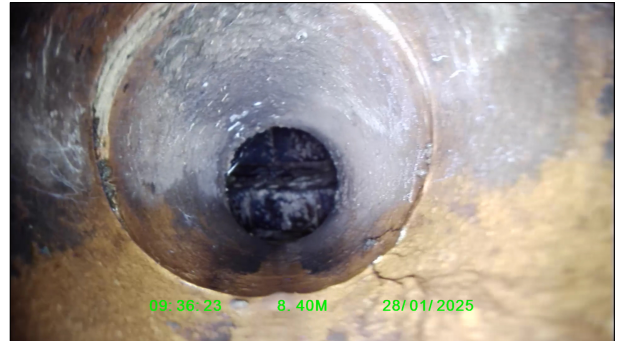
Photo: 3\_3\_33\_A.jpg  
8.5m, Roots, fine at joint

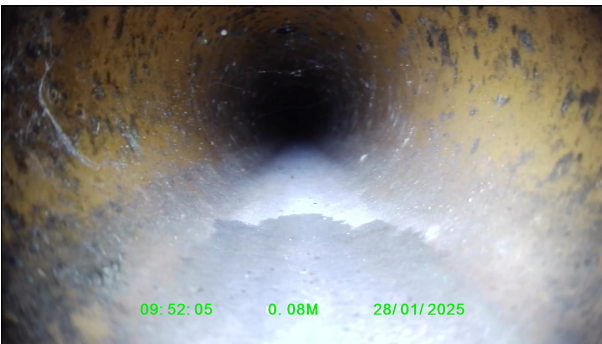
Photo: 4\_4\_40\_A.jpg

0m, Attached deposits, fouling, from 3 to 9 o'clock, 5% cross-sectional area loss, Start Remarks: vision obscured

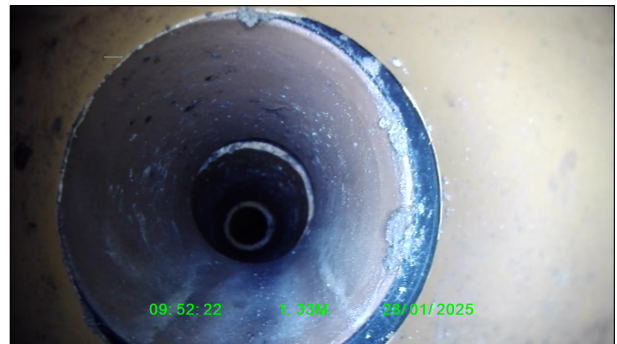
Photo: 4\_4\_41\_A.jpg

1.4m, Line deviates left Remarks: joint pulled

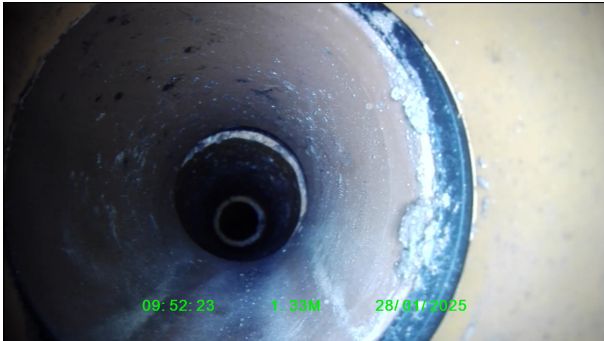
Photo: 4\_4\_42\_A.jpg  
1.4m, Open joint, medium Remarks: joint pulled

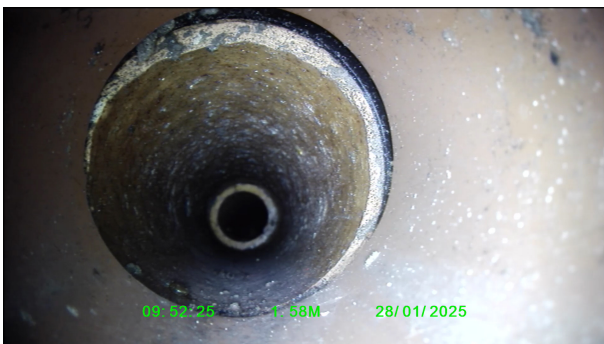
Photo: 4\_4\_45\_A.jpg  
1.7m, Open joint, medium Remarks: joint pulled

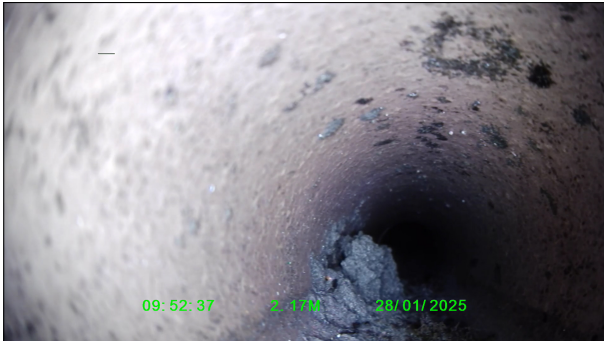
Photo: 4\_4\_48\_A.jpg  
2.1m, Settled deposits, fine, 15% cross-sectional area loss, Start

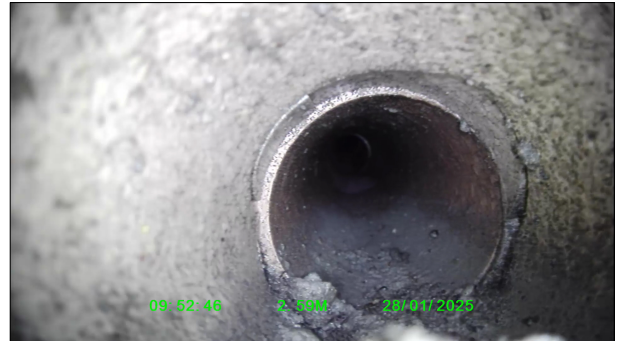
| Service defects | | | |
|---|---|---|---|
| 3 | Gully X | 3 | Multiple defects at 2.7m |

Photo: 4\_4\_49\_A.jpg  
2.7m, Fracture, circumferential at joint, from 9 to 4 o'clock

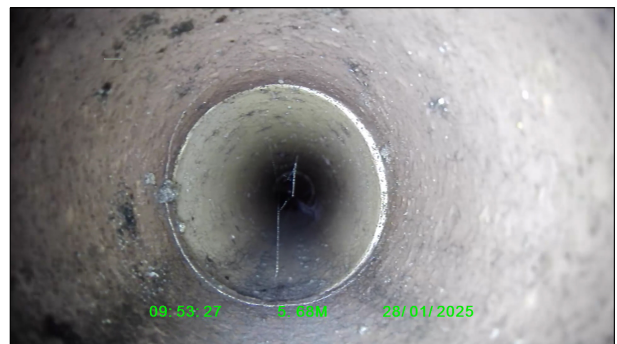
Photo: 4\_4\_52\_A.jpg  
5.8m, Crack, circumferential at joint, from 4 to 11 o'clock

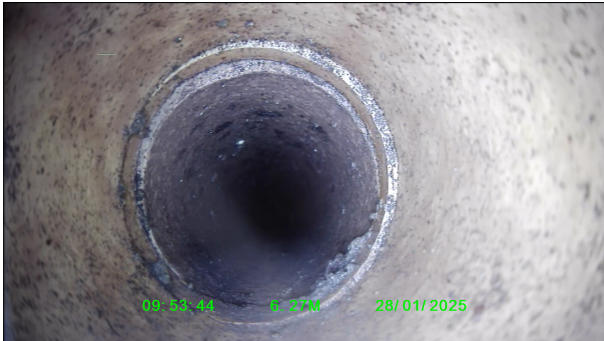
Photo: 4\_4\_53\_A.jpg  
6.3m, Fracture, circumferential at joint, from 12 to 12 o'clock

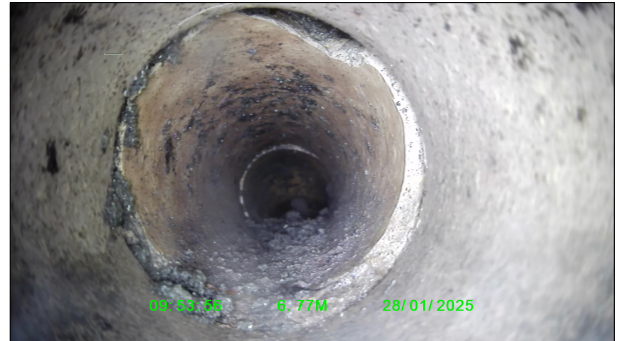
Photo: 4\_4\_54\_A.jpg  
6.8m, Broken pipe at joint, from 12 to 2 o'clock

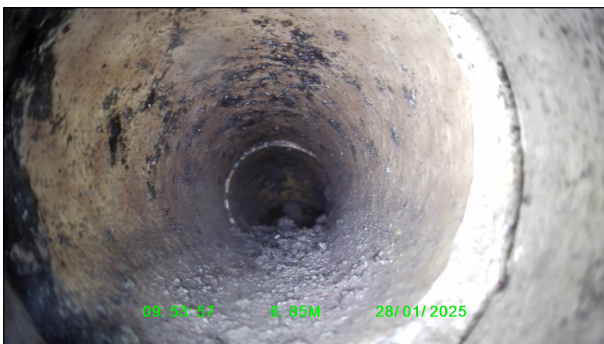
| Camera no access | | |
|---|---|---|
| 3 | Gully X | Settled deposits, fine, 10% cross-sectional area loss, End |

Photo: 4\_4\_56\_A.jpg  
6.8m, Settled deposits, fine, 10% cross-sectional area loss, Start

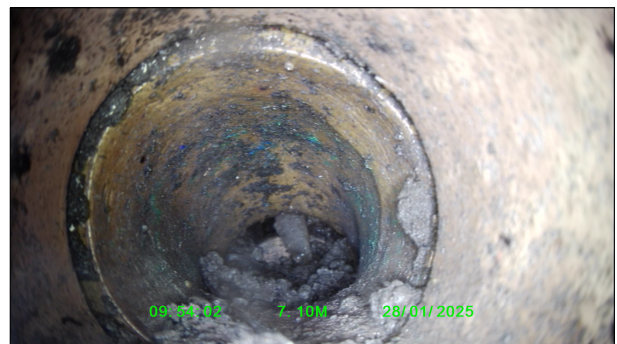
Photo: 4\_4\_75\_A.jpg  
7.3m, Survey abandoned Remarks: unable to pass beyond this point

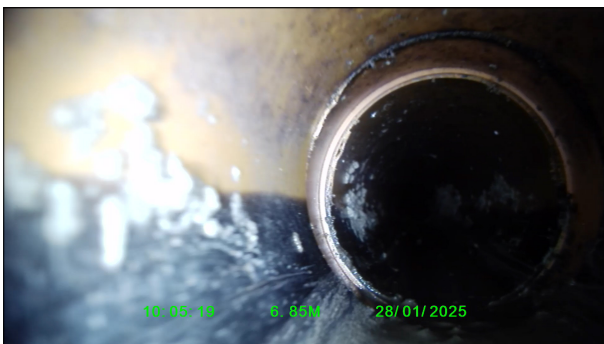
Photo: 5\_5\_67\_A.jpg

6.9m, Attached deposits, grease, from 2 to 10 o'clock, 5% cross-sectional area loss, Start Remarks: vision obscured

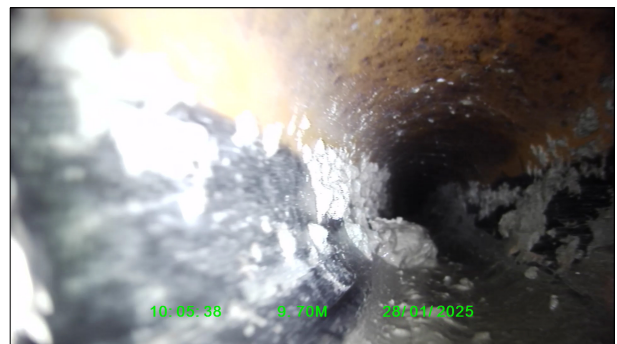
Photo: 5\_5\_68\_A.jpg

9.7m, Attached deposits, grease, from 2 to 10 o'clock, 15% cross-sectional area loss, Start Remarks: vision obscured

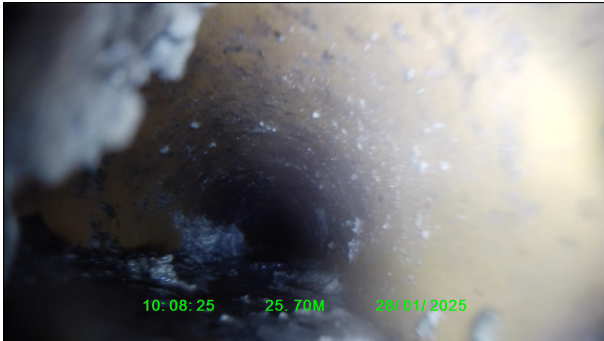
Photo: 5\_5\_71\_A.jpg

25.7m, Settled deposits, fine, 25% cross-sectional area loss,  
Start Remarks: vision obscured
