Report No **NACS/2939** for

Lombardy Lodge
Portland Road
Toton

ASBESTOS SURVEY REPORT 2939

Name and Address of Client 650	Property Name ,Address & Ref No 4975
Broxtowe Borough Council	Lombardy Lodge
Chief Executive Department	Portland Road
Town Hall, Foster Avenue, Beeston	Toton
Nottingham	Notts
NG9 1AB	
Type of Survey	Related Documents
Type 2 full survey	BS report 8233
Nature of Clients Request	Air report -
Carry Out Type 2 Surveys (communal To Residences)	Plan report 29266v1, 29267v1.
Name of surveyor(s)	Photo file 17515-17521, 20936-20942
SD Smith/I Haney	Register 4078
Survey Limitations	Priority One -
Communal areas	Misc documents
	Survey Date 9.6.2005 Report Date 30.6.2005

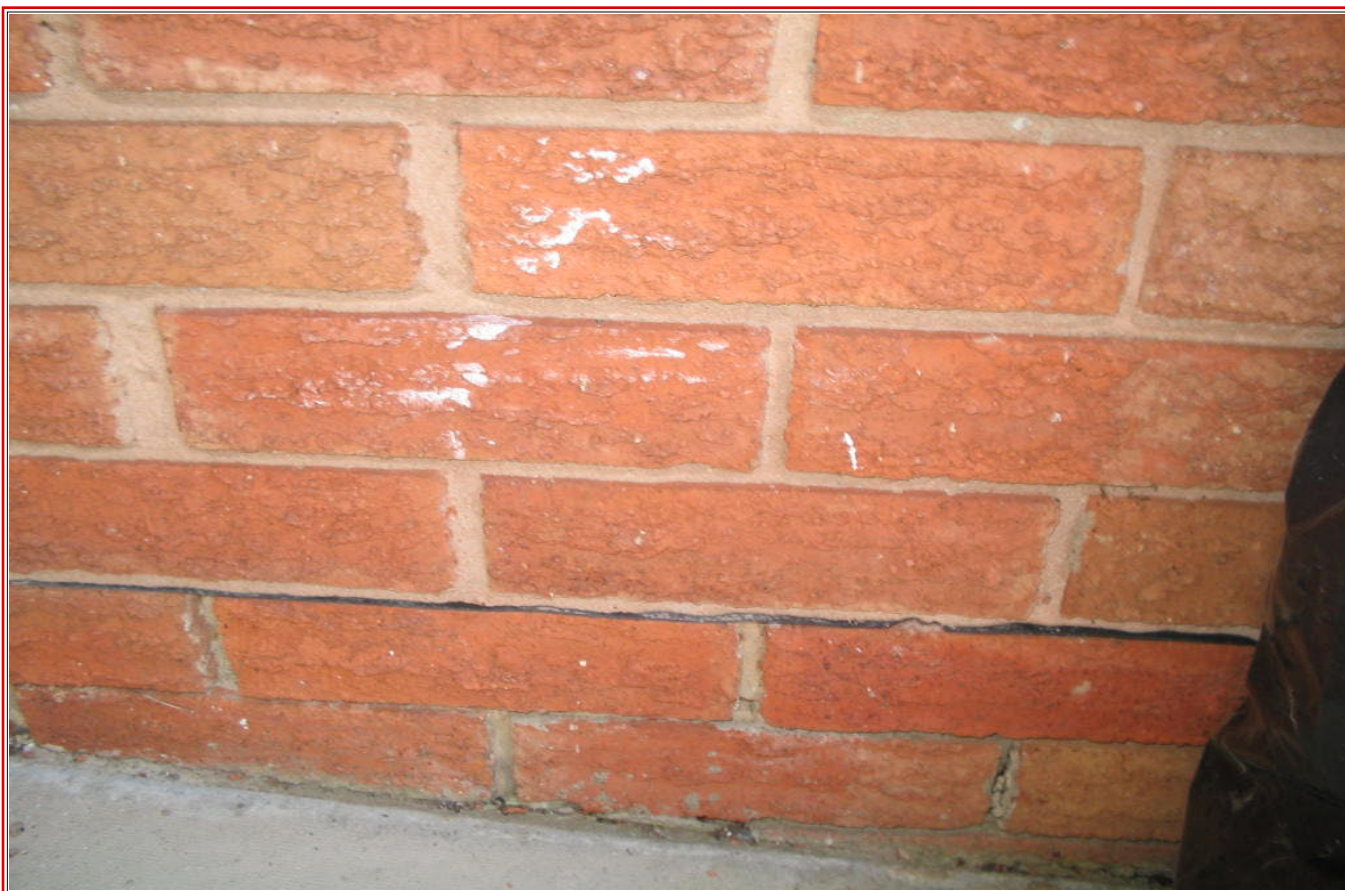
Dpm

Test No.	1254	score
* Component	7	
Condition		
Acm Type		
Asbestos type	Non Asbestos	0
Material Risk Assessment Score		0
Accessibility		Priority:
Extent (m2)		
* 7= non asbestos (see registers)

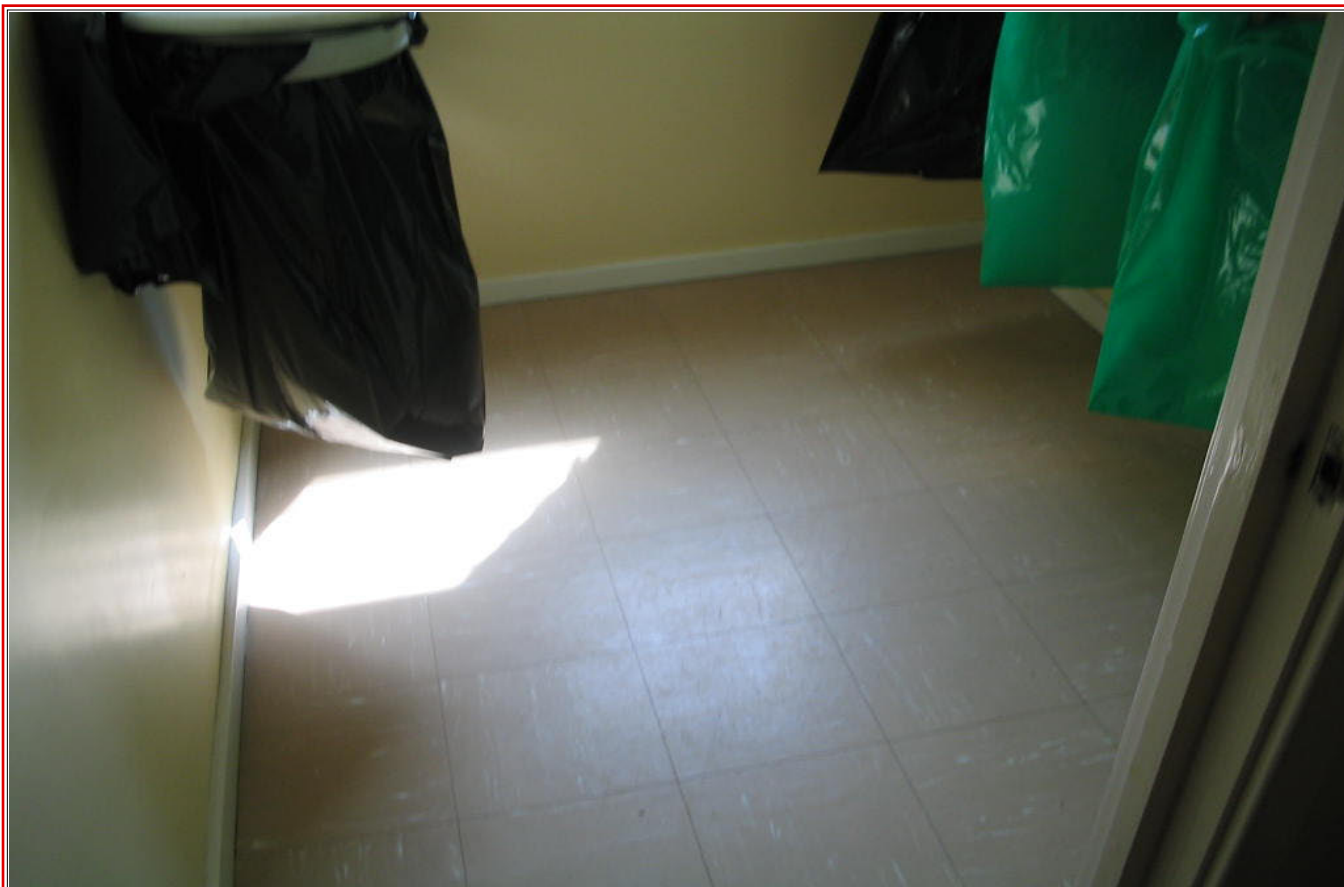
Beige Floor Tiles

Test No.	1256	score
* Component	7	
Condition		
Acm Type		
Asbestos type	Non Asbestos	0
Material Risk Assessment Score		0
Accessibility		Priority:
Extent (m2)		
* 7= non asbestos (see registers)

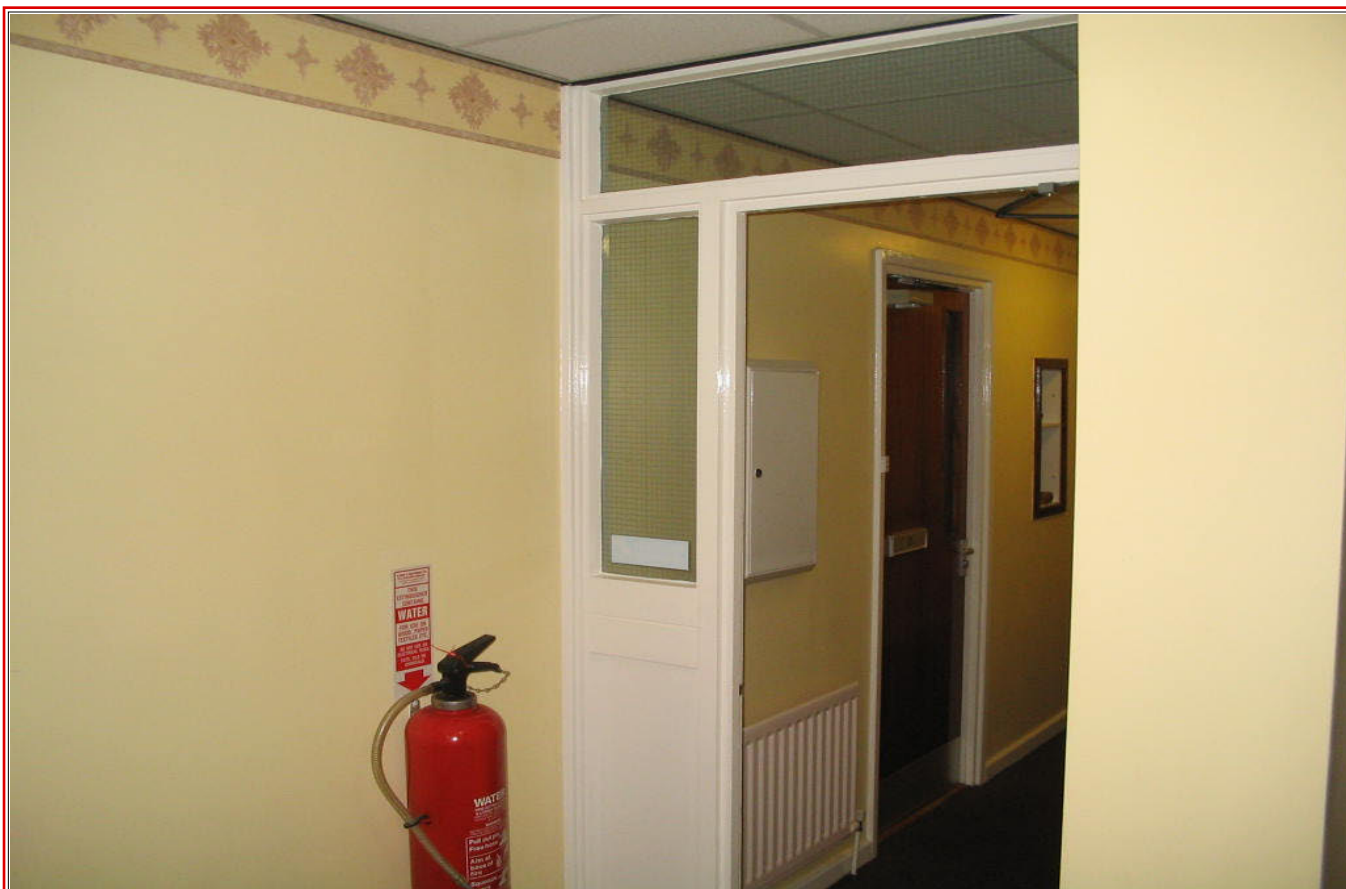
L L Panel Adjacent To Fire Door

Test No.	1258	score
* Component	7	
Condition		
Acm Type		
Asbestos type	Non Asbestos	0
Material Risk Assessment Score		0
Accessibility		Priority:
Extent (m2)		
* 7= non asbestos (see registers)

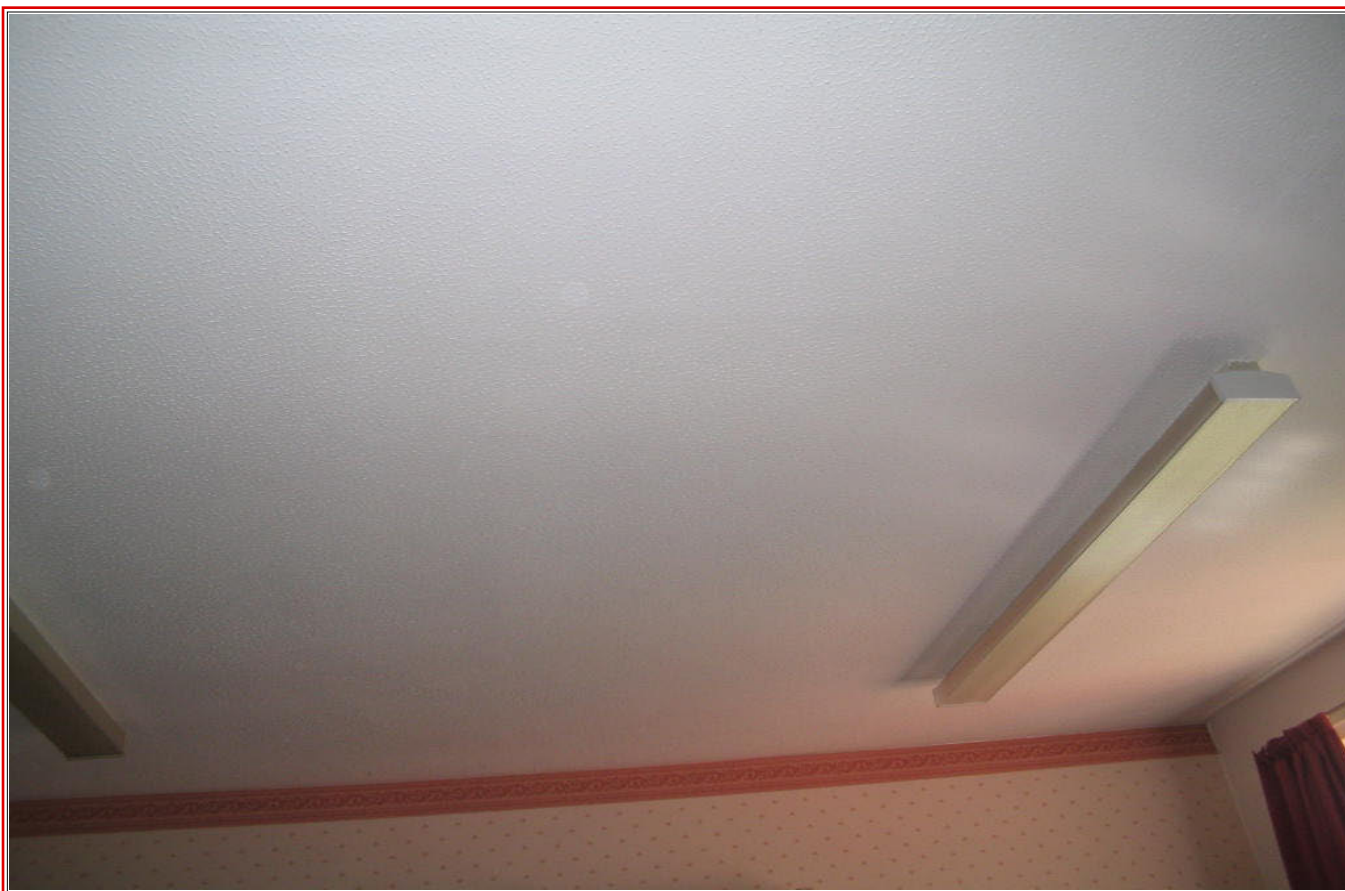
Textured Coating To Ceiling

Test No.	1260	score
* Component	7	
Condition		
Acm Type		
Asbestos type	Non Asbestos	0
Material Risk Assessment Score		0
Accessibility		Priority:
Extent (m2)		
* 7= non asbestos (see registers)

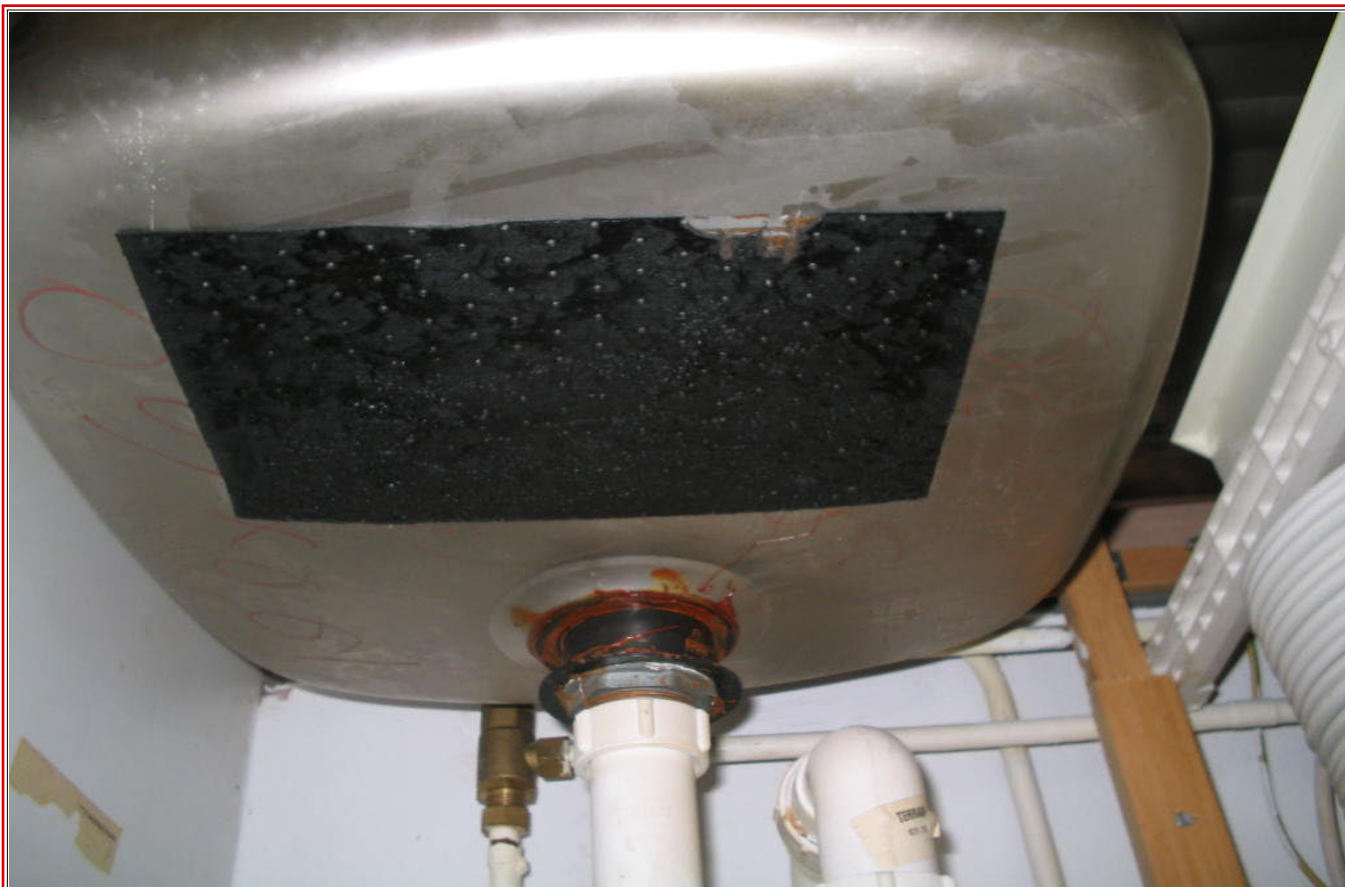
Sink Pad

Test No.	1262	score
* Component	7	
Condition		
Acm Type		
Asbestos type	Non Asbestos	0
Material Risk Assessment Score		0
Accessibility		Priority:
Extent (m2)		
* 7= non asbestos (see registers)

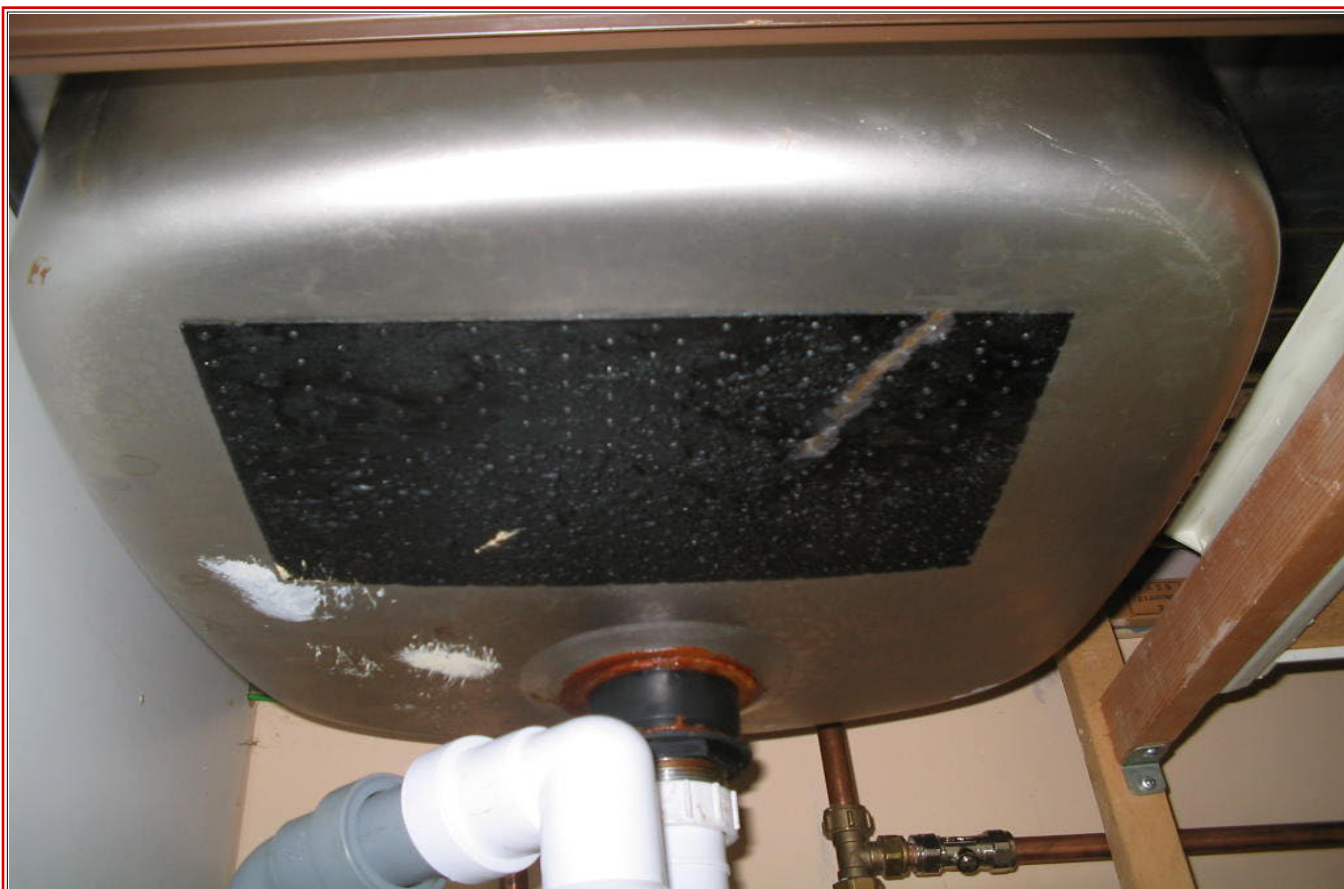
Sink Pad

Test No.	1264	score
* Component	7	
Condition		
Acm Type		
Asbestos type	Non Asbestos	0
Material Risk Assessment Score		0
Accessibility		Priority:
Extent (m2)		
* 7= non asbestos (see registers)

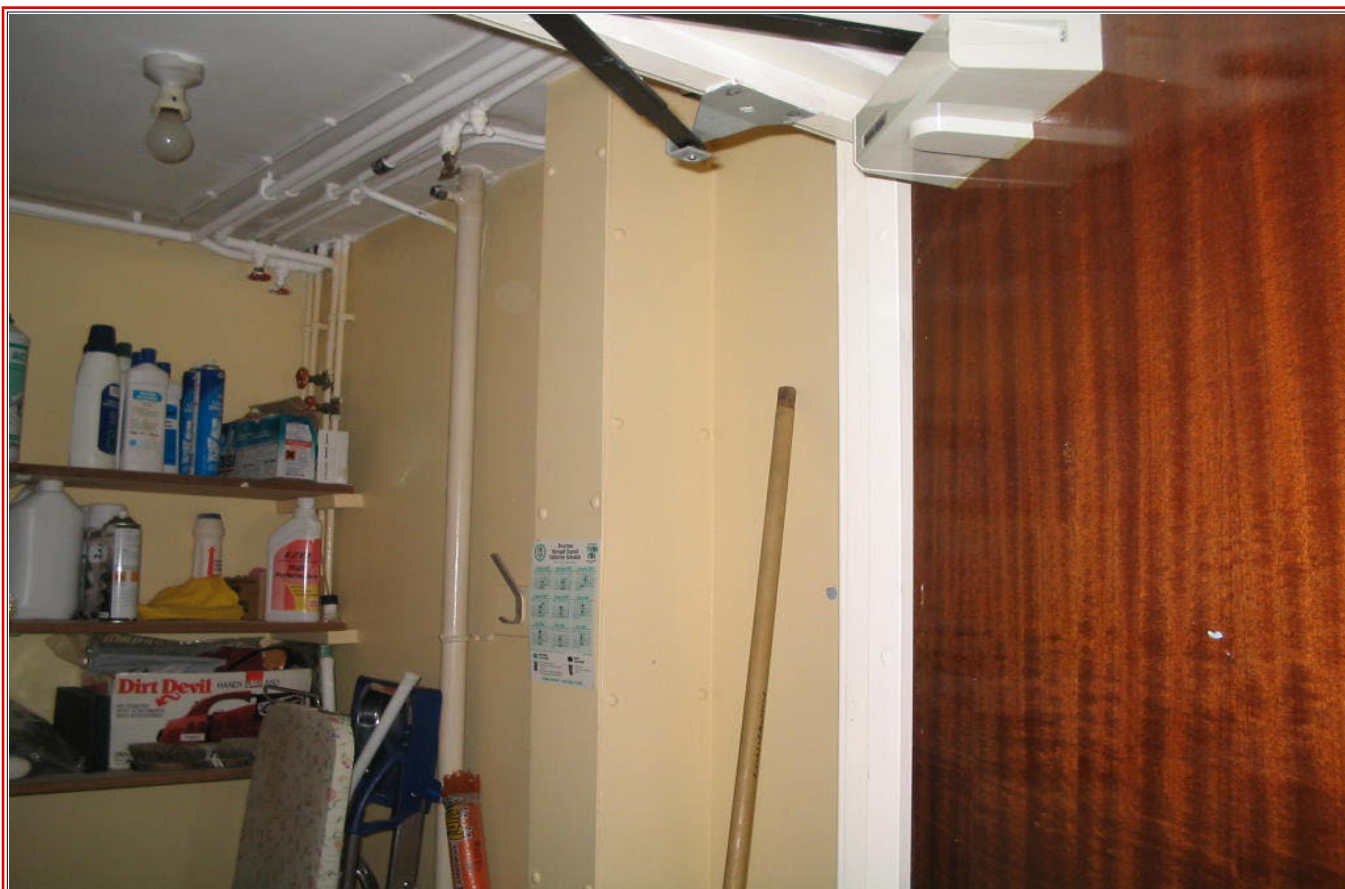
Boxing In Cleaners Store

Test No.	1266	score
* Component	7	
Condition		
Acm Type		
Asbestos type	Non Asbestos	0
Material Risk Assessment Score		0
Accessibility		Priority:
Extent (m2)		
* 7= non asbestos (see registers)

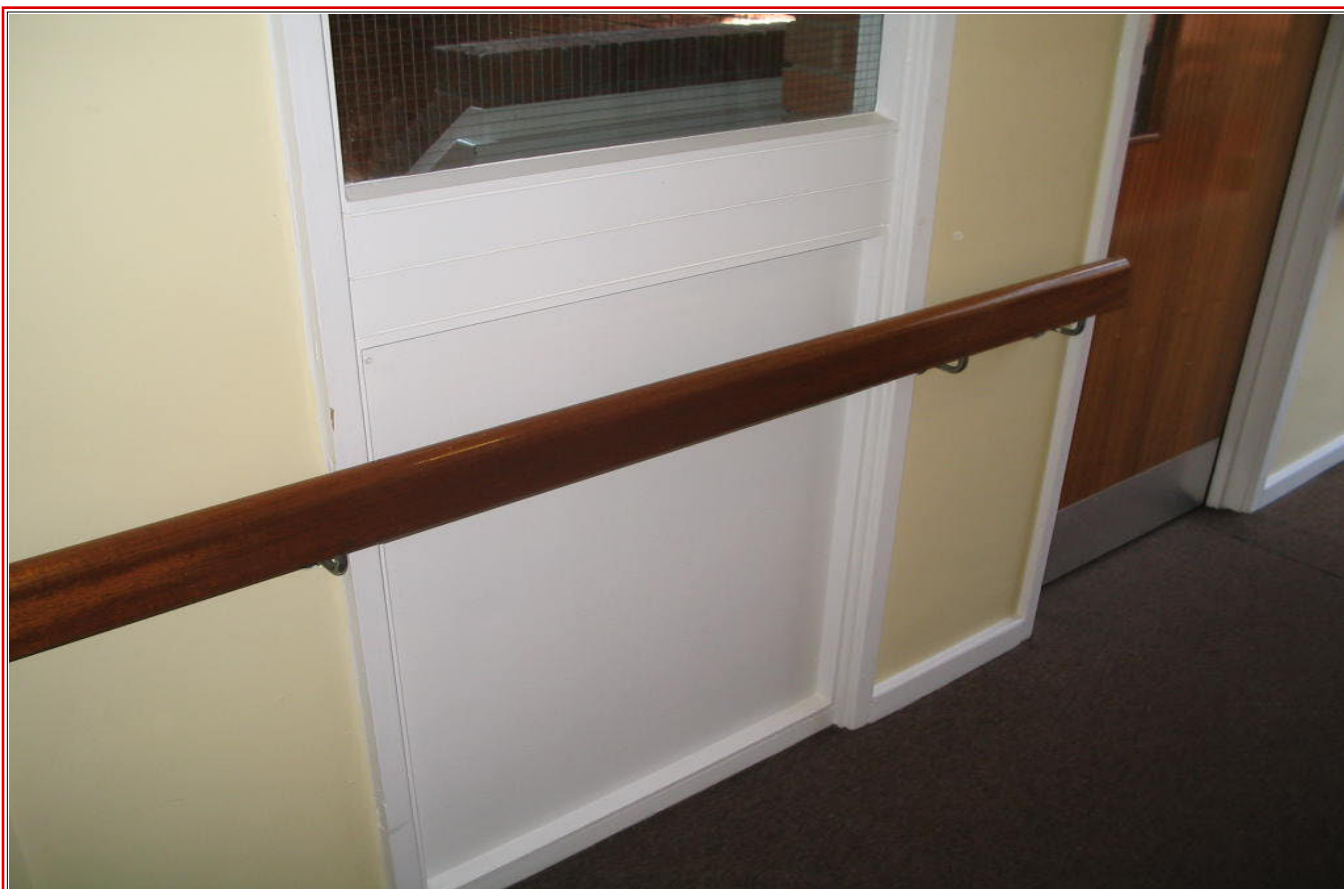
Llwp Top Of Stairs

Test No.	1255	score
* Component	7	
Condition		
Acm Type		
Asbestos type	Non Asbestos	0
Material Risk Assessment Score		0
Accessibility		Priority:
Extent (m2)		
* 7= non asbestos (see registers)

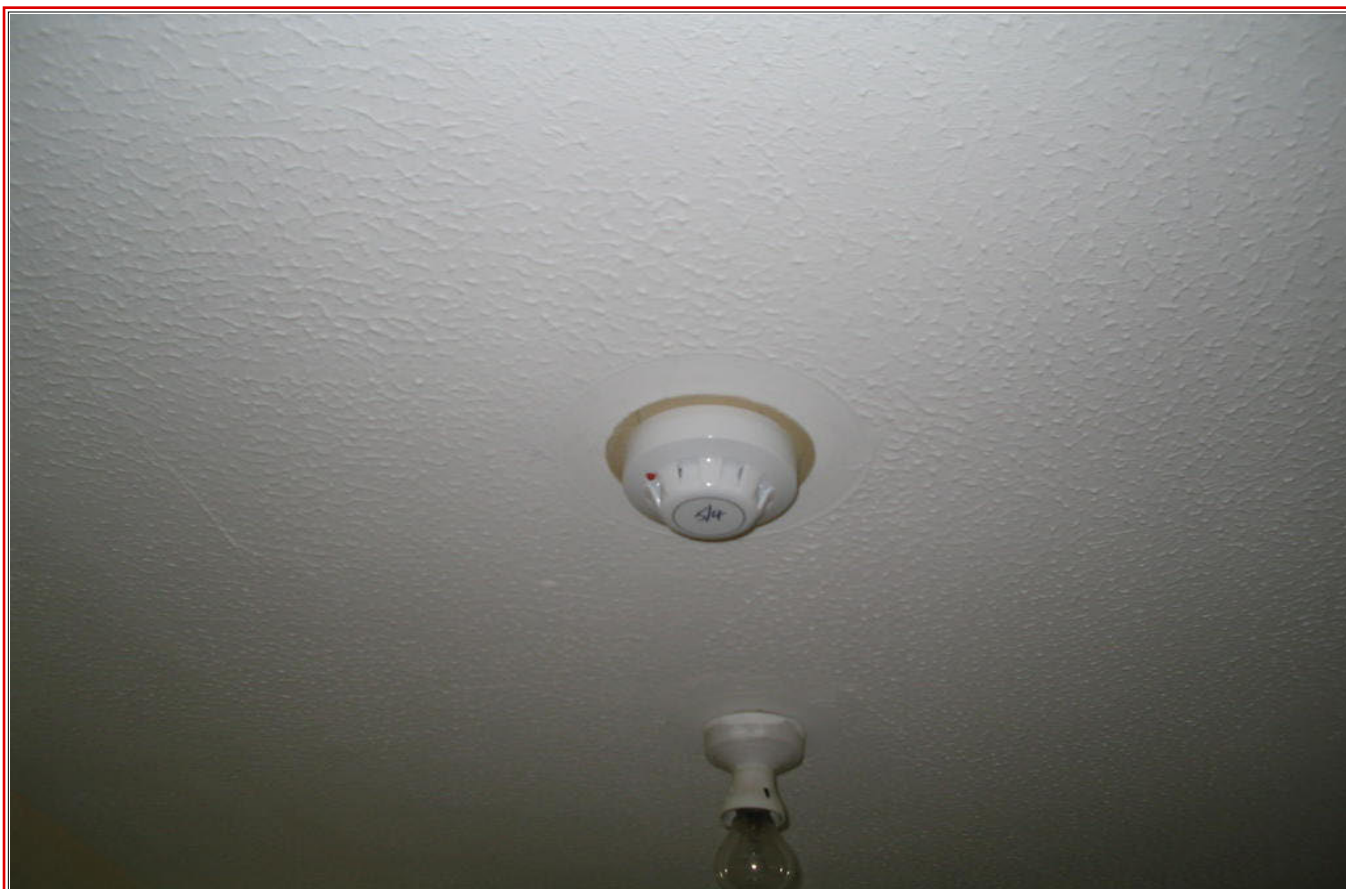
Textured Coating To Ceiling

Test No.	1257	score
* Component	7	
Condition		
Acm Type		
Asbestos type	Non Asbestos	0
Material Risk Assessment Score		0
Accessibility		Priority:
Extent (m2)		
* 7= non asbestos (see registers)

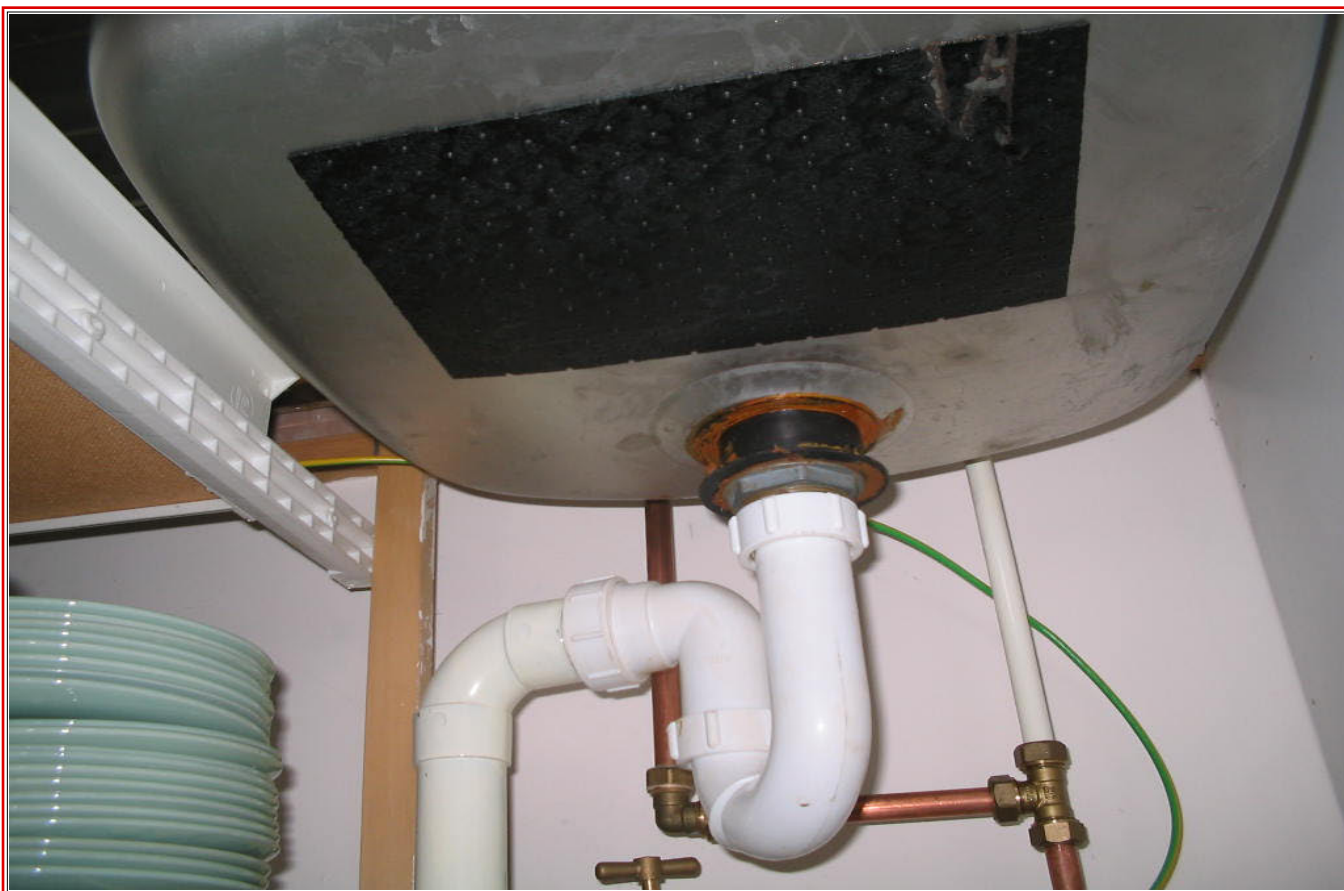
Sink Pad

Test No.	1259	score
* Component	7	
Condition		
Acm Type		
Asbestos type	Non Asbestos	0
Material Risk Assessment Score		0
Accessibility		Priority:
Extent (m2)		
* 7= non asbestos (see registers)

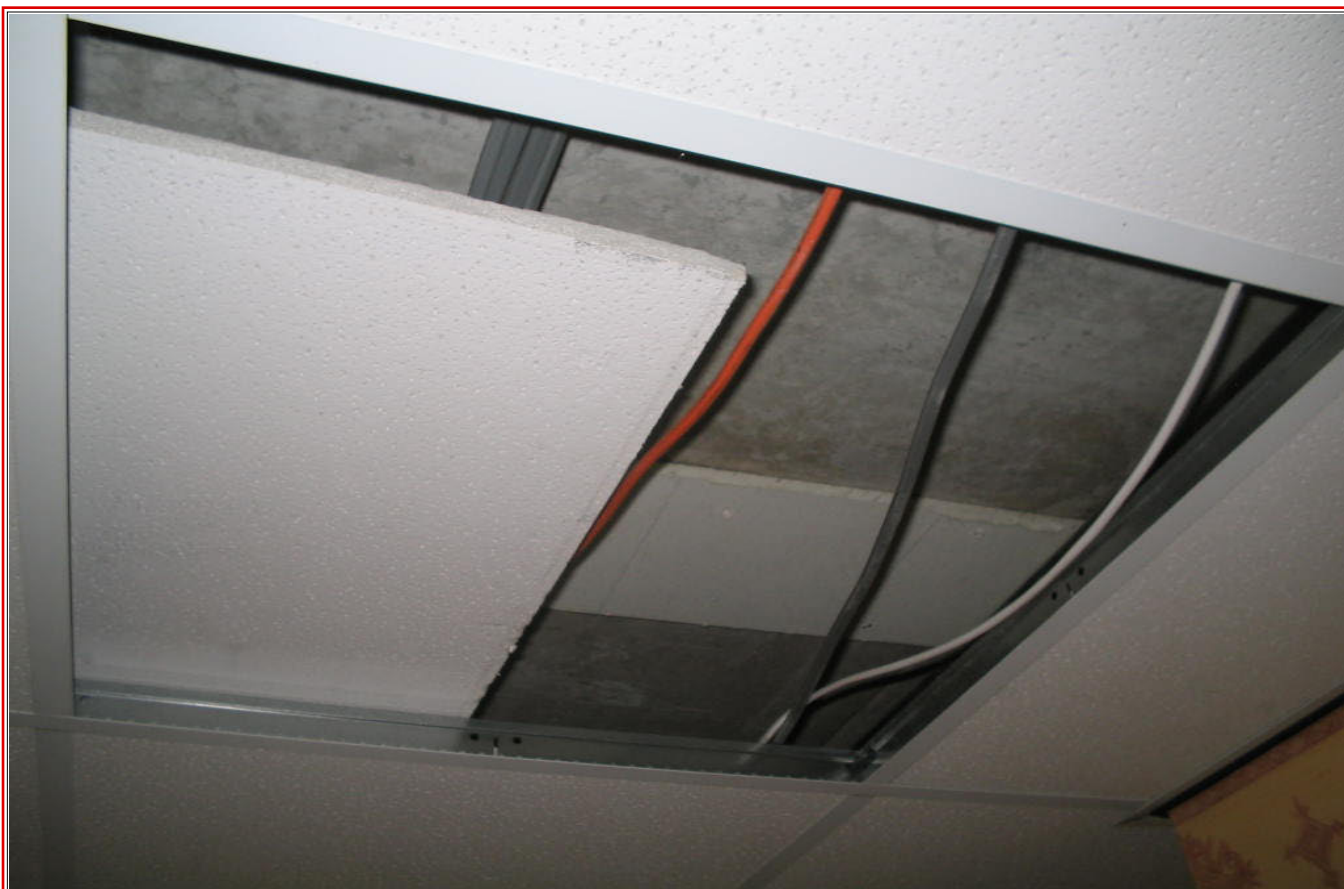
Beam Cladding

Test No.	1261	score
* Component	7	
Condition		
Acm Type		
Asbestos type	Non Asbestos	0
Material Risk Assessment Score		0
Accessibility		Priority:
Extent (m2)		
* 7= non asbestos (see registers)

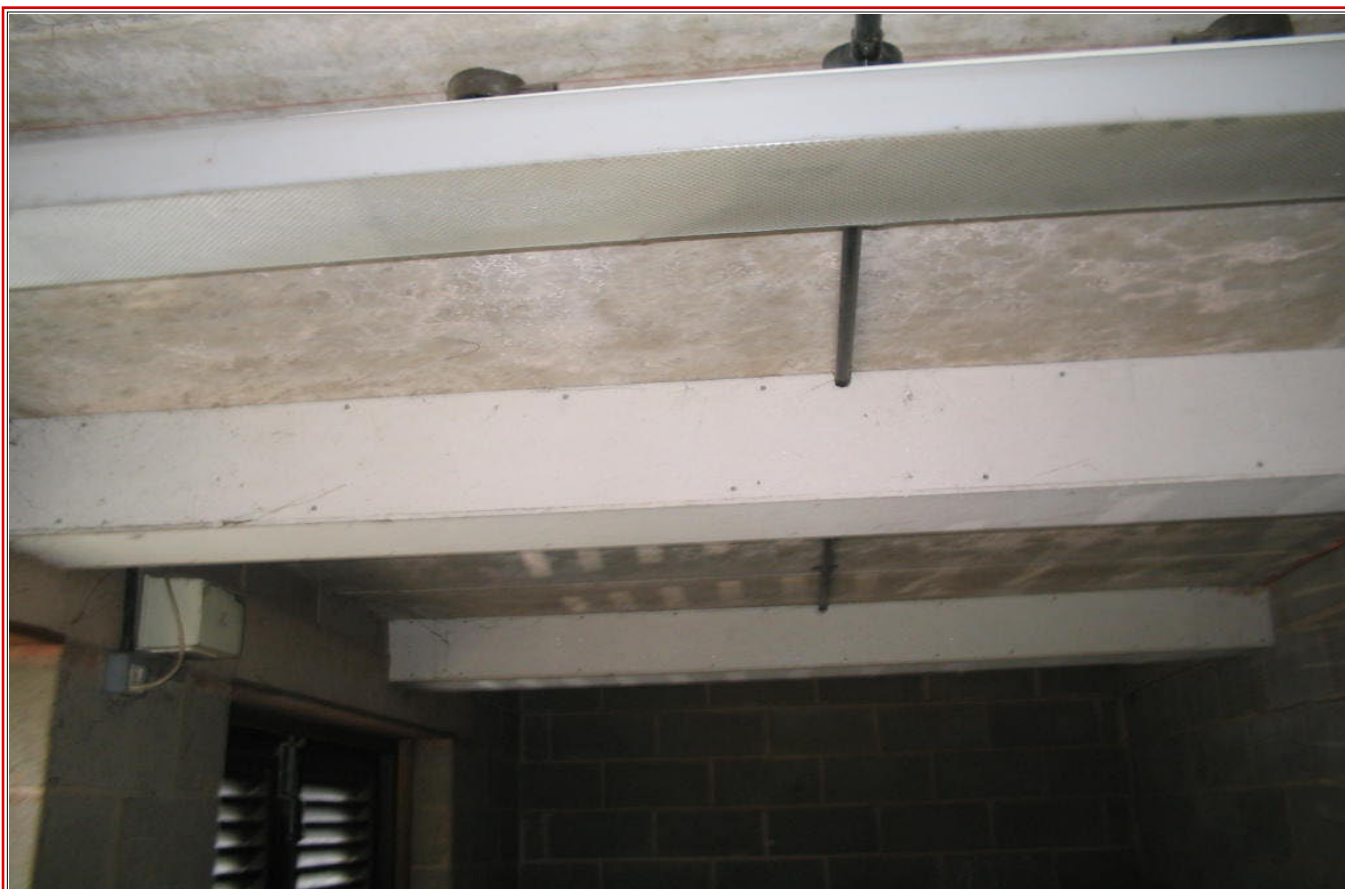
Beam Cladding

Test No.	1263	score
* Component	7	
Condition		
Acm Type		
Asbestos type	Non Asbestos	0
Material Risk Assessment Score		0
Accessibility		Priority:
Extent (m2)		
* 7= non asbestos (see registers)

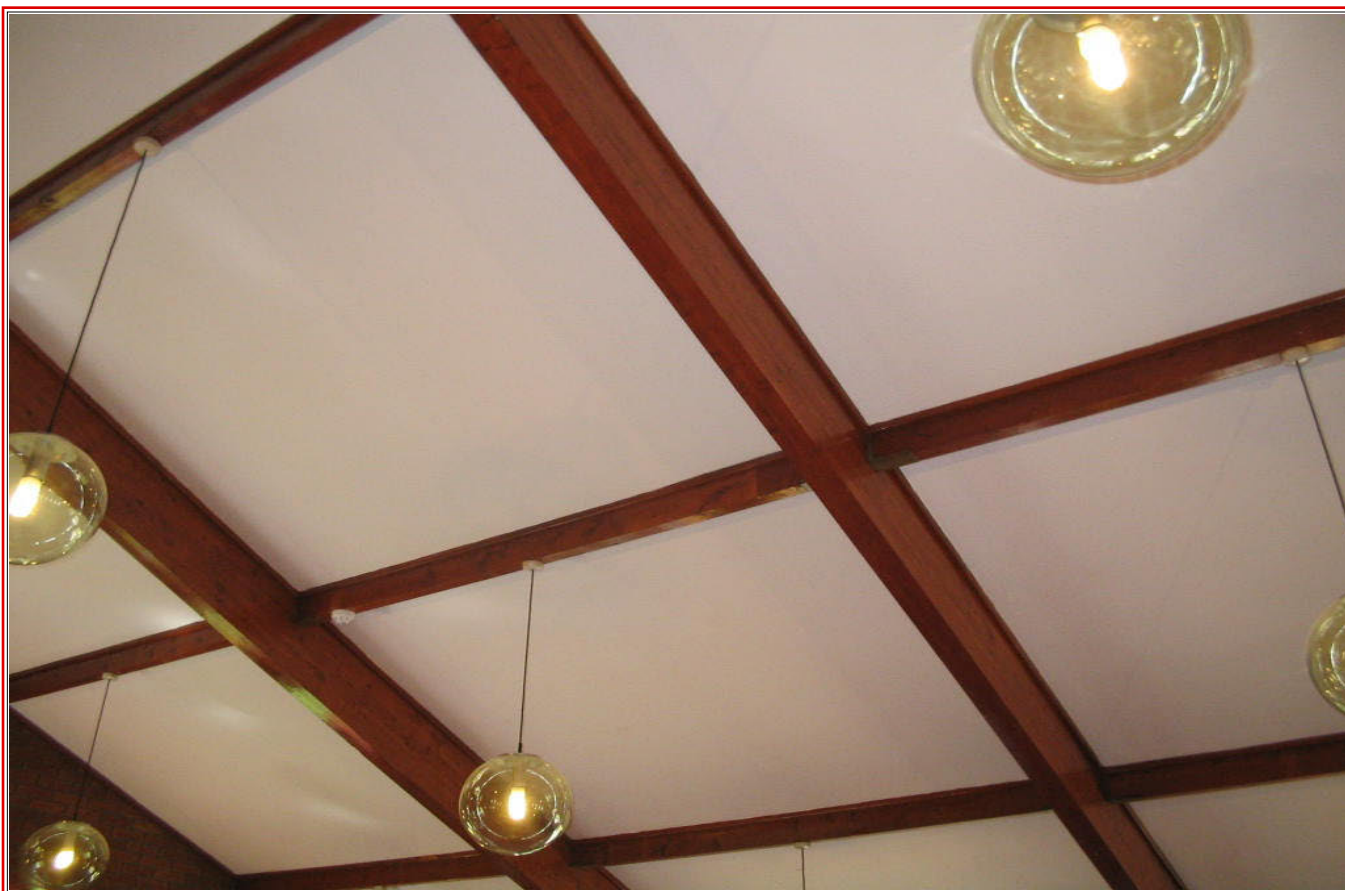
Textured Coating To Ceiling

Test No.	1265	score
* Component	7	
Condition		
Acm Type		
Asbestos type	Non Asbestos	0
Material Risk Assessment Score		0
Accessibility		Priority:
Extent (m2)		
* 7= non asbestos (see registers)

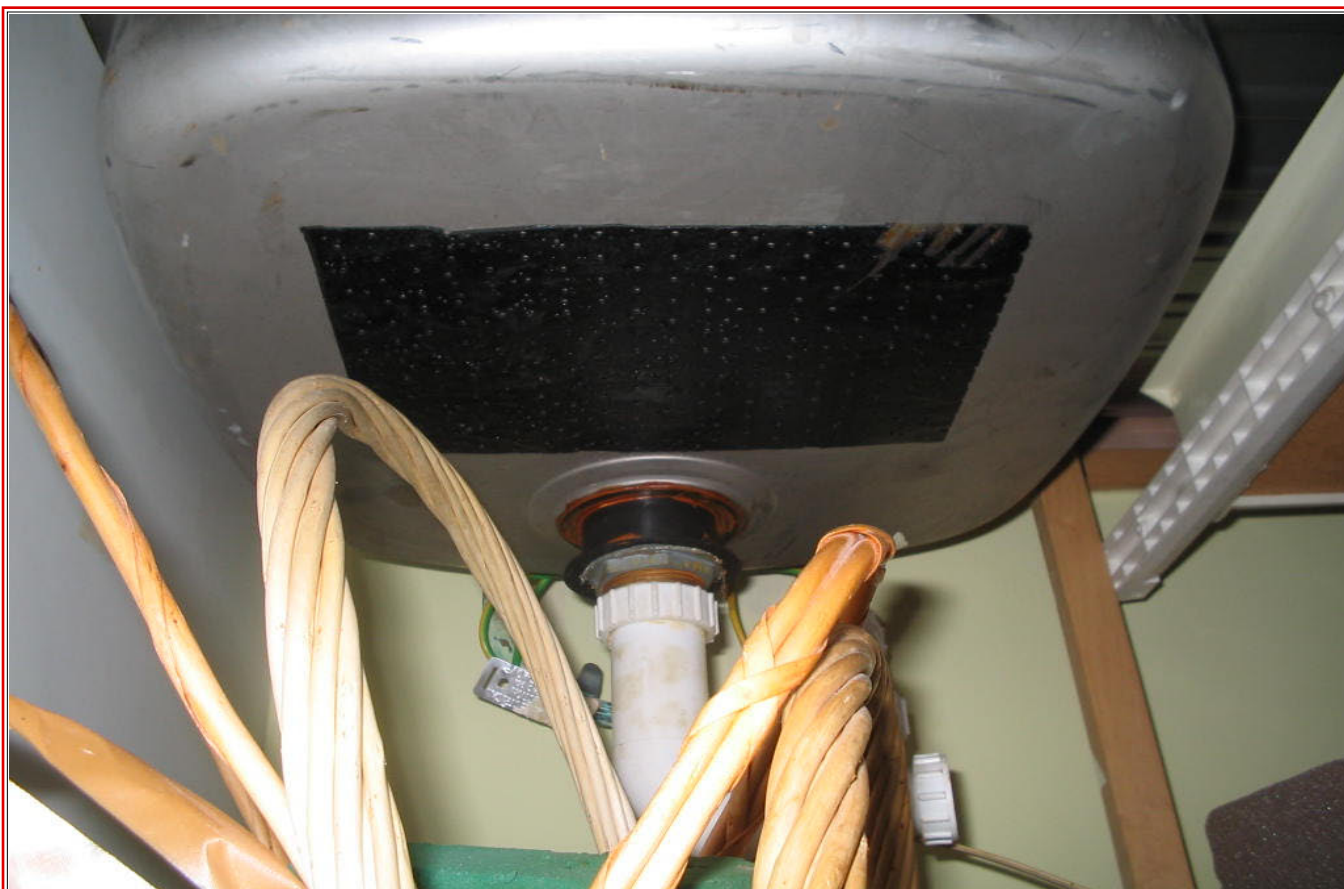
Sink Pad

Test No.	1267	score
* Component	7	
Condition		
Acm Type		
Asbestos type	Non Asbestos	0
Material Risk Assessment Score		0
Accessibility		Priority:
Extent (m2)		
* 7= non asbestos (see registers)
