# CONDITION SURVEY

## HOP POLE INN, LIMPLEY STOKE

HBA 345 – 21<sup>st</sup> NOVEMBER 2022

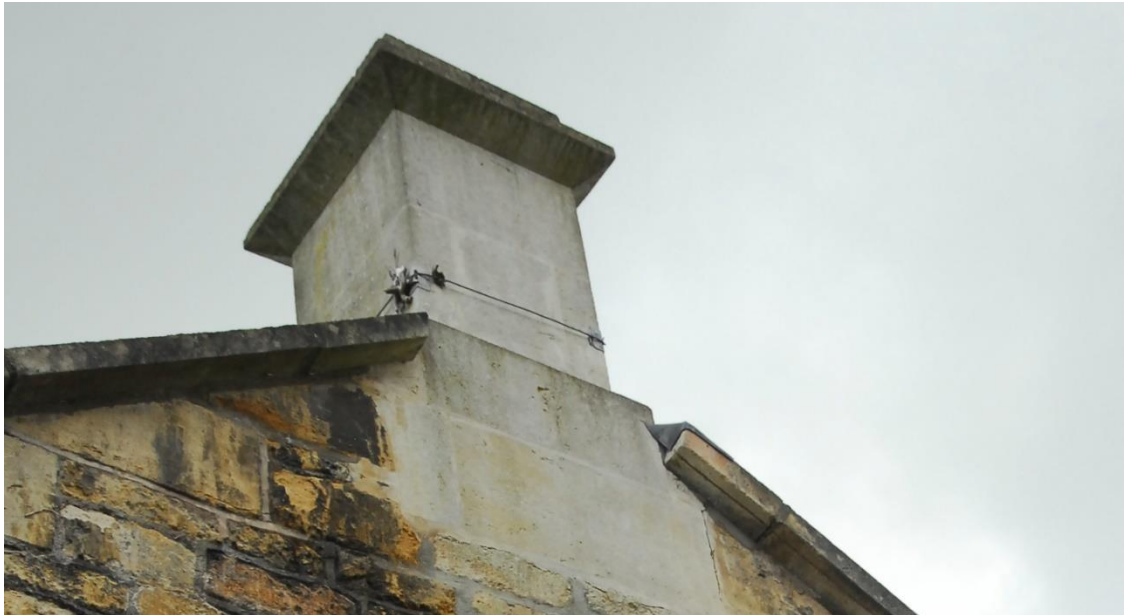
Figure 1 West elevation of CH1

- 3.1.1 Stack 1 comprises a capping course above a simple inverted chamfered drip moulding over the main ashlar shaft which sits on a plinth course set at the level of the roof ridge. The stack appears to have been recently rebuilt and the condition is **GOOD**.

- 3.1.2 There are no pots or evidence of capping. There is a redundant aerial bracket fixed to the lower part of the stack which will need to come off.
- 3.1.3 The flashing onto the roof is generally lead that appears to be held in place with mortar flaunching. On the front RS 1 elevation where the flashing abuts the stack it is defective. There is on upstand or cover flashing and a clear and evident gap at the base of the stack where water can bypass the flashing causing an internal leak. (See roofspace) The flashings are **POOR**.

- 3.5.1 In summary the stacks are generally in good condition. Most of the issues relate to the chimneys relationships with the rooves and adjoining masonry and in particular the flashings. Any roof works will necessitate the replacement of these at which point the correct detailing should be established.
- 3.5.2 If the chimneys are to be used then they will need to be lined with the correct diameter flue liner to mitigate the risk of fire.

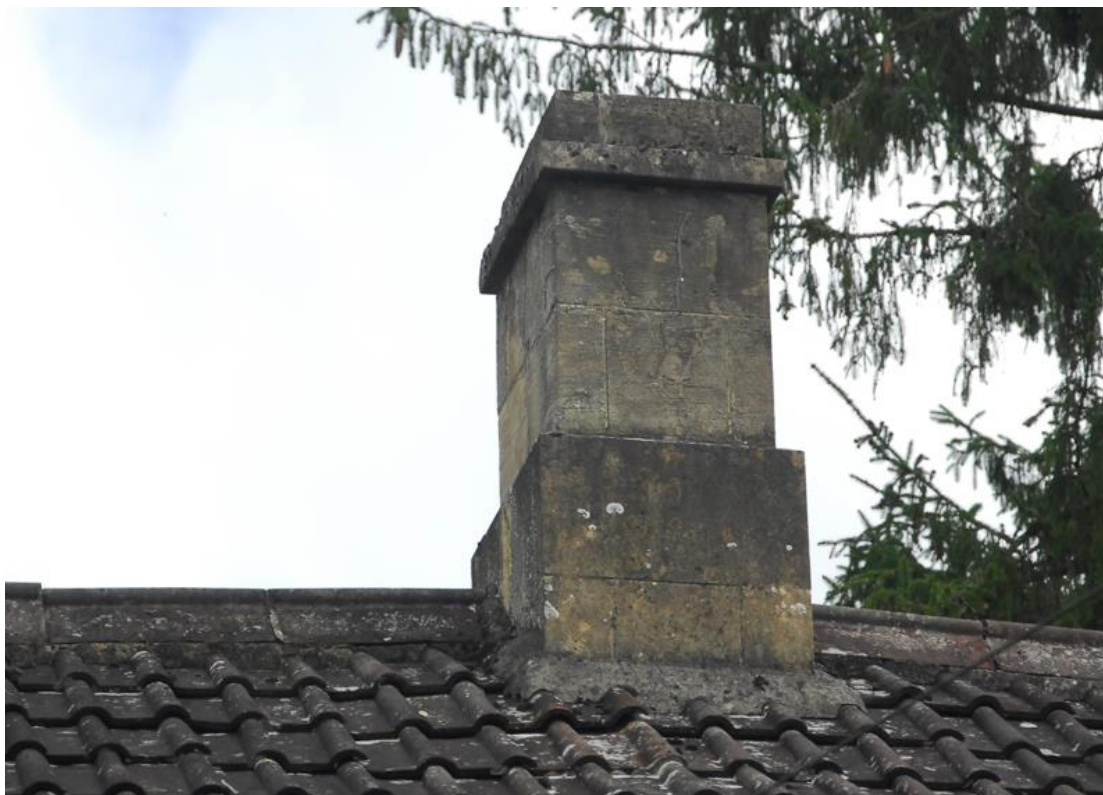
Figure 3 South elevation of CH2

- 3.2.1 Detailed in a similar style to CH1 this stack also appears to have been rebuilt but prior to CH1. The stack masonry appears to be in sound condition with the exception of a vertical soft bed to the lower masonry on the west elevation. There is a crack to the stonework on the west side the extent of which could not be determined. Condition **REASONABLE**
- 3.2.2 There are no pots or evidence of capping suggesting the flues are unlined
- 3.2.3 There is no flashing to the chimney. The junction with the tiles has a cement flaunching which appears locally cracked and will need further examination. Condition **REASONABLE**

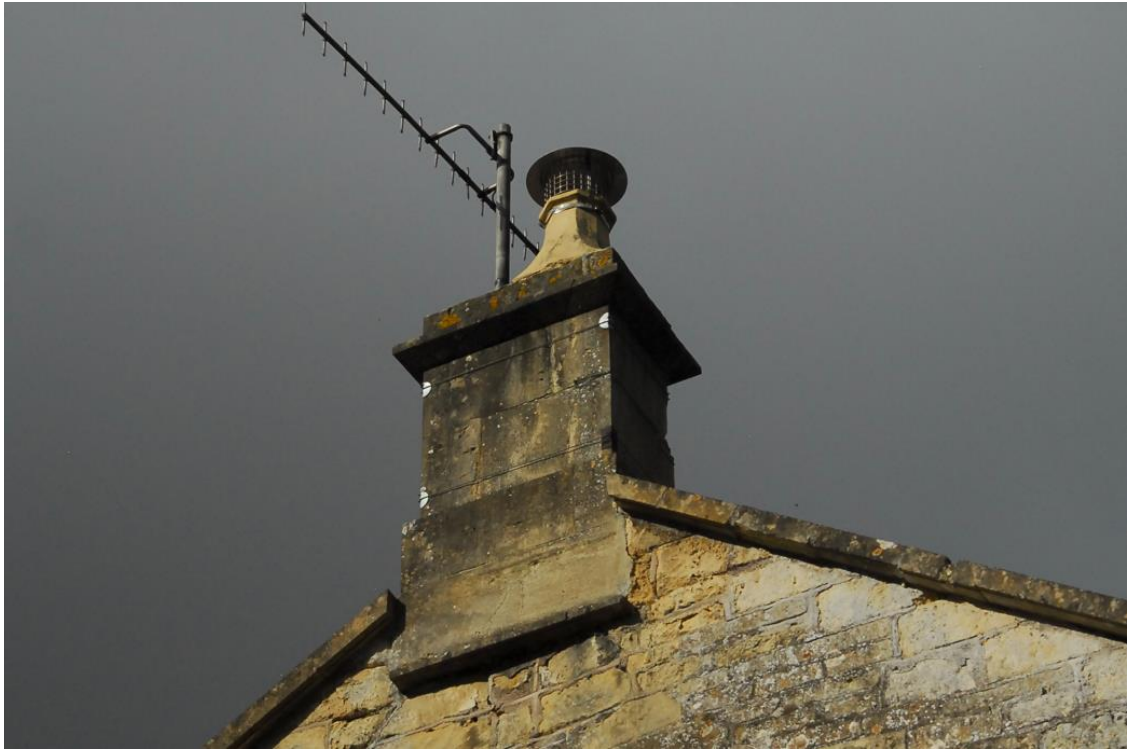
Figure 4 East elevation of CH3

- 3.3.1 The masonry stack has similar detailing to 1 & 2 and also appears to be a rebuild. What is notable about this stack is that the rebuild extends below the roofline as viewed from the east and clearly relates to a lower roof line. The masonry is in poor condition especially on the west side where there is a large amount of stone loss below the drip moulding and evidence of a large vertical fracture that has been repaired in cement. This will require more detailed inspection off a scaffold but viewed from the ground provision should be made for partial dismantling and rebuild. Condition **POOR**

- 3.3.2 The chimney would have had 2 flues one of which has been capped without venting and the other has a ceramic Victorian octagonal pot with a spark and bird guard. This will serve the ground floor wood burner in G4. There is also an aerial bracket post and antenna fitted to the SW corner which will need to be removed.

- 3.3.3 The stack is flashed with flashing it appears significantly better than CH1 and appears recent there's no obvious defects but the junction with the ridge is clumsy. Condition **GOOD**

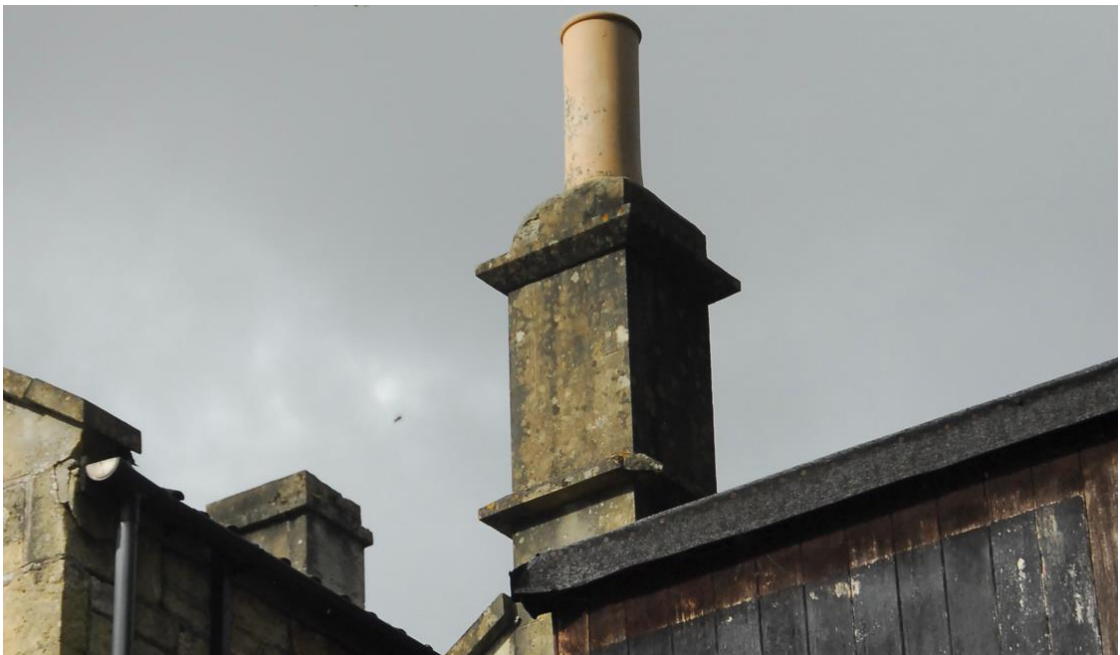
Figure 5 East elevation of CH4

- 3.4.1 The detailing of CH4 is not dissimilar to the other stacks inasmuch that it comprises a capping stone an inverted chamfered drip moulding and a shaft of 2 stones in height. However rather than sitting on a plinth course there is a second drip moulding course sitting on top of a further section of stack also 2 courses high. What is odd is that the lower shaft extends below the gable coping stones in a comparable manner to CH3 but there is no obvious justification for this. The main shaft is in good condition but there is a vertical gap which in places is open between the lower section of the stack and the gable end masonry to RS8. Condition **GOOD**

- 3.4.2 The flue has a ceramic pot with a flaunching that is showing some signs of distress.
- 3.4.3 The chimney is crudely flashed with lead fitted directly into the shaft (no cover flashing) where it meets RS 7 and RS8. There is an active wasp's nest at this location on RS8. Condition **REASONABLE**

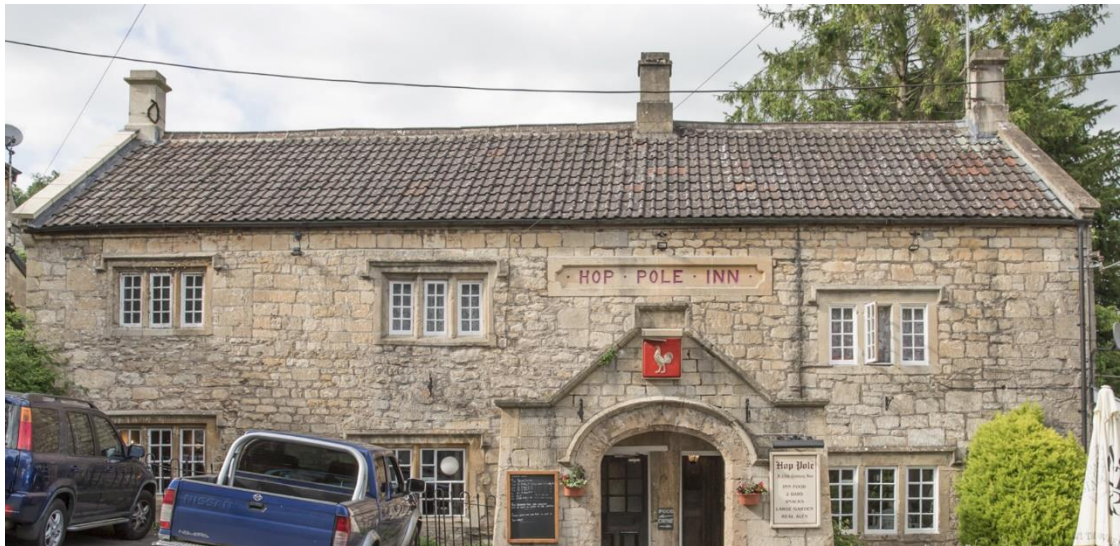
Figure 6 South elevation

- 4.1.1 RS1 is the primary south facing roof slope to the building. The slope is formed from 11 courses of Bridgewater pattern 10 double Roman tiles and capped with ceramic roll top ridge tiles. The ridges appear fully bedded and flaunched in cement. There are a total of 17 ridge tiles between CH1 and CH2 and 10 between CH2 and CH3. The ridges appear **REASONABLE** condition although several are kicked out of line and they will prove challenging to remove due to the cement. There are a number of open perpends to the ridges.

- 4.1.2 The roof slope is intact with no obvious holes. Some areas have been patched including and areas above WF2 where at least four tiles have been replaced. There is a similar area of replacements over the entrance porch. There is a clear kick to the lower courses of tiles below CH2 / above the front door. The rainwater goods also dip at this location. The roof covering appears in **REASONABLE** condition but there are concerns about the battening.

- 4.1.4 The abutments with the projecting parapet gables are different. The west gable junction has been flashed with lead in 4 sections of cover flashing which appears to be dressed onto the tiles in a slightly unorthodox detail. The east gable is not parallel to the roof resulting in a fillet gap between the tiles and masonry at low level. This appears to have been addressed with soakers to the lower 6 or 7 courses which are held in place by a flaunching that does not extend down onto the tiles in another unusual detail. The flashings are in **REASONABLE** condition.

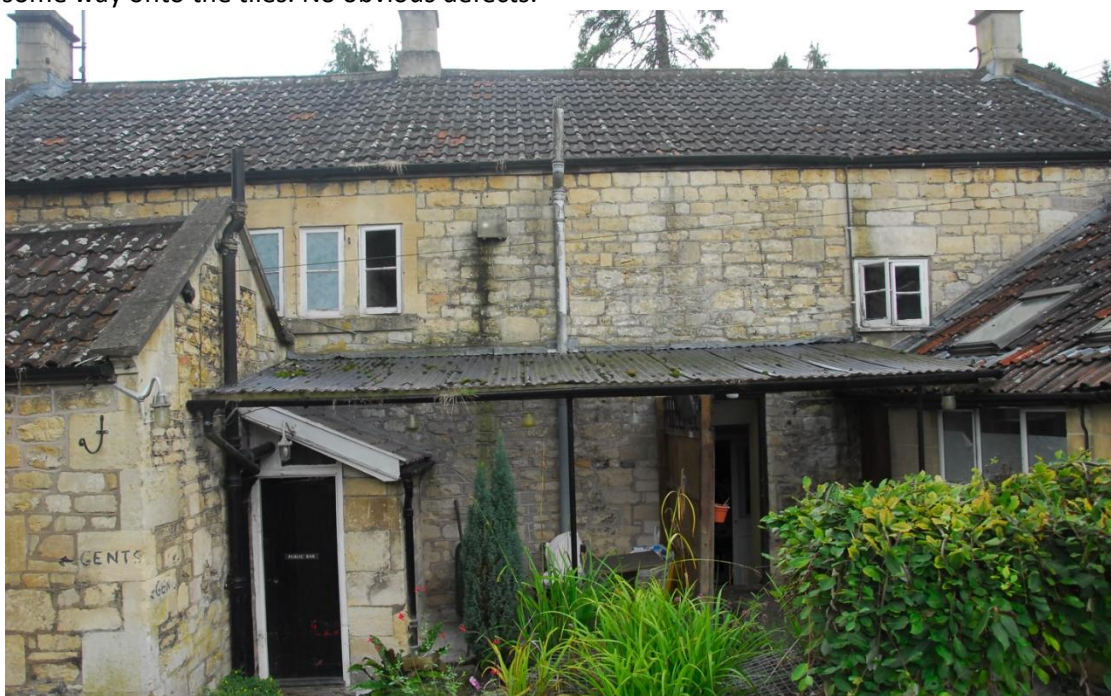
Figure 7 North elevation

- 4.2.1 North elevation roof covering to building comprising 11 courses of Bridgewater pattern 10 tiles. Generally, in **REASONABLE** condition with no obvious missing or broken tiles although there is evidence of at least 12 locations where the tiles have been replaced mainly between CH3 and CH2.
- 4.2.2 The ridge tile flaunching has failed between in numerous places along the ridge and there are multiple open perpends. Flaunching in **POOR** condition.

- 4.2.3 The abutments with the gable ends are reasonably flashed with lead which has been taken some way onto the tiles. No obvious defects.

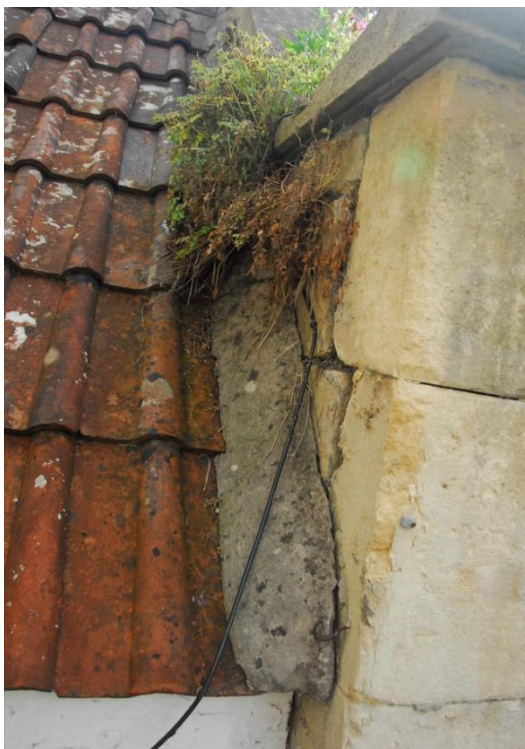
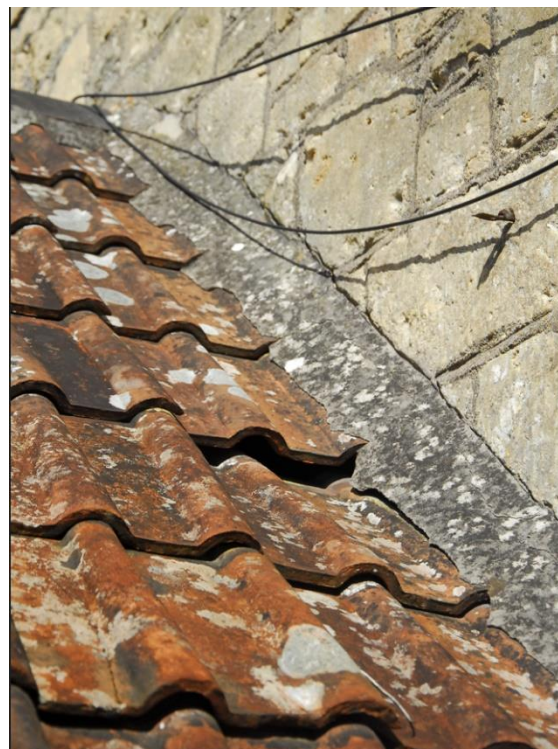
- 4.3.4 Both roofs are flaunched in position against the main masonry wall of the building and the porch front wall. The mortar against the porch wall has failed and there are plants growing out of the resulting cracks. The flaunching sounds hollow suggesting complete debonding. The flaunching against the wall of the main building has also fractured but remains sound. These flaunchings are in **POOR** condition

- 4.4.1 As RS3 this is a 7 course roof as detailed above. The tiles are in **REASONABLE** condition but are drooping at the lower courses where they are unsupported by a fascia board which has failed. A single tile has disengaged from the batten half way up the slope where it abuts the main building.
- 4.4.2 The flaunching on both sides of the slope is cement and in the case of the porch junction has again failed and has significant organic growth in the resulting cracks. The junction with the main wall has also completely failed with a clear debonding from the wall. **POOR** condition

Figure 8 Porch abutment flaunching

Figure 9 Porch abutment flaunching

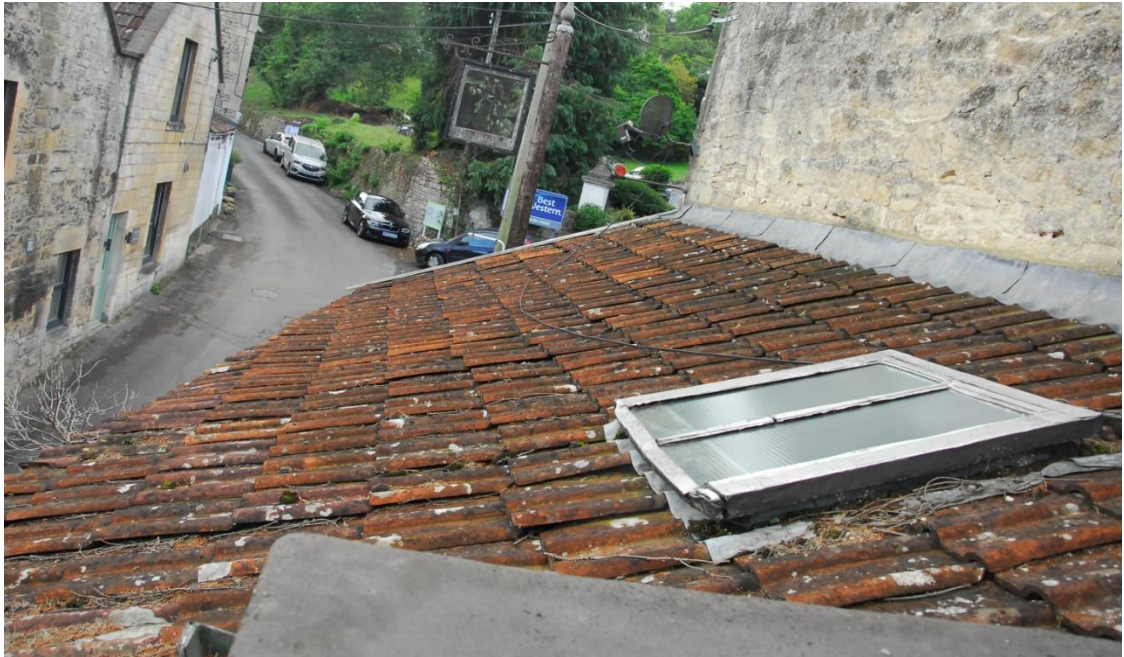
Figure 10 Cellar Roof

- 4.5.2 The roof slope is again double Roman tiles of **POOR** condition. There is a fair degree of frost spalling and a large number of tiles appear to be misaligned suggesting batten failure or tile slippage. At the eaves line there is clearly some movement in an area to the left of WG4. There is a small tree growing out of the roof at this location.

- 4.5.4 The southern verge has been closed using a fascia board and coverboard to provide a Suffolk eaves detail. It was unclear if this has been flashed or relying on the cover timber to provide the seal with the tiling. The cover timber is peeling and decorations have failed. **POOR** condition.

- 4.5.5 The eaves line is projecting beyond the line of the wall by about 100mm and there is a fascia board with gutter. See below in section 4. The tiles overhang considerably and for practically the entire length of the eaves are drooping. **POOR** condition

- 4.5.6 The abutment with RS6 is a mess due to the complexity of abutting a flat roof midway down a pitched roof. There is a mixture of failed mortar bedding and numerous areas of flash banding where the junction has not been resolved. There is a similar Suffolk verge detail where RS 5 projects beyond RS 6. **POOR** condition.

- 4.5.7 The rooflight RL1 in RS 5 has been heavily flash banded as well lead flashed suggesting a historic failure. The rooflight is in **POOR** condition.

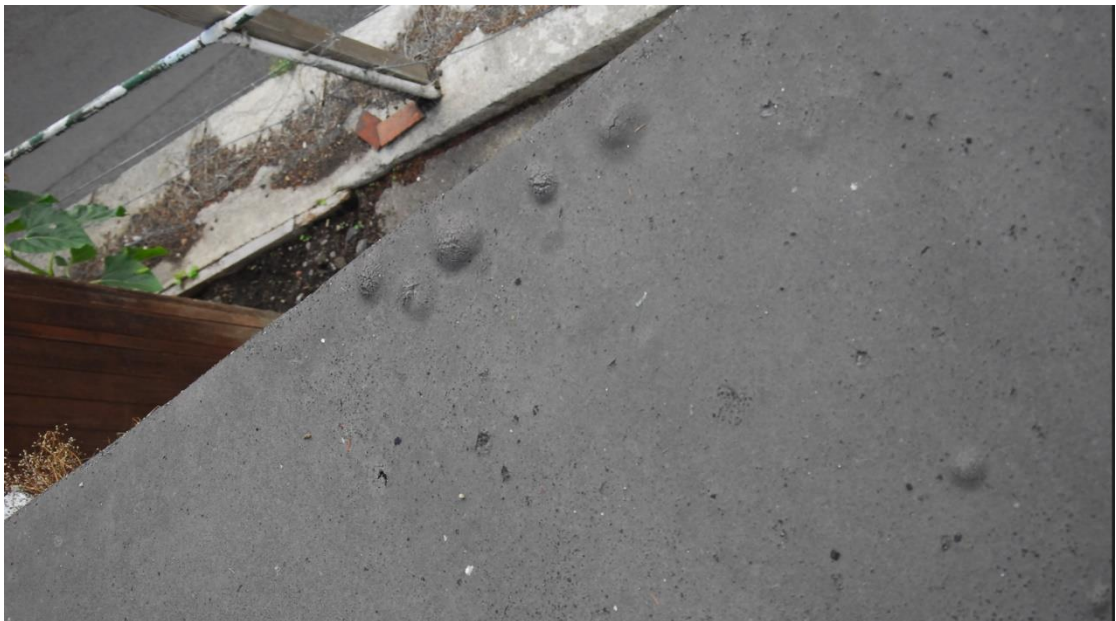
- 4.6.1 RS 6 is an asphalt roof which is being pitched to fall to the road. The roof covering has some blistering along defined lines suggesting that these are at the abutment of the roofing boards. The roof appears to be weathertight and in REASONABLE condition.
- 4.6.2 It has a continuous flashing against the gable wall to G6. This lead appears in reasonable condition, but cement pointed.

Figure 11 Blistering to RS 6

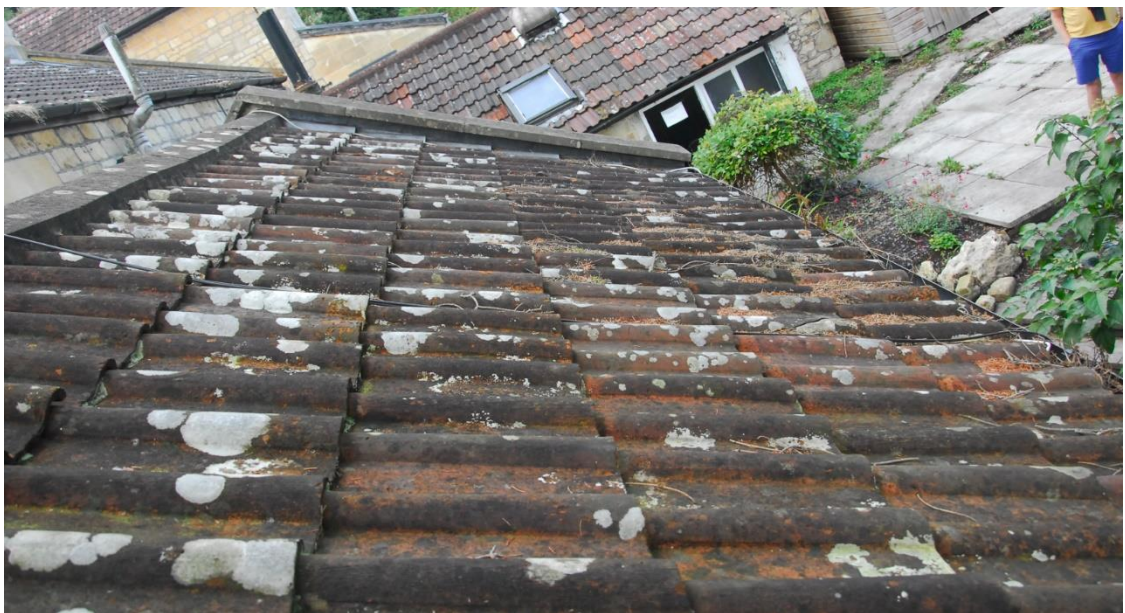
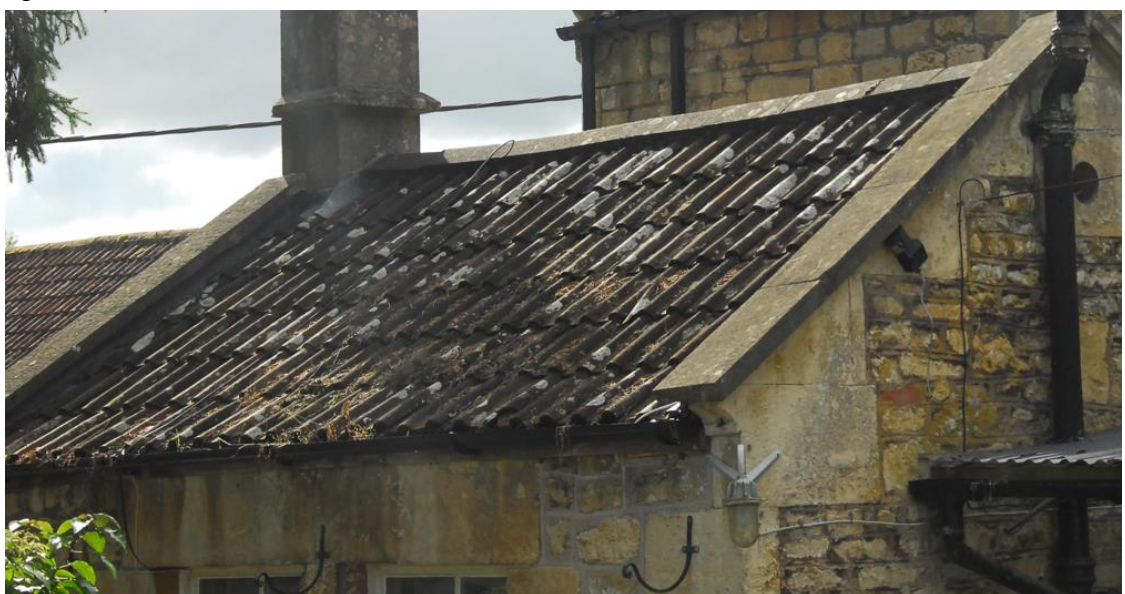
Figure 12 RS 7

- 4.7.1 The north and south slopes to G6 comprise 6 and 5 courses of tiles respectively laid at a pitch of about 30°. The roof is built off the north elevation of the main building and runs parallel to the main roof resulting in a lead valley gutter at the junction of the two structures.
- 4.7.2 The ridge is formed from approximately 9 V shaped cement tiles set in a cement flaunching which has failed and cracked in numerous places. **REASONABLE** condition.
- 4.7.3 The roof covering is generally in **GOOD** condition although a number of tiles have signs of frost damage and one tile is fractured
- 4.7.4 The abutments with the gable end masonry comprises lead soakers and cover flashings set correctly below the coping stones.
- 4.7.5 The roof is below a coniferous tree and has a lot of debris on it. The gutter is plastic and head on a fascia board.

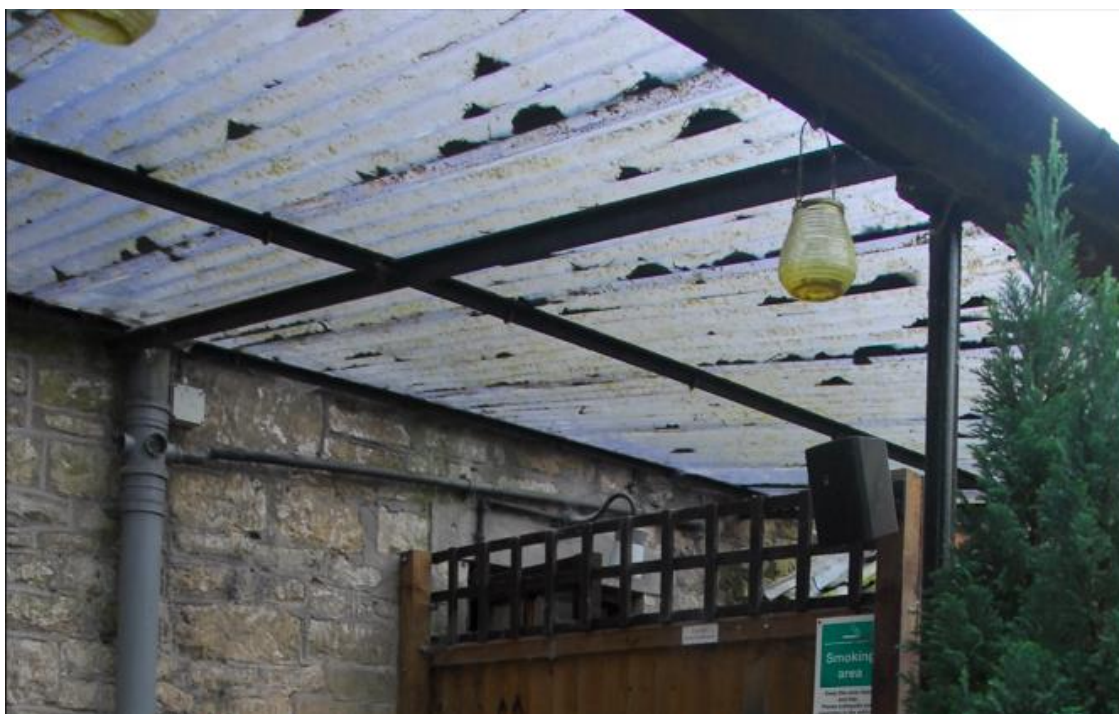
- 4.9.1 RS9. Is a plastic corrugated plastic roof with a low pitch, held on a metal frame. Will be uncontested and therefore there should be no objection to its removal. The roof has clearly been introduced to allow covered passage from the public bar to the kitchens.
- 4.9.2 The roof has been flashed into the main building with lead flashings dressed onto the plastic corrugations with limited success. The abutment with G6 is completely un-flashed and the west end is an open verge.
- 4.9.3 An area of flashing immediately below a gutter overflow from RS2 has been lifted to try and divert water.
- 4.9.4 Whilst this roof is serviceable it is a very **POOR** addition to the building

Figure 15 Inappropriate corrugated plastic roof which should be removed and is unlikely to be consented

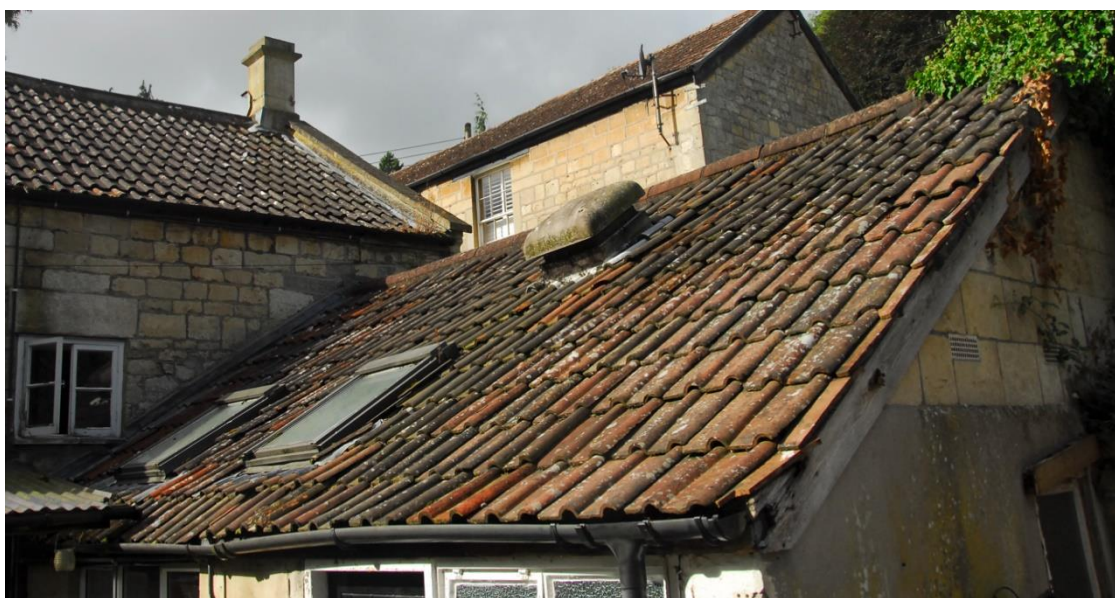
Figure 16 RS 10 kitchen and ladies toilets

- 4.10.1 RS10 and RS11 form an asymmetric roof to the kitchens and ladies toilets. Both slopes are double Roman tiled roof with a half round ridge set in cement flaunching. RS 10 comprises 11 tile courses and RS 11 4 courses. RS 10 has 2 rooflights and a vent in it. See RL2 and RL3
- 4.10.2 The ridges have come loose in three locations at the most northerly end of the roof.
- 4.10.3 The roof is showing signs of considerable undulation especially at the lower ¼ of the pitch. A number of tiles are completely dislodged. The roof is in **POOR** condition

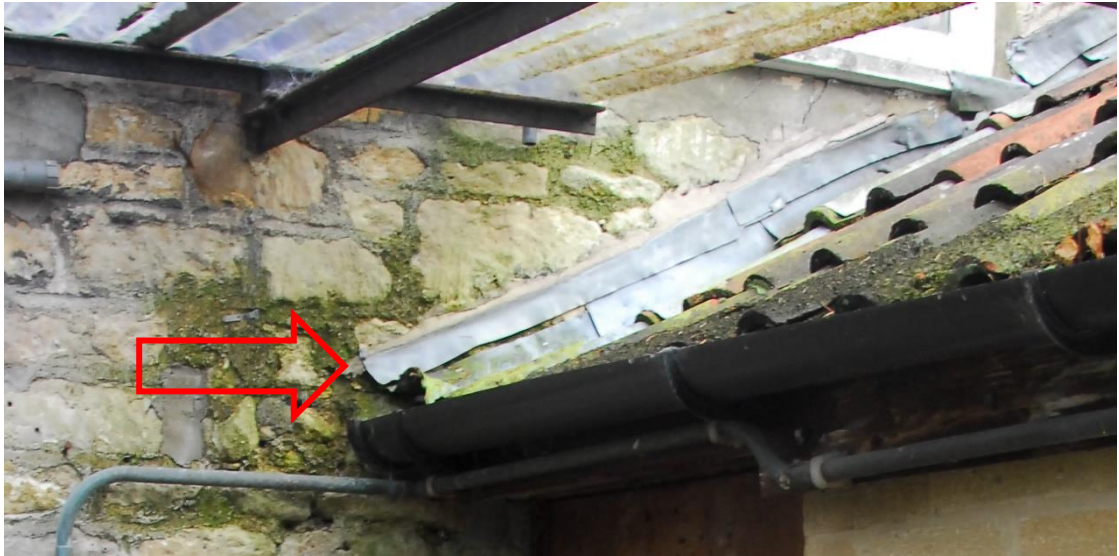
- 4.10.4 The abutment with the main building is lead flashed with soakers and cover flashings. This is interrupted where the sill of WF5 collides awkwardly with the roof-slope. Below the point the lead flashing does not actually extend to cover the soakers so there is an open joint for water ingress. **POOR** condition.

Figure 17 RS 10 kitchen and ladies toilets abutment with main building. Failed flashings

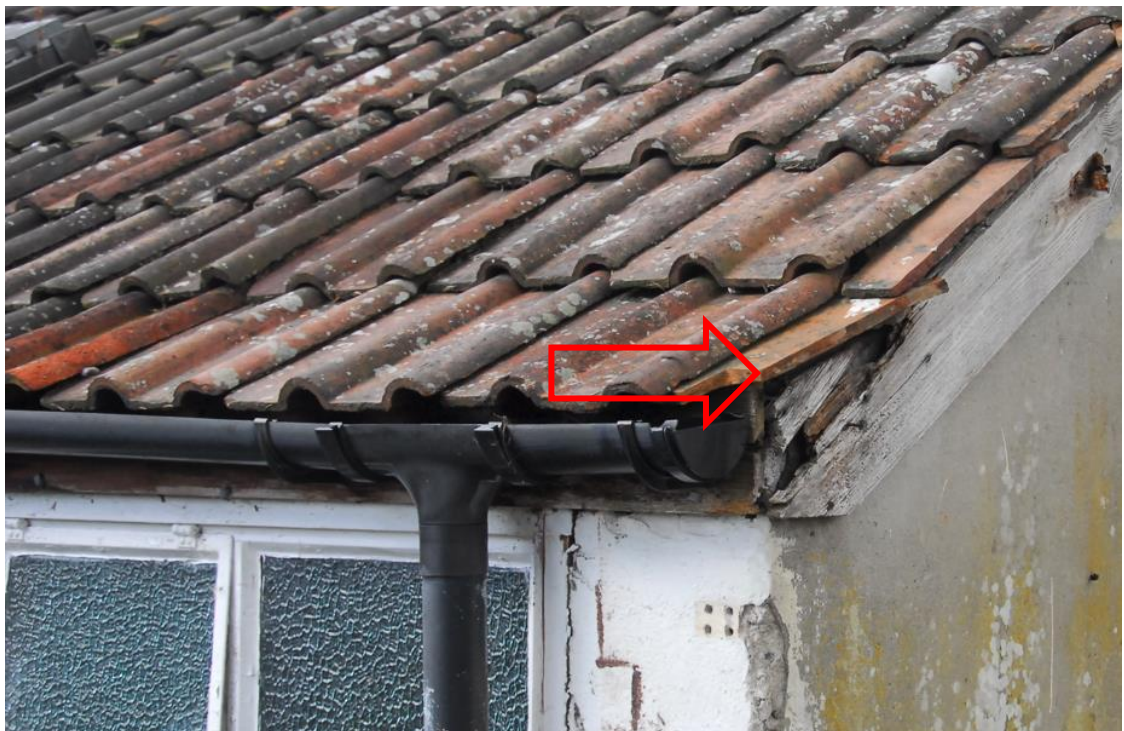
- 4.10.5 The northern end of the slope is a traditional verge detail with a slight tile overhang. The verge board as rotted and failed. Any pointing has been lost. **POOR** condition.

Figure 18 RS 10 kitchen and ladies toilets abutment with main building. Failed verge board

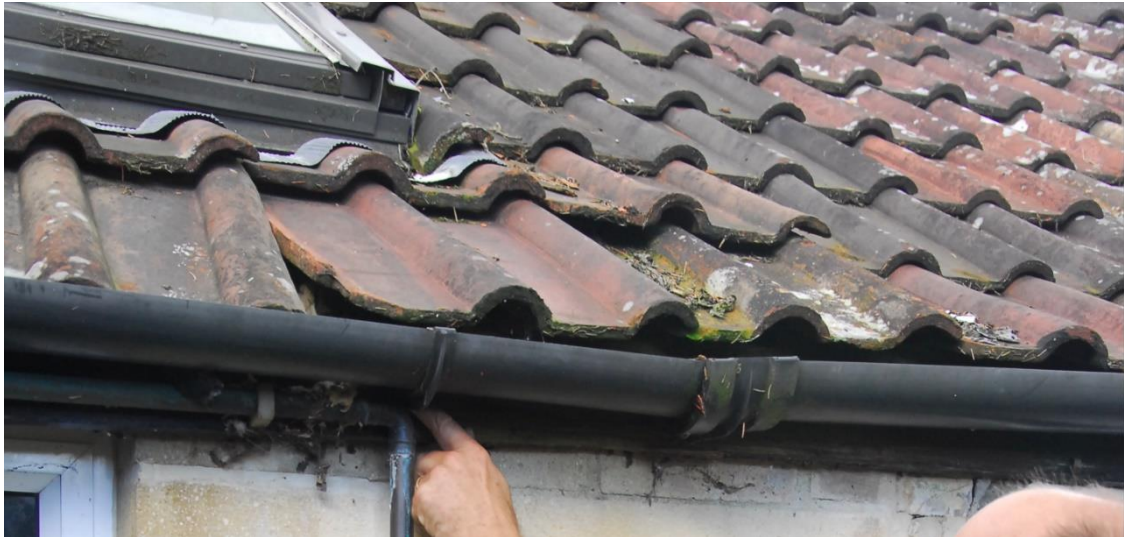
Figure 18 RS 10 Dislodged tiles most likely associated with top plate or rafter end failure

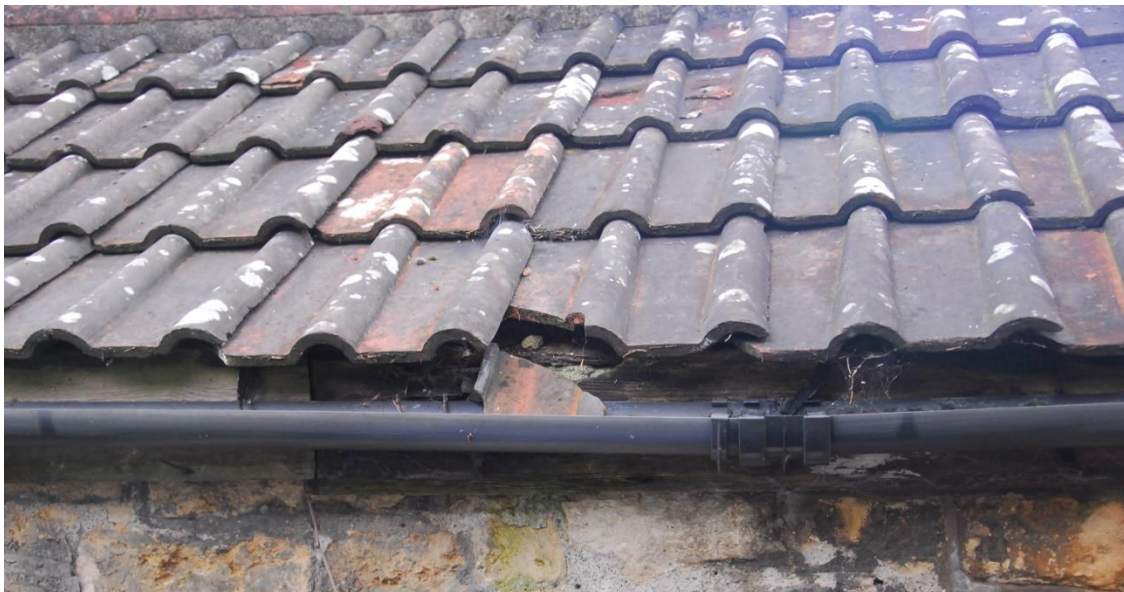
- 4.11.1 RS11 comprises 4 courses of double Roman tiles. Significantly overgrown at the northern end with vegetation.
- 4.11.2 Flaunching to ridge tile missing or failed
- 4.11.3 Number the tiles delaminating or broken to an extent where there is potential for water ingress.
- 4.11.4 Abutment with main building has been flashed with integral soakers and cover flashing.

Figure 19 RS 11 Dislodged tiles most likely associated with top plate or rafter end failure

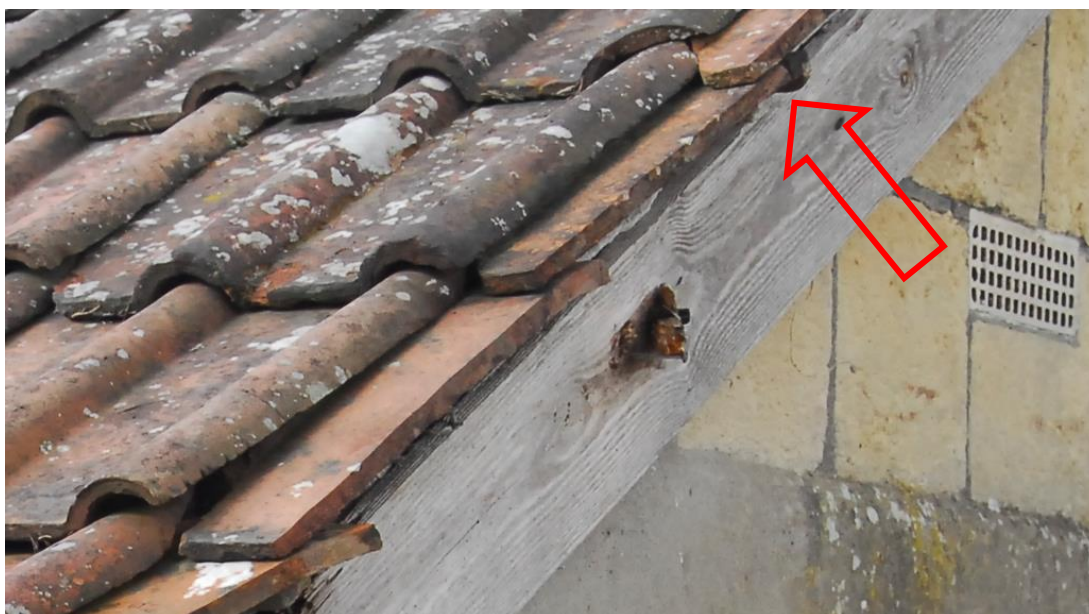
However, the fluted nature of the tiles means that they often are stretched out and gauged incorrectly with a very small head lap. This is in part because they are difficult to cut. The lack of the correct gauging and open flutes makes the roof prone to leakage from wind driven rain. This then impacts on battens and fixings. From what we were able to observe none of the roofs were correctly gauged. This is best seen by looking at the verges.

Figure 20 Minimal headlap and open flutes

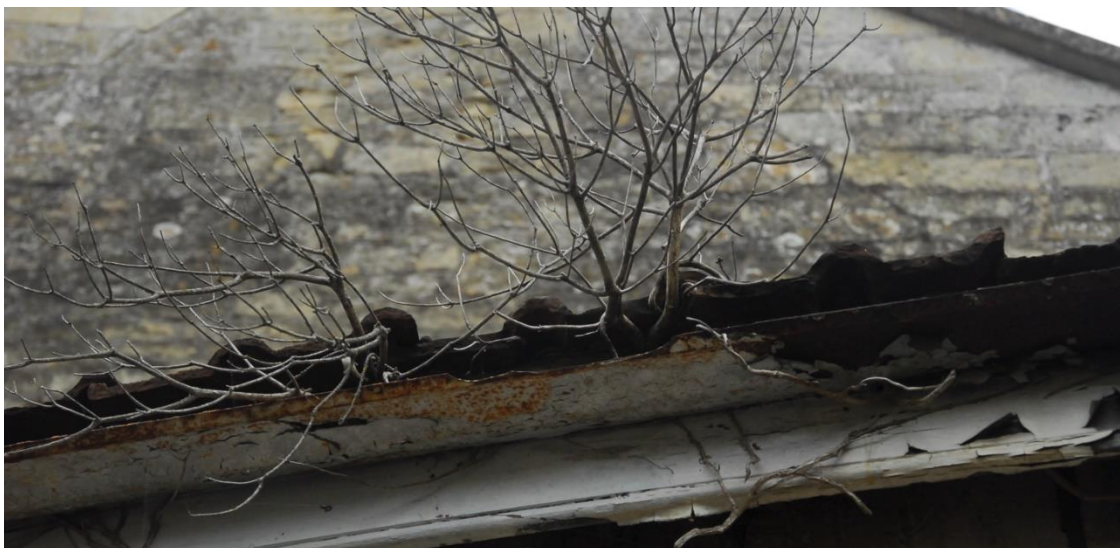
Figure 21 Gutter to RS5

5.4.1 There is a timber fascia board but no guttering. Decorations failed and the fascia has become dislodged and is rotting. **POOR** condition

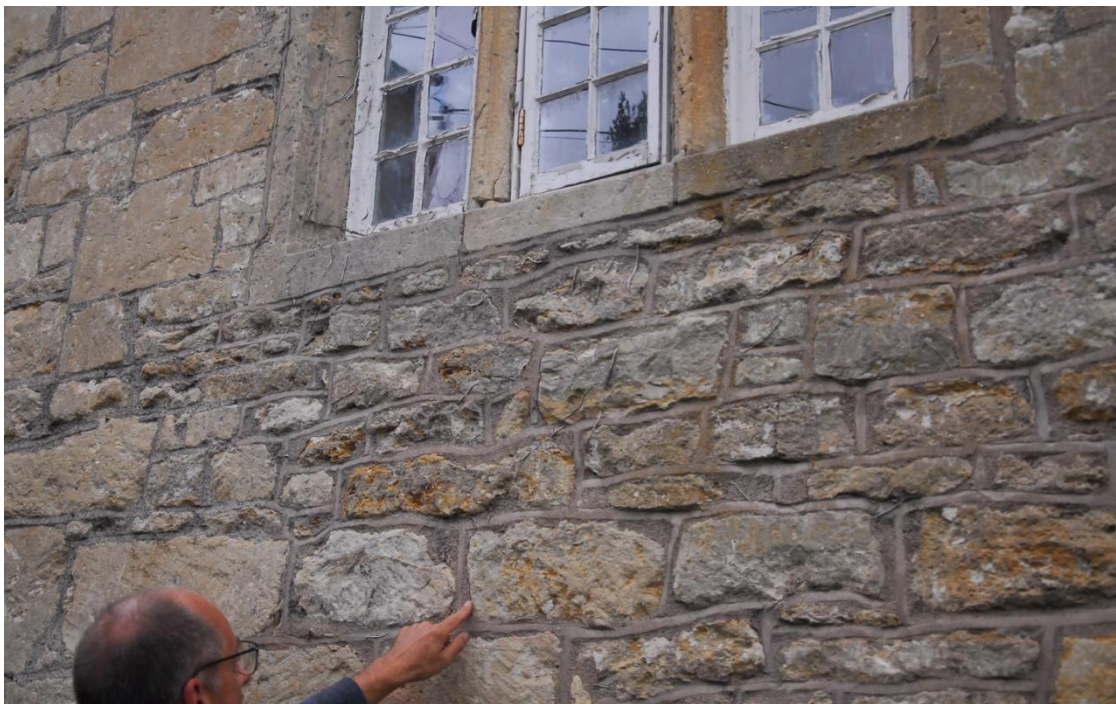
- 6.1.5 The masonry between the ground floor is also irregular. There is evidence of a bulge between WG1 and WG2. This has been ribbon pointed with cement mortar. There is a vertical crack in this area.

Figure 22 Vertical crack below WF2

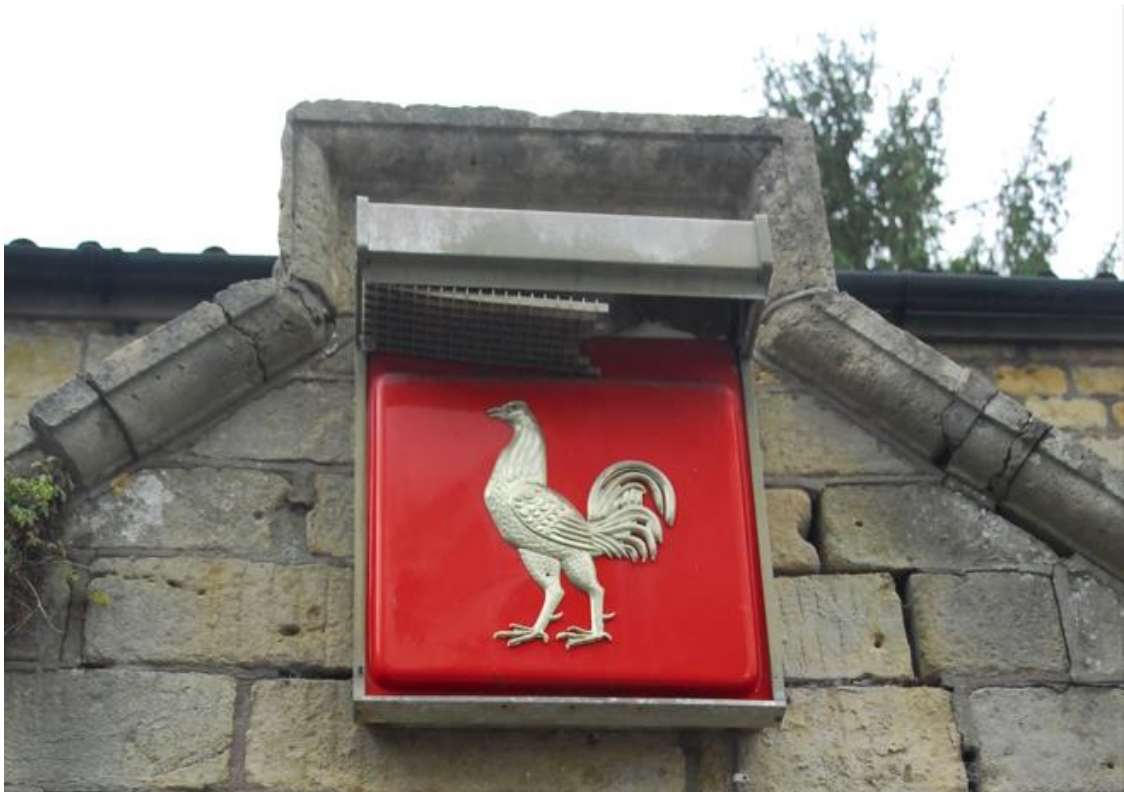
Figure 22 Awkward jointing to merlon and open joints.

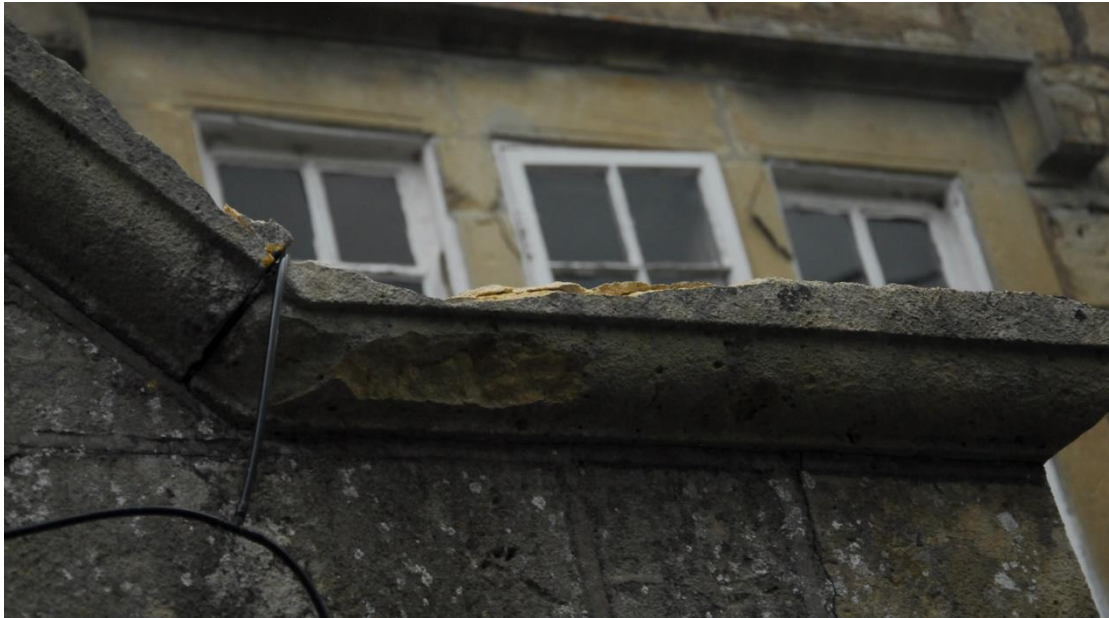
- 6.1.10 The coping stones which are ovolo moulded with a small fillet have been displaced in practically in every location with open bed joints and purpends. At high level next to the merlon there are 2 small indents suggesting the merlon may be an alteration. A number of joints and stones have failed at high level. The horizontal coping to the right-hand buttress has failed. These will need to be re-seated. The horizontal copings are in **POOR** condition

Figure 23 Failed horizontal coping

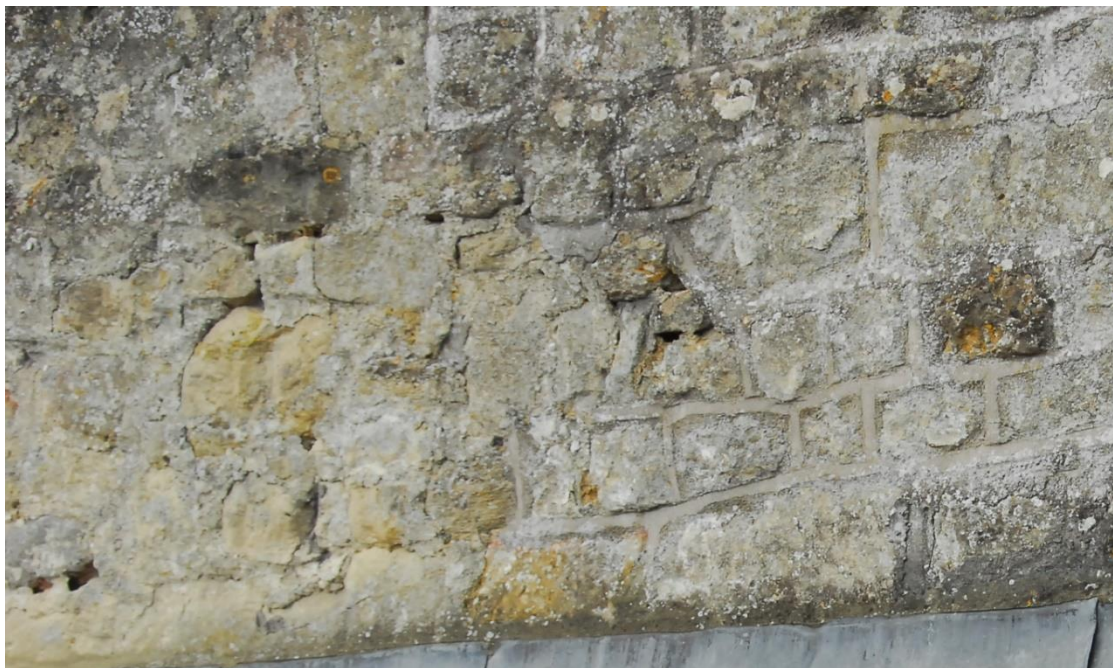
mortar has been lost or the stone has failed. These were not accessible due to RS5. Areas in **POOR** condition

Figure 24 Typical open joints in stonework

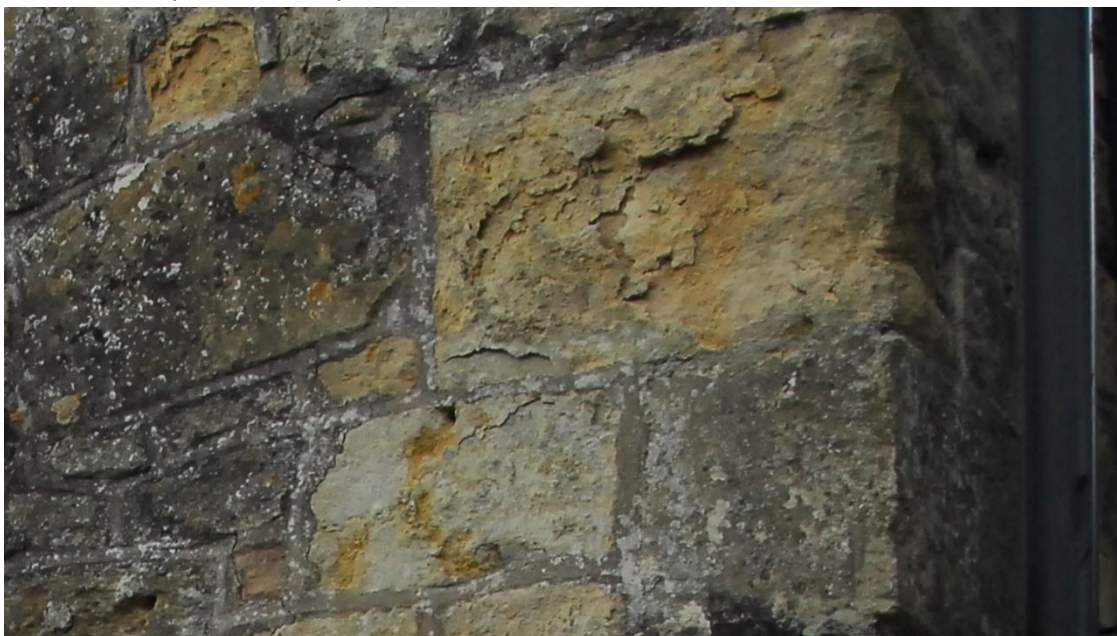
- 6.2.5 The triangular spandrel panels above the original roof line appear more coursed work and have been repointed in cement. There are a number of stones that are severely delaminating due to exfoliation predominantly on the NE corner. Areas in **POOR** condition.

Figure 25 Exfoliating stonework

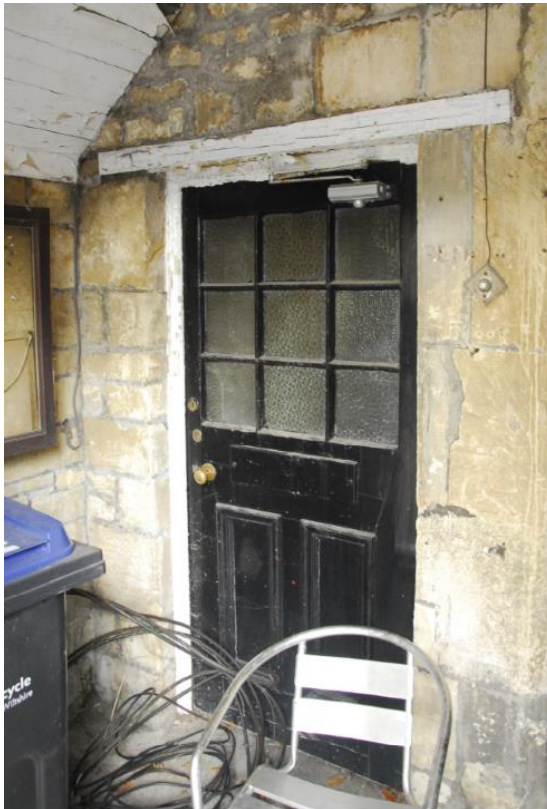
- 7.1.1 The door is inserted into an opening cut into the original masonry to the side of the chimney stack to CH2 and is believed to date from circa 1900's. The leaf is a Victorian style partially glazed door with gunstock shouldered styles at the mid rail and a 9 pane upper panel with heavy glazing bars over paired panels divided by a vertical mid rail below.
- 7.1.2 The door has a timber lintel above the frame and the reveals are made good masonry with considerable amounts of cement. The lintel appears sound.
- 7.1.3 Door frame and lintel are in **REASONABLE** serviceable condition but in need of redecoration.

Figure 26 DG1 inserted door

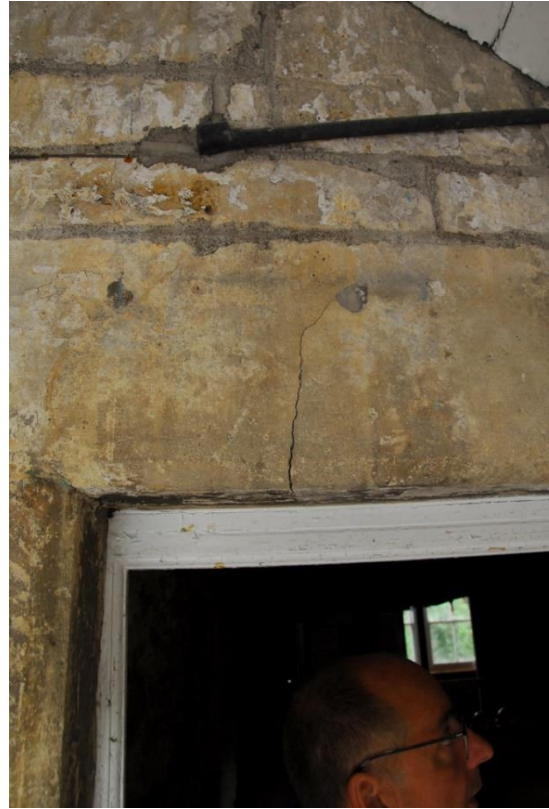
Figure 27 Fractured lintel over DG2
