# CONDITION SURVEY

## HOP POLE INN, LIMPLEY STOKE

HBA 345 – 21<sup>st</sup> NOVEMBER 2022

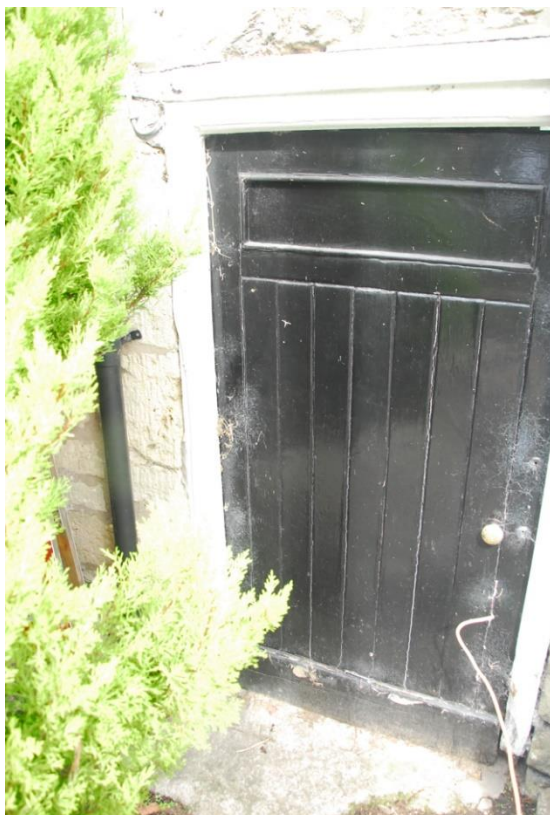
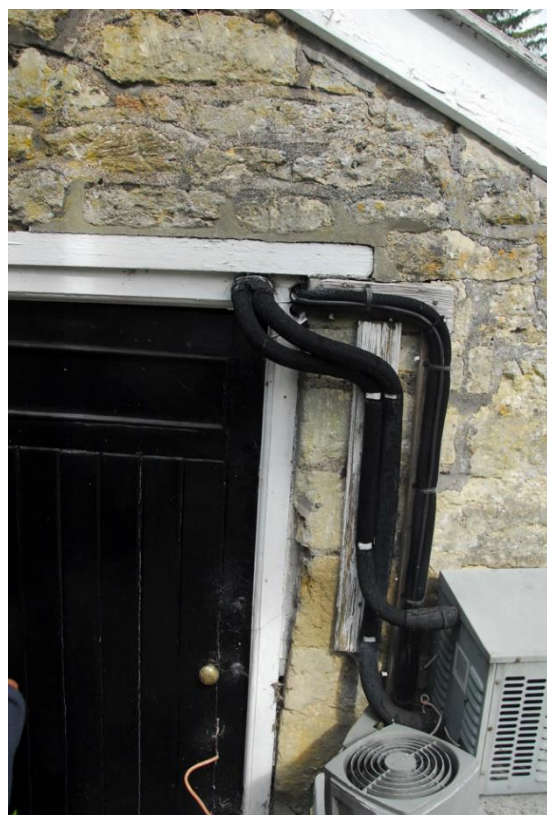
- 7.3.2 The leaf itself has been fitted with a kickplate behind which the boards have rotted.
- 7.3.3 Ideally the frame should be removed and repaired, and the chiller units supplied by a discrete hole through the masonry. The door leaf is in a serviceable condition but in need of repair. **REASONABLE** condition.

Figure 28 DG3 boarded door

Figure 29 DG3 Compromised frame

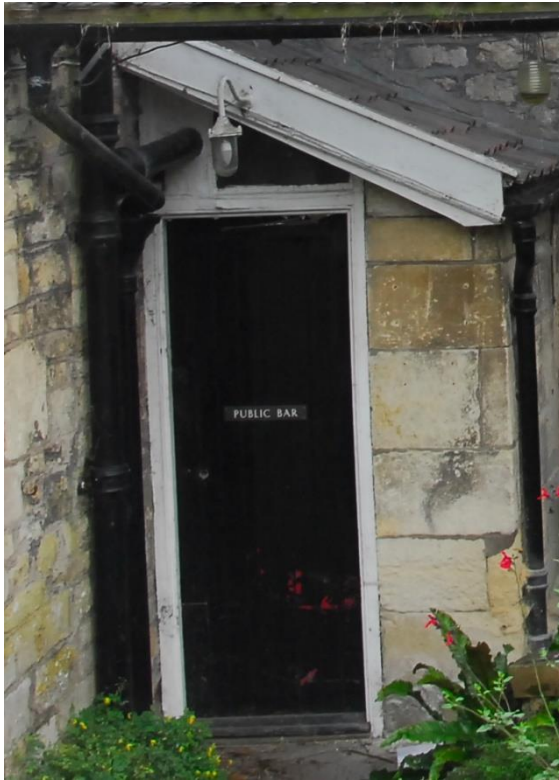
Figure 30 DG5

- 7.5.1 Currently sealed vertically boarded door in a frame that extends above the head to form a triangular fanlight. The door has a throw at low level. The door leaf is in **REASONABLE** condition.
- 7.5.2 Externally the frame at low level on the left-hand side has signs of decay. Internally the frame has significant damage from what looks like donkioporia expansa but is more likely to be Serpula Lacrymans which favours softwood. This will need to be removed and replaced. The over panel is only partly glazed with the rest given over to a timber panel through which drainage pipes pass. **VERY POOR** condition.
- 7.5.3 In need of significant intervention.

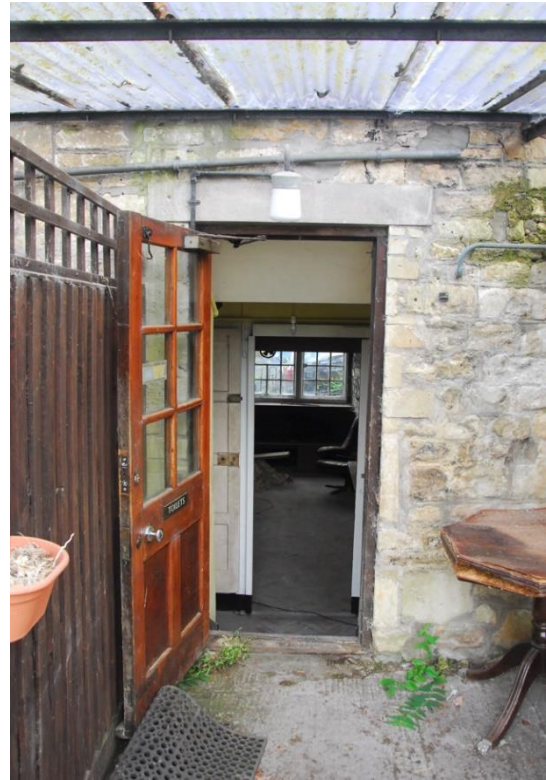
Figure 31 DG6 Modern part glazed door

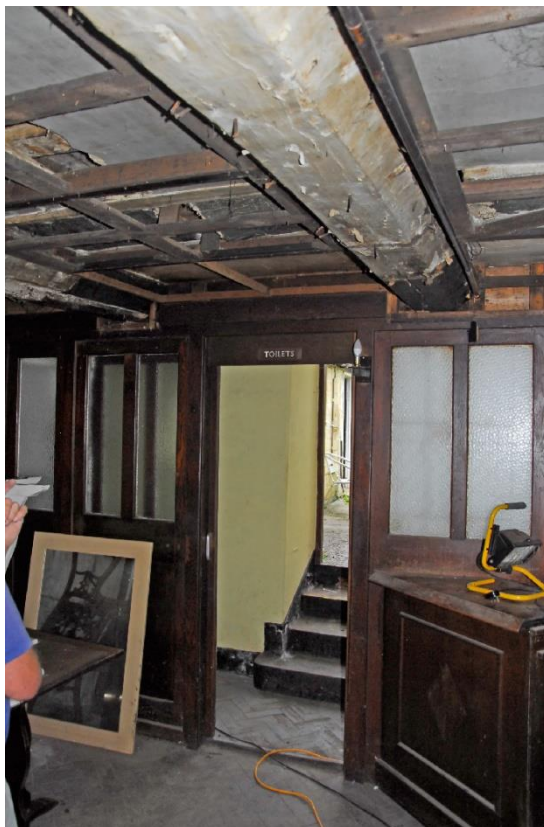
Figure 32 DG16 1960's glazed partition

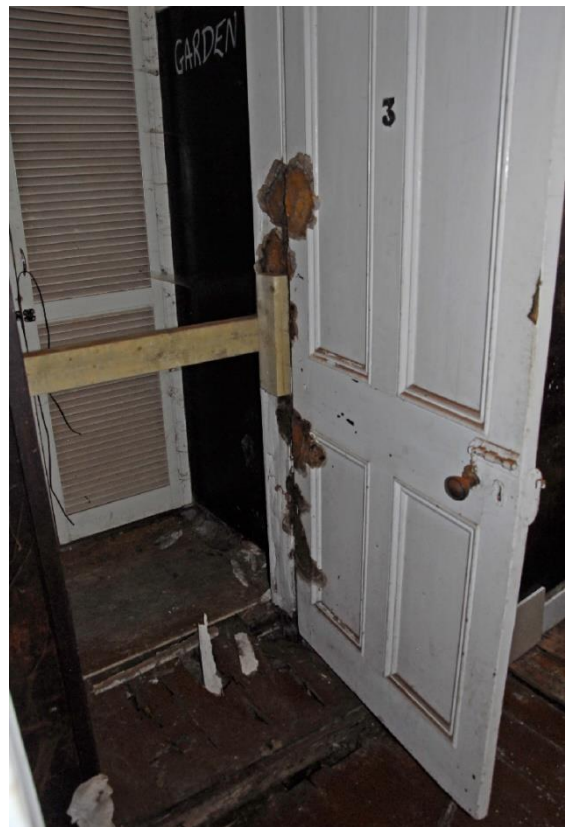
- 7.9.3 With the exception of DG15 which is in **VERY POOR** condition these doors are in **REASONABLE** condition. It is highly likely that all the doors bar DG11, DG12, DG15 and DG16 are modern unconsented replacements.

Figure 33 DG15 suffering from fungal attack

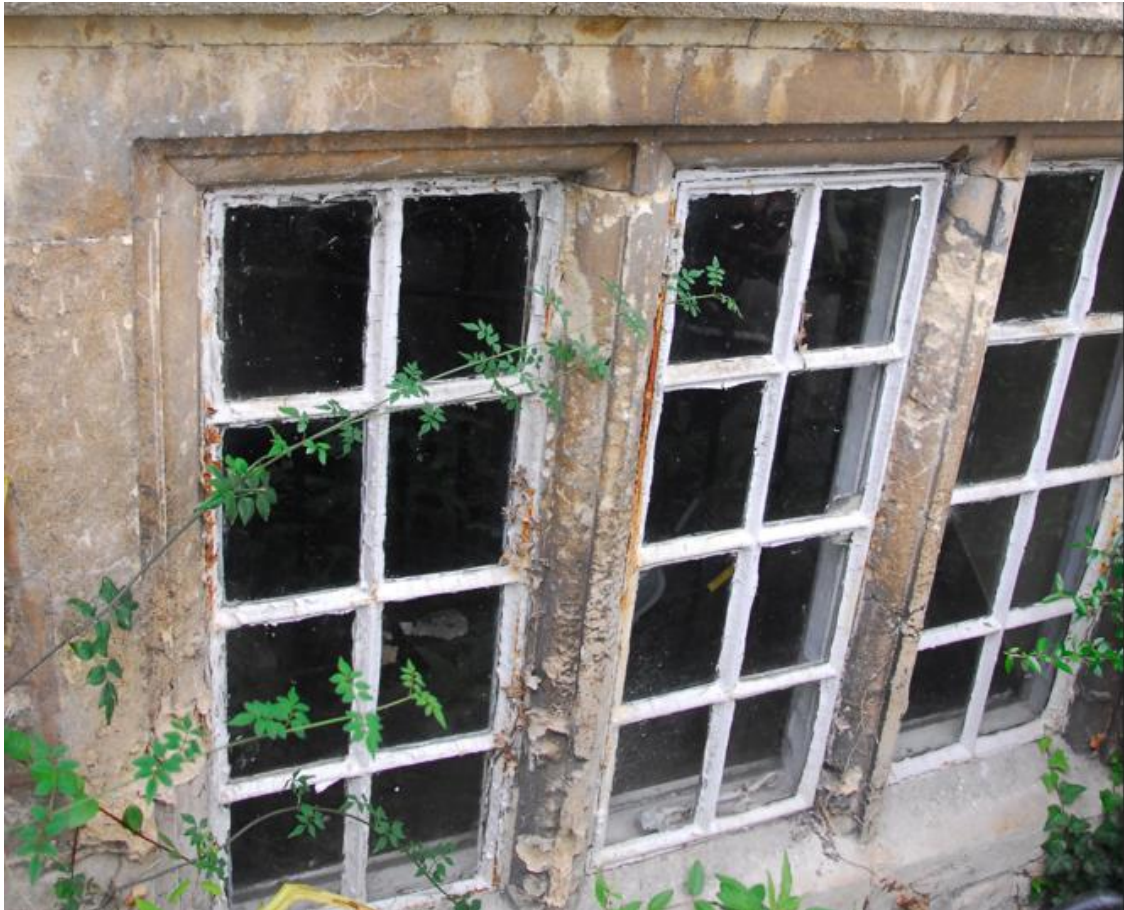
Figure 34 WG1 Metal casement windows

- 8.1.1 Triple light hood moulded heavy mullioned ovolo profile stone window with two fixed lights either side of an opening casement. The hood moulding appears to be an addition. Stonework is generally in **REASONABLE** condition externally but there is a degree of exfoliation and salt damage and there are, but a number of open joints in need of mortar repairs. Internally, the windows are painted with a heavy gloss paint.
- 8.1.2 3 metal casements set within the stonework comprise 8 panes each. Central one should be opening but hasp has failed sealed shut. Repairable. Glass intact but decorations have failed. **REASONABLE** condition

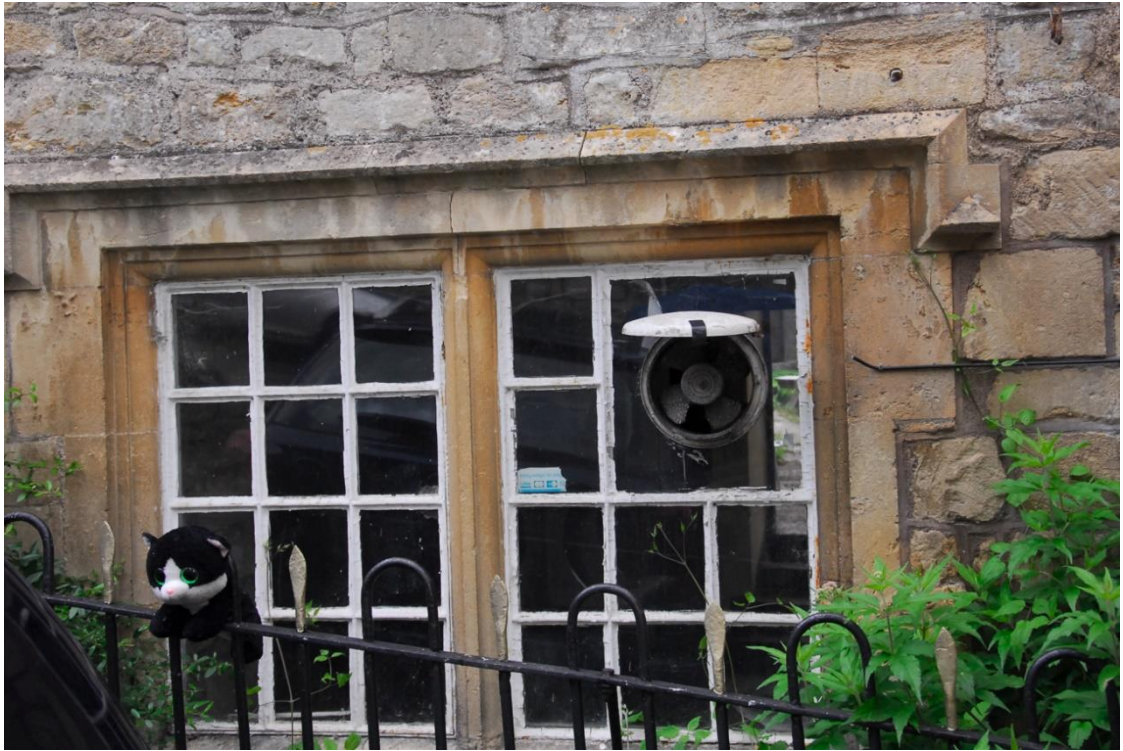
Figure 35 WG2 Metal casement windows

- 8.2.1 Double light hood moulded heavy mullioned ovolo profile stone window with two fixed lights. These are also metal casement but are configured differently to any other window in the building being 12 panes each comprising 3 columns of 4. Externally the stonework is in **REASONABLE** condition there is some exfoliation of the central mullion and some areas requiring repointing. Internally, the windows are painted with a heavy gloss paint.
- 8.2.2 The windows are painted shut but the left-hand light was originally opening. Internally the hasp has been lost which is why it has been painted shut. Repairable. The right-hand light has been modified by the removal of some glazing bars to create a large aperture for an inline plastic vent. This is unsightly and unconsented. **REASONABLE** condition

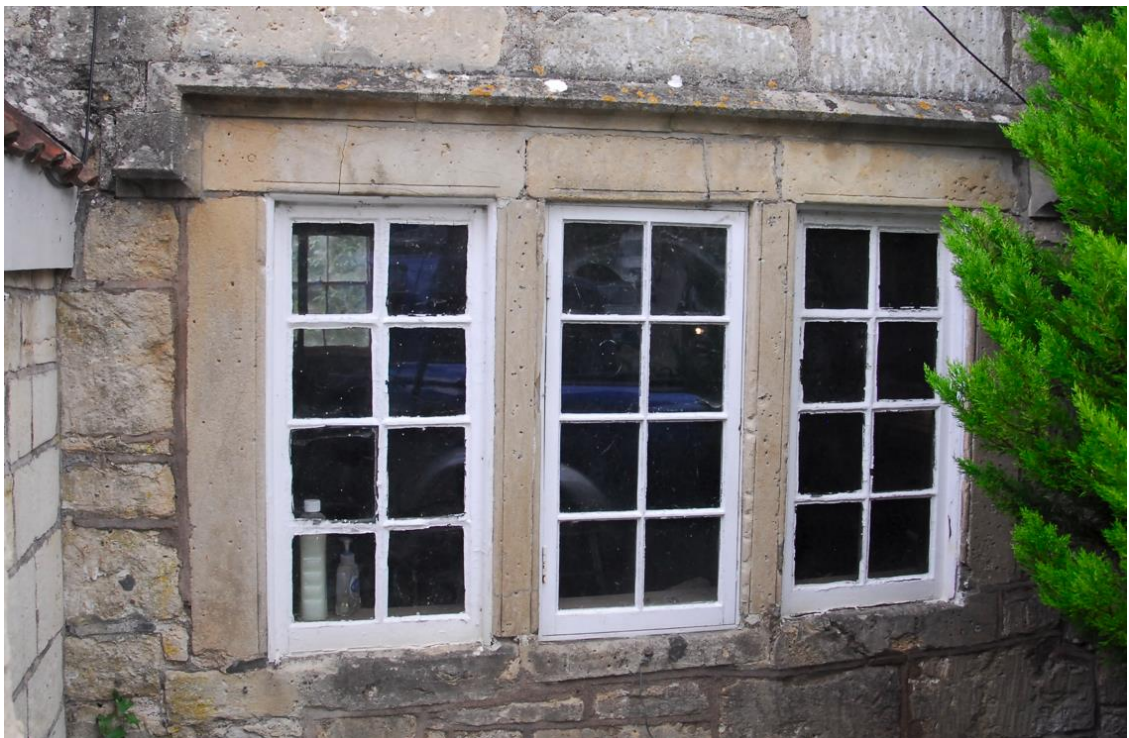
Figure 36 WG3 Timber casement windows

- 8.3.1 The style of this window differs from 1 & 2. Triple light hood moulded heavy mullioned square profile stone window with two fixed lights either side of an opening casement. Sill stones have very limited drip slope. Windows mounted between the mullions rather than behind them. The left-hand mullion also appears to have slightly dropped arising in a distorted lintel line. **REASONABLE /POOR condition**

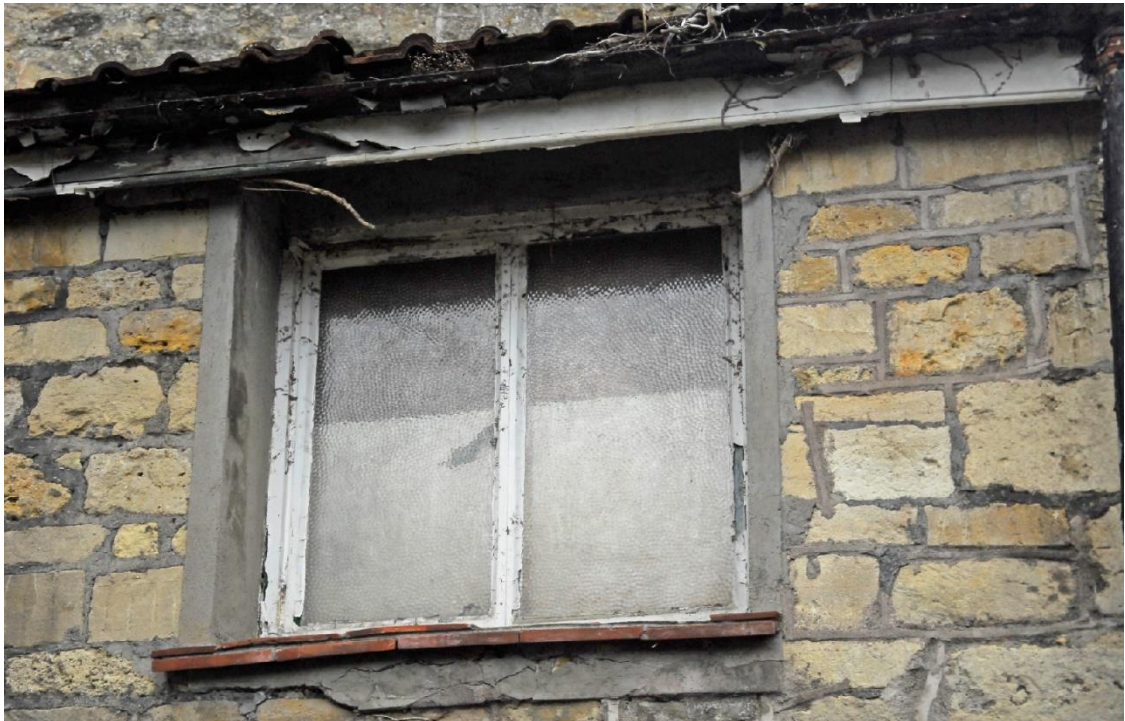
Figure 37 WG4 Metal casement windows

- 8.4.1 WG4 has been inserted into the east wall rather than being built in at the time of construction. It is a double light Crittall type window with one opening light and one fixed. The window opening has cement reveals and a tile sill which is heaving at the centre point. The sill is bedded on a heavy band of cement which has cracked. The head is at wallplate level. This insertion is typical of the 1960's. **POOR** condition

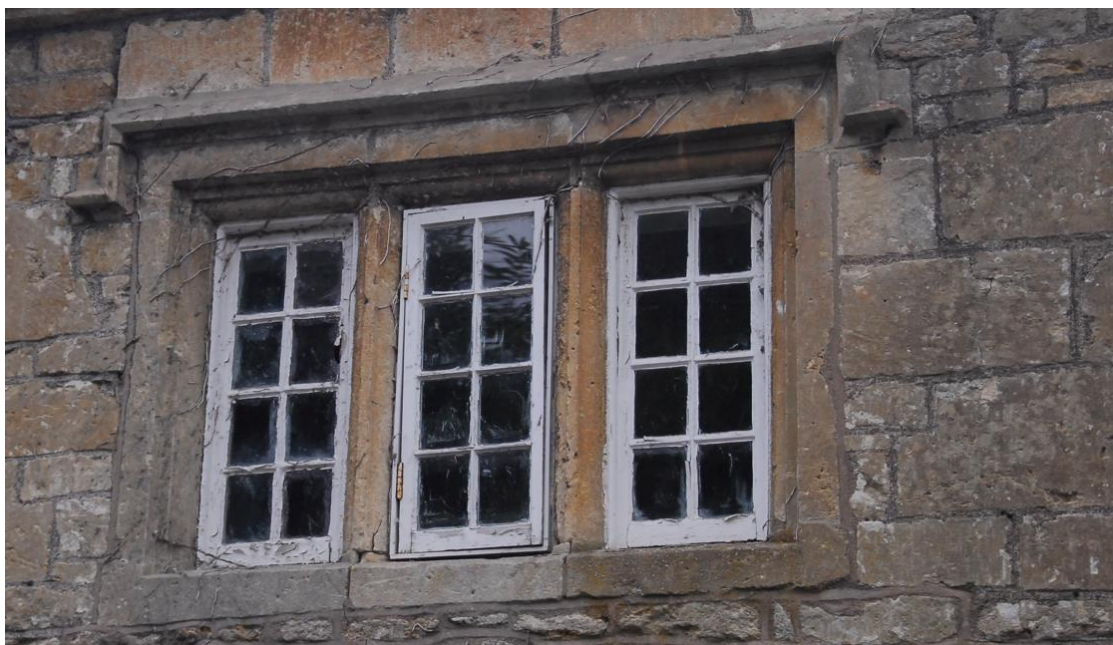
Figure 38 WF1 Timber casement windows

8.11.1 Triple light hood moulded heavy mullioned ovolo profile stone window with two fixed lights either side of an opening casement. Externally there is a fracture to the left-hand mullion at low level. This continues as a crack through and below the windowsill. There is a failed perpend on the jamb stone where it abuts the main wall. Several other joints are open Internally the stonework has been painted.

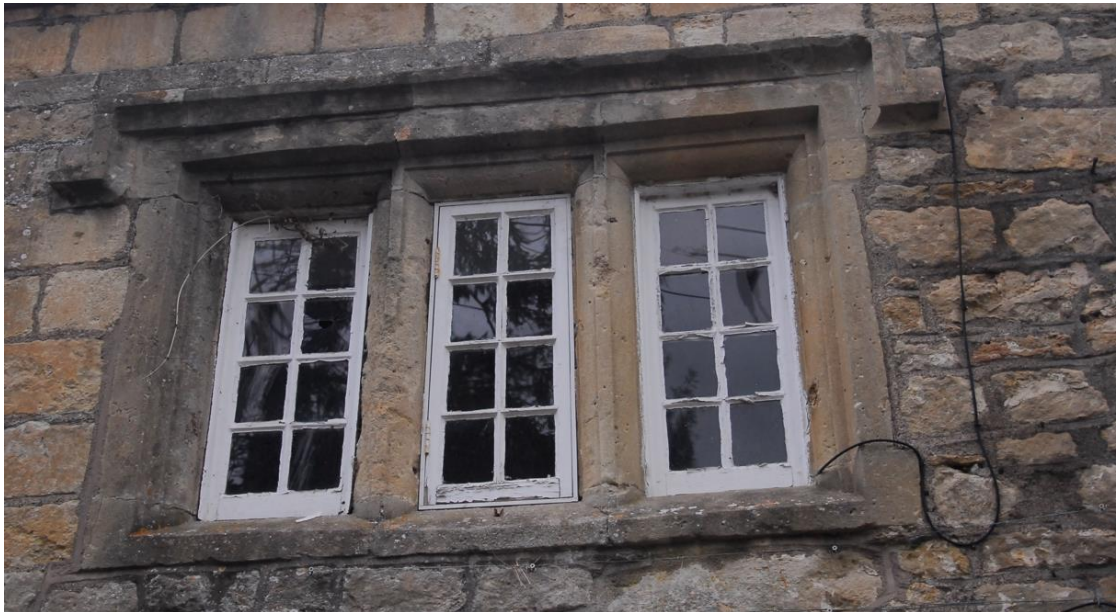
Figure 39 WF2 Timber casement windows

- 8.12.1 As WF1 in detail but with chunkier stonework. Open bed joints externally to left hand mullion and some loss of central fillet detail. Stonework painted internally.
- 8.12.2 Window configuration as WF1 but central light has a different moulding to any WF1 mouldings. 1 pane broken

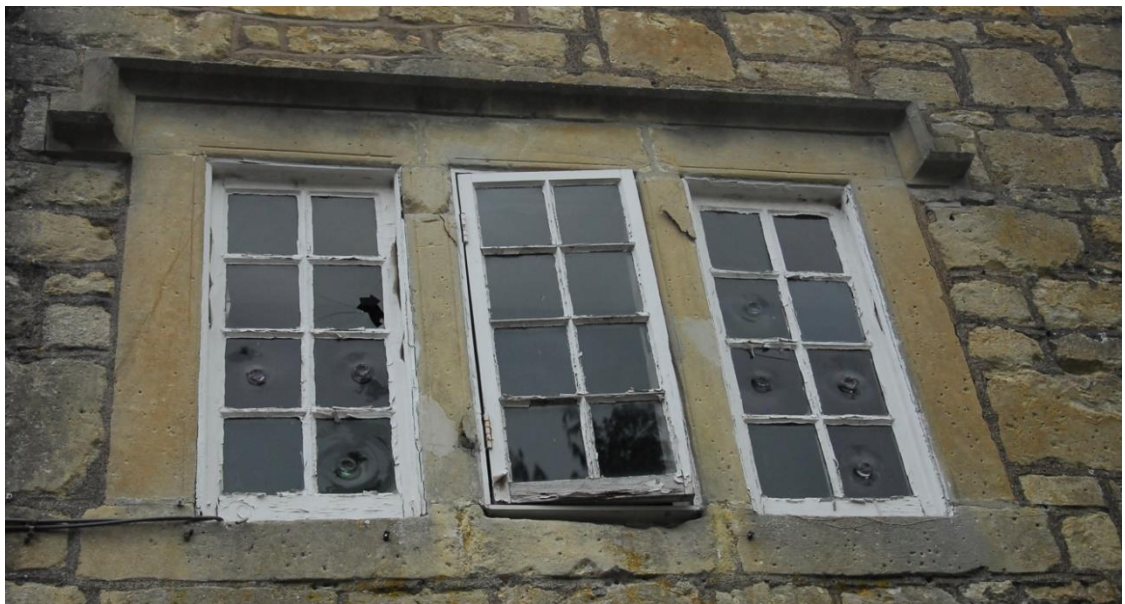
Figure 40 WF3 Timber casement windows

- 8.13.1 Triple light hood moulded heavy mullioned square profile stone window with two fixed lights either side of an opening casement. Externally both mullions are showing signs of damage at the hinge points and are need of repair. The central sill section has also eroded quite badly. Unlike WF1 and WF2 where all three lights were in the same plane in this instance the central light has been set well forward of where it should be. Stonework painted internally. **POOR** condition

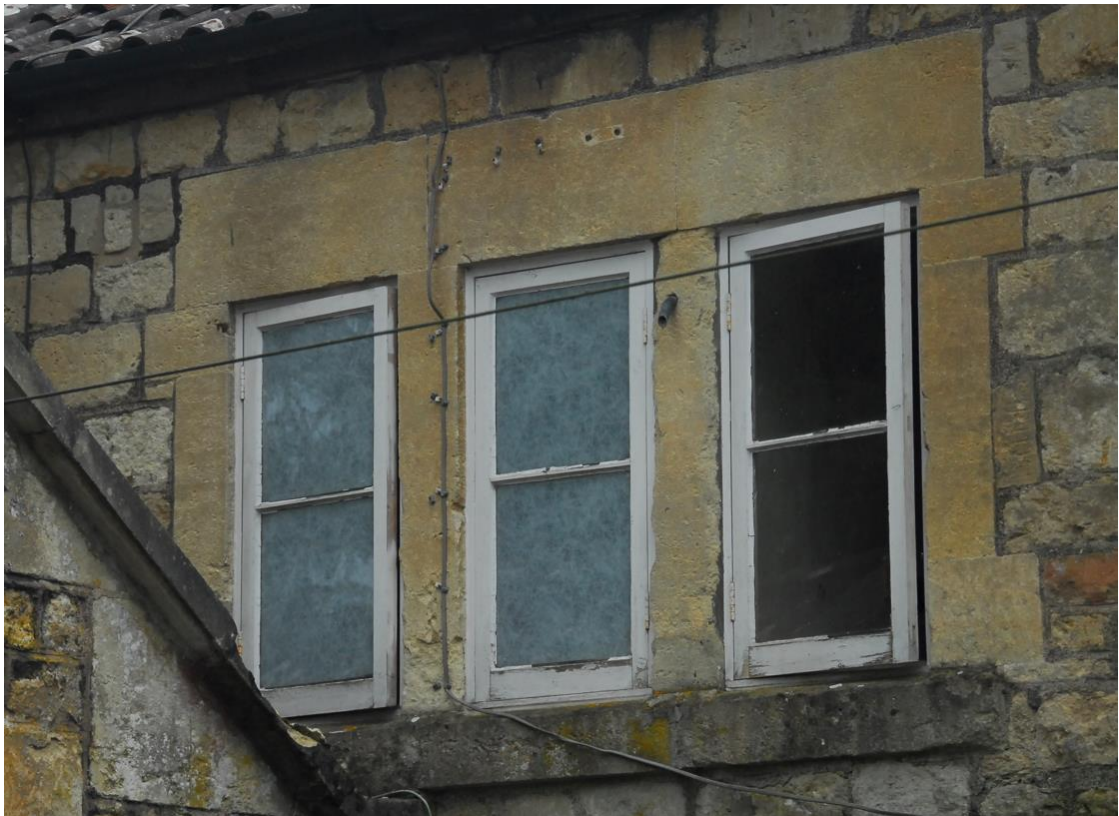
Figure 41 WF4 Timber casement windows

- 8.14.1 Triple light square section unmoulded mullioned window with 3 opening casements. Stonework generally **GOOD** condition but has cement repairs and a water overflow pipe through the mullion.

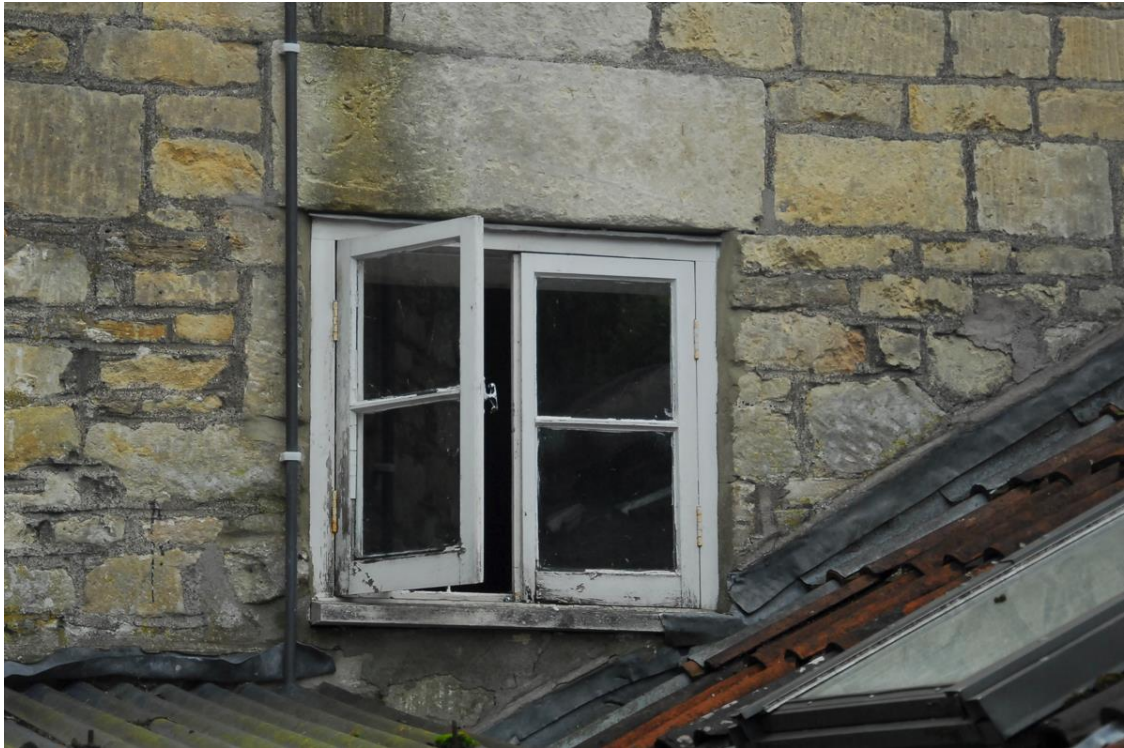
Figure 42 WF5 Timber casement windows

- 8.15.1 Double casement modern softwood window set in a crudely formed opening with a large lintel that only just bears on the reveal stonework either side which is random rubble and un-quoined. The window is crudely pointed into place with cement and has a flashing over the top to deflect water from a defective gutter. **POOR** condition.
- 8.15.2 Both lights open and have meeting styles to create an escape window without a mullion. The timber is suffering extensive decay and there is putty loss to both lights. Access to this window is extremely hard due to the roof configuration. **POOR** condition

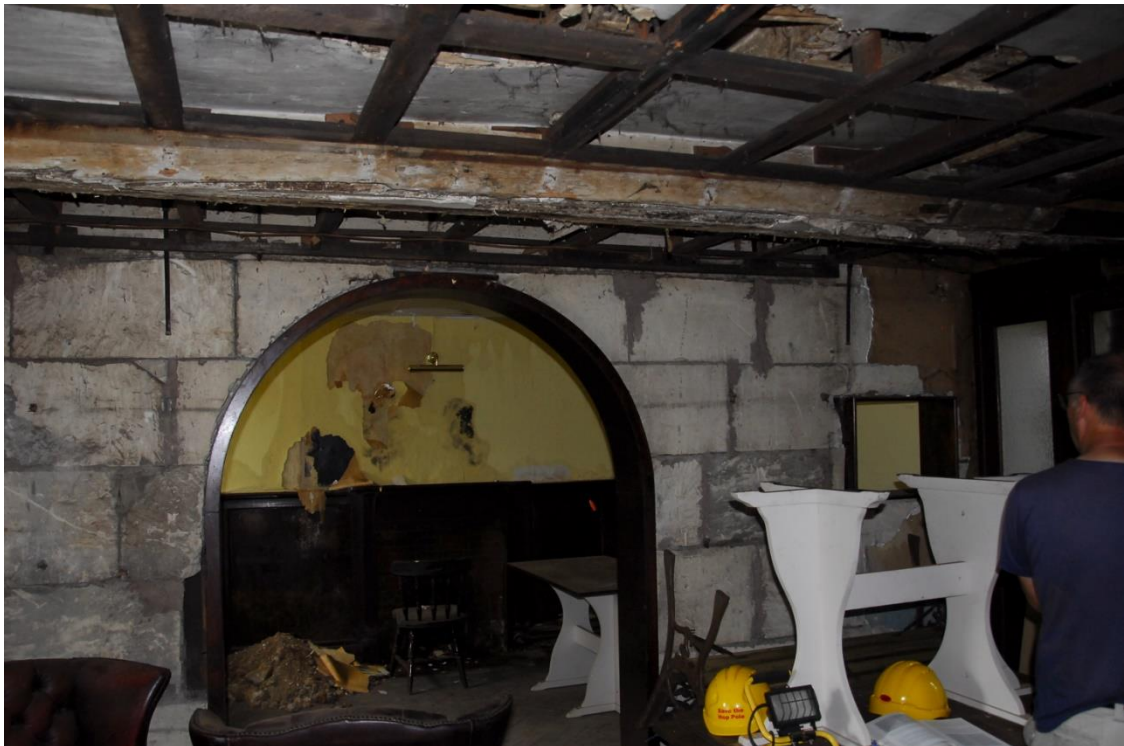
10.2.1 The ceiling has been removed. It was until recently a suspended plasterboard ceiling held in place by a softwood structure slung below an earlier ceiling of lathe and plaster set between the main floor structure. 100% of the plasterboard ceiling has been removed (but not its structure) revealing a 35-45% intact lathe and plaster and a number of service pipes at a higher level. The ceiling generally is in very **POOR** condition.

Figure 43 Double ceiling to G2

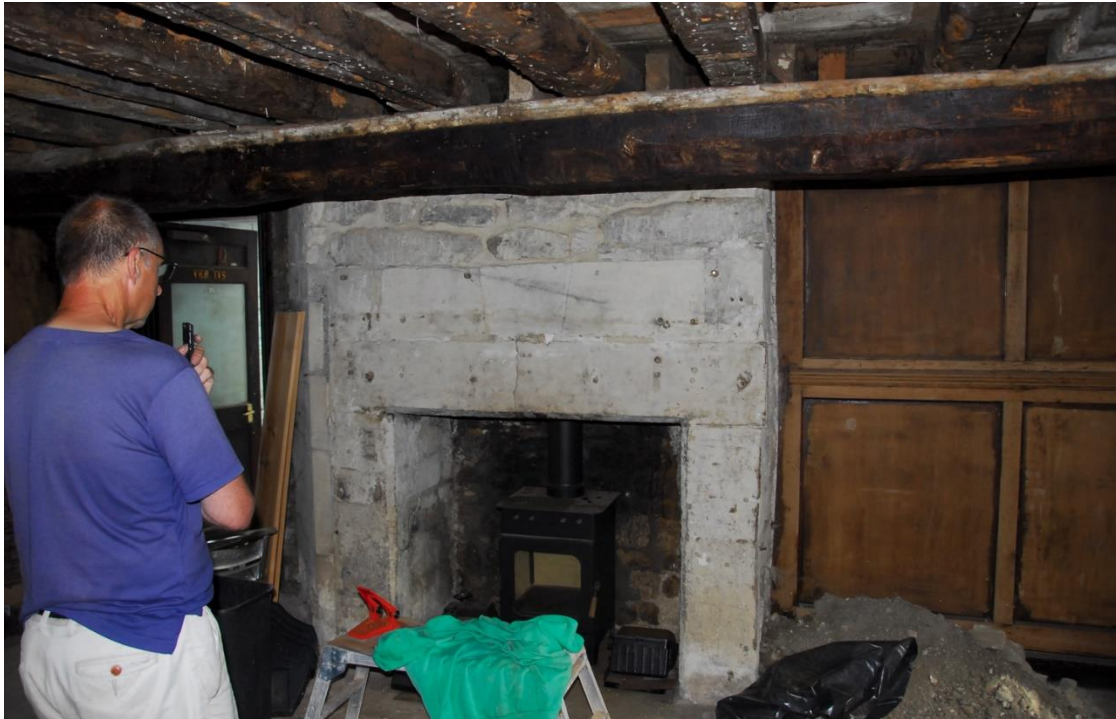
- 10.3.1 The ceiling finish has been completely removed revealing the ceiling structure. There is clear evidence by way of fixings that suggest the ceiling was at one stage lathe and plastered. The ceiling is in **VERY POOR** condition

Figure 44 G3 Exposed ceiling structure

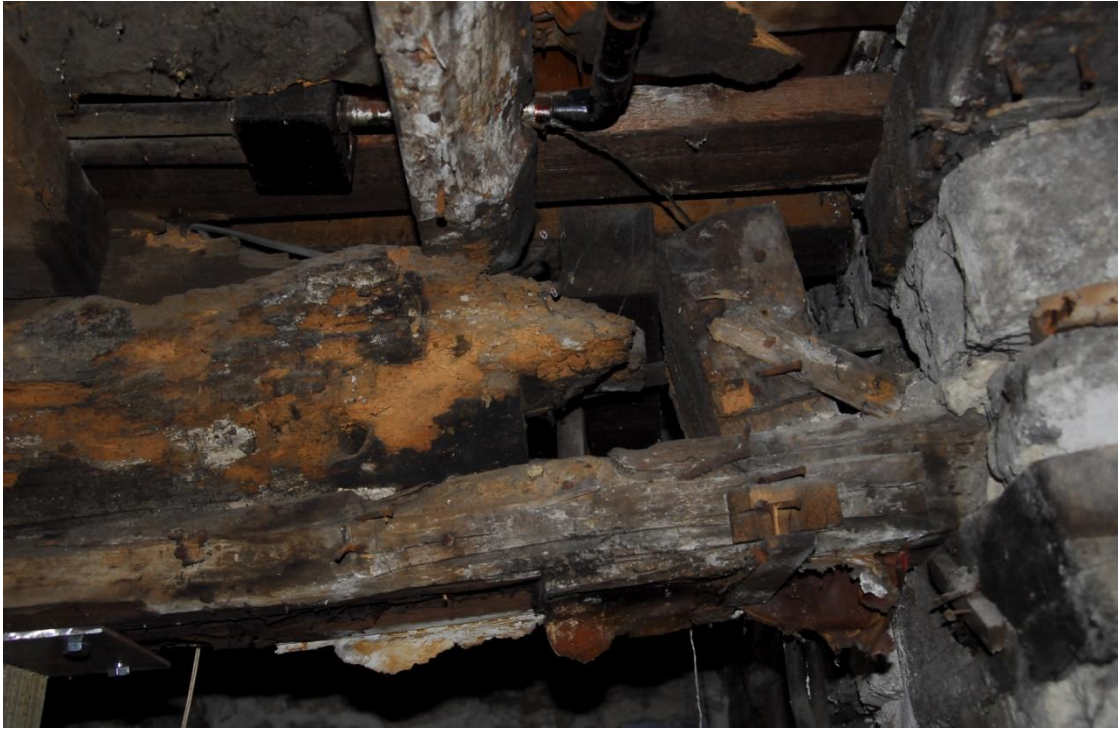
- 10.3.5 Both these timbers differ significantly in character to the carrier imbedded in the chimney CH2 wall. This contains regularly spaced and sized mortices for floor joists and is clearly original although severely ravaged by death-watch beetle. The joists running into this beam are clearly later as dimensionally they don't match the mortices (joists too narrow) **VERY POOR** condition

Figure 45 G3 failed western floor carrier

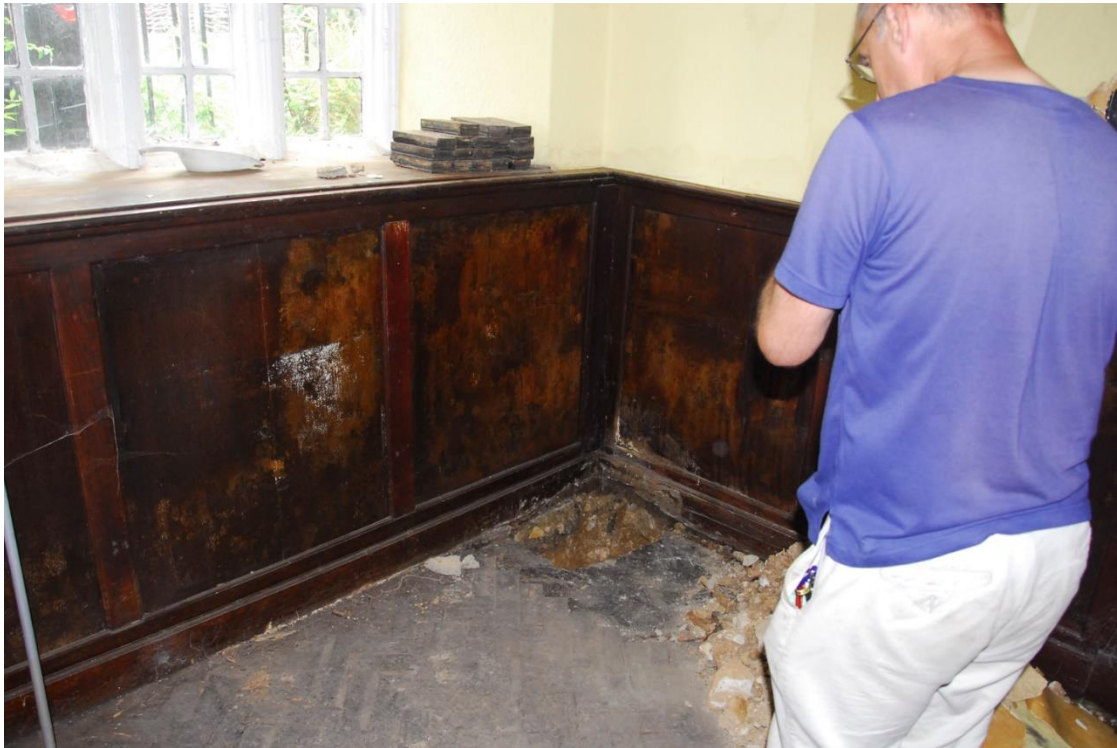
Figure 48 G1 Walls and panelling (saturated)

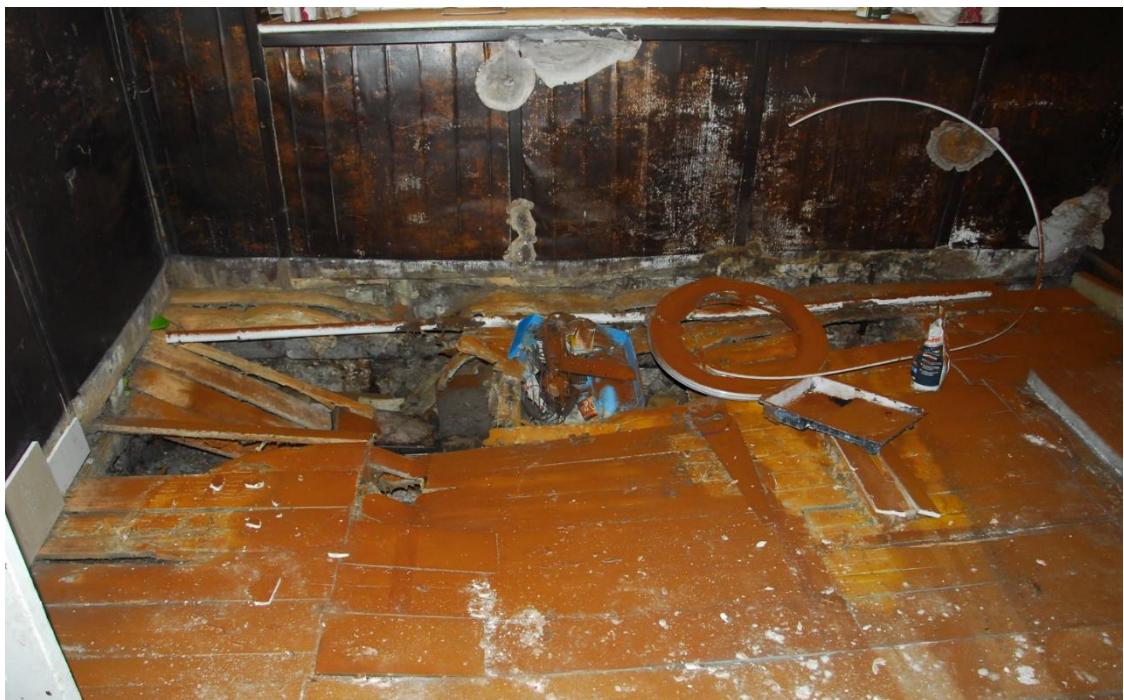
Figure 53 G7 panelling with fungal activity.
