## Domestic Services Risk Assessment & Written Scheme for the Control and Prevention of Legionellosis

Carried out at  
**Tendering District Council**  
**Clacton Leisure Centre**  
**Vista Road, Clacton-on-Sea**  
**Essex, CO15 6DB**

**Date of Assessment:** 20<sup>th</sup> January 2022

**Assessment No:** 12717CS

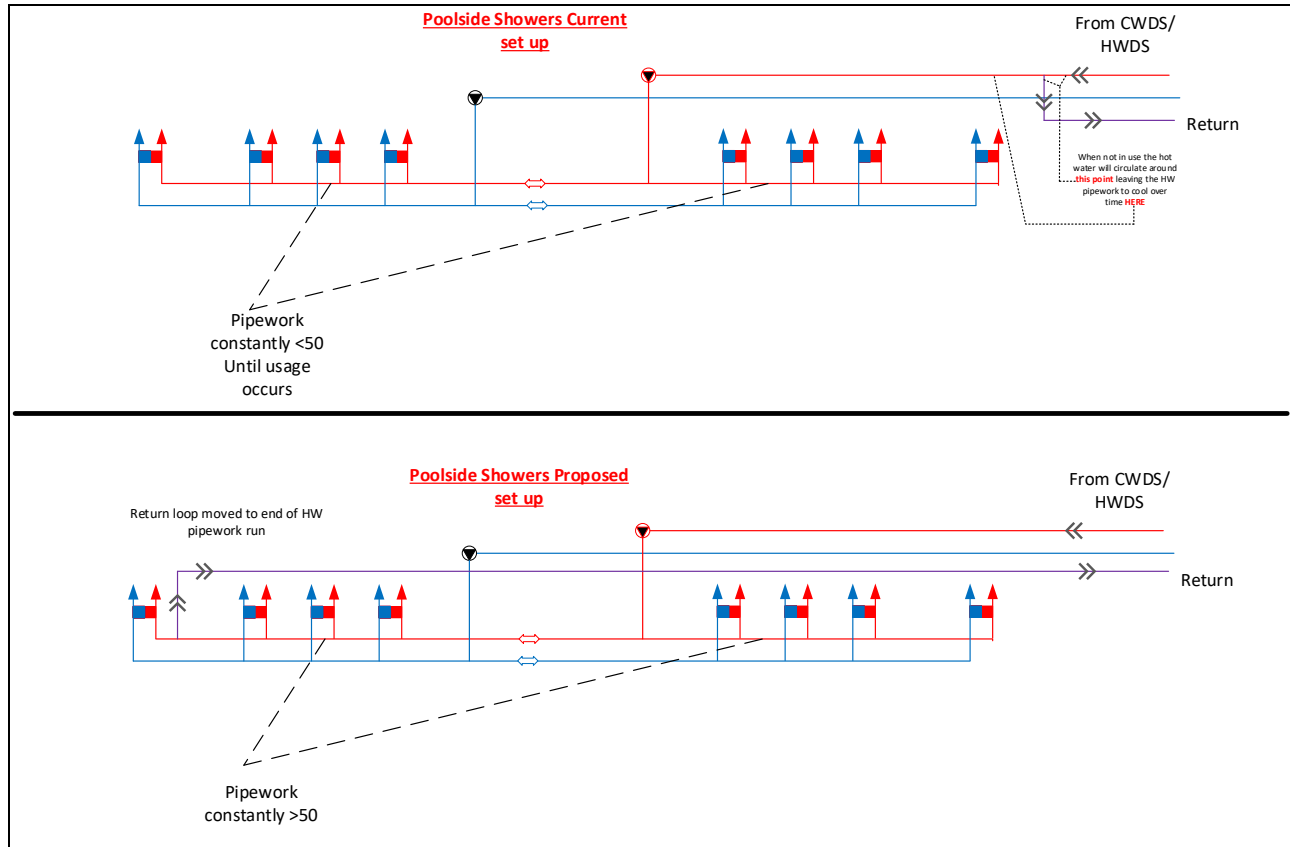
**Wet Side HWS** – at the time of the survey it was noted that the return pump was no operating correctly and the entire return loop of this system was dormant. Because of the faulty circulation pump there were several issues occurring on site; hot water was taking up to 5 minutes to reach far reaching outlets including showers. Due to this issue water was sitting in the hot pipework at 30-40°C which is a favourable temperature for legionella growth in water systems. Water in the circulation (return) loop was also at temperatures favourable to legionella growth and while the circulation pump was not operational was stagnating in the pipework. This led to several incidences of legionella bacteria being present in the water system.

It should also be noted that this areas (Wet Side) has had a complete refurbishment and upgrade of the domestic water system. it was noted that local hot water pumps had been installed at the sinks in the toilet area and also the showers – it is my opinion that the reason for installation of such pumps was carried out due to poor hot water pressure [ in my thoughts due to the faulty circulation pump]. I believe that no investigation was carried out by the installers of the operation of the circulation pump. ***This issue has now been addressed by site; it was discovered that there was an airlock in the hot water return. site have assured me (and presented evidence) that the return loop is now operational and at >50°C which is sufficient to control legionella growth.***

It was also noted that the booster pumps have been installed after the return loop on the pipework (see diagram). As such these pumps although able to draw hot water from the supply loop would not compensate for the lack of circulation. Also, it is my opinion that the return loop (in the shower area) has been installed incorrectly (see diagram) and as such creates a large deadleg where warm water could stagnate and potentially allow bacterial growth. It is recommended that the return pipework is altered to allow a complete circulation loop and avoid potential bacterial growth (**remedial action 1**).

Remedial Actions & Recommendations						
N°	Inherent Risk	Risk Rating	Time Frame	Action Required	Residual Risk Rating	Signed Off Date & Signature
1	<b>Wet Side Showers – Circulation</b>  Due to the location of the return loop, there is a risk that hot water will sit in pipework throughout the hot manifold of the showers, if the water cools to 20-45°C (which could happen through lack of usage or overnight) there is a risk of legionella growth.	1	3 Months	Consider (where possible) moving the return pipework loop to the very end shower (SH8) to ensure that hot water is fully circulated through the hot manifold (see diagram pg.14	0	
2/3	<b>Limescale Building Up – Wet Side First Aid Room, gym change sinks &amp; dry side sinks</b>  Limescale is building up on the kitchen taps. Limescale will act as a growth medium and source of nutrition for legionella bacteria.  Contamination risk.	1	3 Months  Ongoing	Ensure all scaled outlets are cleaned.  Inspect outlets frequently and clean/de-scale as required.	0

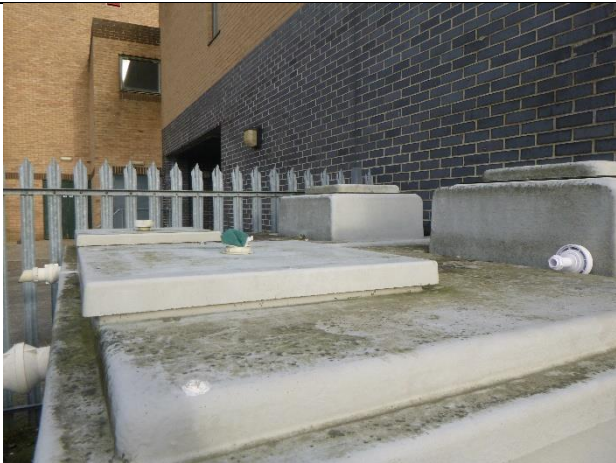
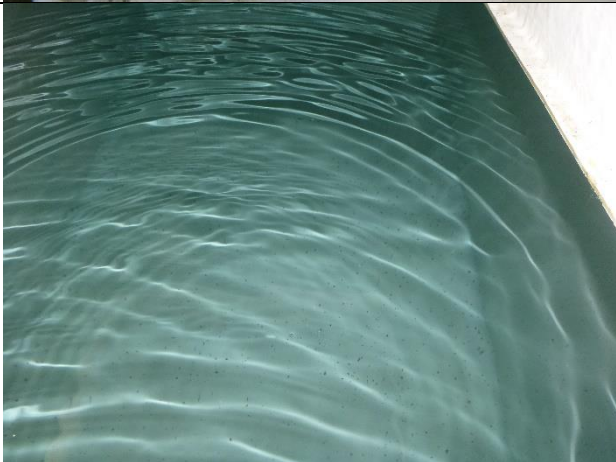
Tank title/asset number	CWST 2&3
Location	External to Spa Plant Room
Size (m) / volume (m <sup>3</sup> )	2000 litres
Materials of construction	GRP
External Photograph of Tank

Comments/actions required	Replace Broken Lid Vent (Beacon to complete)
<b>Overall Risk Rating</b>	<b>0</b>

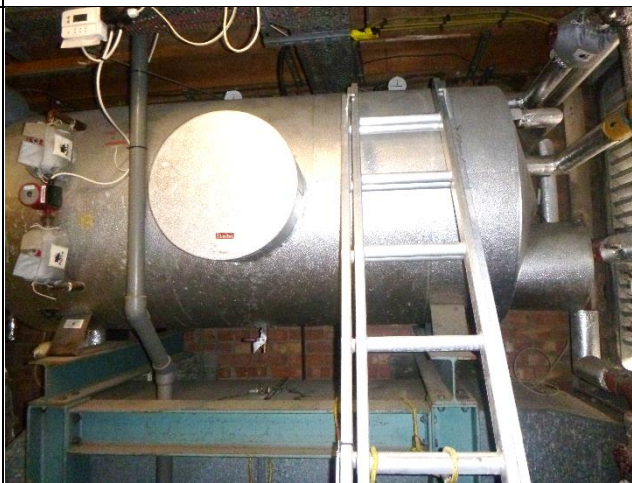
Hot water generator title/asset number	CAL 1			
Location	Wet Side – Pool Plant Room			
Stored water Volume	Approx. 1000 litres			
Materials of construction	Steel			
Photograph of Hot Water Storage Vessel

**CAL 1 Wet Side Plant Room** – at the time of the survey it was noted that the return pump was no operating correctly and the entire return loop of this system was dormant. Because of the faulty circulation pump there were several issues occurring on site; hot water was taking up to 5 minutes to reach far reaching outlets including showers. Due to this issue water was sitting in the hot pipework at 30-40°C which is a favourable temperature for legionella growth in water systems. Water in the circulation (return) loop was also at temperatures favourable to legionella growth and while the circulation pump was not operational was stagnating in the pipework. This led to several incidences of legionella bacteria being present in the water system.

Comments: - *Circulation pump faulty at the time of the survey – now repaired and working sufficiently.				
Overall Risk Rating	No Action

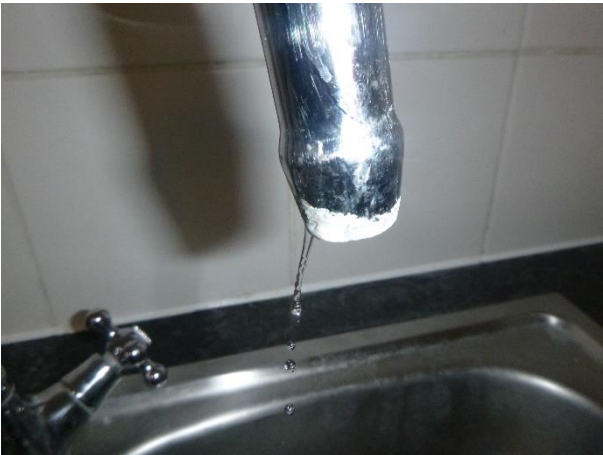
However, hot water temperatures (**at the time of the survey**) were slow to reach the recommended  $>50^{\circ}\text{C}$  (1 minute) and in one case did not reach over 50 degrees – First Aid Sink. This was due to a circulation pump issue which has now been addressed – site have assured me that all hot water temperatures exceed  $>50^{\circ}\text{C}$  well within 1 minute.

Scaled Outlet (Staffroom)

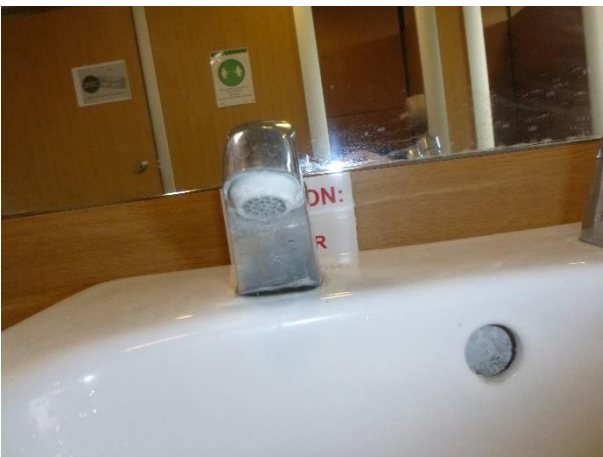
**Spa/Gym Side** - Outlets were found to be in fair condition in line with their age, most of the tap outlets had a degree of limescale build-up. Limescale can provide an ideal environment for legionella and other bacteria and as such should be removed (**remedial action 2 refers**)

Limescale Building Up

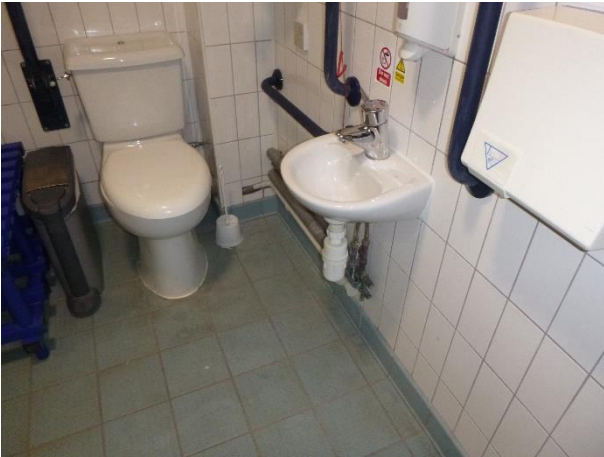
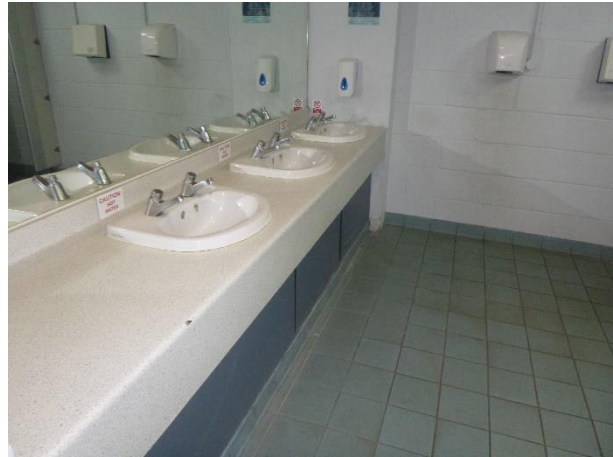
**Dry Side** - Outlets were found to be in fair condition in line with their age, most of the tap outlets had a degree of limescale build-up. Limescale can provide an ideal environment for legionella and other bacteria and as such should be removed (**remedial action 2 refers**)

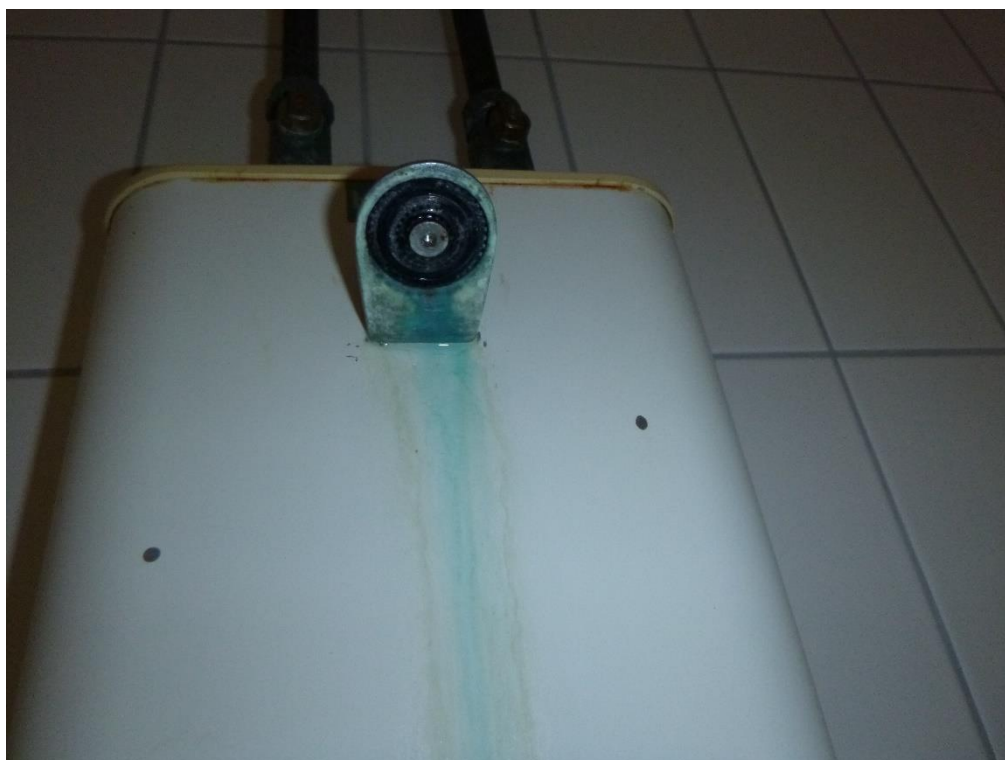
Showers can be found in all three areas of the site. All showers are well used and were found to be operational at the time of the survey. Showers in both the dry side changing and gym changing are showing signs of age with scaling to the shower body and heads which will need to be removed with acid to prevent legionella growth. (**Remedial action 3**).

General Information	Risk Comment	Risk
State the Location of the shower/s	Gym Male Change 1 <sup>st</sup> Floor	0
State Number of Showers	10	0
Is this an emergency shower/s	No	0
Is the shower/s Electric, Thermostatic or Mixer Controlled?	TMV	0
State the cold water supply source to the shower/s	Cold water Storage Tank (Boosted)	0
State the hot water supply source to the shower/s	Domestic HWS	0
Is the shower-head/s clean & free from scale or mould	No - scale around shower rose and body	2
Is the shower/s regularly used	Yes	0
Is there a single blender control serving several showers	No	0
Is the showerhead/s regularly cleaned & disinfected	Yes	0
Mixer Inlet Temp Cold	9.5°C	0
Mixer Inlet Temp Hot	61.9°C	0
Outlet Temp	~38°C	0
Overall Risk	2

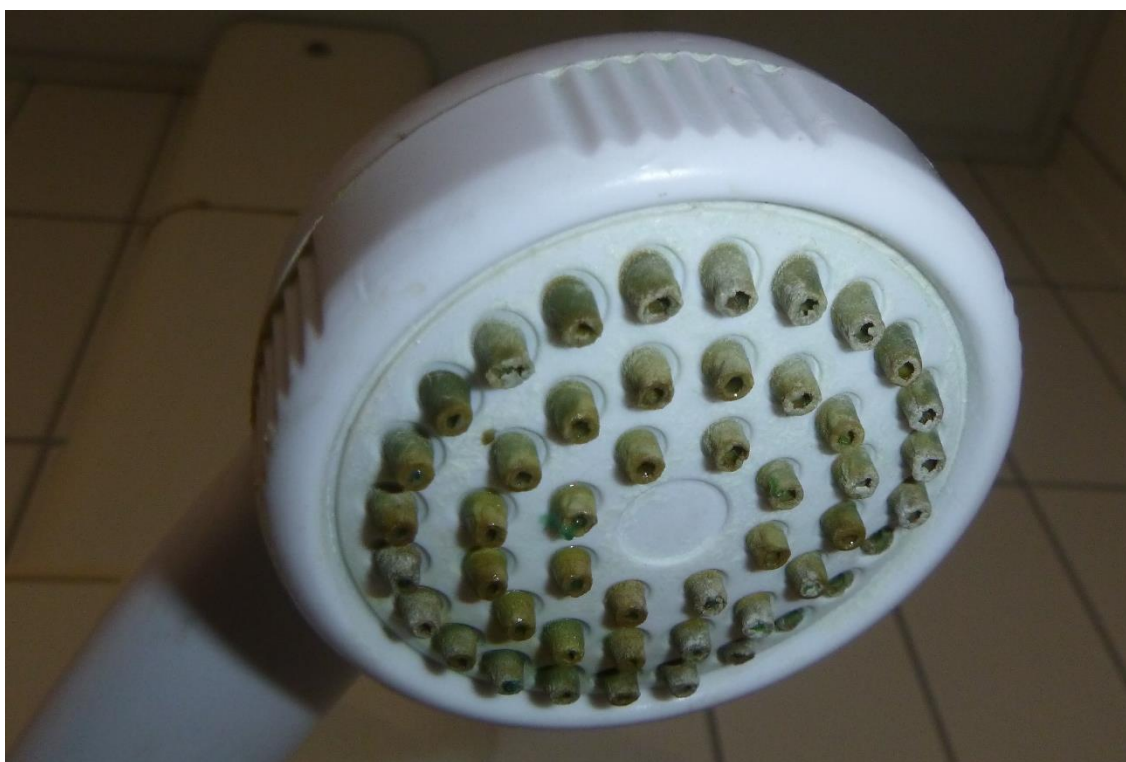
4	<b>Gym Accessible Change Shower Head</b>  The shower head has deteriorated, and the rubber is beginning to erode, limescale is building up. Legionella bacteria will readily grow in these conditions	2	<3 Months	Replace the shower head with a new unit.	0

General Information	Risk Comment	Risk
State the Location of the shower/s	Gym Accessible Change	0
State Number of Showers	1	0
Is this an emergency shower/s	No	0
Is the shower/s Electric, Thermostatic or Mixer Controlled?	TMV	0
State the cold water supply source to the shower/s	Cold water Storage Tank	0
State the hot water supply source to the shower/s	Domestic HWS	0
Is the shower-head/s clean & free from scale or mould	Shower Head is deteriorated and requires replacing	2
Is the shower/s regularly used	Yes	0
Is there a single blender control serving several showers	No	0
Is the showerhead/s regularly cleaned & disinfected	Yes	0
Mixer Inlet Temp Cold	9.9°C	0
Mixer Inlet Temp Hot	59.6°C	0
Outlet Temp	38°C	0
Overall Risk	2

It is recommended that the disabled shower head is replaced to prevent legionella taking hold (**remedial action 4**).

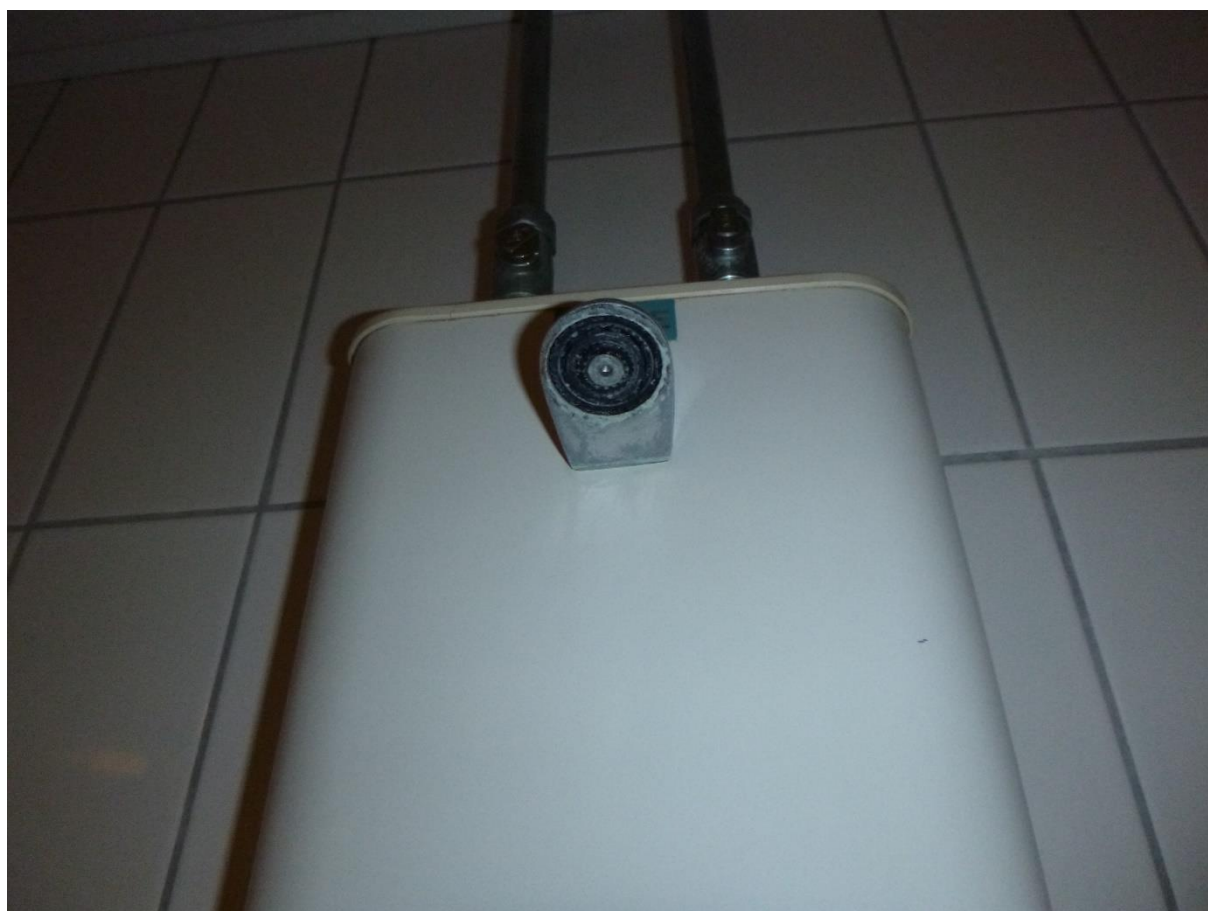
General Information	Risk Comment	Risk
State the Location of the shower/s	Dry-side Male Change	0
State Number of Showers	5	0
Is this an emergency shower/s	No	0
Is the shower/s Electric, Thermostatic or Mixer Controlled?	TMV	0
State the cold water supply source to the shower/s	Cold water Storage Tank (Boosted)	0
State the hot water supply source to the shower/s	Domestic HWS	0
Is the shower-head/s clean & free from scale or mould	No - scale around shower rose and body	2
Is the shower/s regularly used	Yes	0
Is there a single blender control serving several showers	No	0
Is the showerhead/s regularly cleaned & disinfected	Yes	0
Mixer Inlet Temp Cold	10.3°C	0
Mixer Inlet Temp Hot	55.6°C	0
Outlet Temp	~38°C	0
Overall Risk	2
