Report:	Asbestos Survey
Type:	Two (2)

Site:	Depot, Robinson Way, Kettering, NN16 8PQ
Contract:	CO2064-38
Survey Date:	30 th April 2009
Report Date:	1 st May 2009
Client:	Kettering Borough Council, Municipal Offices, Bowling Green Road, Kettering, NN15 7QX

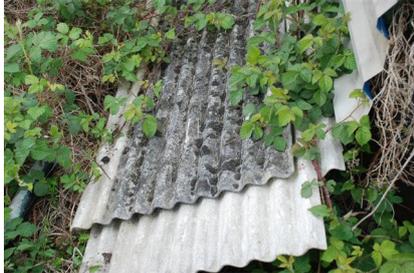
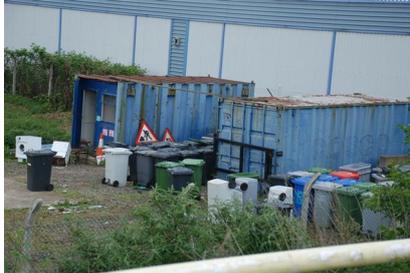
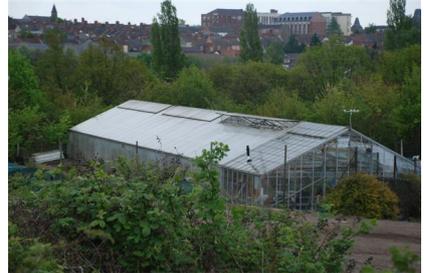
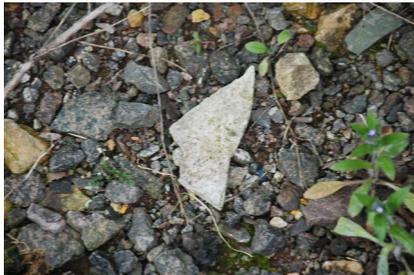
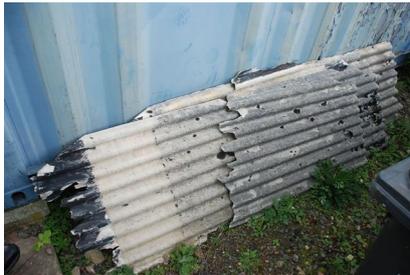
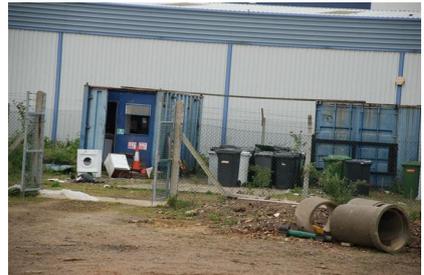
The building was brick at low level with high level metal cladding supported by a steel frame. The roof was metal lined and the rain water products metal and plastic. To the rear of the vehicle workshop there was a chemical and metal store which were metal containers. A walk around the site identified areas of cement sheeting stored behind metal containers.

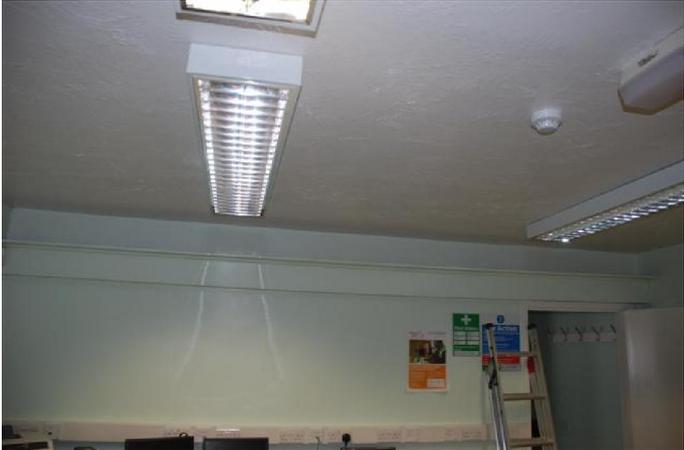
Floor:	First		
Room Area:	Room 5		
Description:	Textured Coating		
Quantity:	22 Square Meters		
Friability:	Low		
Product Type:	(Score 1,2,3 = 1) Textured Coating		
Damage Extent:	(Score 0,1,2,3 = 1) Low		
Surface Treatment:	(Score 0,1,2,3 = 1) Composite		
Asbestos Type:	(Score 1,2,3 = 1) No Asbestos Detected	Re-inspection Due:	N/A
Material Assessment:	Risk Score = 0 No Asbestos Detected	Site UPRN:	N/A
HSE Notifiable:	N/A	Sample Ref:	S01
<u>Comments:</u> Textured coating ceiling to the room 5.			
<u>Recommendations:</u> N/A No asbestos detected within the sample.

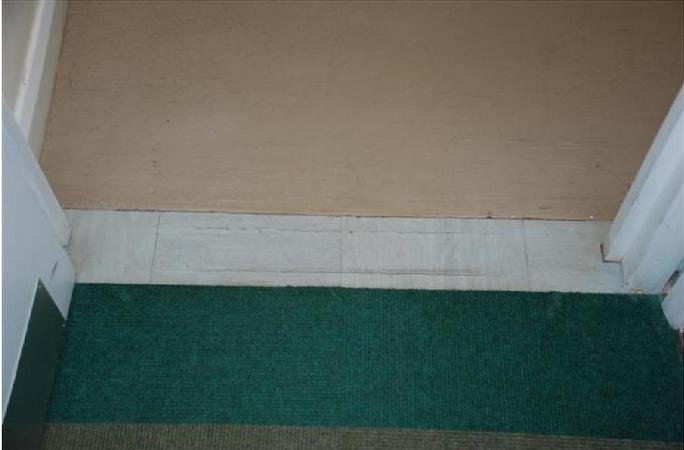
Floor:	First		
Room Area:	Room 7		
Description:	Vinyl Tiles		
Quantity:	1 Square Meters		
Friability:	Low		
Product Type:	(Score 1,2,3 = 1) Vinyl Tiles		
Damage Extent:	(Score 0,1,2,3 = 1) Low		
Surface Treatment:	(Score 0,1,2,3 = 1) Composite	Photograph Ref:	P2
Asbestos Type:	(Score 1,2,3 = 1) No Asbestos Detected	Re-inspection Due:	N/A
Material Assessment:	Risk Score = 0 No Asbestos Detected	Site UPRN:	N/A
HSE Notifiable:	N/A	Sample Ref:	S02
<u>Comments:</u> Small section of vinyl to the corridor section.			
<u>Recommendations:</u> N/A No asbestos detected within the sample.

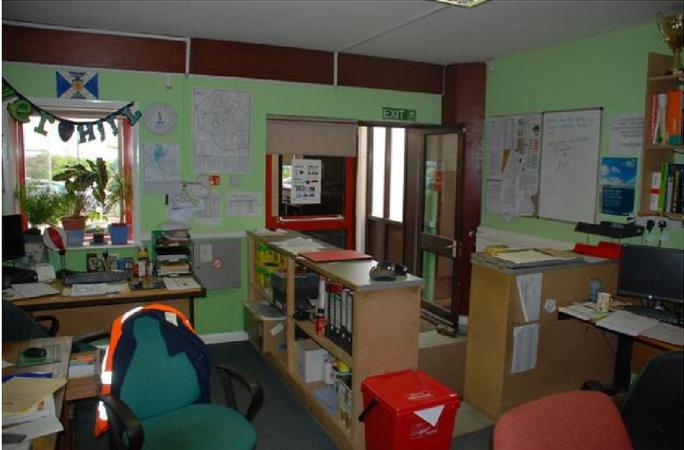
Floor:	Ground		
Room Area:	Room 8		
Description:	Vinyl Tiles		
Quantity:	3 Square Meters		
Friability:	Low		
Product Type:	(Score 1,2,3 = 1) Vinyl Tiles		
Damage Extent:	(Score 0,1,2,3 = 1) Low		
Surface Treatment:	(Score 0,1,2,3 = 1) Composite		
Asbestos Type:	(Score 1,2,3 = 1) No Asbestos Detected	Re-inspection Due:	N/A
Material Assessment:	Risk Score = 0 No Asbestos Detected	Site UPRN:	N/A
HSE Notifiable:	N/A	Sample Ref:	S03
<u>Comments:</u> Vinyl tiles to section of the floor on entrance.			
<u>Recommendations:</u> N/A No asbestos detected within the sample.

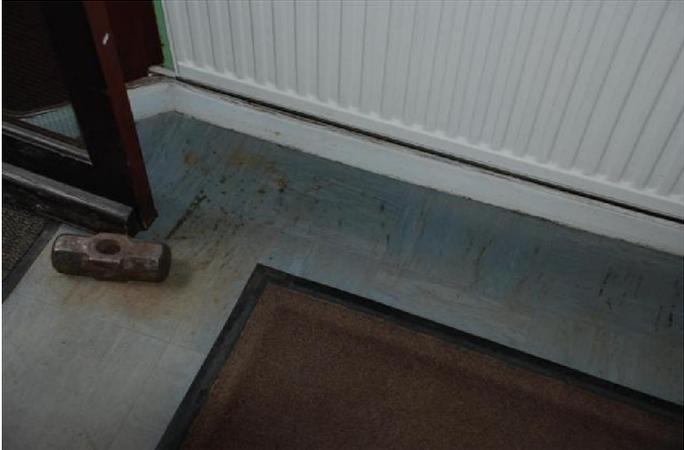
Floor:	Ground		
Room Area:	Room 9		
Description:	Vinyl Tiles		
Quantity:	3 Square Meters		
Friability:	Low		
Product Type:	(Score 1,2,3 = 1) Vinyl Tiles		
Damage Extent:	(Score 0,1,2,3 = 1) Low		
Surface Treatment:	(Score 0,1,2,3 = 1) Composite	Photograph Ref:	P4
Asbestos Type:	(Score 1,2,3 = 1) No Asbestos Detected	Re-inspection Due:	N/A
Material Assessment:	Risk Score = 0 No Asbestos Detected	Site UPRN:	N/A
HSE Notifiable:	N/A	Sample Ref:	S04
<u>Comments:</u> Vinyl tiles to the floor of the room.			
<u>Recommendations:</u> N/A No asbestos detected within the sample.

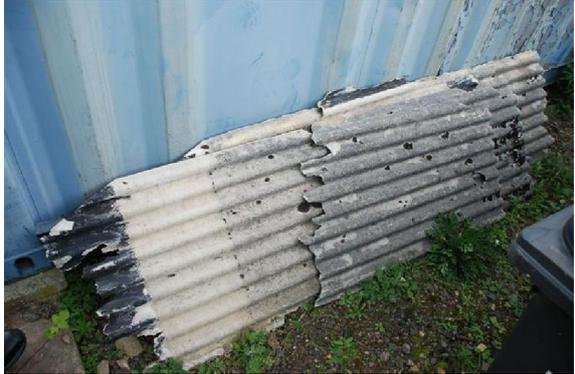
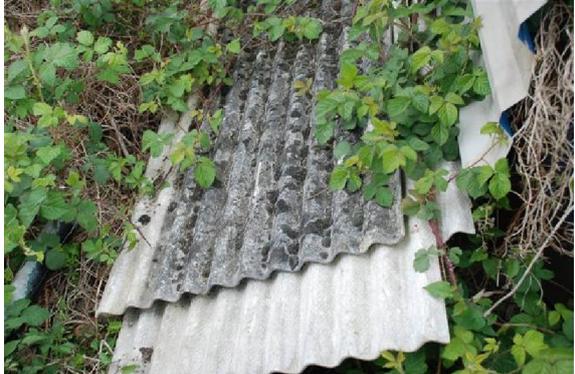
No:	Room / Area:	Product Type:	Asbestos Type:	Extent:	Page:
1	External	Cement Sheeting	Chrysotile (White)	12 Sq Mtrs	17

Floor:	Ground		
Room Area:	External		
Description:	Cement Sheeting		
Quantity:	12 Square Meters		
Friability:	Low		
Product Type:	(Score 1,2,3 = 1) Cement		
Damage Extent:	(Score 0,1,2,3 = 2) Medium		
Surface Treatment:	(Score 0,1,2,3 = 1) Unsealed	Photograph Ref:	P5
Asbestos Type:	(Score 1,2,3 = 1) Chrysotile (White)	Re-inspection Due:	02/04/10
Material Assessment:	Risk Score = 5 Low	Site UPRN:	N/A
HSE Notifiable:	No	Sample Ref:	S05
Comments: Cement roof sheeting stacked in piles in two locations, with associated debris to the floor.			
Recommendations: The asbestos cement is redundant and should be removed, the surrounding area should be inspected and all debris removed.

- 2.4 The current site assessment is 'Low'. This assessment following the recommended remedial work can be reduced to '0' as all the asbestos containing materials identified will be removed from the site.

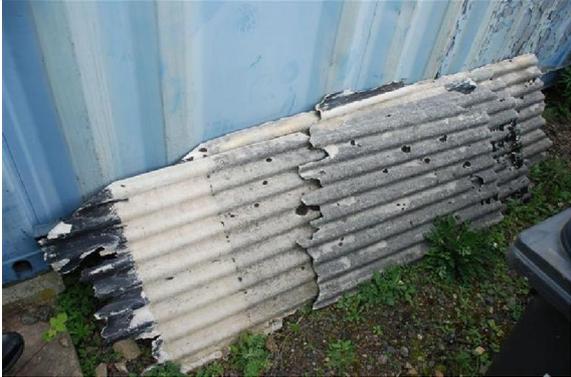
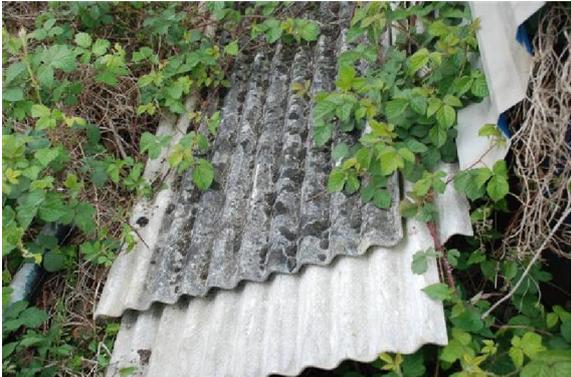
Floor:	Ground				
Room Area:	External				
Description:	Cement Sheetting				
Quantity:	12 Square Meters				
Friability:	Low				
Product Type:	(Score 1,2,3 = 1) Cement				
Damage Extent:	(Score 0,1,2,3 = 2) Medium				
Surface Treatment:	(Score 0,1,2,3 = 1) Unsealed	Photograph Ref:	P5		
Asbestos Type:	(Score 1,2,3 = 1) Chrysotile (White)	Re-inspection Due:	02/04/10		
Material Assessment:	Risk Score = 5 Low	Site UPRN:	N/A		
HSE Notifiable:	No	Sample Ref:	S05		
Re-inspection or remedial work undertaken:		Consultant / Contractor Involved:		Date work undertaken:
