**Partial Refurbishment/ Management Survey  
For asbestos containing materials and material risk  
assessment at:**

**Kings Bromley Village Hall  
Kings Bromley  
Burton Upon Trent**

<b>Report No.</b>	
SR340163

<b>Date:</b>	
29th October 2018

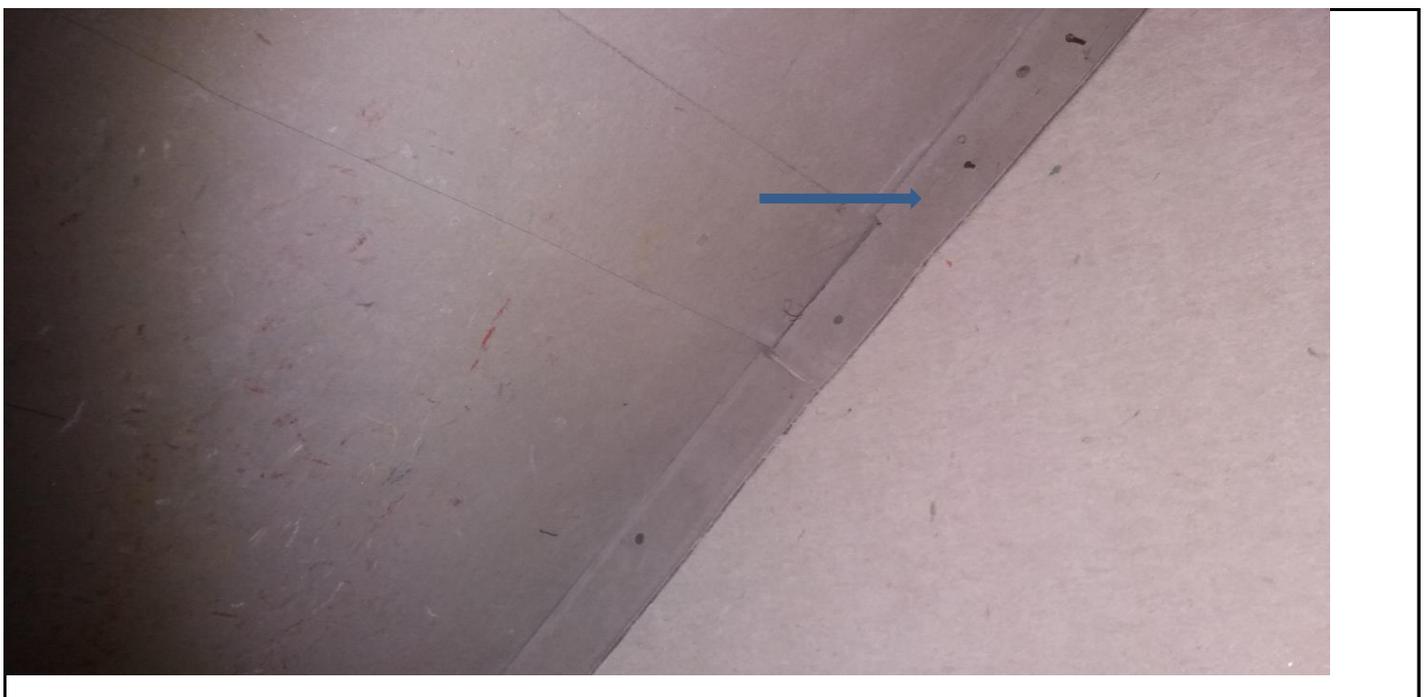
<b>Client:</b>	Kings Bromley Village Hall	<b>Report Number:</b>	SR340163
<b>Location Address:</b>	Kings Bromley Village Hall Kings Bromley	<b>Survey Date:</b>	29th October 2018
		<b>Sample Taken:</b>	Yes
		<b>Analyst:</b>	EML
<b>Survey By:</b>	Andrea Bysh		
<b>Area/Location:</b>	Under Stairs		
<b>Position:</b>	Ceiling		
<b>Item/Material:</b>	Fillet Board

<b>Sample Number:</b>	002	<b>Analysis:</b>	No asbestos detected	<b>Analysis Date:</b>	6th November 2018
-----------------------	-----	------------------	----------------------	-----------------------	-------------------

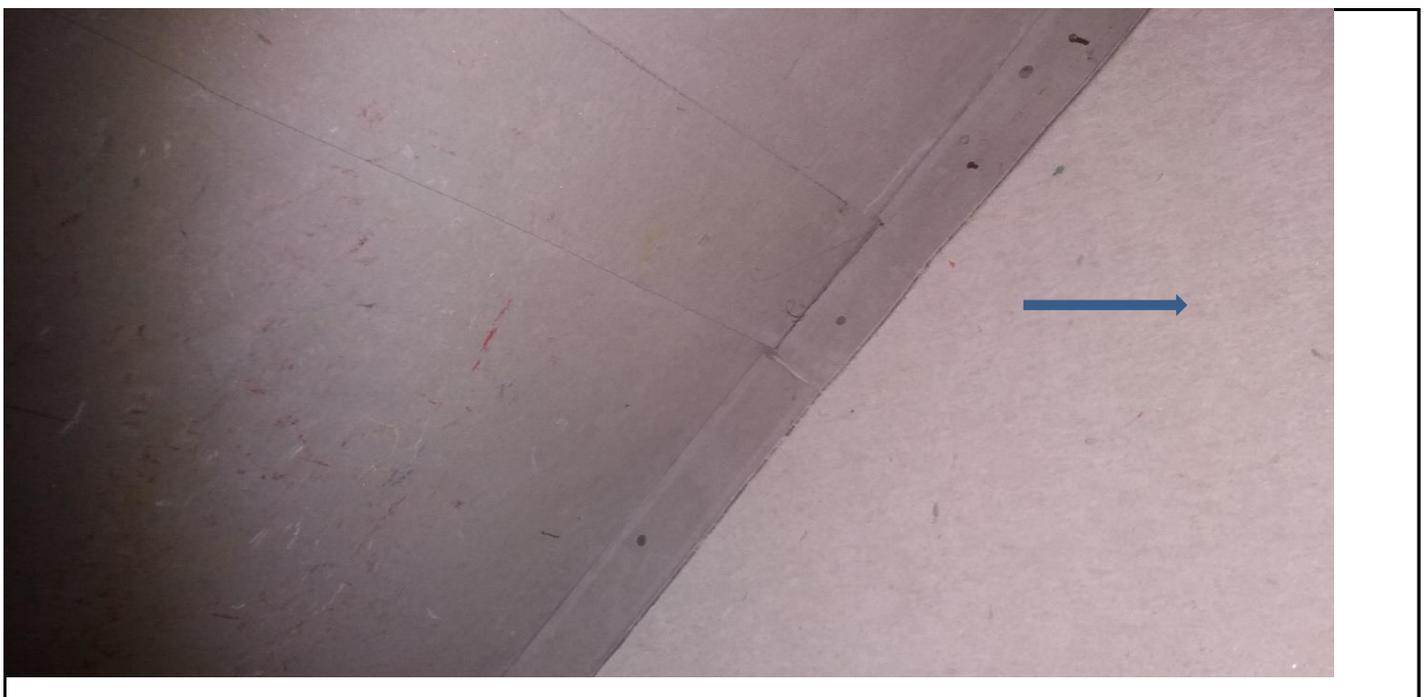
<b>Client:</b>	Kings Bromley Village Hall	<b>Report Number:</b>	SR340163
<b>Location Address:</b>	Kings Bromley Village Hall Kings Bromley	<b>Survey Date:</b>	29th October 2018
		<b>Sample Taken:</b>	Yes
		<b>Analyst:</b>	EML
<b>Survey By:</b>	Andrea Bysh		
<b>Area/Location:</b>	Under Stairs		
<b>Position:</b>	Ceiling & Walls		
<b>Item/Material:</b>	Light Board

<b>Sample Number:</b>	003	<b>Analysis:</b>	No asbestos detected	<b>Analysis Date:</b>	6th November 2018
-----------------------	-----	------------------	----------------------	-----------------------	-------------------

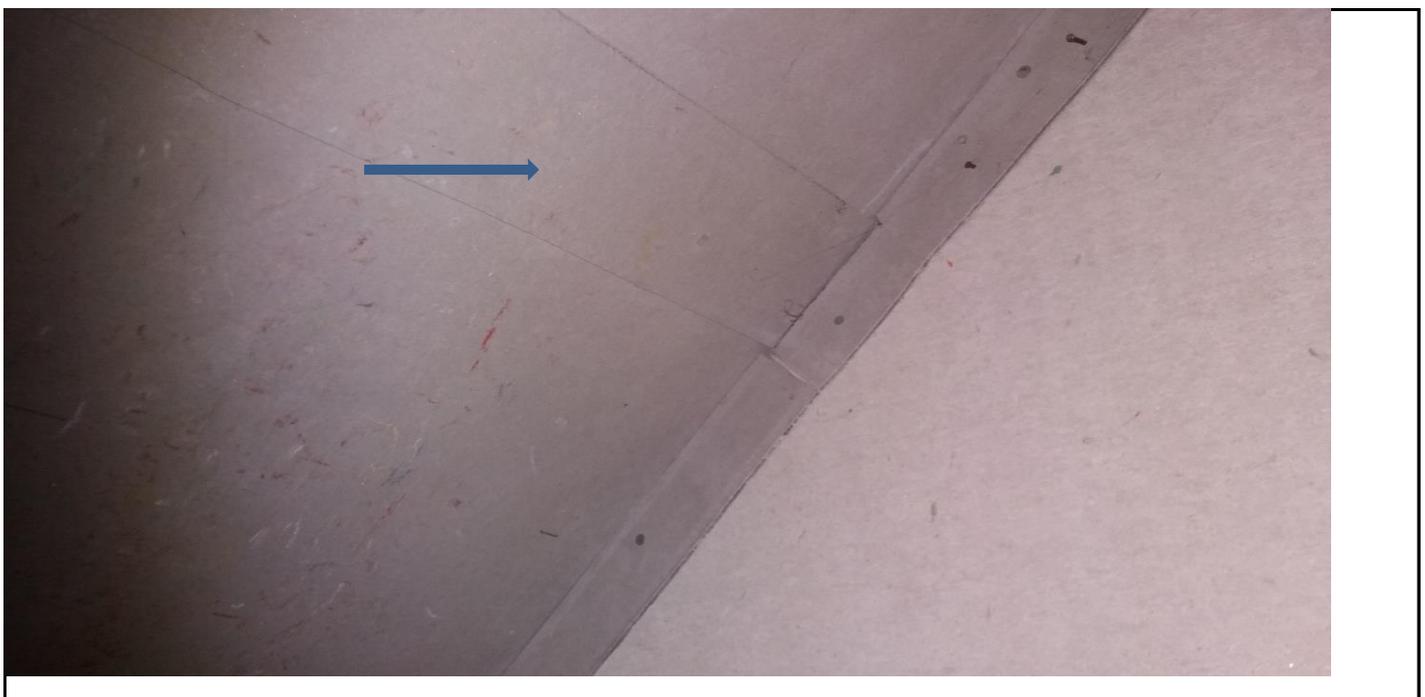
<b>Client:</b>	Kings Bromley Village Hall
<b>Location Address:</b>	Kings Bromley Village Hall Kings Bromley
<b>Survey By:</b>	Andrea Bysh
<b>Area/Location:</b>	Under Stairs
<b>Position:</b>	Ceiling & Walls
<b>Item/Material:</b>	Dark Board

<b>Sample Number:</b>	004	<b>Analysis:</b>	No asbestos detected	<b>Analysis Date:</b>	6th November 2018
-----------------------	-----	------------------	----------------------	-----------------------	-------------------

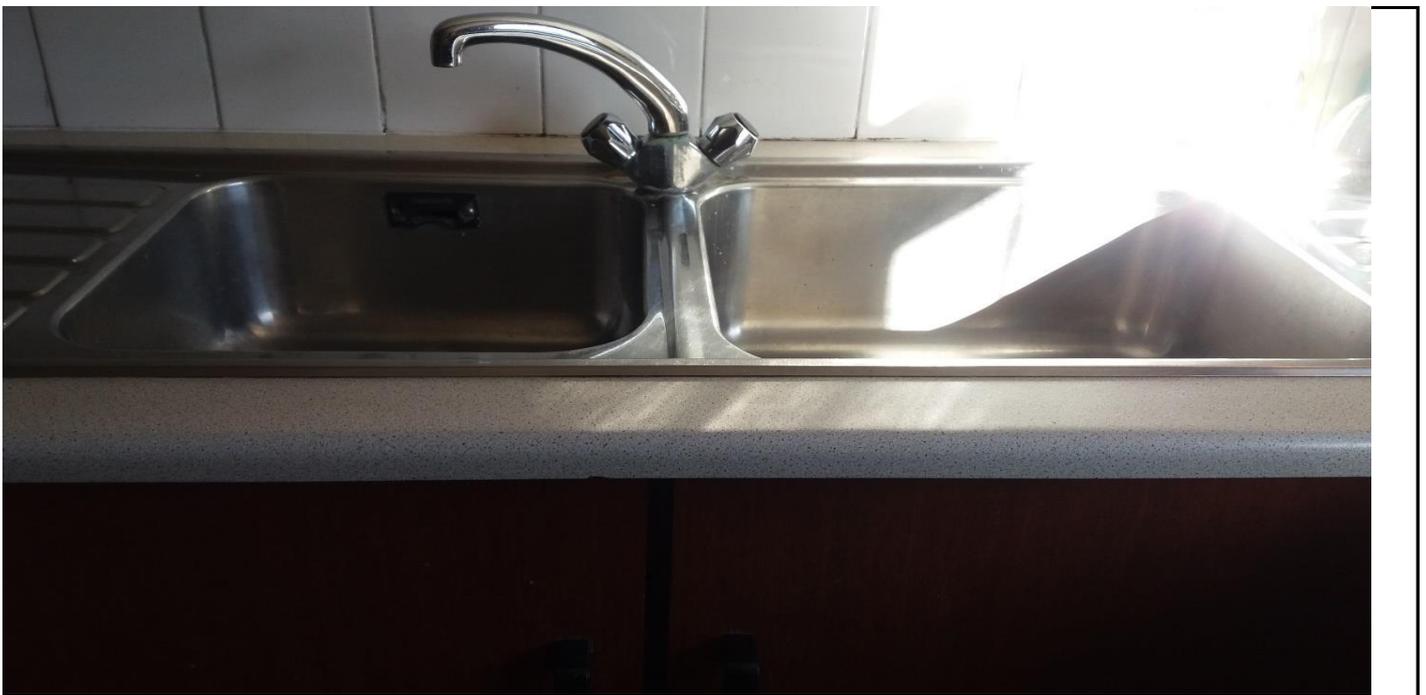
<b>Client:</b>	Kings Bromley Village Hall	<b>Report Number:</b>	SR340163
<b>Location Address:</b>	Kings Bromley Village Hall Kings Bromley	<b>Survey Date:</b>	29th October 2018
		<b>Sample Taken:</b>	Yes
		<b>Analyst:</b>	EML
<b>Survey By:</b>	Andrea Bysh		
<b>Area/Location:</b>	Kitchen		
<b>Position:</b>	Sink		
<b>Item/Material:</b>	Sink Pad

<b>Sample Number:</b>	005	<b>Analysis:</b>	Chrysotile	<b>Analysis Date:</b>	6th November 2018
-----------------------	-----	------------------	------------	-----------------------	-------------------

Product Type		Extent of Damage		Surface Treatment		Asbestos Type		Material Score
Plastic/ Resin/AC/TC	1	Good / No Damage	0	Plastics / Resin	0	Chrysotile	1	3
AIB/ Millboard/ Woven/Paper	2	Low scratches / broken edge	1	AC / Painted AIB / Enclosed Ins/spray	1	Amosite	2	
Insulation / Spray Coating	3	Medium - Broken boards/ debris	2	Unsealed AIB/ Sealed ins/spray	2	Crocidolite	3	Asbestos Sink Pad
		High Damage - Insulation/ Spray debris	3	Unsealed Ins/spray	3			
1		1		0		1

<b>Comments:</b>	Removal is classed as non licensed asbestos removal
------------------	---

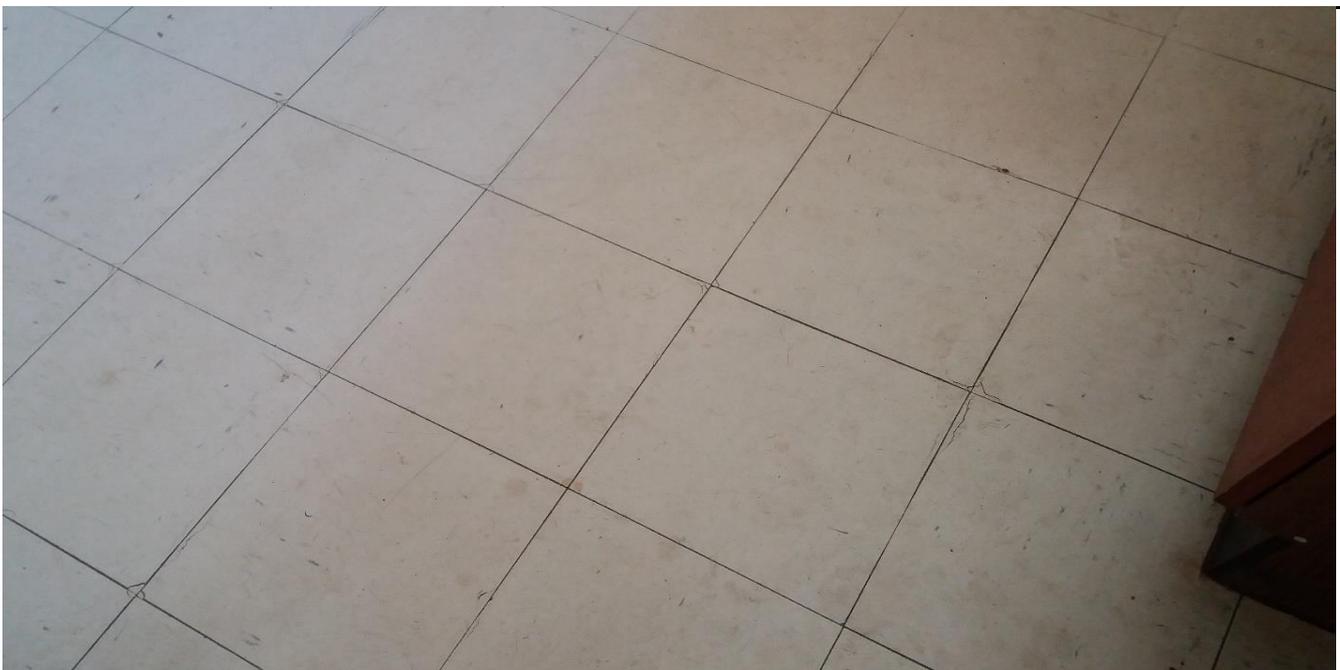
<b>Client:</b>	Kings Bromley Village Hall	<b>Report Number:</b>	SR340163
<b>Location Address:</b>	Kings Bromley Village Hall Kings Bromley	<b>Survey Date:</b>	29th October 2018
		<b>Sample Taken:</b>	Yes
		<b>Analyst:</b>	EML
<b>Survey By:</b>	Andrea Bysh		
<b>Area/Location:</b>	Kitchen		
<b>Position:</b>	Floor		
<b>Item/Material:</b>	Floor Tiles and Adhesive

<b>Sample Number:</b>	006	<b>Analysis:</b>	Chrysotile	<b>Analysis Date:</b>	6th November 2018
-----------------------	-----	------------------	------------	-----------------------	-------------------

Product Type		Extent of Damage		Surface Treatment		Asbestos Type		Material Score
Plastic/ Resin/AC/TC	1	Good / No Damage	0	Plastics / Resin	0	Chrysotile	1	<b>3</b>
AIB/ Millboard/ Woven/Paper	2	Low scratches / broken edge	1	AC / Painted AIB / Enclosed Ins/spray	1	Amosite	2	
Insulation / Spray Coating	3	Medium - Broken boards/ debris	2	Unsealed AIB/ Sealed ins/spray	2	Crocidolite	3	
		High Damage - Insulation/ Spray debris	3	Unsealed Ins/spray	3			
<b>1</b>		<b>1</b>		<b>0</b>		<b>1</b>		<b>Asbestos Adhesive</b>

<b>Quantity:</b>	50m2
------------------	------

<b>Recommendations:</b>	Same tiles present in store room and toilets
-------------------------	--

<b>Comments:</b>	Removal is classed as non licensed asbestos removal
------------------	---

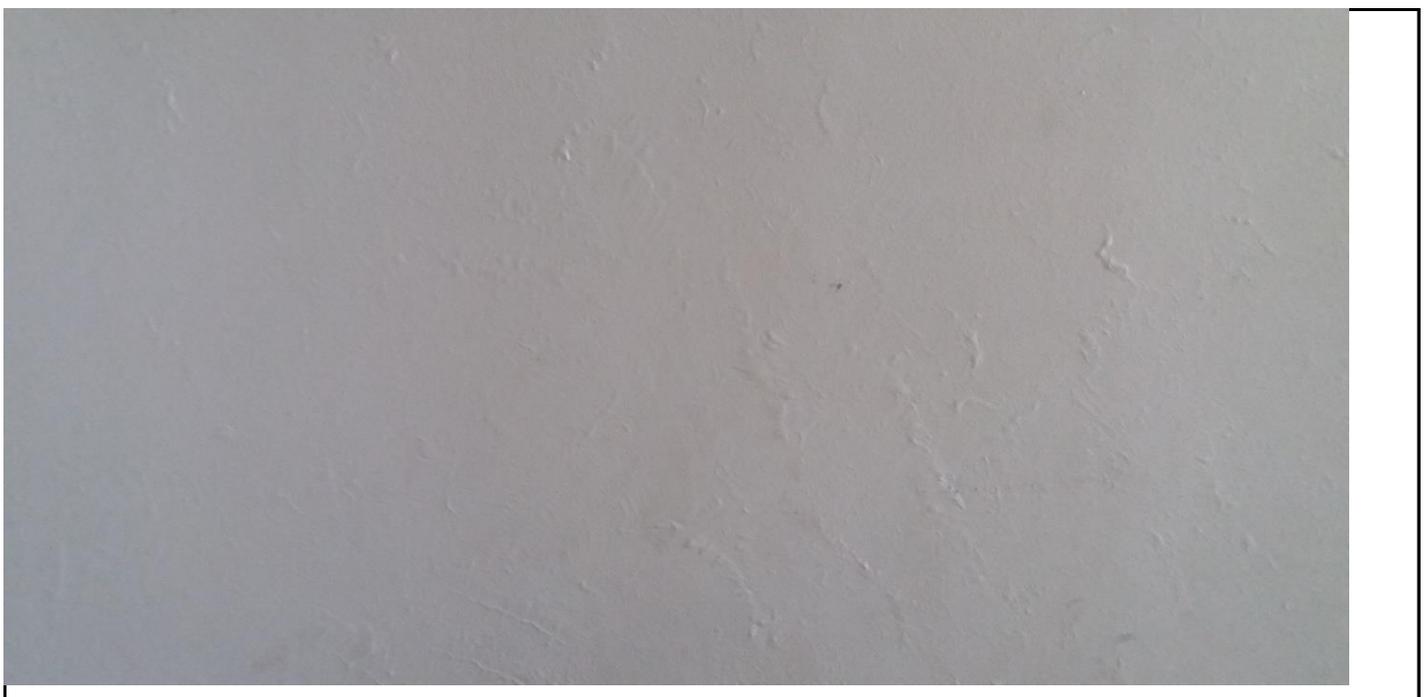
<b>Client:</b>	Kings Bromley Village Hall	<b>Report Number:</b>	SR340163
<b>Location Address:</b>	Kings Bromley Village Hall Kings Bromley	<b>Survey Date:</b>	29th October 2018
		<b>Sample Taken:</b>	Yes
		<b>Analyst:</b>	EML
<b>Survey By:</b>	Andrea Bysh		
<b>Area/Location:</b>	Ladies		
<b>Position:</b>	Wall		
<b>Item/Material:</b>	Textured Coating

<b>Sample Number:</b>	007	<b>Analysis:</b>	No asbestos detected	<b>Analysis Date:</b>	6th November 2018
-----------------------	-----	------------------	----------------------	-----------------------	-------------------

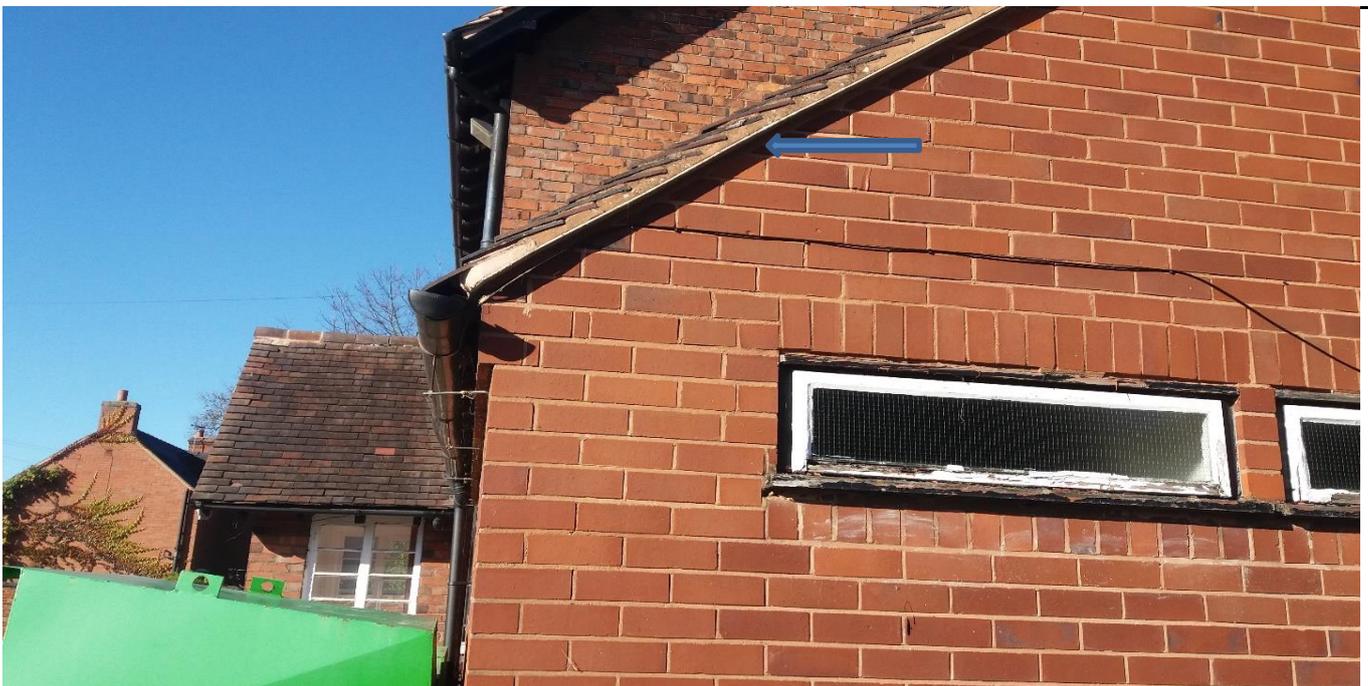
<b>Client:</b>	Kings Bromley Village Hall	<b>Report Number:</b>	SR340163
<b>Location Address:</b>	Kings Bromley Village Hall Kings Bromley	<b>Survey Date:</b>	29th October 2018
		<b>Sample Taken:</b>	Yes
		<b>Analyst:</b>	EML
<b>Survey By:</b>	Andrea Bysh		
<b>Area/Location:</b>	External		
<b>Position:</b>	Roof Line		
<b>Item/Material:</b>	Under Cloaking

<b>Sample Number:</b>	008	<b>Analysis:</b>	No asbestos detected	<b>Analysis Date:</b>	6th November 2018
-----------------------	-----	------------------	----------------------	-----------------------	-------------------
