Road	M69	Link & Section	2400M69/156	Location	Drawing number - HE601892-KIER-VGN-M69_ML_M1_JN1_B-DE-CH-0000-08				Length (m)	1019	VCS undertaken by	Date	00/00/0000
------	-----	----------------	-------------	----------	--	--	--	--	------------	------	-------------------	------	------------

Visual Survey Key												
Cracking	Reinstatement /patching	Fretting	Crazing	Pothole	Open joint	Construction Joint	Rutting/ depression	Core	Loops	Nodes	G - GULLY OG - OFFSET KG - KERB	Deflectograph

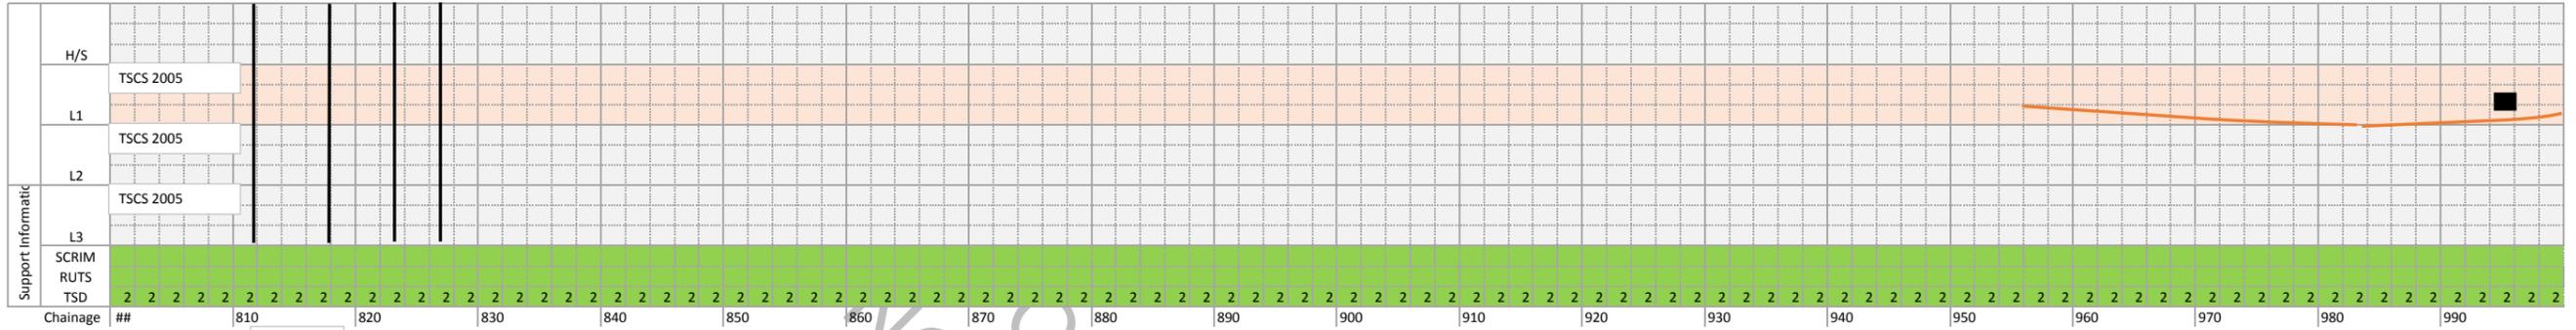
C51a, 51 & 52

Asphaltic plug joints

Repeating Defect over several years/ repairs
