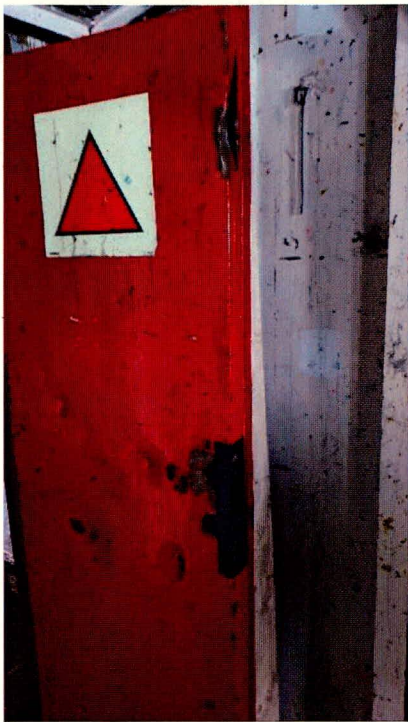
TASK NO.	TASK/DESCRIPTION	NOTES
	H8 INTERNAL DECKS, DOORS AND LADDERS	
H8.02	<p>Galley Doors</p>

<p>The main steel galley access doors (x3) have been damaged and the latching mechanism no longer functions correctly. Doors to be REFURBISHED. If unable to repair then new doors to be supplied and RENEWED.</p>

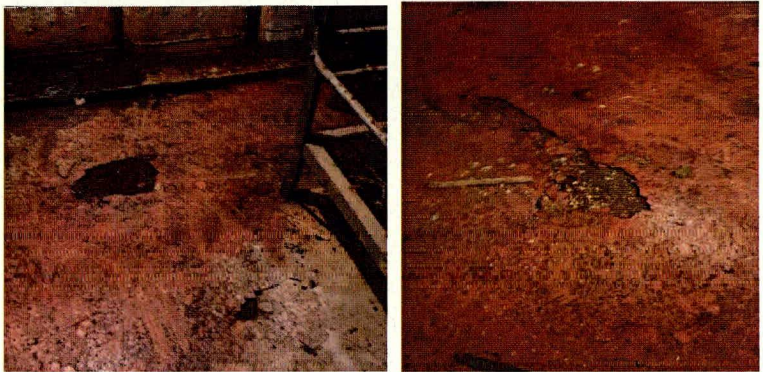
TASK NO.	TASK/DESCRIPTION		NOTES
	H8	INTERNAL DECKS, DOORS AND LADDERS	
H8.04	Stbd Troop Accommodation Compartment Deck

<p>Following a compartment flood, the deck screed has broken down in certain areas. Damaged screed to be removed to SURVEY steel deck below. Compartment requires confirmed dry (possible dehumidifiers required) with screed RENEWED and REPRESENTED on completion.</p> <p>ALLOW for 6m² screed RENEWAL. ALLOW for 6m² REPRESENTATION.</p>		<p>Adequate ventilation to be arranged before work commences IAW General 3.2.</p> <p>IAW Paint scheme -General 12 and Annex B refer.</p>

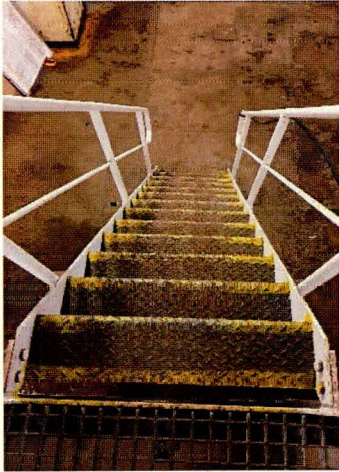
TASK NO.	TASK/DESCRIPTION	NOTES
	H8 INTERNAL DECKS, DOORS AND LADDERS	
H8.05	<p>Tank Deck Training Area Ladders</p>

<p>Both tank deck gantry access ladders showing breakdown of paint coverings. REPRESENT both ladders.</p> <p>ALLOW for 5m² REPRESENTATION.</p>	IAW Paint scheme -General 12 and Annex B refer.

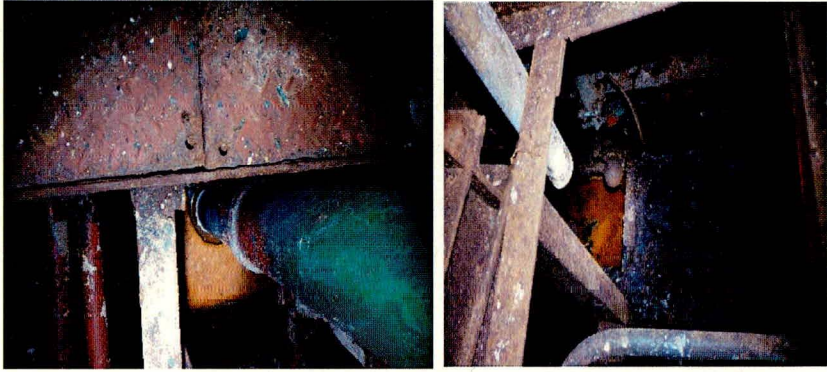
TASK NO.	TASK/DESCRIPTION	NOTES
	H8 INTERNAL DECKS, DOORS AND LADDERS	
H8.06	<p>Main Engine Room Deckplates</p> <div data-bbox="406 470 1236 840">

</div> <p>Engine room deckplates are loose in many areas and require re-securing. Some deckplates are missing. All loose items currently blocking access throughout engine room walkways are to be removed and disposed of. Deckplates to be re-secured and missing deckplates manufactured and replaced with comparable checker-plate to current fit.</p> <p>ALLOW for 80 man hours. ALLOW for 15m² deckplate replacement.</p>

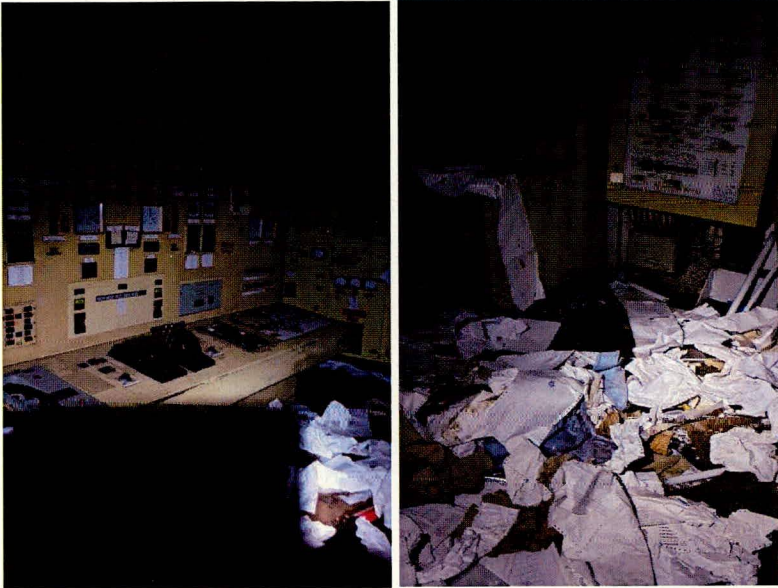
TASK NO.	TASK/DESCRIPTION	NOTES
	H8 INTERNAL DECKS, DOORS AND LADDERS	
H8.07	<p>Machinery Control Room</p> <div data-bbox="399 468 1181 1052">

</div> <p>The Machinery Control Room (MCR) is currently not used for training purposes and contains a large amount of unused material. Contractor is to remove and dispose of all loose material to allow it to become a the training zone.</p>	<p>To be done in conjunction with L1.02 – Training Zone Lighting</p>
