STRUCTURAL INSPECTION

**SAXON HALL,
THORPE ST,
RAUNDS,
NN9 6LT.**

Reference: 24 / 55514

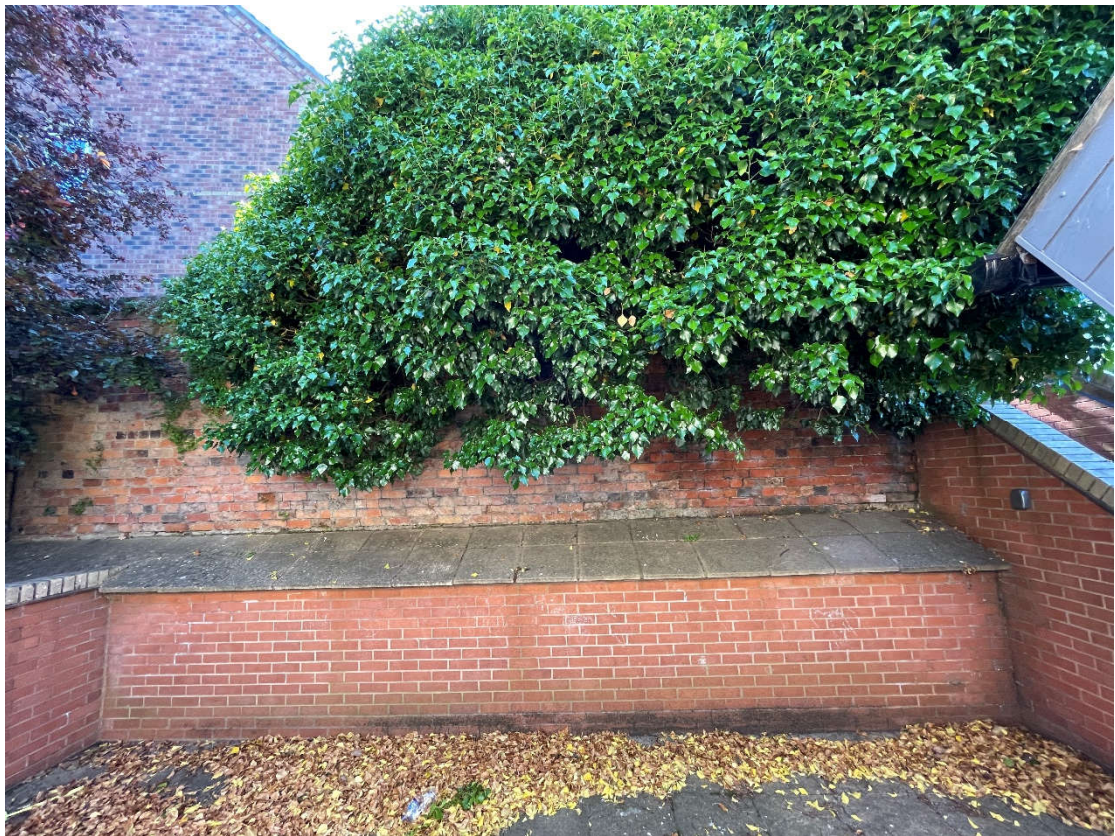
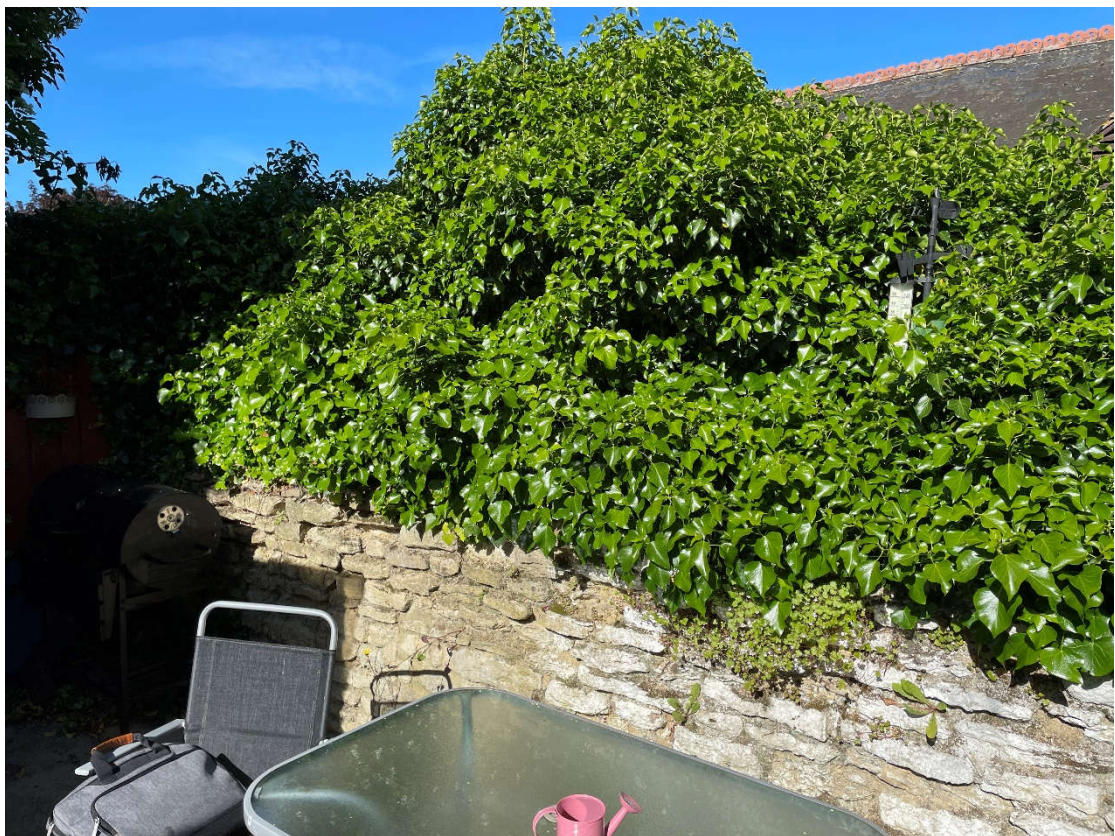
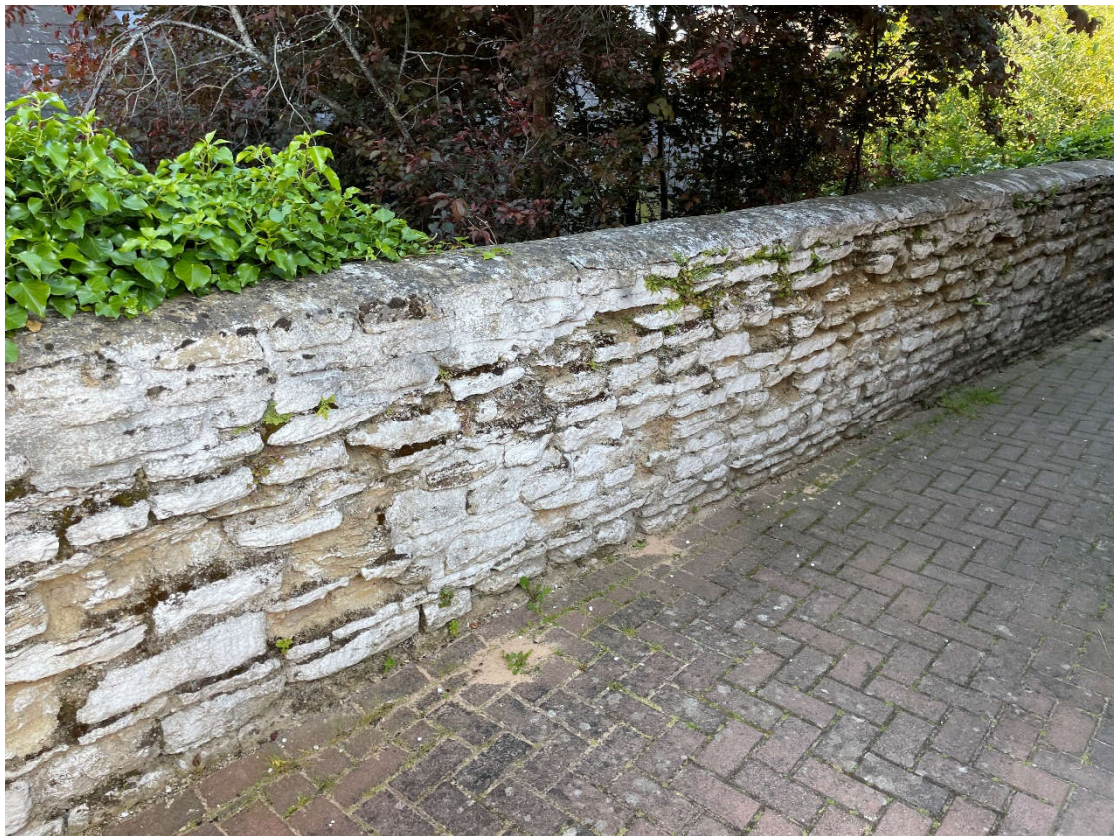
2.3 Refer to Photographs 1 - 3 in Appendix A for the overview pictures of the areas inspected.

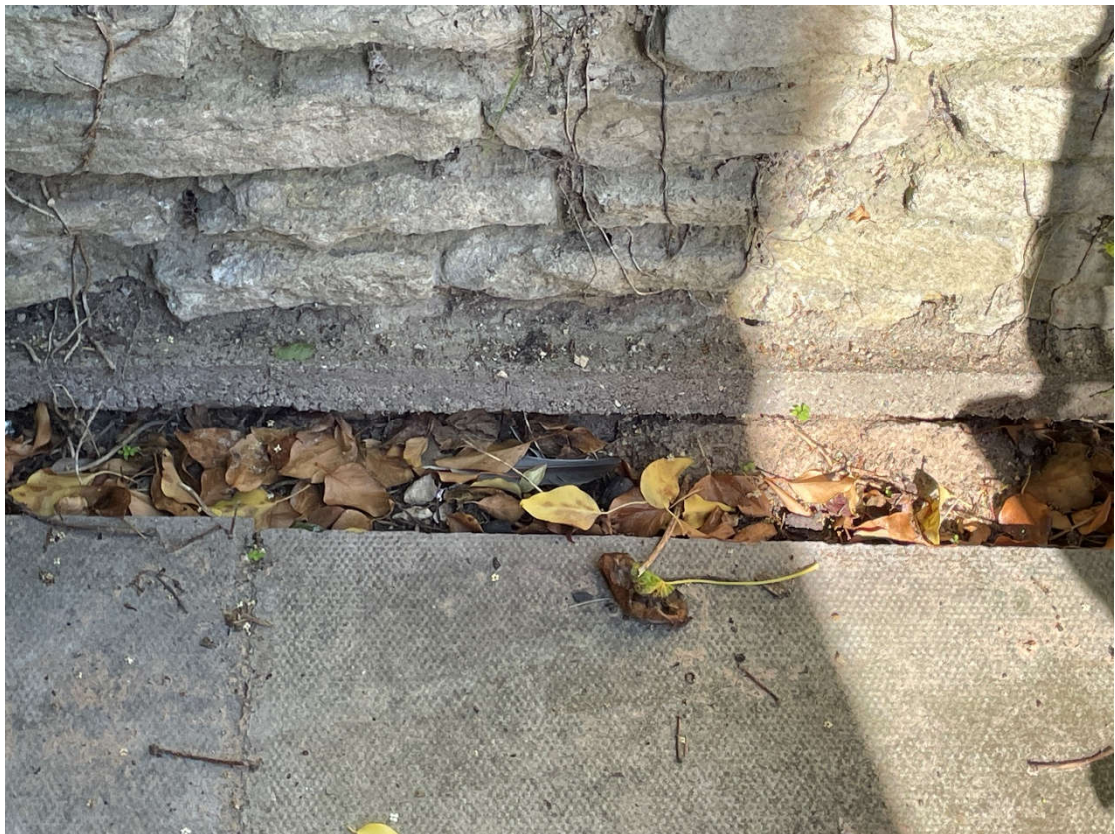
Photograph 4

- 4.1.1 Several defects were noted within the upper portion of the wall. A portion of the ground level had dipped approximately 90.00 mm. This dip in the ground coincided with the large bulge that is visible from the lower level of the wall. Refer to Photo 4 in Appendix A.

- 5.1 In our opinion the defects noted within the report show signs of movement within the wall, specifically in the area where the bulge is located. This area should be propped and the large ivy bush that is situated on the wall removed. This will alleviate some of the stress on the wall.
- 5.2 It is recommended to implement a soil nailing and plating remediation to effectively anchor the wall into the supporting soil behind it.
- 5.3 The defective masonry should be replaced with similar masonry and mortar, where possible.

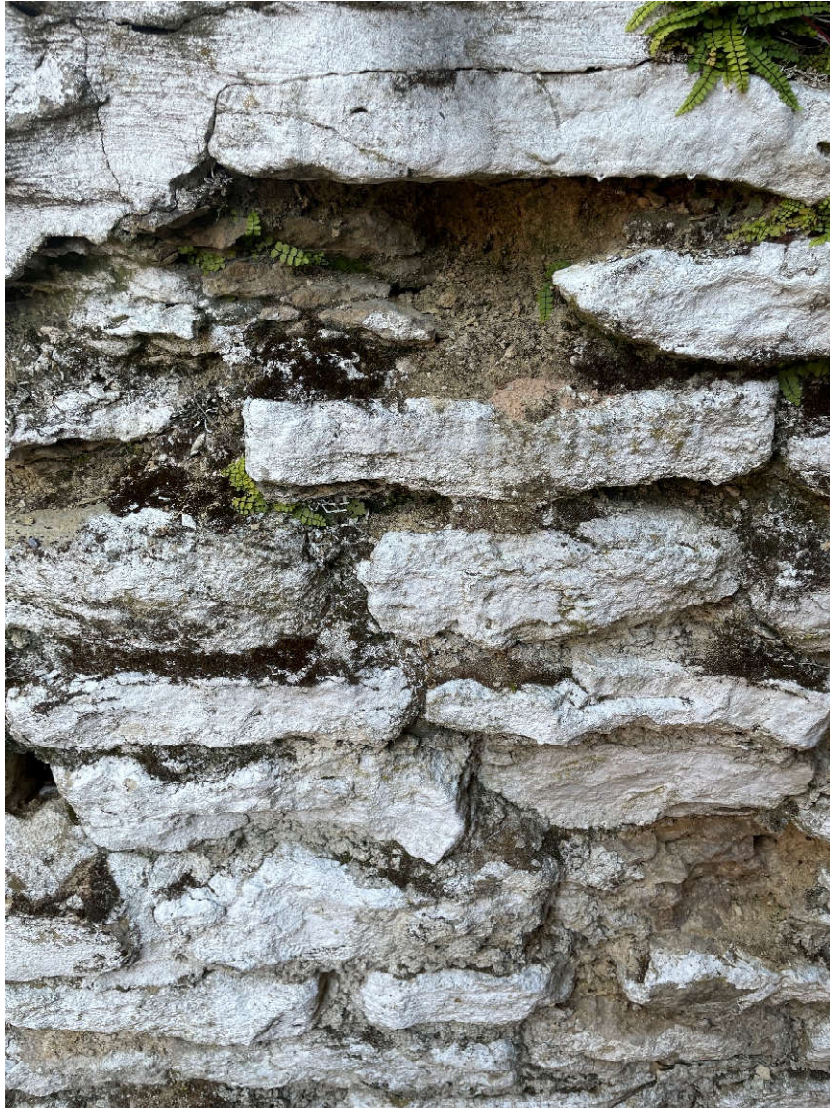
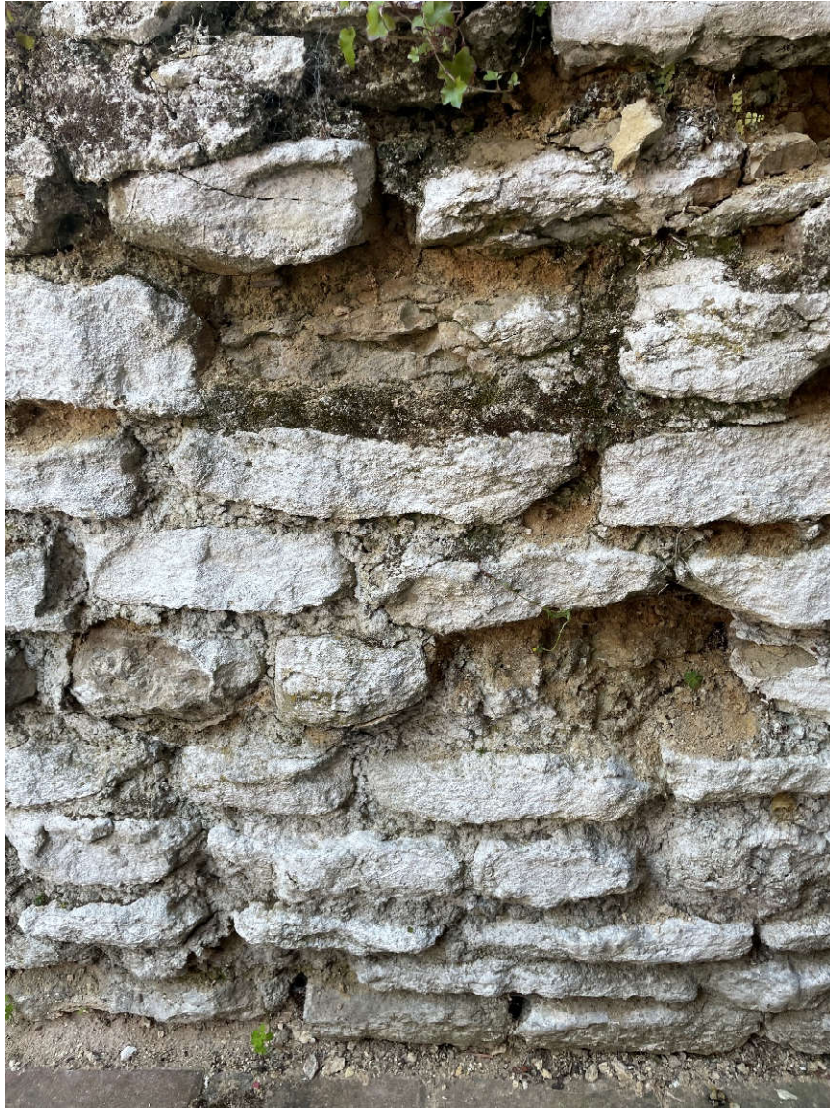
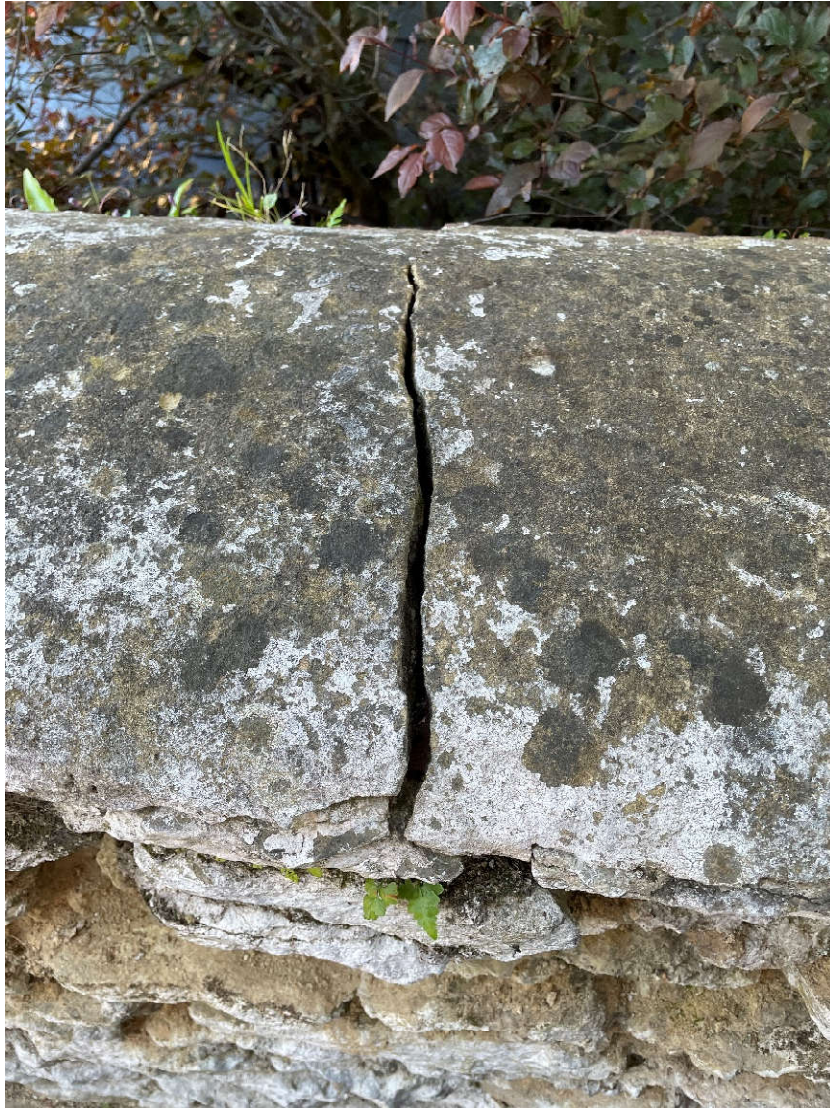
- 4.1.2 There were sections of loose and weathered stone visible at the top level of the retaining wall. Within the top of the coping of the wall a large crack was visible, this was in the approximate location of the start of the bulge within the wall. Refer to Photo 5 - 7 in Appendix A.

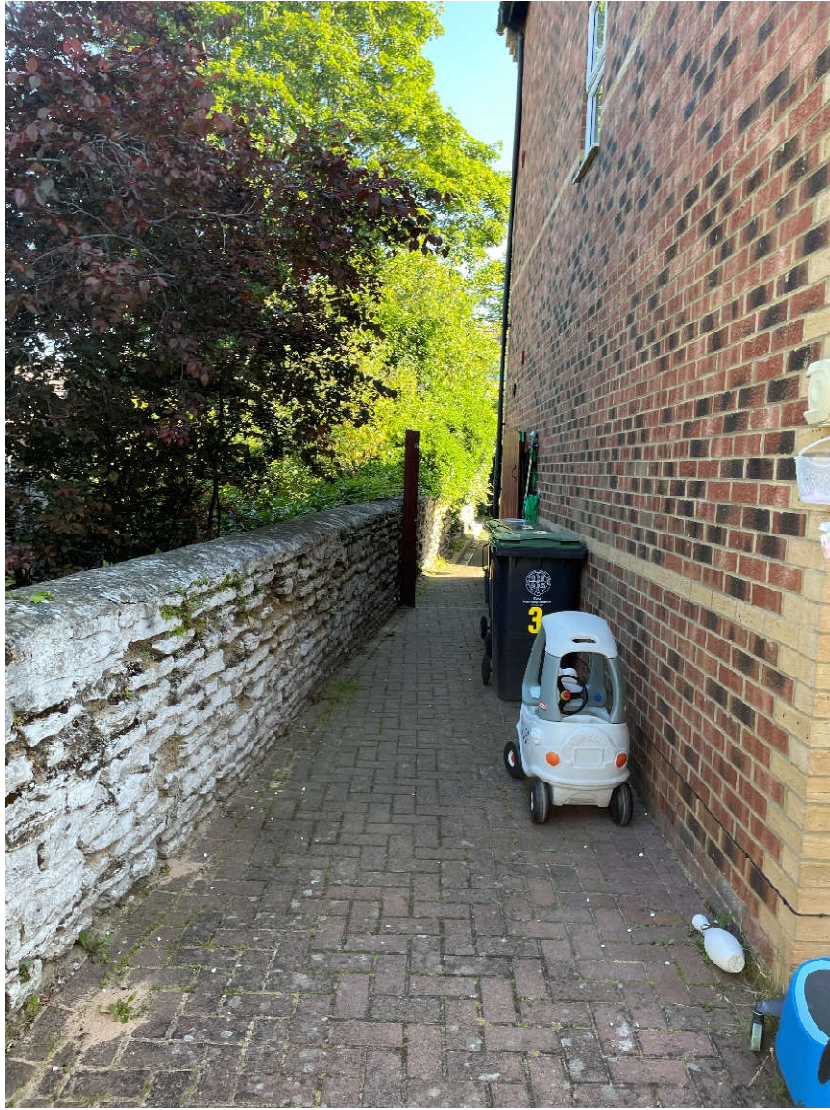
Photograph 8

- 4.1.3 The house that is closest to the retaining wall is approximately 1.00m from the wall at the front of the property and 2.00m at the rear. This house is circa 20 years old. Refer to Photo 8 in Appendix A.

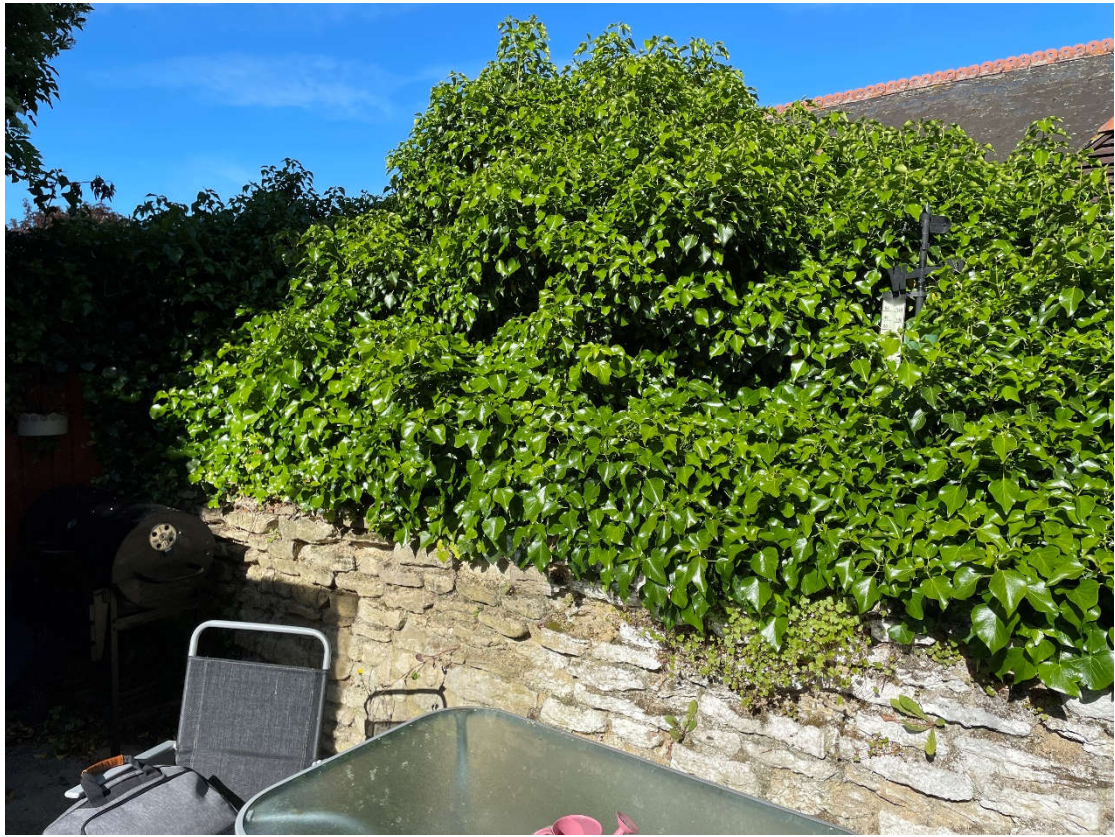
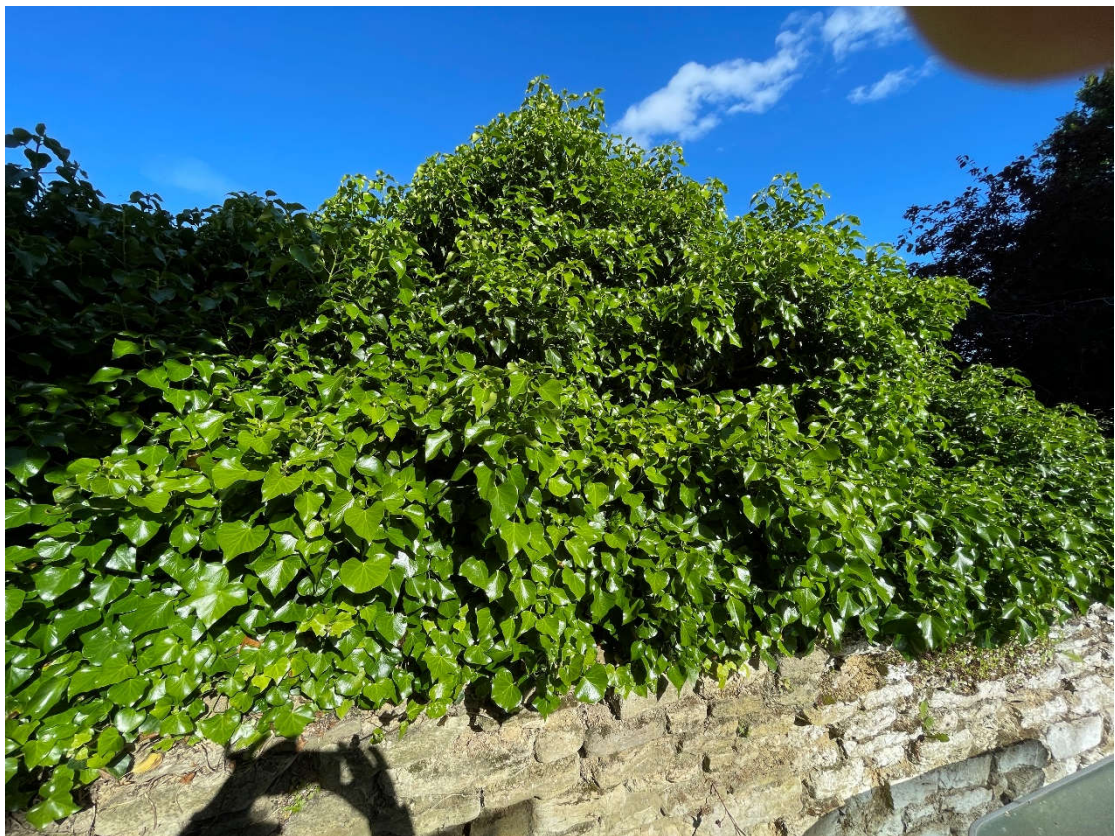
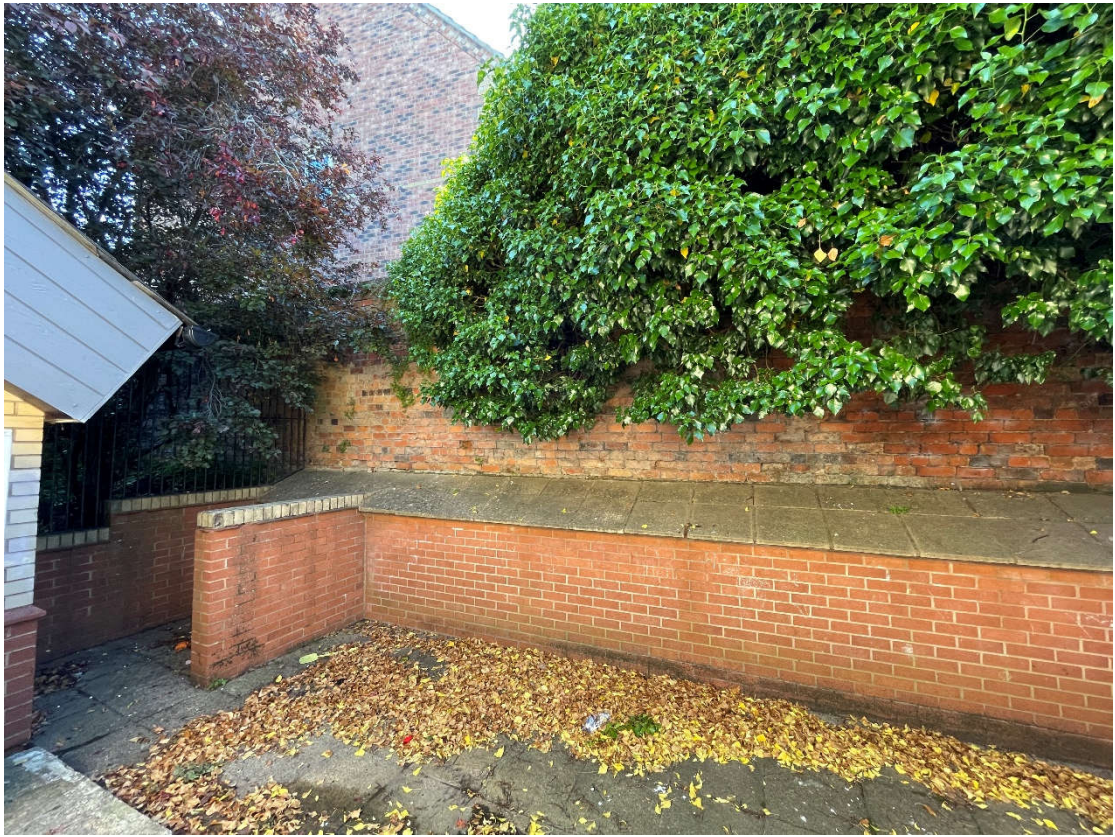
- 4.1.4 An ivy bush of significant size has grown along above and over the wall, this vegetation is thought to be causing stress to the retaining wall. Refer to Photo 9 - 11 in Appendix A.

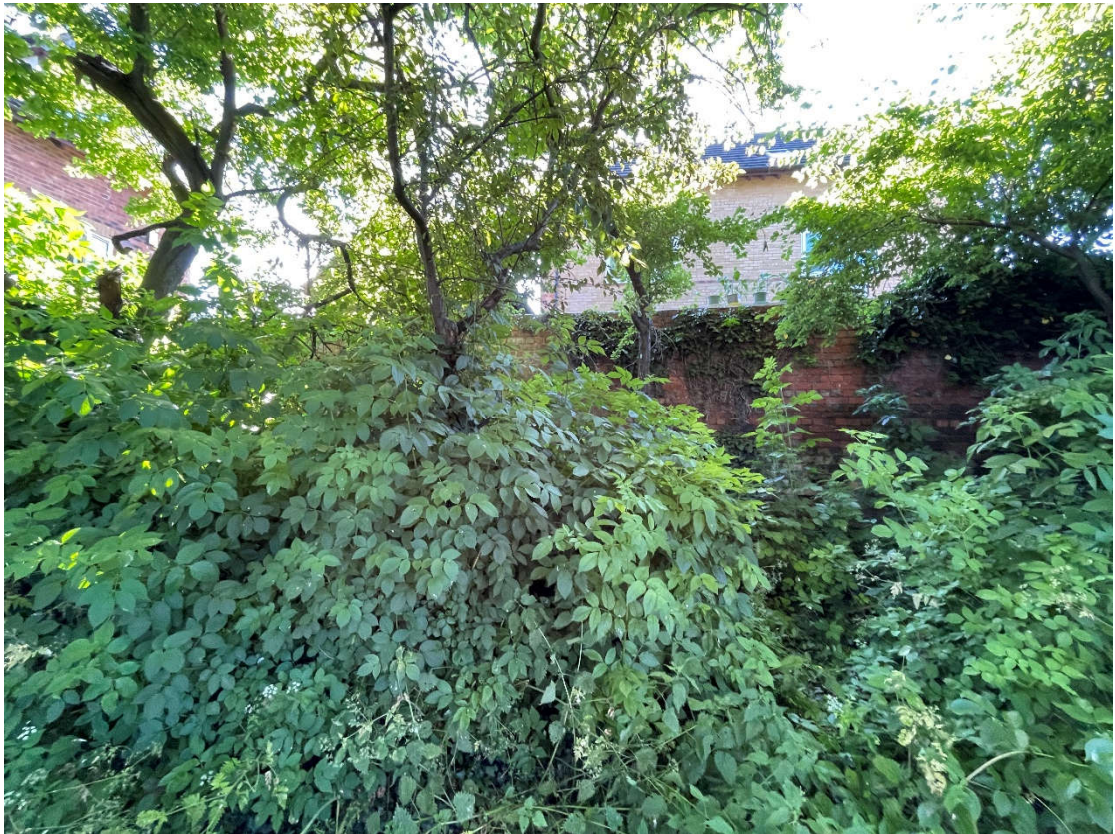
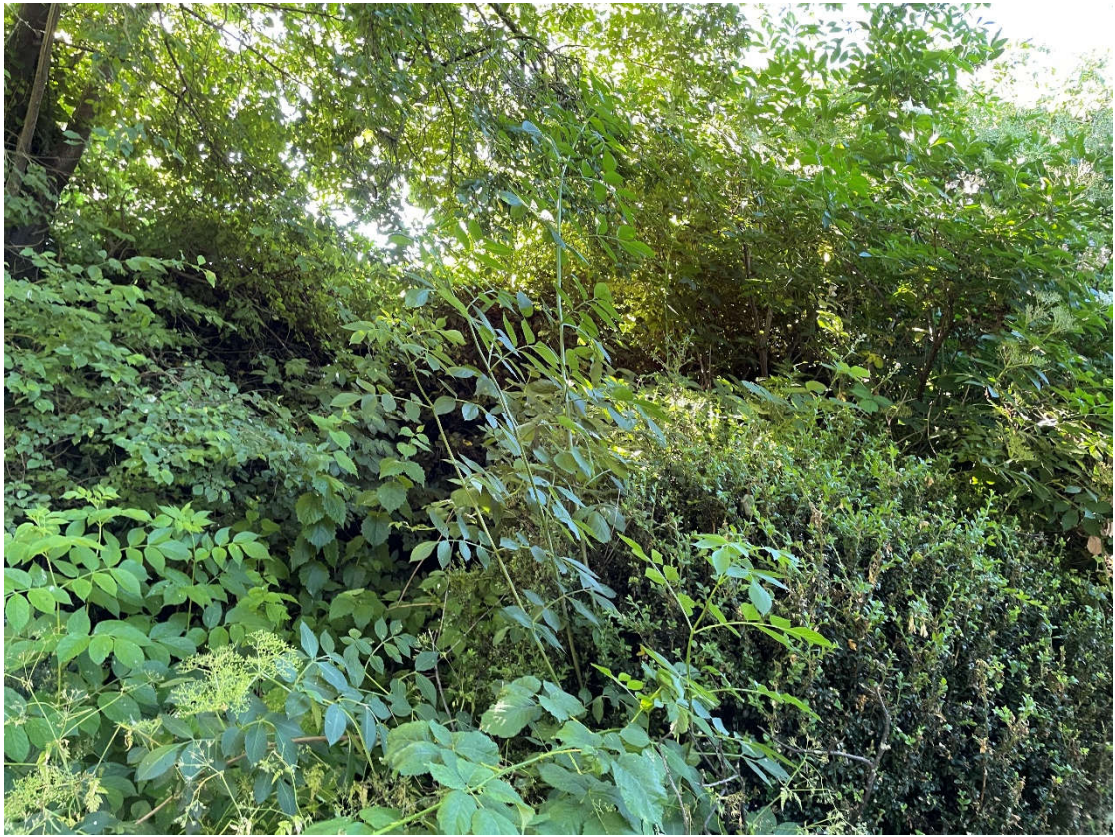
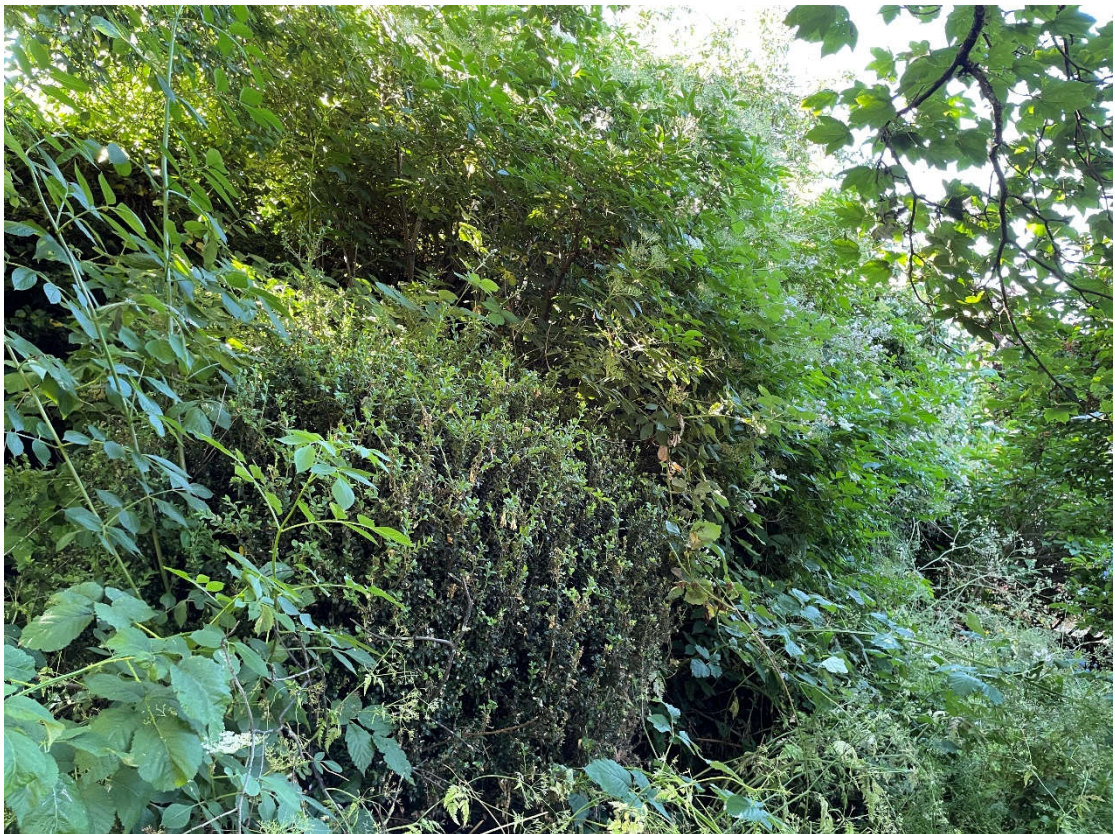
- 4.2 Lower Level – The lower face of the retaining wall is constructed of solid masonry, a large portion of the lower wall is inaccessible due to vegetation situated at the front of the retaining wall. Refer to Photo 12 - 14 in Appendix A.
- 4.2.1 Where the wall was accessible in the green area / terrace several masonry defects were visible within the wall. The lower portion of the wall had significant staining to the face of the wall. Refer to Photo 15 - 16 in Appendix A.
- 4.2.2 A large bulge was visible within the retaining wall at the midpoint of the upper section of wall. This is situated in the service area behind Saxon Hall. The ivy is of significant size in this area. Refer to Photo 17 - 18 in Appendix A.
