# Asbestos Refurbishment Survey

The Coach House

Penzance

| PROJECT REF NO:<br>BC111224/1 | Report Date: 11/12/2024 | SITE: The Coach House, Penzance, TR16 4JG |

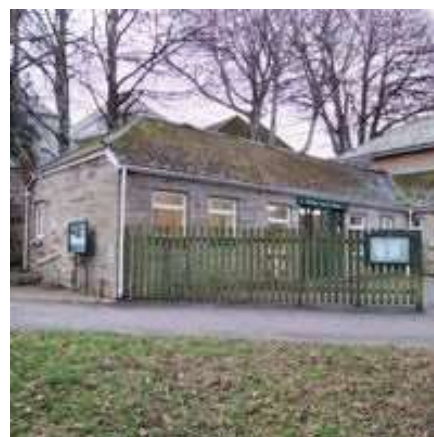
| Location: | Product Type: | Extent: | Accessibility: | Condition: | Surface Treatment: | Asbestos Type: | Sample Ref: | Identification: | Photo Ref: | Comments: |
|---|---|---|---|---|---|---|---|---|---|---|
| External, Front Elevation, Roof Tiles | Cement | 24m <sup>2</sup> | Low | Weathered | Unsealed | Chrysotile | 1 | Sampled | 1 | Remove prior to disturbance. Contractor to take own measurements for removal. |

Photo 1. Asbestos Cement Roof Tiles

**Comments: Asbestos cement is a low-risk product. The fibres are tightly bound within the cement matrix. A trained and competent individual is required to work in accordance with CAR, 2012 and Approved Codes of Practice.**

| <b>REQUIRED ACTION:</b> | Safe to remain in-situ undisturbed /<br>Remove prior to disturbance. |

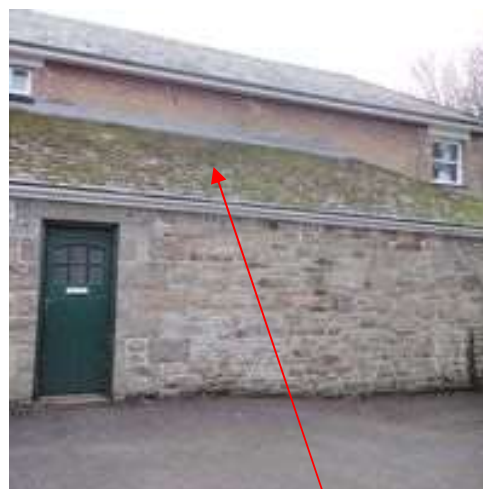
| Location: | Product Type: | Extent: | Accessibility: | Condition: | Surface Treatment: | Asbestos Type: | Sample Ref: | Identification: | Photo Ref: | Comments: |
|---|---|---|---|---|---|---|---|---|---|---|
| External, Front Elevation, Roof Tiles (facing tennis court café) | Cement | 24m <sup>2</sup> | Low | Weathered | Unsealed | Chrysotile | VS 1 | Sampled | 2 | Remove prior to disturbance. Contractor to take own measurements for removal. |

Photo 2. Asbestos Cement Roof Tiles

**Comments: Asbestos cement is a low-risk product. The fibres are tightly bound within the cement matrix. A trained and competent individual is required to work in accordance with CAR, 2012 and Approved Codes of Practice.**

| <b>REQUIRED ACTION:</b> | Safe to remain in-situ undisturbed /<br>Remove prior to disturbance. |

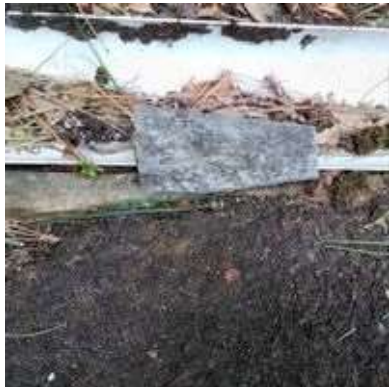
| Location: | Product Type: | Extent: | Accessibility: | Condition: | Surface Treatment: | Asbestos Type: | Sample Ref: | Identification: | Photo Ref: | Comments: |
|---|---|---|---|---|---|---|---|---|---|---|
| External, Broken Roof Tile (front elevation) | Cement | 0.2m <sup>2</sup> | Low | Good | Unsealed | Chrysotile | VS 1 | Sampled | 3 | Remove prior to disturbance. Surface pick all cement tile debris. The debris is mixed in leaf litter. |

| <b>BUILDING:</b> | Coach House | <p>Photo 3. Asbestos Cement Roof Tiles Debris</p> |

**Comments: Asbestos cement is a low-risk product. The fibres are tightly bound within the cement matrix. A trained and competent individual is required to work in accordance with CAR, 2012 and Approved Codes of Practice. The debris can be surface picked.**

| <b>REQUIRED ACTION:</b> | Safe to remain in-situ undisturbed /<br>Remove prior to disturbance. | |

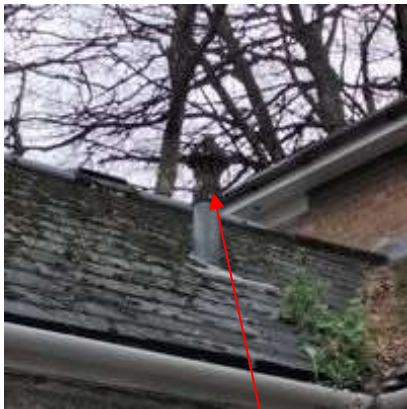
| Location: | Product Type: | Extent: | Accessibility: | Condition: | Surface Treatment: | Asbestos Type: | Sample Ref: | Identification: | Photo Ref: | Comments: |
|---|---|---|---|---|---|---|---|---|---|---|
| Flue Cap | Cement | 1 x item | Low | Weathered | Unsealed | Chrysotile | - | Strongly Presumed | 4 | Remove prior to disturbance. Contractor to take own measurements for removal. |

| <b>BUILDING:</b> | Coach House | <p>Photo 4. Asbestos Cement Flue Cap</p> |
