ASBESTOS REFURBISHMENT SURVEY REPORT

White House
Basset Road, Camborne TR14 8SL

Merit Report J3070b

Issue Date: 22nd February 2023

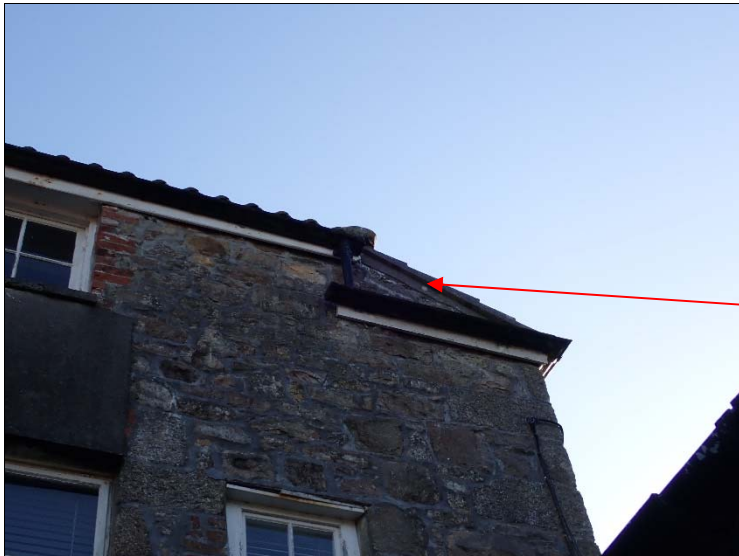
Photo Number	4	Sample Reference	Strongly Presumed
	Plan Ref	External		
	Location	Main Building		
	Position / Description	Asbestos Cement Undercloaking		
	Note / Comments	Manage and re-inspect or remove by an Unlicensed Asbestos Removal Contractor who has the appropriate insurance, training and following a safe system of work

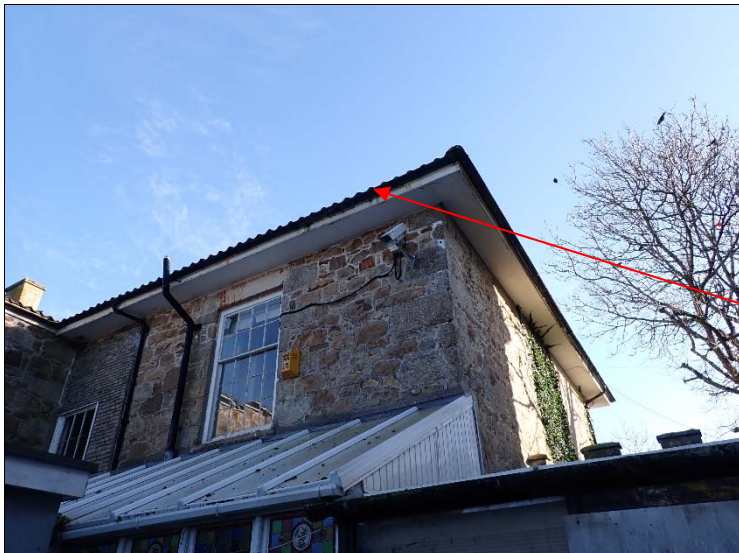
Photo Number	5	Sample Reference	No Access
	Plan Ref	External		
	Location	Main Building		
	Position / Description	Guttering		
	Note / Comments	No Access due to height

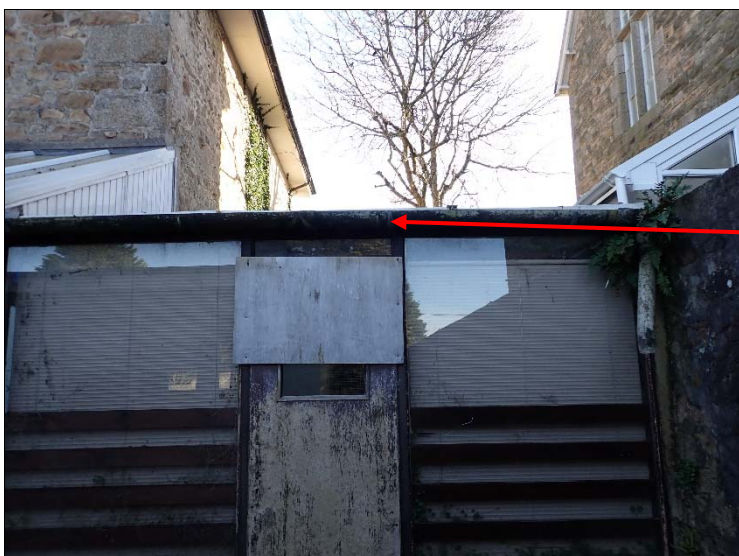
Photo Number	6	Sample Reference	S16
	Plan Ref	External		
	Location	Store		
	Position / Description	Asbestos Cement rain water goods		
	Note / Comments	Remove by an Unlicensed Asbestos Removal Contractor who has the appropriate insurance, training and following a safe system of work

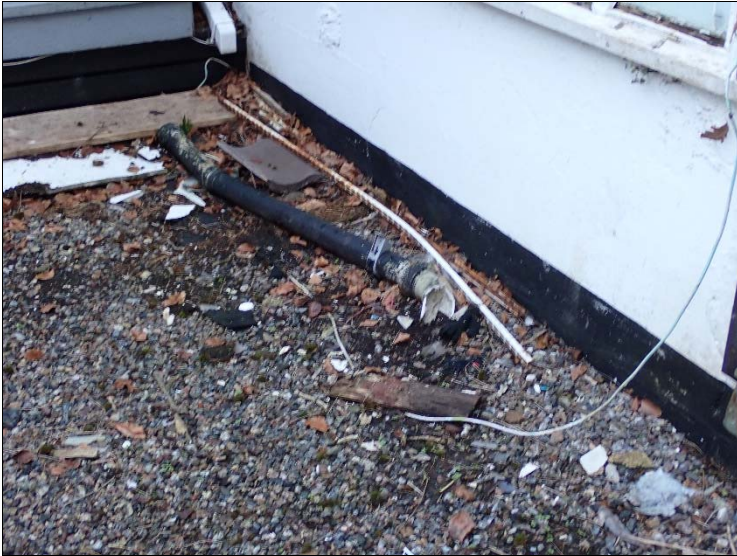
Photo Number	7	Sample Reference	S16
	Plan Ref	External		
	Location	Store		
	Position / Description	Asbestos Cement rain water goods debris		
	Note / Comments	Remove by an Unlicensed Asbestos Removal Contractor who has the appropriate insurance, training and following a safe system of work

Locations	Comments
External – Store – Asbestos Cement debris	The debris may be removed by an Unlicensed Asbestos Removal Contractor who has the appropriate insurance, training and following a safe system of work

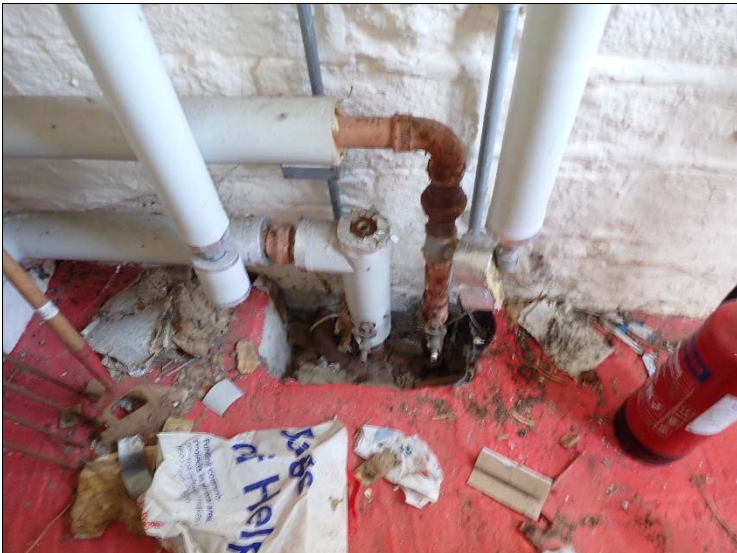
Photo Number	8	Sample Reference	S17
	Plan Ref	External		
	Location	Boiler Room		
	Position / Description	Debris on pipes		
	Note / Comments	No Action Required

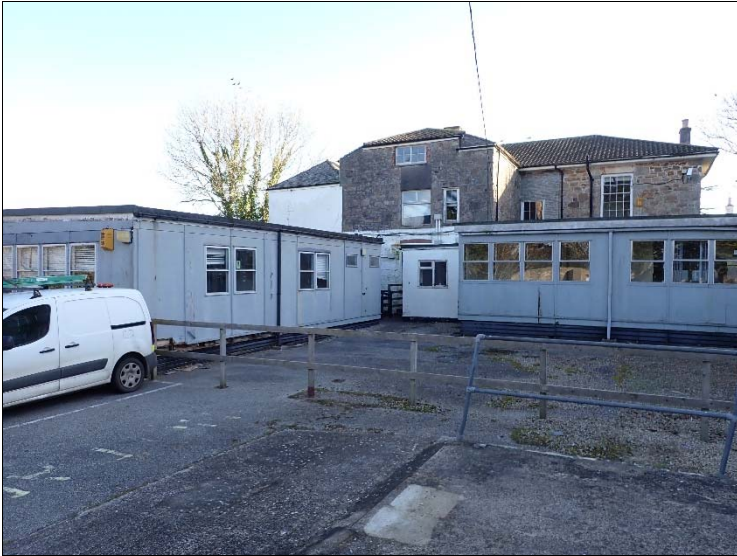
Photo Number	10	Sample Reference	S17
	Plan Ref	External		
	Location	Porta-Cabins		
	Position / Description	Textured Coating to walls		
	Note / Comments	No Action Required

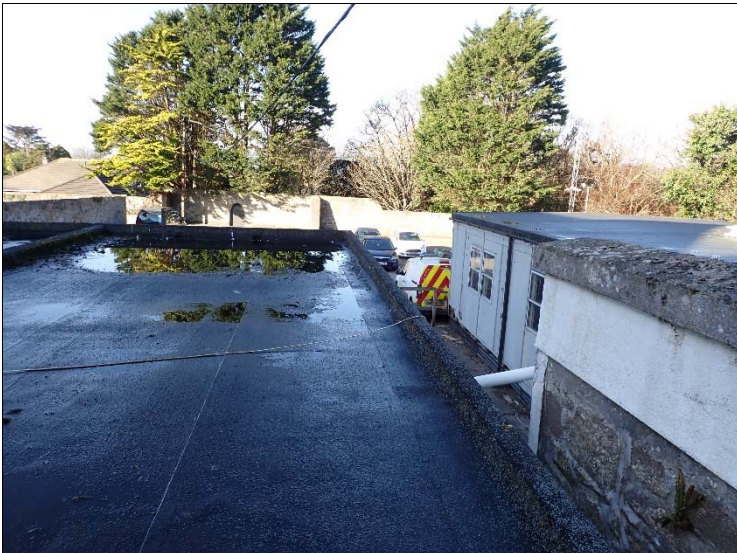
Photo Number	11	Sample Reference	S17
	Plan Ref	External		
	Location	Porta-Cabins		
	Position / Description	Roof felt		
	Note / Comments	No Action Required

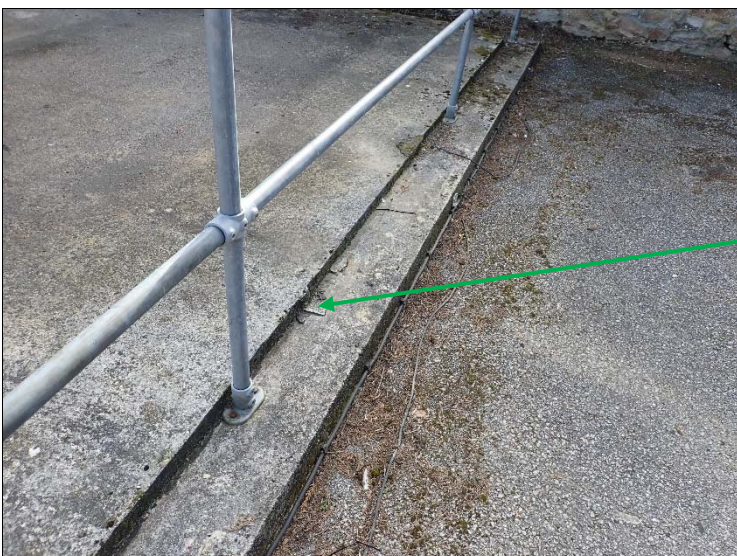
Photo Number	12	Sample Reference	S19
	Plan Ref	External		
	Location	Removed Porta-Cabins		
	Position / Description	Shuttering		
	Note / Comments	No Action Required

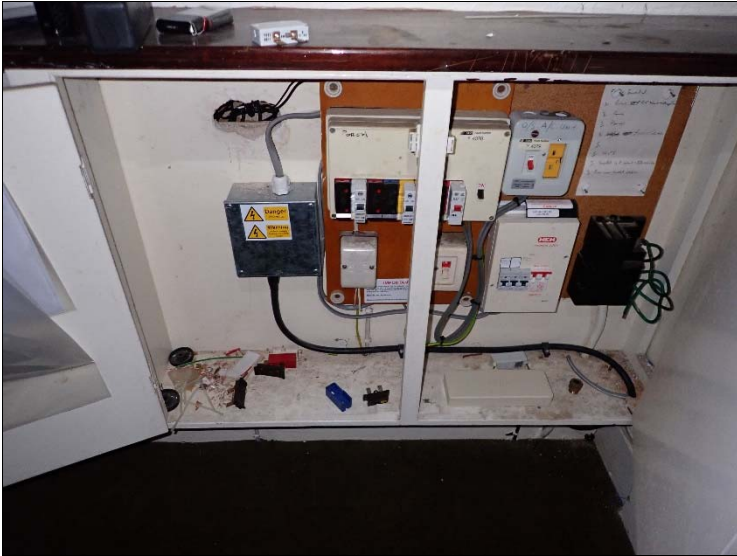
Photo Number	13	Sample Reference	For reference
	Plan Ref	GF01		
	Location	Lobby		
	Position / Description	Electrical switchgear		
	Note / Comments	No Action Required

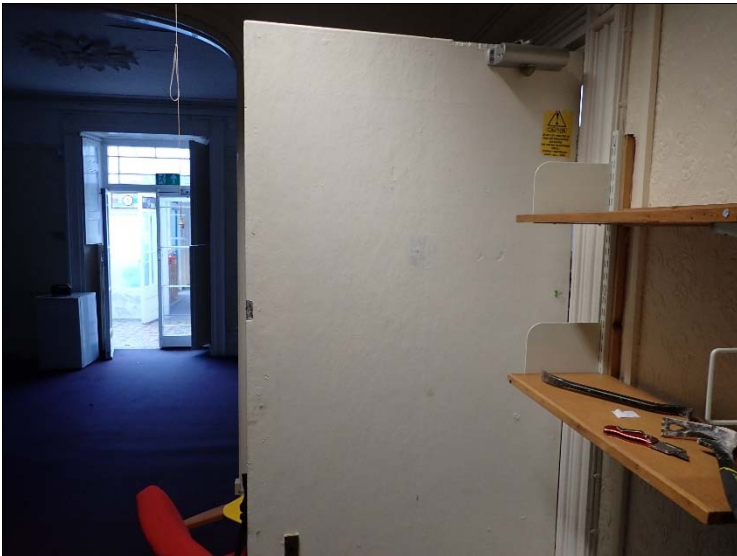
Photo Number	16	Sample Reference	S03
	Plan Ref	GF02		
	Location	Office		
	Position / Description	Asbestos Insulating Board panel to door		
	Note / Comments	Remove by an Unlicensed Asbestos Contractor who has the appropriate insurance, training and following a safe system of work (subject to risk assessment)

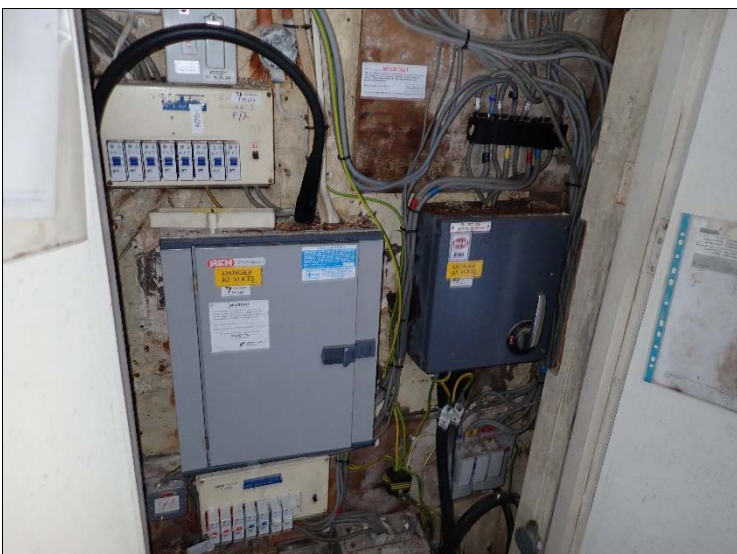
Photo Number	21	Sample Reference	No Access
	Plan Ref	GF14		
	Location	Electrical Room		
	Position / Description	Electrical switchgear		
	Note / Comments	No Access Gained

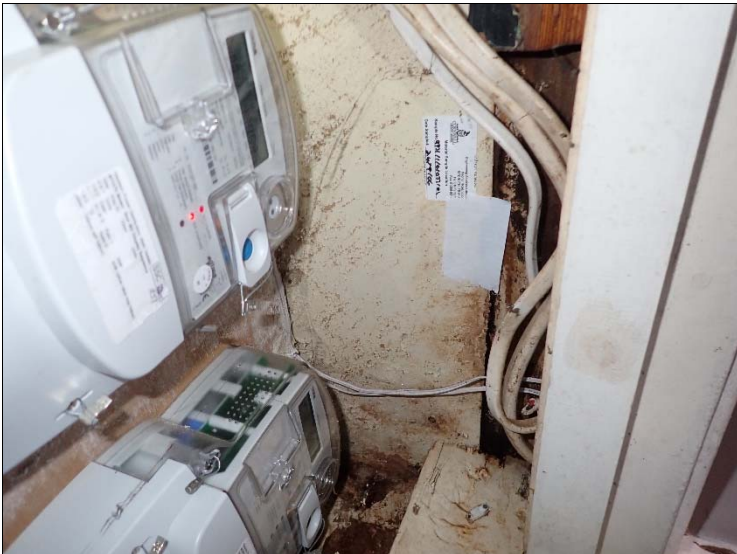
Photo Number	22	Sample Reference	S06
	Plan Ref	GF14		
	Location	Electrical Room		
	Position / Description	Asbestos Cement panel above electrical switchgear		
	Note / Comments	Remove by an Unlicensed Asbestos Contractor who has the appropriate insurance, training and following a safe system of work

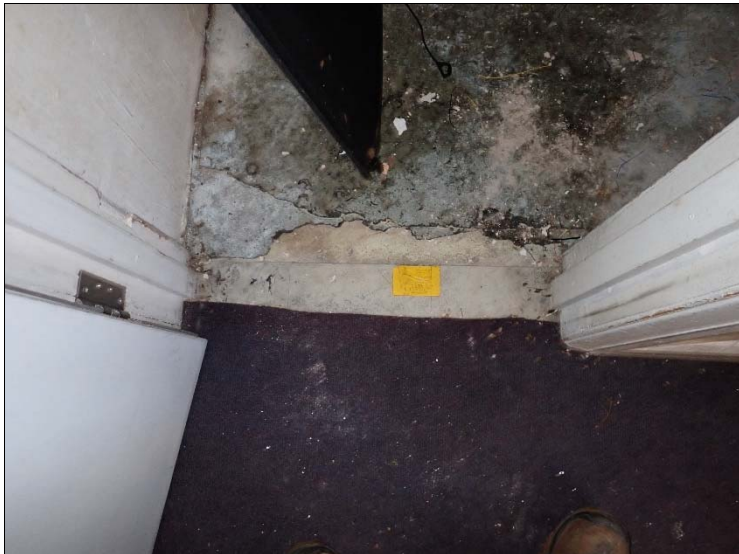
Photo Number	25	Sample Reference	AWS07
	Plan Ref	GF16		
	Location	Store		
	Position / Description	Vinyl floor tiles		
	Note / Comments	Remove by an Unlicensed Asbestos Contractor who has the appropriate insurance, training and following a safe system of work

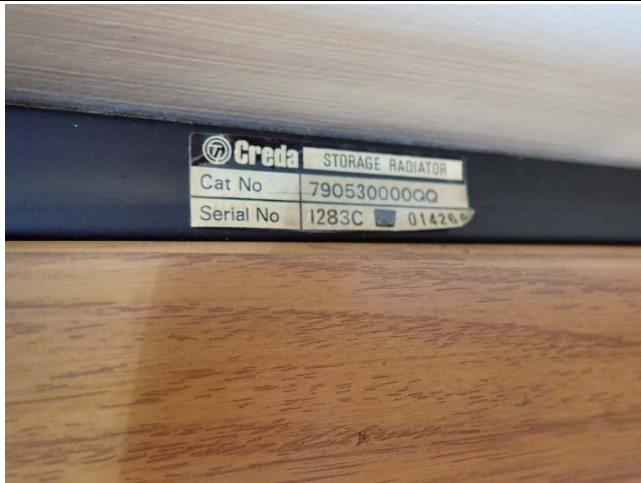
Photo Number	28	Sample Reference	For reference
	Plan Ref	GF24		
	Location	Office		
	Position / Description	Creda Night Storage Heaters		
	Note / Comments	Model number C1283C checked against database – no asbestos present

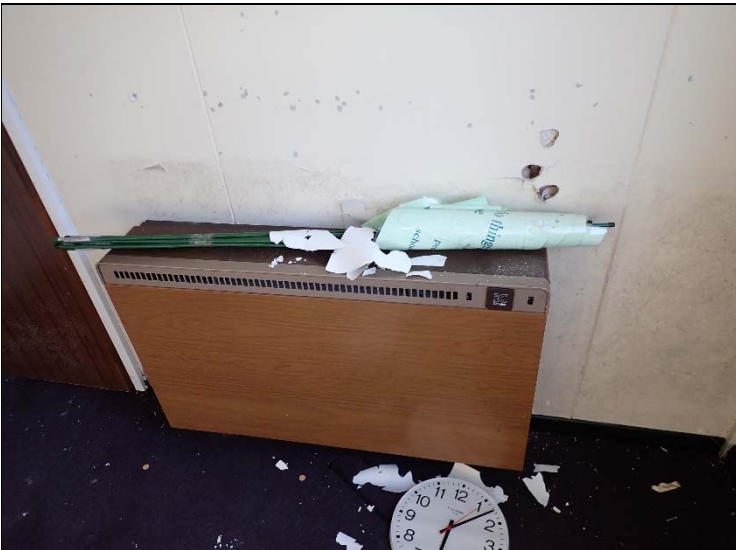
Photo Number	29	Sample Reference	No Access
	Plan Ref	GF31		
	Location	Office		
	Position / Description	Dimplex Night Storage Heaters		
	Note / Comments	No Access No model / serial number present

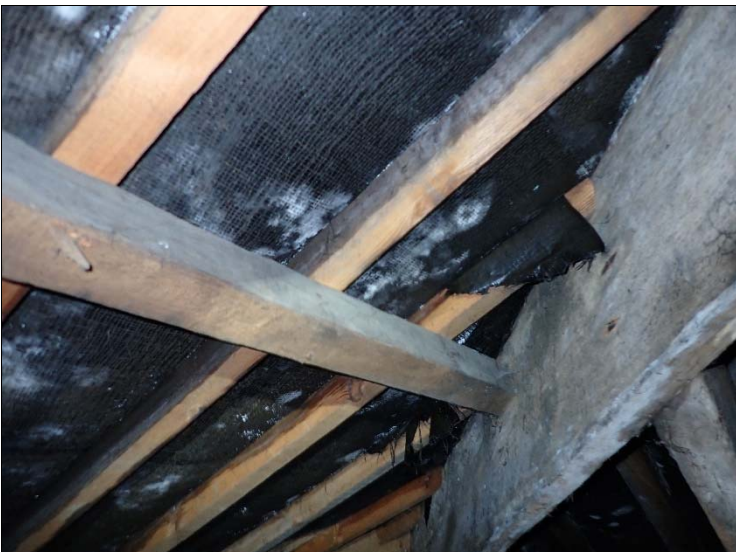
Photo Number	30	Sample Reference	AWS12
	Plan Ref	Loft		
	Location	Accessed from 1F06 - Bedroom 5		
	Position / Description	Roof felt		
	Note / Comments	No Action Required

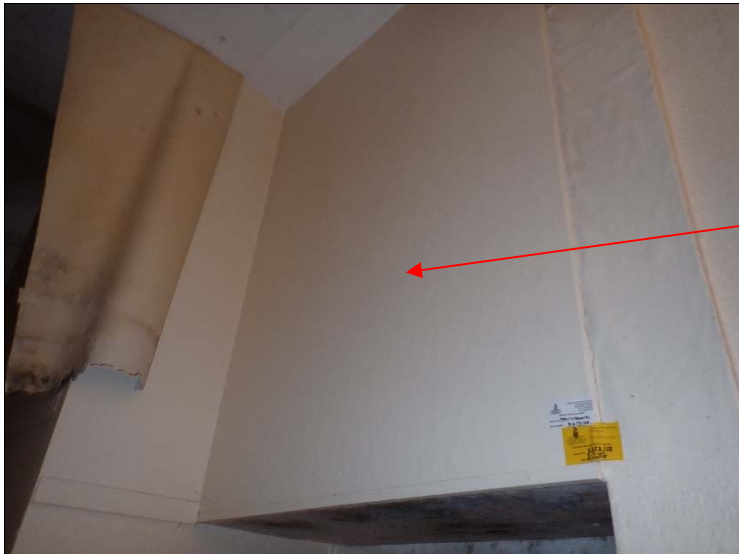
Photo Number	31	Sample Reference	S09
	Plan Ref	1F07		
	Location	Corridor		
	Position / Description	Asbestos Insulating Board panel to corridor		
	Note / Comments	Remove by a Licensed Asbestos Removal Contractor who has submitted a 14-day notification to the HSE

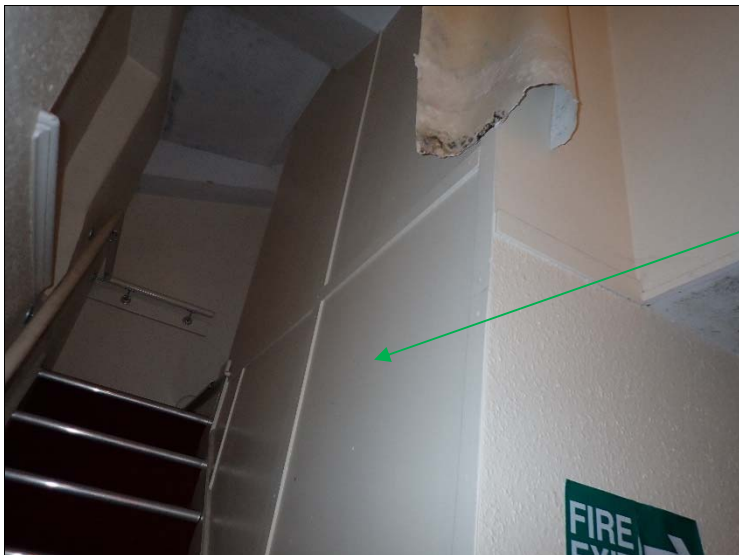
Photo Number	32	Sample Reference	S11
	Plan Ref	1F07		
	Location	Corridor		
	Position / Description	Panels to stairs		
	Note / Comments	No Action Required

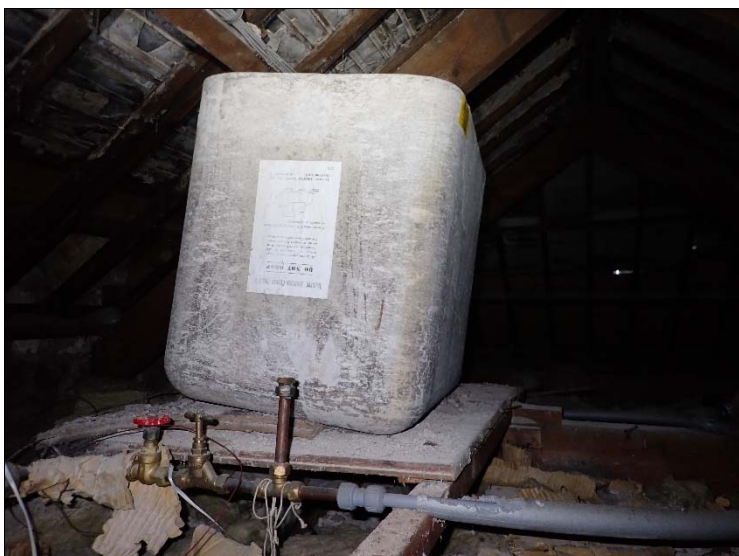
Photo Number	33	Sample Reference	Strongly Presumed
	Plan Ref	Loft		
	Location	Accessed from 1F11 Bedroom		
	Position / Description	Asbestos Cement water tank		
	Note / Comments	Manage and re-inspect or Remove by an Unlicensed Asbestos Contractor who has the appropriate insurance, training and following a safe system of work

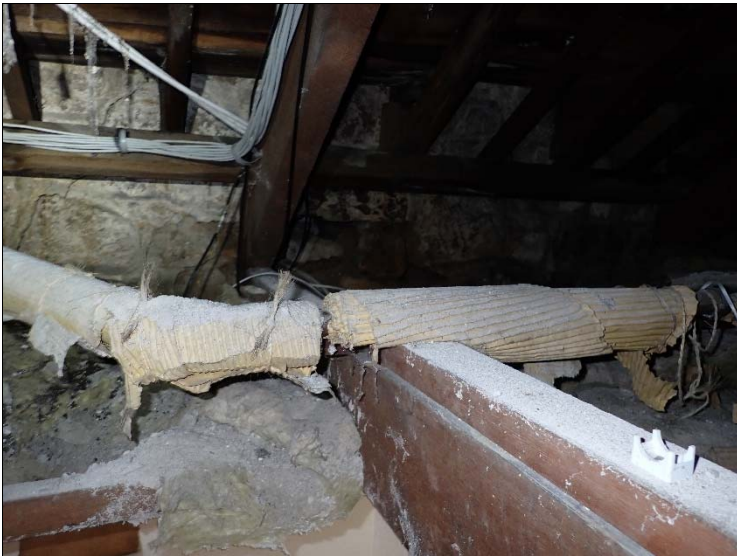
Photo Number	34	Sample Reference	S10
	Plan Ref	Loft		
	Location	Accessed from 1F11 Bedroom		
	Position / Description	Cardboard insulation to pipes		
	Note / Comments	No Action Required

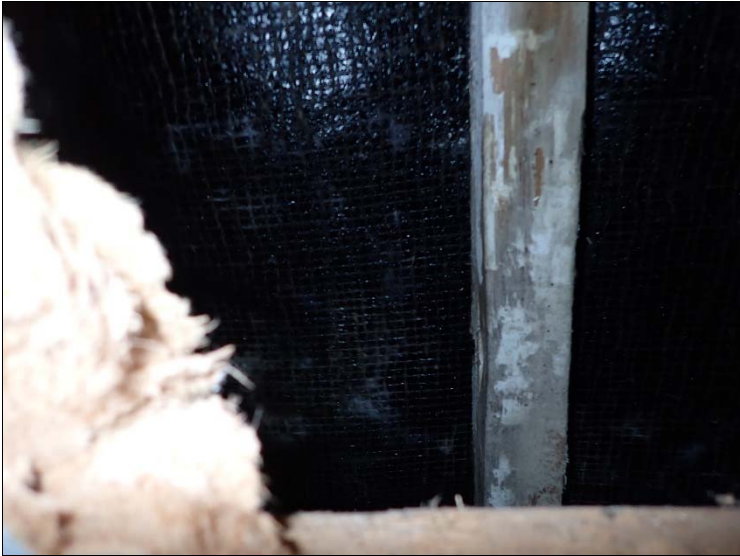
Photo Number	37	Sample Reference	S12
	Plan Ref	2F02		
	Location	Office		
	Position / Description	Roof felt		
	Note / Comments	No Action Required
