**Asbestos Refurbishment Survey Report
Of
12A Blandford Gardens
Leeds
LS2 9AL**

Client: Leeds Federated Housing Association
Order Placed By: Peter Thirtle
MCP Project Number: M-08936
UPRN: 0000868 MCP-1189W-009 (12A Blandford Gardens)
Survey Date: 24/03/2017
Report Date: 13/04/2017

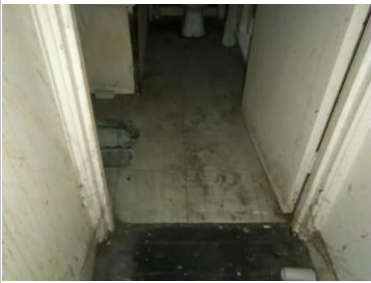
S001	Thermoplastic Floor Tiles Floor	ID	12A Blandford Gardens / Bathroom	3	9m ²	-	-	-	NAD	-	-
005	0

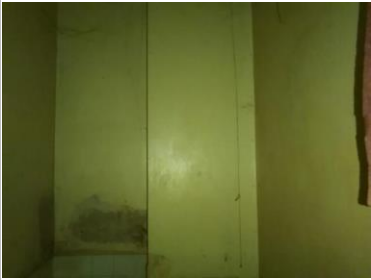
S002	Insulating Board Boxing	ID	12A Blandford Gardens / Bathroom	3	6m ²	-	-	-	NAD	-	-
