ASBESTOS MANAGEMENT PLAN

Danesholme Communicare Centre

Reference Number	Version Number	Date Issued	Review Date	Summary of Amendments	Policy Author
ASB002	1	01/04/15	31/03/16	Initial Issue	M. Warburton
ASB002	2	04/01/17	03/01/18	Re-inspection	M. Warburton

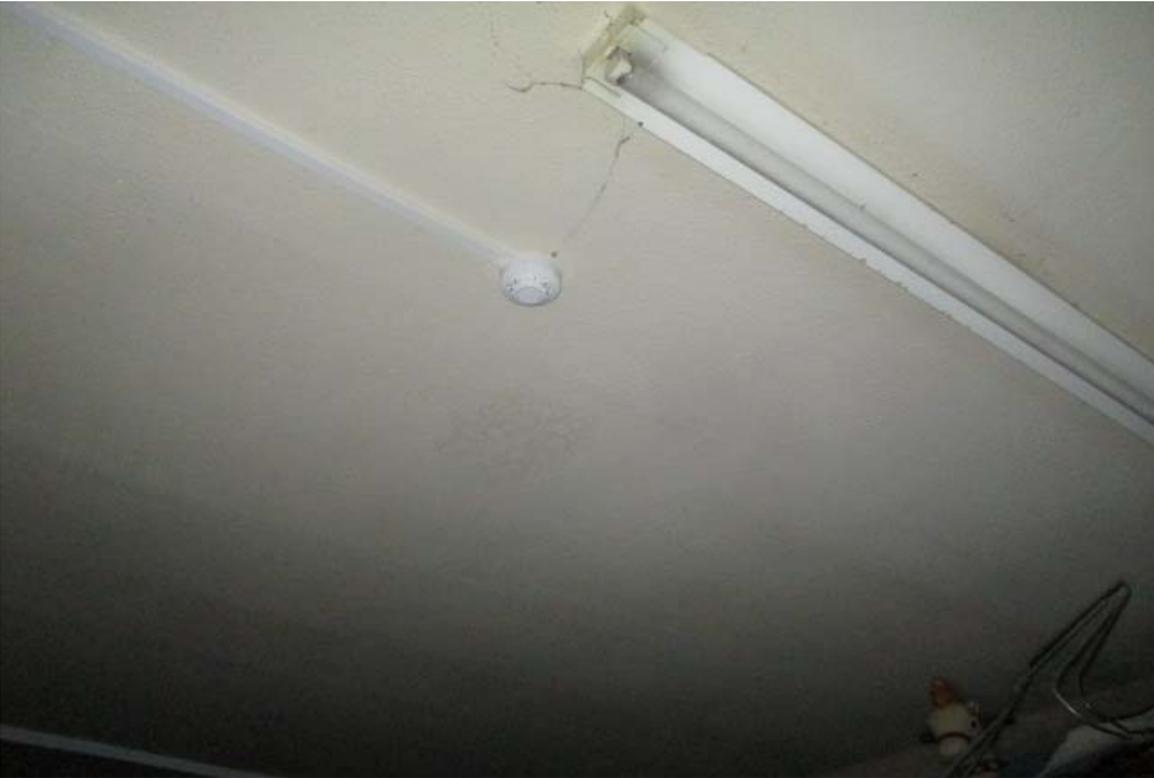
Photo Number	5	Reference number	160516R110
Inspection / Sample	Inspection	Inspection Cross Reference / Visual I.D.	Visual Identification

Notes	Reference to sample: 13/10/B/30/DS5

Building	Danesholme Communicare Centre	Condition	Fair	1
Floor Level	Ground	Surface Treatment	Composite materials, reinforced plastics, resin, vinyl materials	0
Location	G.03 Willie Moudsley Room	Material Friability	Low	1
Feature	Coating to ceiling	Asbestos Type	Presumed Chrysotile (White)	1
Material Type	Textured Coating			
Extent	24 sq. m.			
Recommendation	Manage in situ via periodic re-inspection	Assessment Score		3
		Assessment Band		D

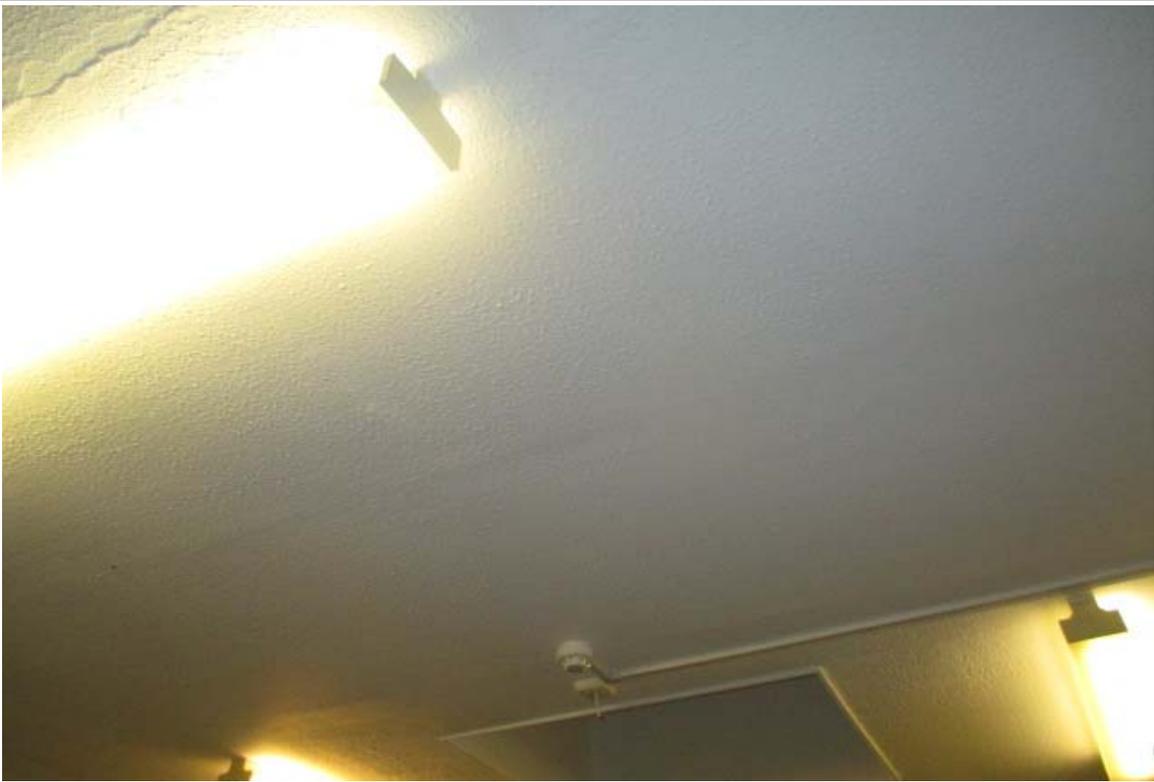
Photo Number	9	Reference number	160516R111
Inspection / Sample	Inspection	Inspection Cross Reference / Visual I.D.	Visual Identification

Notes	Reference to sample: 13/10/B/30/DS8

Building	Danesholme Communicare Centre	Condition	Fair	1
Floor Level	Ground	Surface Treatment	Composite materials, reinforced plastics, resin, vinyl materials	0
Location	G.06 Lobby	Material Friability	Low	1
Feature	Coating to ceiling	Asbestos Type	Presumed Chrysotile (White)	1
Material Type	Textured Coating			
Extent	20 sq. m.			
Recommendation	Reference to sample: 13/10/B/30/DS8	Assessment Score		3
		Assessment Band		D

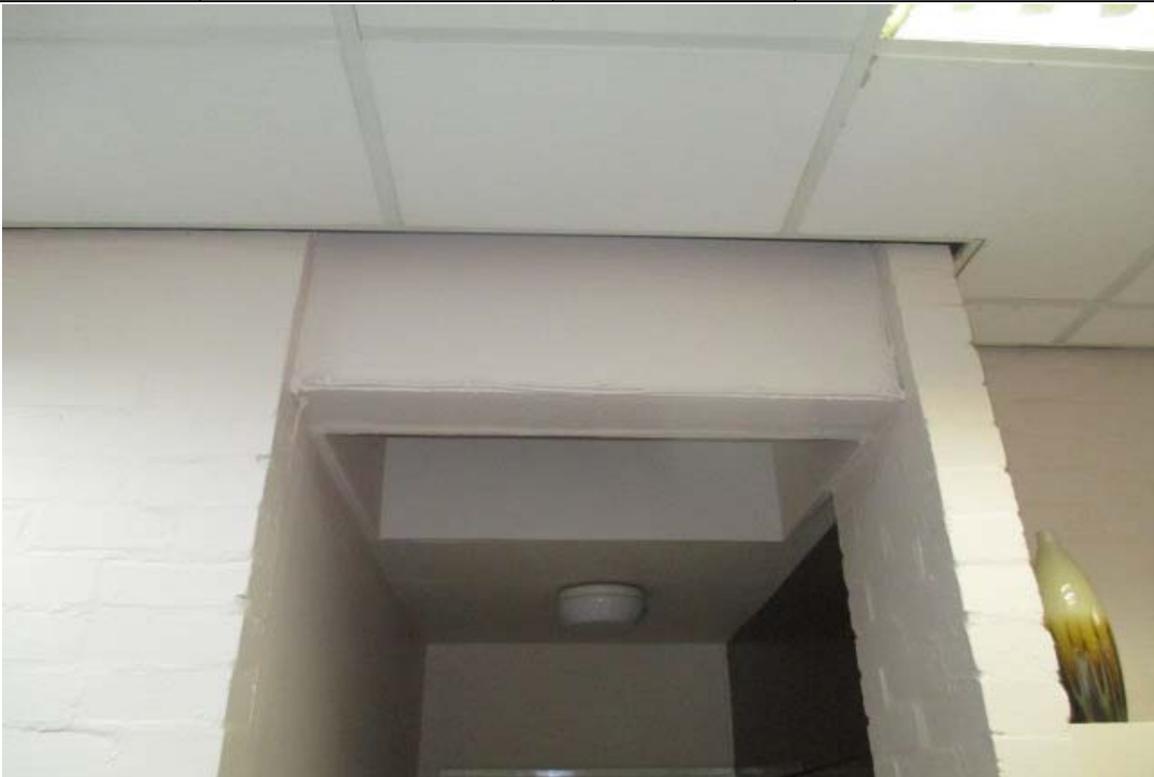
Photo Number	10	Reference number	160516RI12
Inspection / Sample	Inspection	Inspection Cross Reference / Visual I.D.	Visual Identification

Notes	Reference to sample: 13/10/B/30/DS8

Building	Danesholme Communicare Centre	Condition	Fair	1
Floor Level	Ground	Surface Treatment	Composite materials, reinforced plastics, resin, vinyl materials	0
Location	G.06 Lobby	Material Friability	Low	1
Feature	Coating above walls and doors	Asbestos Type	Presumed Chrysotile (White)	1
Material Type	Textured Coating			
Extent	20 sq. m.			
Recommendation	Reference to sample: 13/10/B/30/DS8	Assessment Score		3
		Assessment Band		D

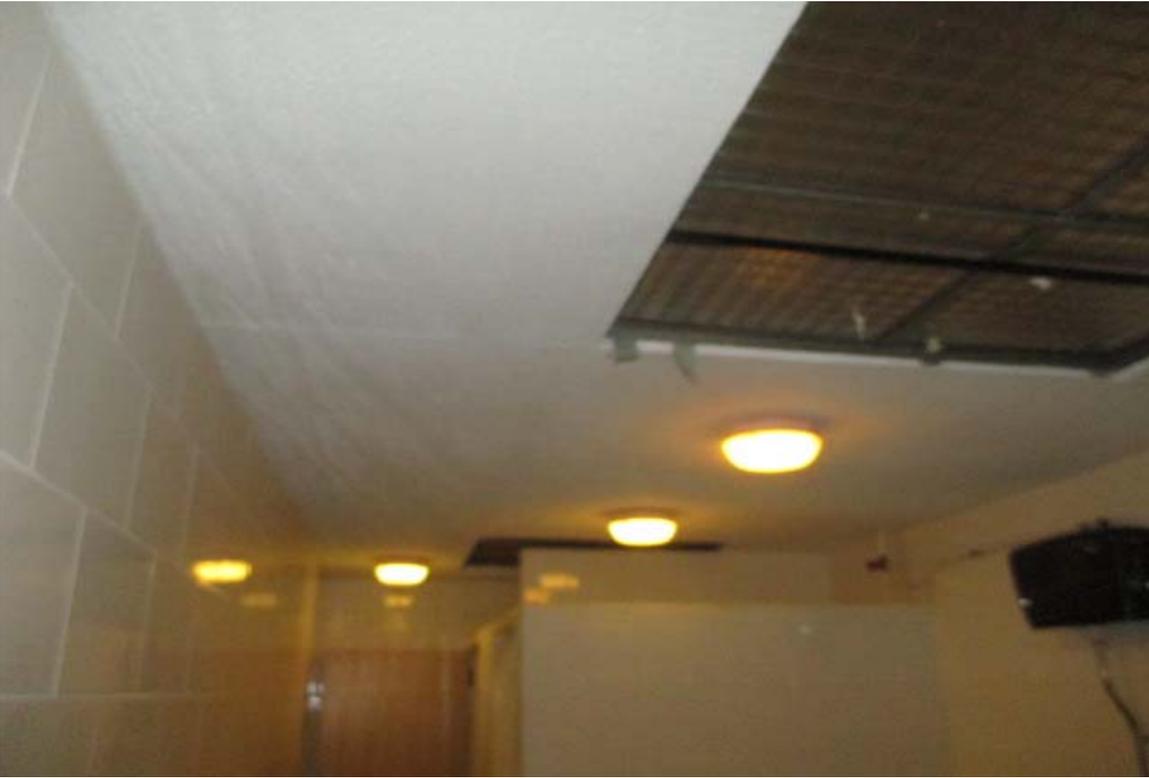
Photo Number	11	Reference number	160516R113
Inspection / Sample	Inspection	Inspection Cross Reference / Visual I.D.	Visual Identification

Notes	Reference to sample: 13/10/B/30/DS8

Building	Danesholme Communicare Centre	Condition	Good	0
Floor Level	Ground	Surface Treatment	Composite materials, reinforced plastics, resin, vinyl materials	0
Location	G.07 Male Toilets	Material Friability	Low	1
Feature	Coating to ceiling	Asbestos Type	Presumed Chrysotile (White)	1
Material Type	Textured Coating			
Extent	10 sq. m.			
Recommendation	Reference to sample: 13/10/B/30/DS8	Assessment Score		2
		Assessment Band		D

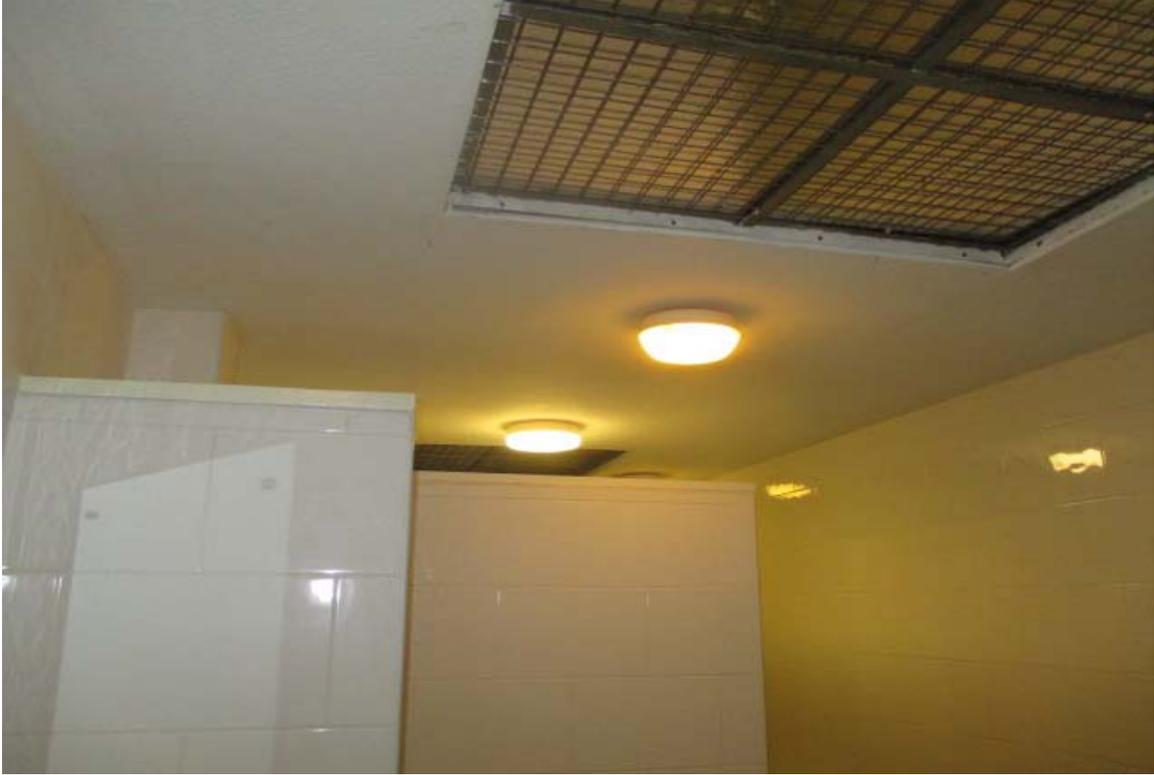
Photo Number	12	Reference number	160516R114
Inspection / Sample	Inspection	Inspection Cross Reference / Visual I.D.	Visual Identification

Notes	Reference to sample: 13/10/B/30/DS8

Building	Danesholme Communicare Centre	Condition	Good	0
Floor Level	Ground	Surface Treatment	Composite materials, reinforced plastics, resin, vinyl materials	0
Location	G.08 Female Toilets	Material Friability	Low	1
Feature	Coating to ceiling	Asbestos Type	Presumed Chrysotile (White)	1
Material Type	Textured Coating			
Extent	10 sq. m.			
Recommendation	Reference to sample: 13/10/B/30/DS8	Assessment Score		2
		Assessment Band		D

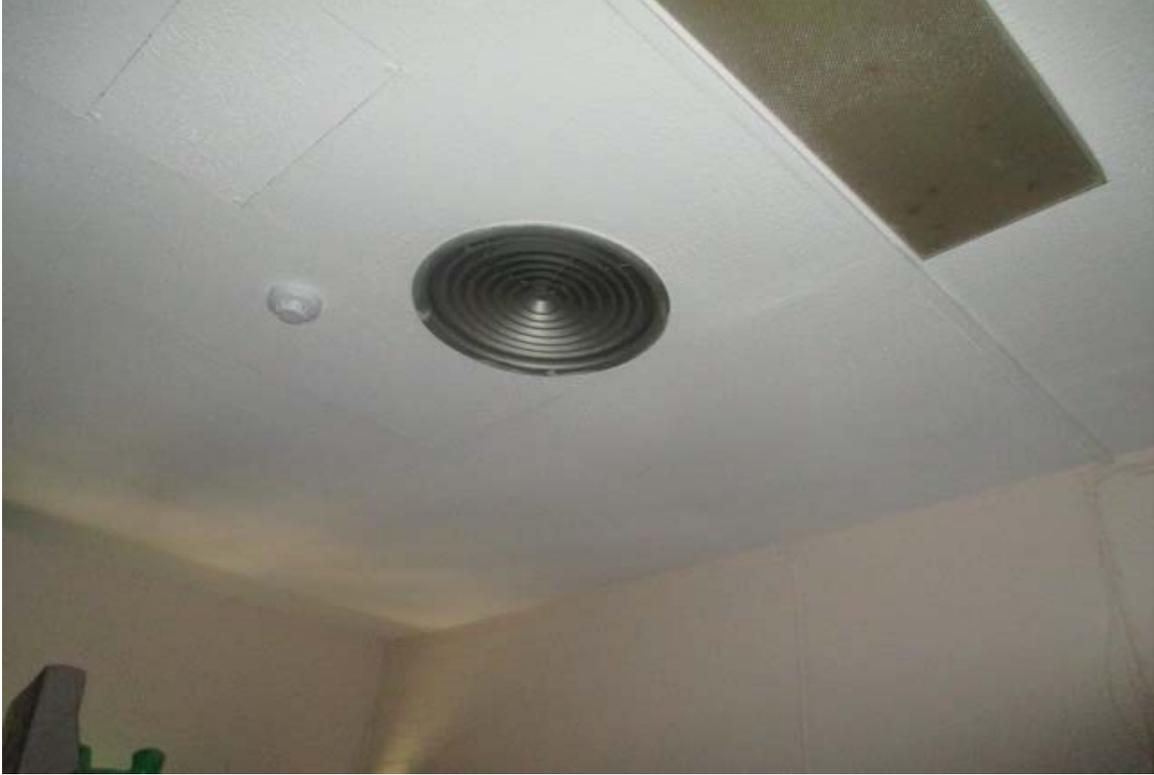
Photo Number	13	Reference number	160516R115
Inspection / Sample	Inspection	Inspection Cross Reference / Visual I.D.	Visual Identification

Notes	Reference to sample: 13/10/B/30/DS8

Building	Danesholme Communicare Centre	Condition	Good	0
Floor Level	Ground	Surface Treatment	Composite materials, reinforced plastics, resin, vinyl materials	0
Location	G.10 Lobby	Material Friability	Low	1
Feature	Coating to ceiling	Asbestos Type	Presumed Chrysotile (White)	1
Material Type	Textured Coating			
Extent	15 sq. m.			
Recommendation	Reference to sample: 13/10/B/30/DS8	Assessment Score		2
		Assessment Band		D

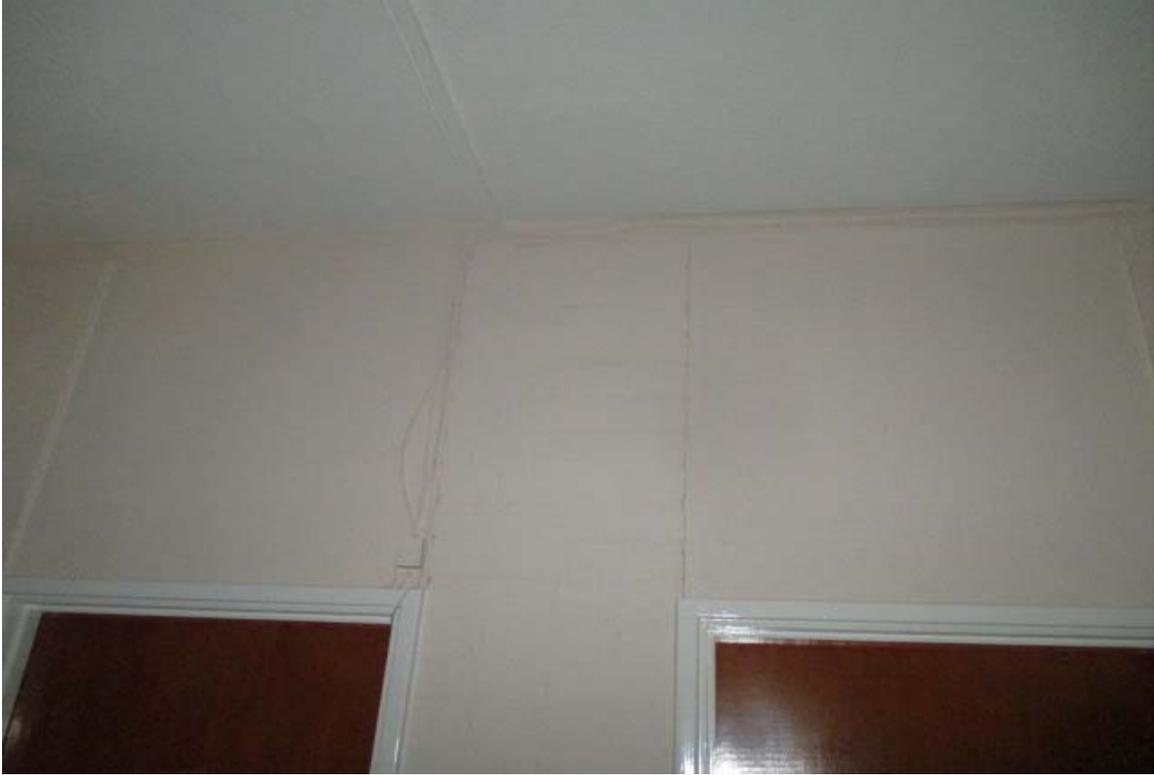
Photo Number	14	Reference number	160516R116
Inspection / Sample	Inspection	Inspection Cross Reference / Visual I.D.	Visual Identification

Notes	Reference to sample: 13/10/B/30/DS8

Building	Danesholme Communicare Centre	Condition	Good	0
Floor Level	Ground	Surface Treatment	Composite materials, reinforced plastics, resin, vinyl materials	0
Location	G.10 Lobby	Material Friability	Low	1
Feature	Coating above walls and doors	Asbestos Type	Presumed Chrysotile (White)	1
Material Type	Textured Coating			
Extent	30 sq. m.			
Recommendation	Reference to sample: 13/10/B/30/DS8	Assessment Score		2
		Assessment Band		D

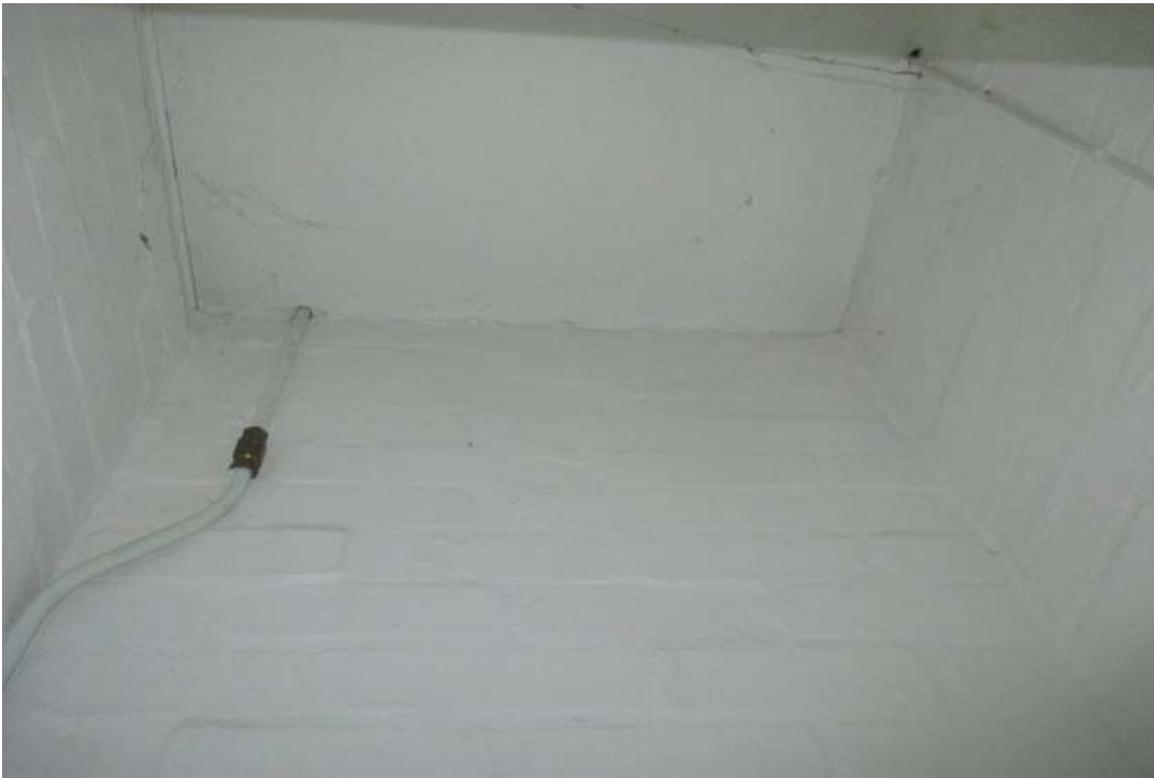
Photo Number	17	Reference number	160516R117
Inspection / Sample	Inspection	Inspection Cross Reference / Visual I.D.	Visual Identification

Notes	Reference to sample: 13/10/B/30/DS8

Building	Danesholme Communicare Centre	Condition	Good	0
Floor Level	Ground	Surface Treatment	Composite materials, reinforced plastics, resin, vinyl materials	0
Location	G.14 Cupboard	Material Friability	Low	1
Feature	Coating to ceiling	Asbestos Type	Presumed Chrysotile (White)	1
Material Type	Textured Coating			
Extent	1 sq. m.			
Recommendation	Reference to sample: 13/10/B/30/DS8	Assessment Score		2
		Assessment Band		D

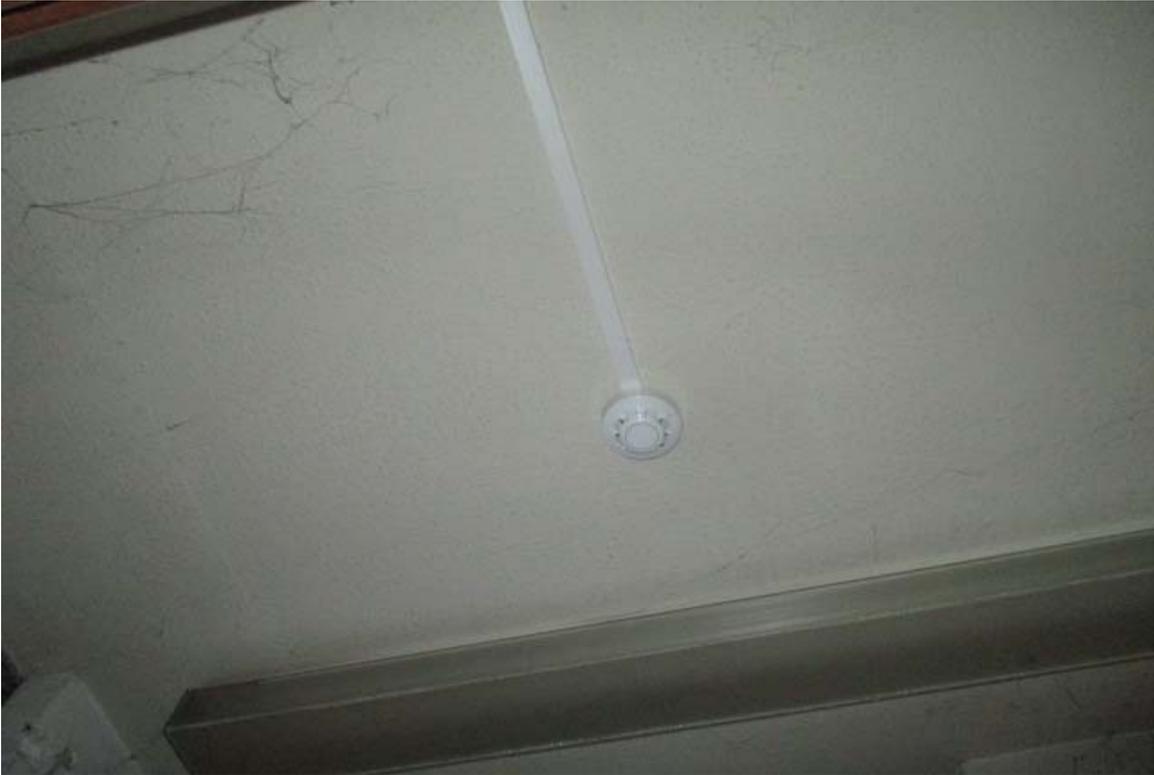
Photo Number	18	Reference number	160516R118
Inspection / Sample	Inspection	Inspection Cross Reference / Visual I.D.	Visual Identification

Notes	Reference to sample: 13/10/B/30/DS8

Building	Danesholme Communicare Centre	Condition	Good	0
Floor Level	Ground	Surface Treatment	Composite materials, reinforced plastics, resin, vinyl materials	0
Location	G.15 Store	Material Friability	Low	1
Feature	Coating to ceiling	Asbestos Type	Presumed Chrysotile (White)	1
Material Type	Textured Coating			
Extent	6 sq. m.			
Recommendation	Reference to sample: 13/10/B/30/DS8	Assessment Score		2
		Assessment Band		D

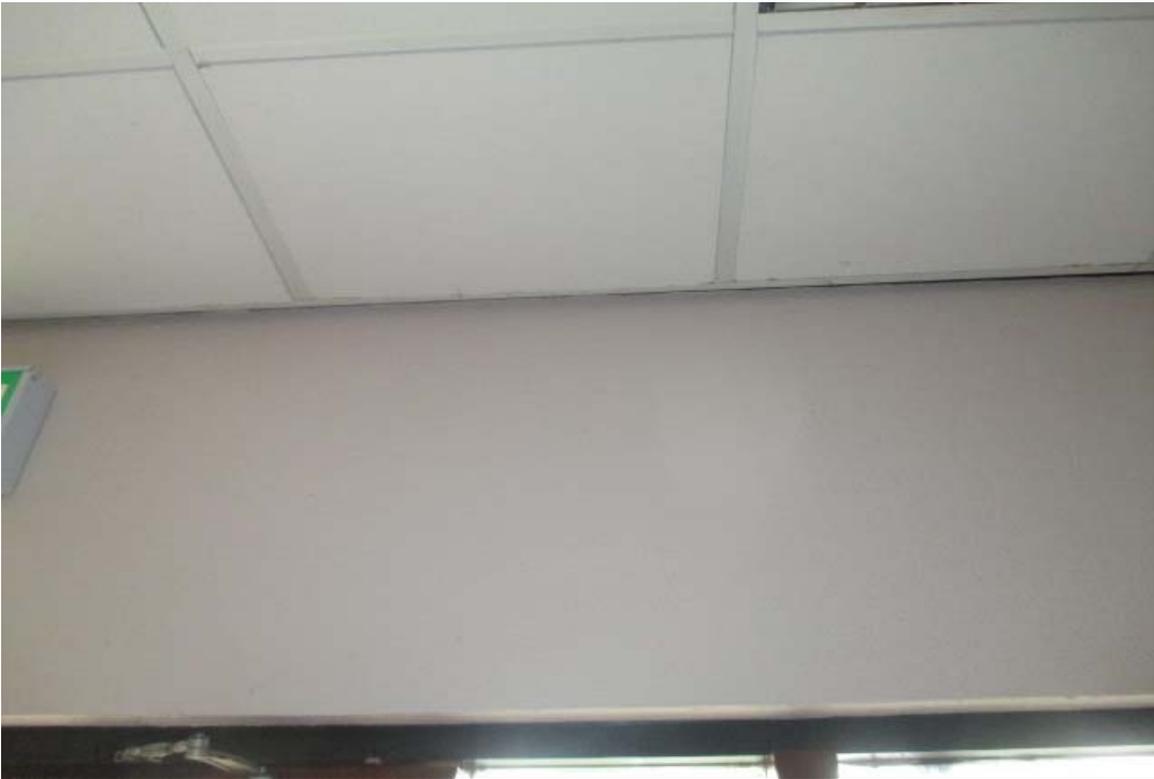
Photo Number	19	Reference number	160516R119
Inspection / Sample	Inspection	Inspection Cross Reference / Visual I.D.	Visual Identification

Notes	Reference to sample: 13/10/B/30/DS8

Building	Danesholme Communicare Centre	Condition	Good	0
Floor Level	Ground	Surface Treatment	Composite materials, reinforced plastics, resin, vinyl materials	0
Location	G.16 Hall	Material Friability	Low	1
Feature	Coating to ceiling	Asbestos Type	Presumed Chrysotile (White)	1
Material Type	Textured Coating			
Extent	150 sq. m.			
Recommendation	Reference to sample: 13/10/B/30/DS8	Assessment Score		2
		Assessment Band		D

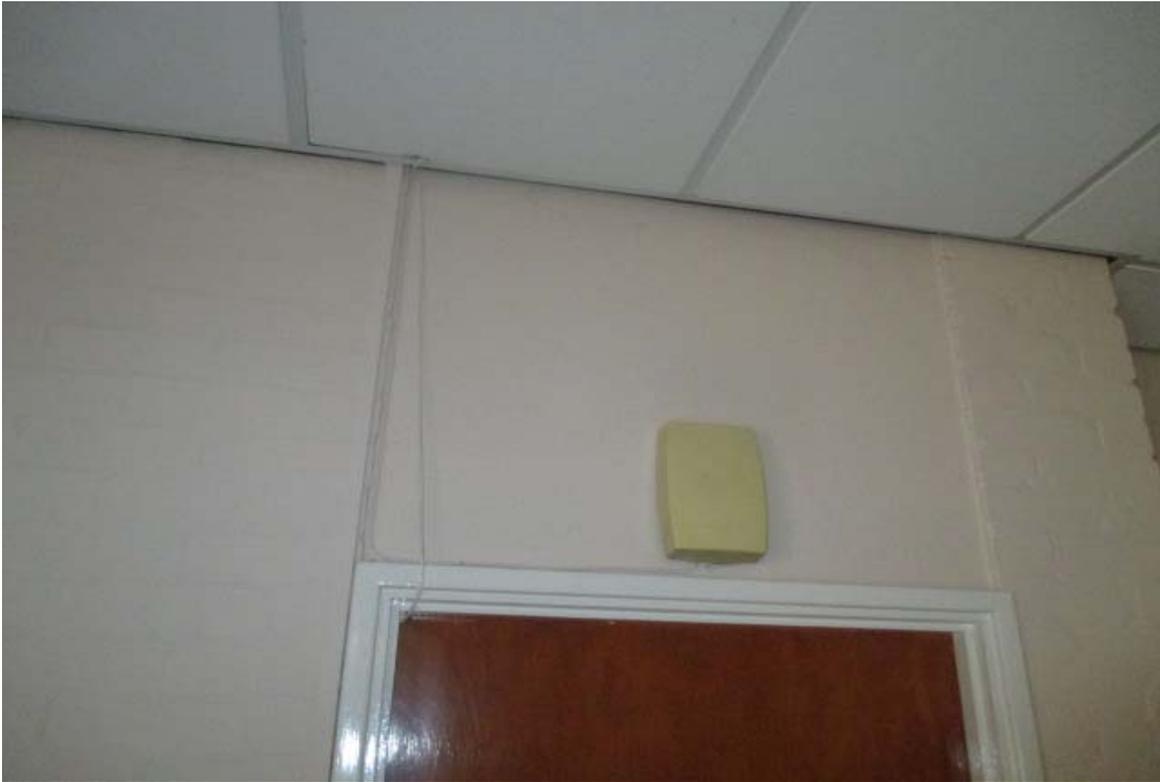
Photo Number	20	Reference number	160516R120
Inspection / Sample	Inspection	Inspection Cross Reference / Visual I.D.	Visual Identification

Notes	Reference to sample: 13/10/B/30/DS8

Building	Danesholme Communicare Centre	Condition	Good	0
Floor Level	Ground	Surface Treatment	Composite materials, reinforced plastics, resin, vinyl materials	0
Location	G.16 Hall	Material Friability	Low	1
Feature	Coating above walls and doors	Asbestos Type	Presumed Chrysotile (White)	1
Material Type	Textured Coating			
Extent	100 sq. m.			
Recommendation	Reference to sample: 13/10/B/30/DS8	Assessment Score		2
		Assessment Band		D

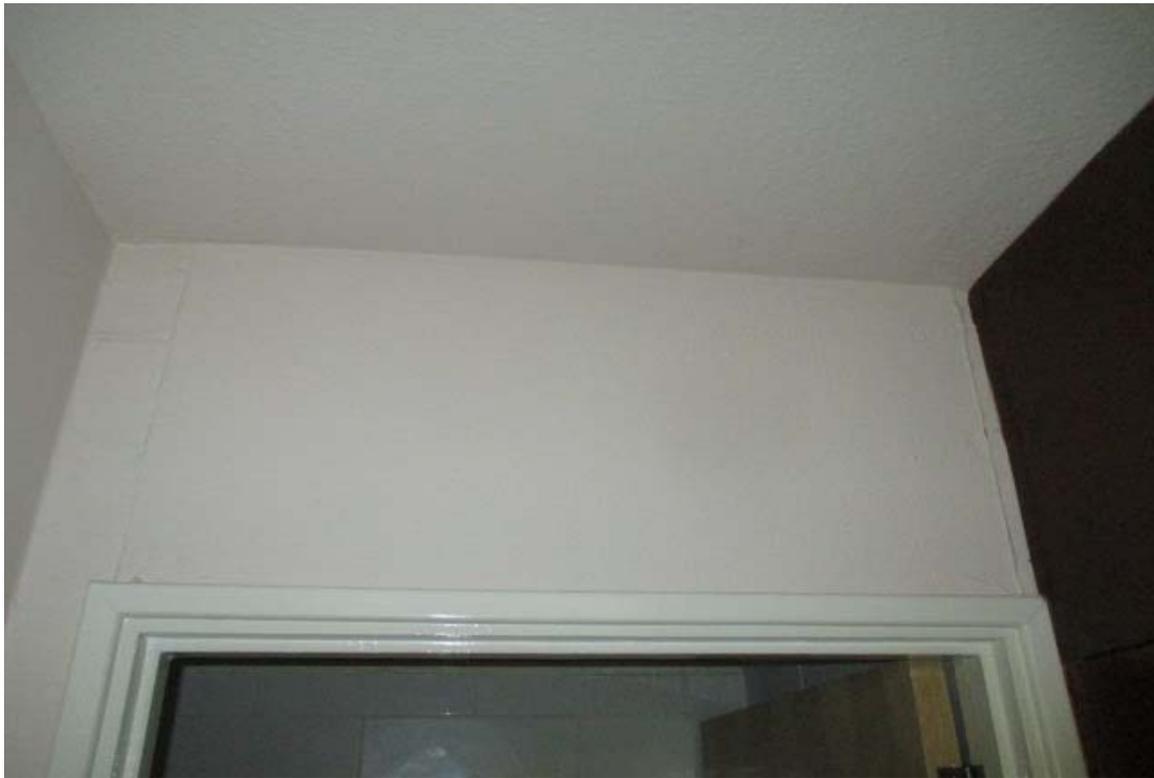
Photo Number	24	Reference number	160516R121
Inspection / Sample	Inspection	Inspection Cross Reference / Visual I.D.	Visual Identification

Notes	Reference to sample: 13/10/B/30/DS8

Building	Danesholme Communicare Centre	Condition	Good	0
Floor Level	Ground	Surface Treatment	Composite materials, reinforced plastics, resin, vinyl materials	0
Location	G.19 Store	Material Friability	Low	1
Feature	Coating to ceiling	Asbestos Type	Presumed Chrysotile (White)	1
Material Type	Textured Coating			
Extent	18 sq. m.			
Recommendation	Reference to sample: 13/10/B/30/DS8	Assessment Score		2
		Assessment Band		D

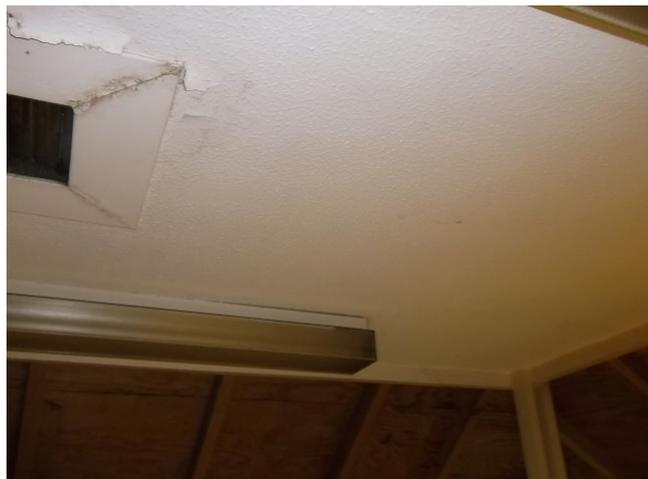
Sample No: 13/10/B/30/DS1
G.01 Kitchen Ceiling Void - Textured coating to plasterboard containing Chrysotile

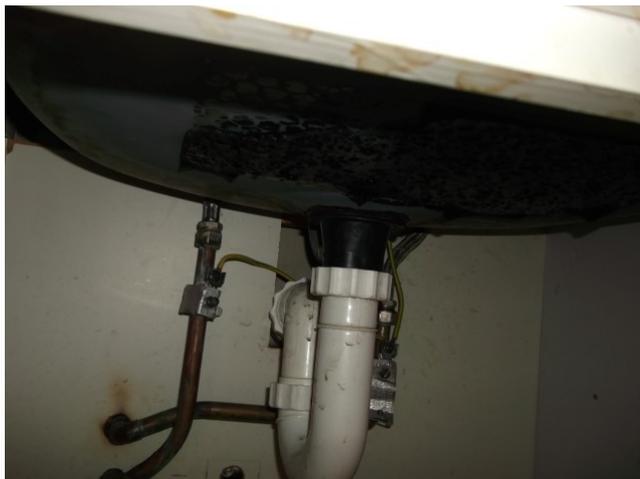
Sample No: 13/10/B/30/DS2
G.01 Kitchen Sink - Bitumen sink pad containing Chrysotile

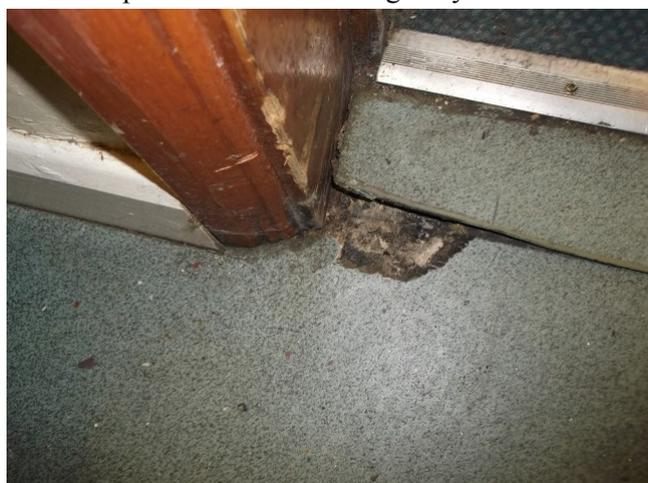
Sample No: 13/10/B/30/DS3
G.01 Kitchen Floor - Vinyl floor covering + bit adhesive containing Chrysotile

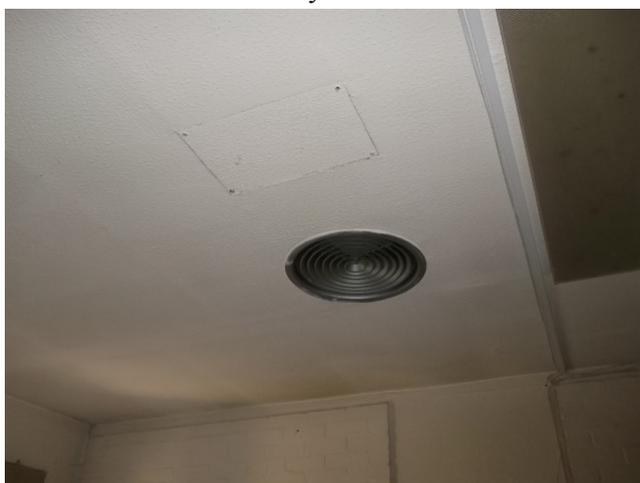
Sample No: Refer to Sample 13/10/B/30/DS1
G.02 Dining Room Ceiling Void - Textured coating to plasterboard containing Chrysotile

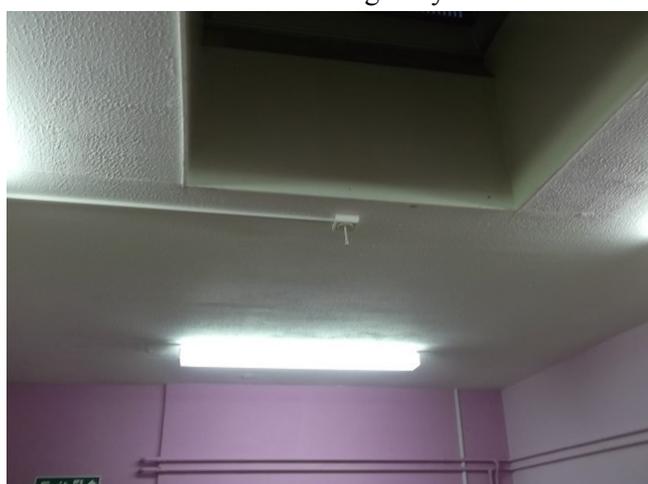
Sample No: 13/10/B/30/DS5
G.03 Willie Maudsley Room Ceiling - Textured coating to plasterboard containing Chrysotile

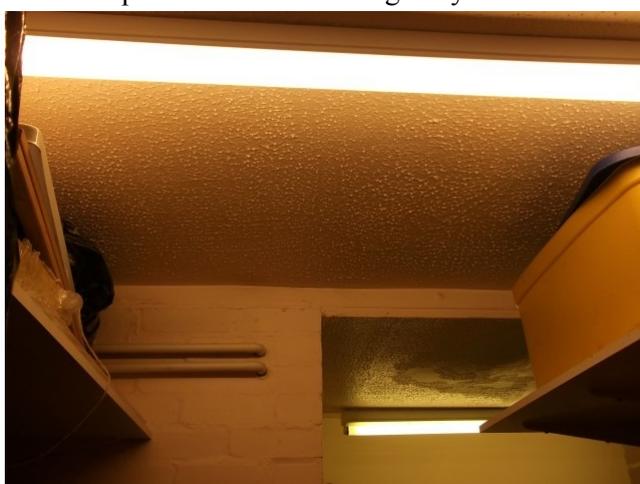
Sample No: 13/10/B/30/DS6
G.04 Office Ceiling - Textured coating to plasterboard containing Chrysotile

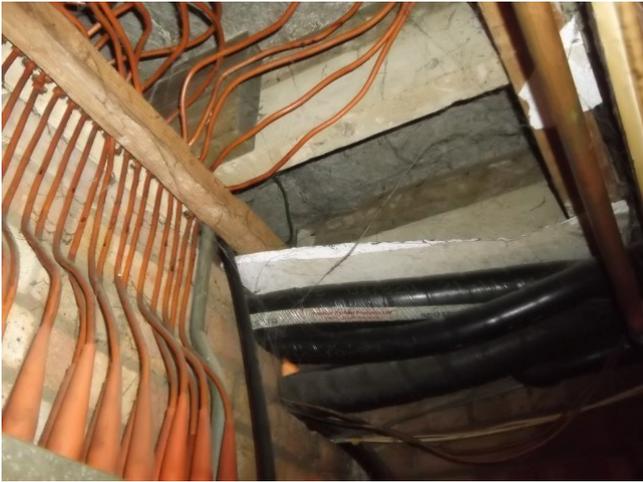
Sample No: 13/10/B/30/DS7
G.05 Cupboard Ceiling - Insulation board containing Amosite & Chrysotile

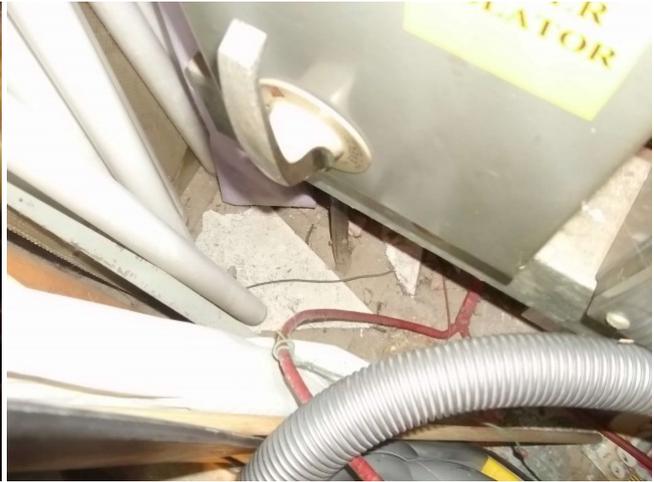
Sample No: Refer to Sample 13/10/B/30/DS7
G.05 Cupboard Floor - Insulation board debris containing Amosite & Chrysotile

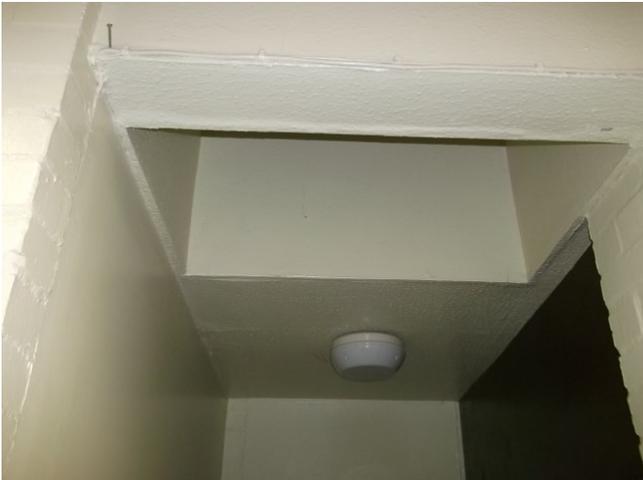
Sample No: 13/10/B/30/DS8
G.06 Lobby Ceiling - Textured coating to plasterboard containing Chrysotile

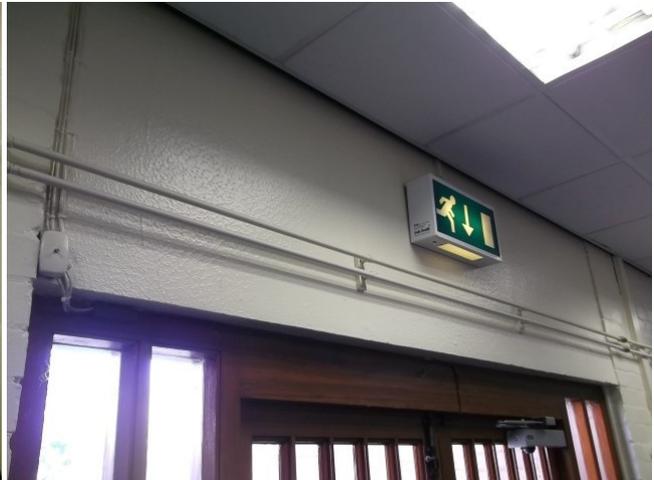
Sample No: Refer to Sample 13/10/B/30/DS8
G.06 Lobby Walls above doors - Textured coating to plasterboard containing Chrysotile

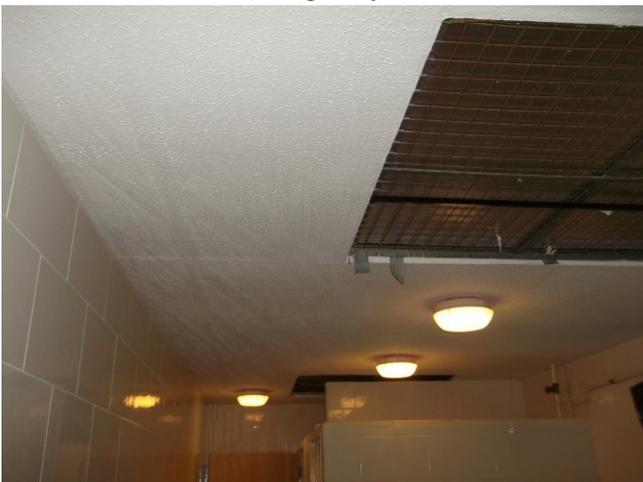
Sample No: Refer to Sample 13/10/B/30/DS8
G.07 Toilet Ceiling - Textured coating to plasterboard containing Chrysotile

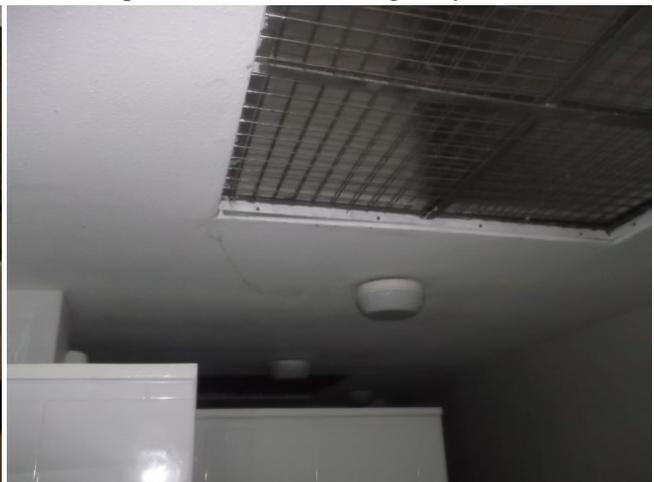
Sample No: Refer to Sample 13/10/B/30/DS8
G.08 Toilet Ceiling - Textured coating to plasterboard containing Chrysotile

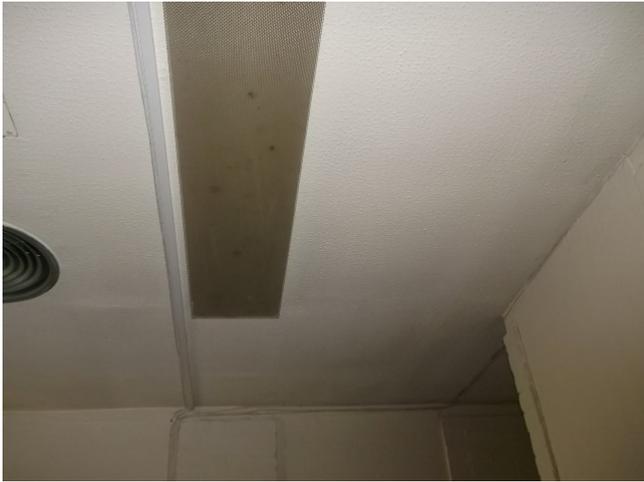
Sample No: Refer to Sample 13/10/B/30/DS8
G.10 Lobby Ceiling - Textured coating to plasterboard containing Chrysotile

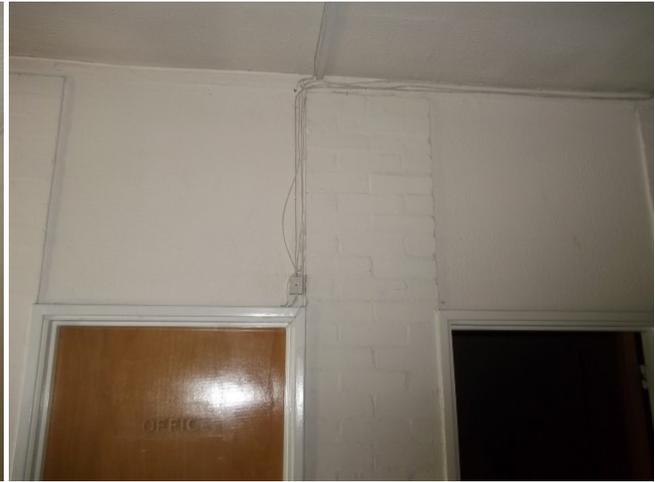
Sample No: Refer to Sample 13/10/B/30/DS8
G.10 Lobby Walls above doors - Textured coating to plasterboard containing Chrysotile

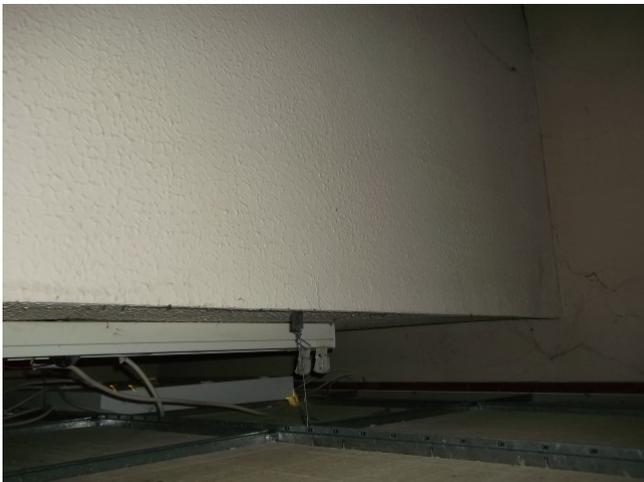
Sample No: Refer to Sample 13/10/B/30/DS8
G.12 Office Ceiling Void - Textured coating to plasterboard containing Chrysotile

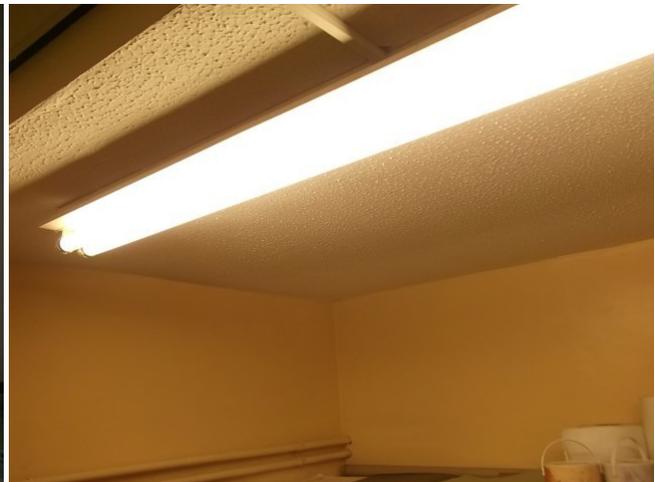
Sample No: Refer to Sample 13/10/B/30/DS8
G.13 Office Ceiling - Textured coating to plasterboard containing Chrysotile

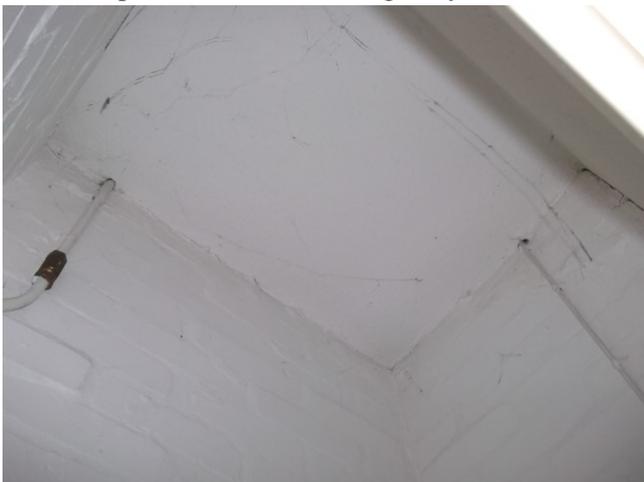
Sample No: Refer to Sample 13/10/B/30/DS8
G.14 Cupboard Ceiling - Textured coating to plasterboard containing Chrysotile

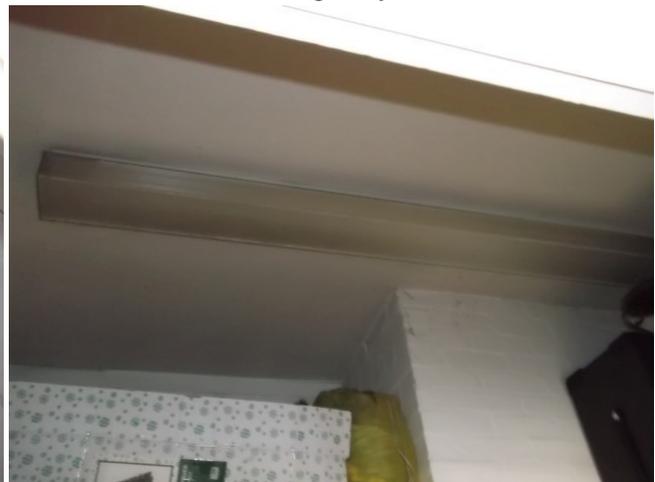
Sample No: Refer to Sample 13/10/B/30/DS8
G.15 Store Ceiling - Textured coating to plasterboard containing Chrysotile

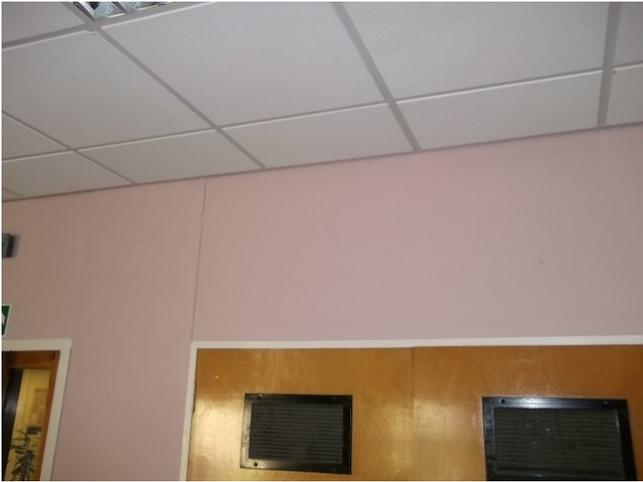
Sample No: Refer to Sample 13/10/B/30/DS8
G.16 Hall Walls above doors - Textured coating to
plasterboard containing Chrysotile

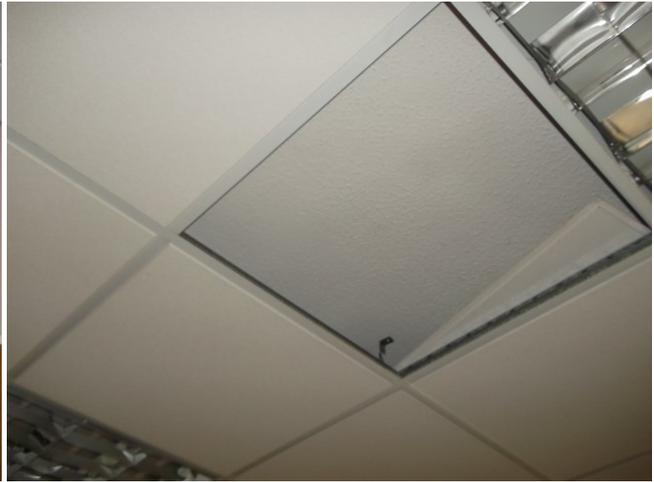
Sample No: Refer to Sample 13/10/B/30/DS8
G.16 Hall Ceiling Void - Textured coating to
plasterboard containing Chrysotile
