CBC Asbestos Refurbishment & Demolition Survey Report 9 Cannock Road, Dens Gym Corby 4th August 2020

CBC Asbestos Refurbishment & Demolition Survey Report 9 Cannock Road, Corby August 2020

CBC undertook an Asbestos Refurbishment & Demolition Survey at 9 Cannock road, Corby.

Daniel Payne & Jacob Foglia undertook the survey on 4th August 2020

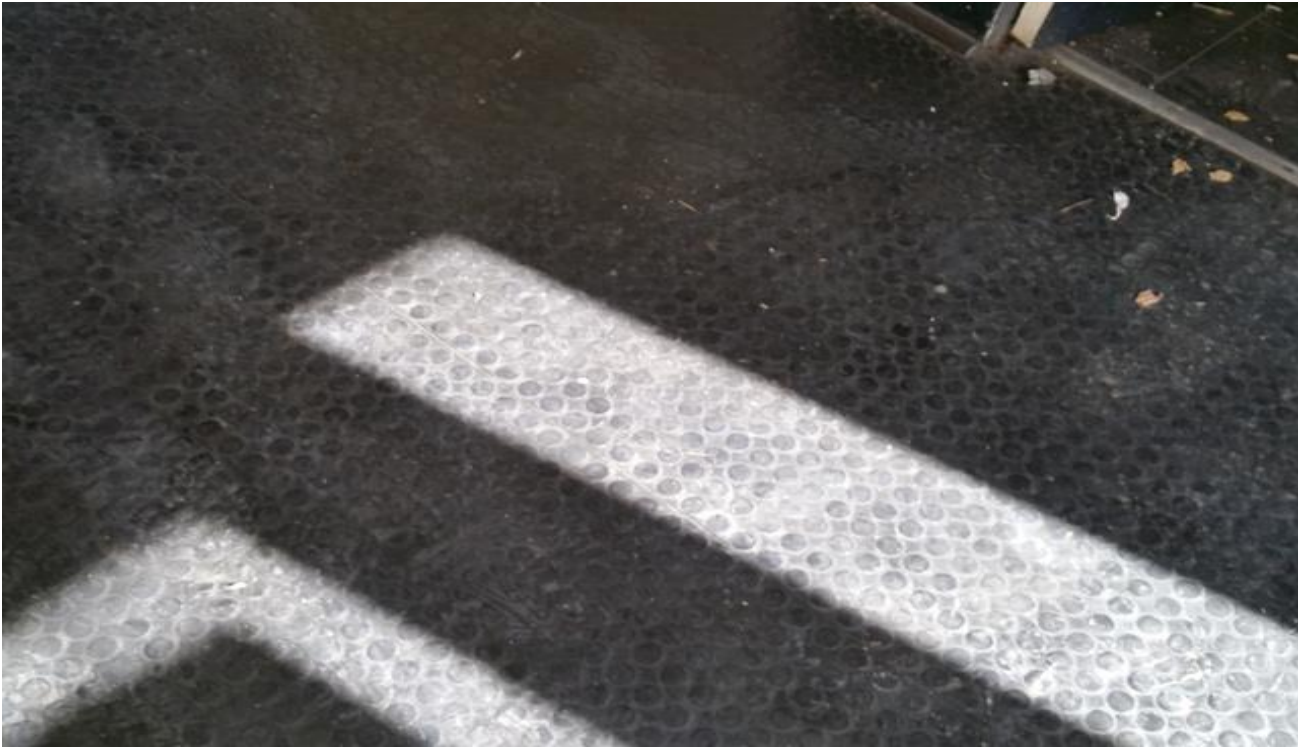
| Photo Number | 1 | Reference number | 040820DP01 |

| Area | Feature | Material Type - (Friability) | Photo No. | Asbestos Fibre | Condition / Surface Treatment | Extent | Access / Position | Reference Number / (Identification) | Risk Band | Recommendations |
|---|---|---|---|---|---|---|---|---|---|---|
| Dens Gym - Cannock Road, Ground, 01 / Entrance Hall | Floor tiles | Floor Tile / Covering - (Low) | 1 | Chrysotile (White Asbestos) | Fair / Composite materials, reinforced plastics, resin, vinyl materials | 7 sq. m. | High / Internal | 040820DP01 (Sample) | Risk Band D Very Low Risk | Manage in-situ via periodic re-inspection |

| Notes | ACM: Asbestos containing material | | |

| Building | Dens Gym - Cannock Road | Condition | Fair | 1 |

| Recommendation | Manage in-situ via periodic re-inspection | Assessment Score | | 3 |

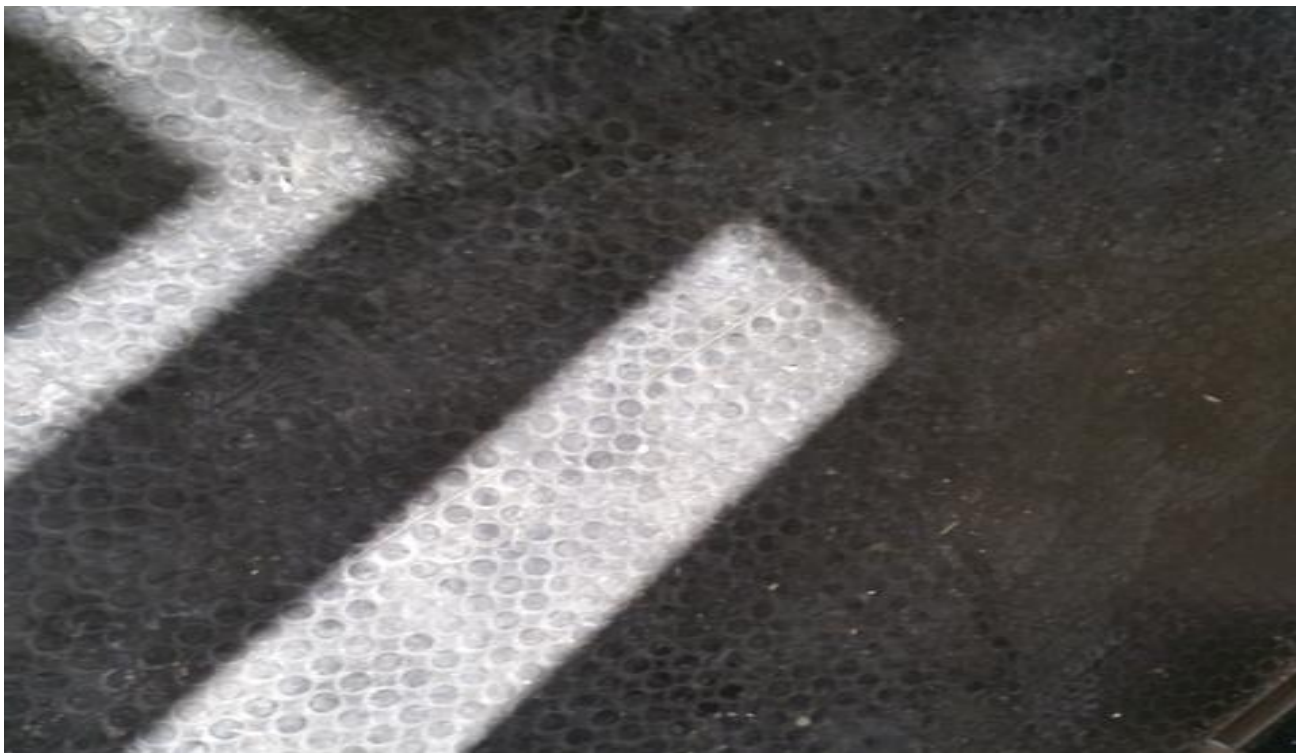
| Photo Number | 5 | Reference number | 040820DP04 |

| Notes | NADIS: No asbestos detected in sample | | |

| Building | Dens Gym - Cannock Road | Condition | Fair | 1 |

| Recommendation | No action necessary | Assessment Score | | 0 |

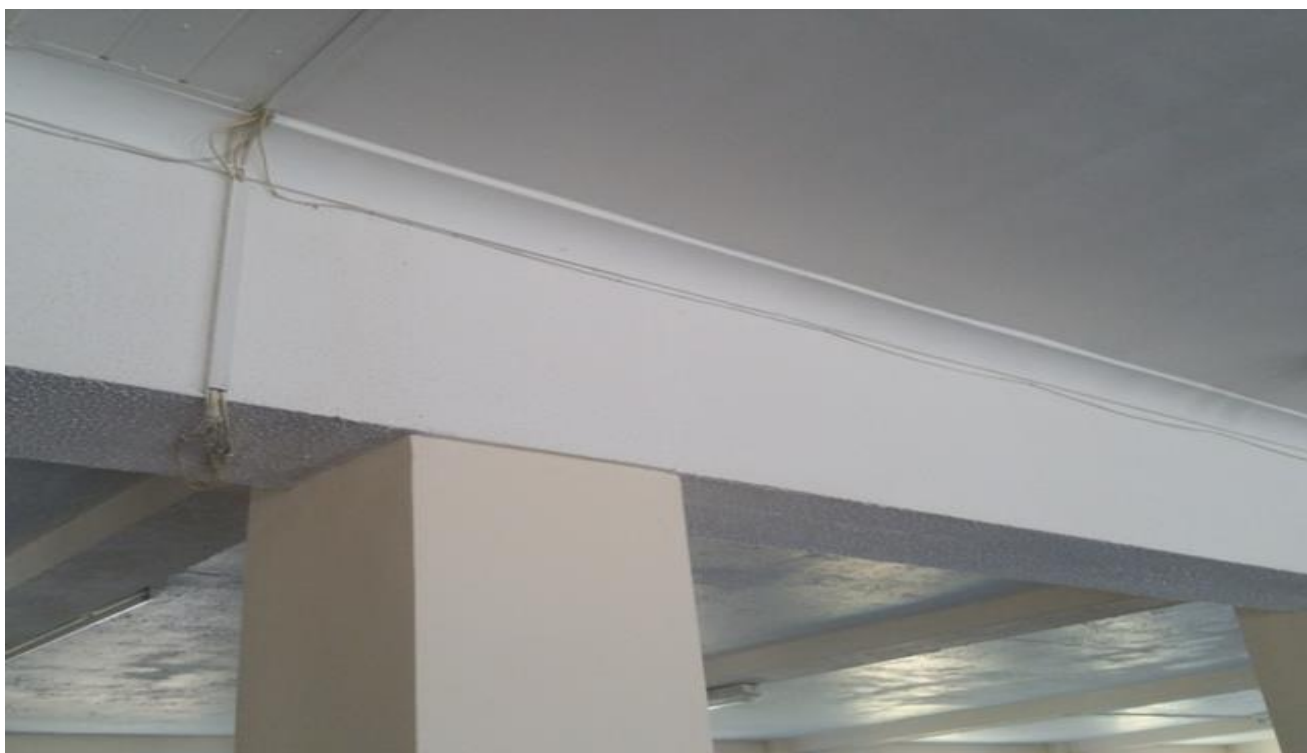
| Photo Number | 7 | Reference number | 040820DP07 |

| Area | Feature | Material Type - (Friability) | Photo No. | Asbestos Fibre | Condition / Surface Treatment | Extent | Access / Position | Reference Number / (Identification) | Risk Band | Recommendations |
|---|---|---|---|---|---|---|---|---|---|---|
| Dens Gym - Cannock Road, Ground, 04 / Side Hall | Textured Coating to ceiling and beams | Textured Coating - (Low) | 7 | Chrysotile (White Asbestos) | Fair / Composite materials, reinforced plastics, resin, vinyl materials | 75 sq. m. | Low / Internal | 040820DP07 (Sample) | Risk Band D Very Low Risk | Manage in-situ via periodic re-inspection |

| Notes | ACM: Asbestos containing material | | |

| Building | Dens Gym - Cannock Road | Condition | Fair | 1 |

| Recommendation | Manage in-situ via periodic re-inspection | Assessment Score | | 3 |

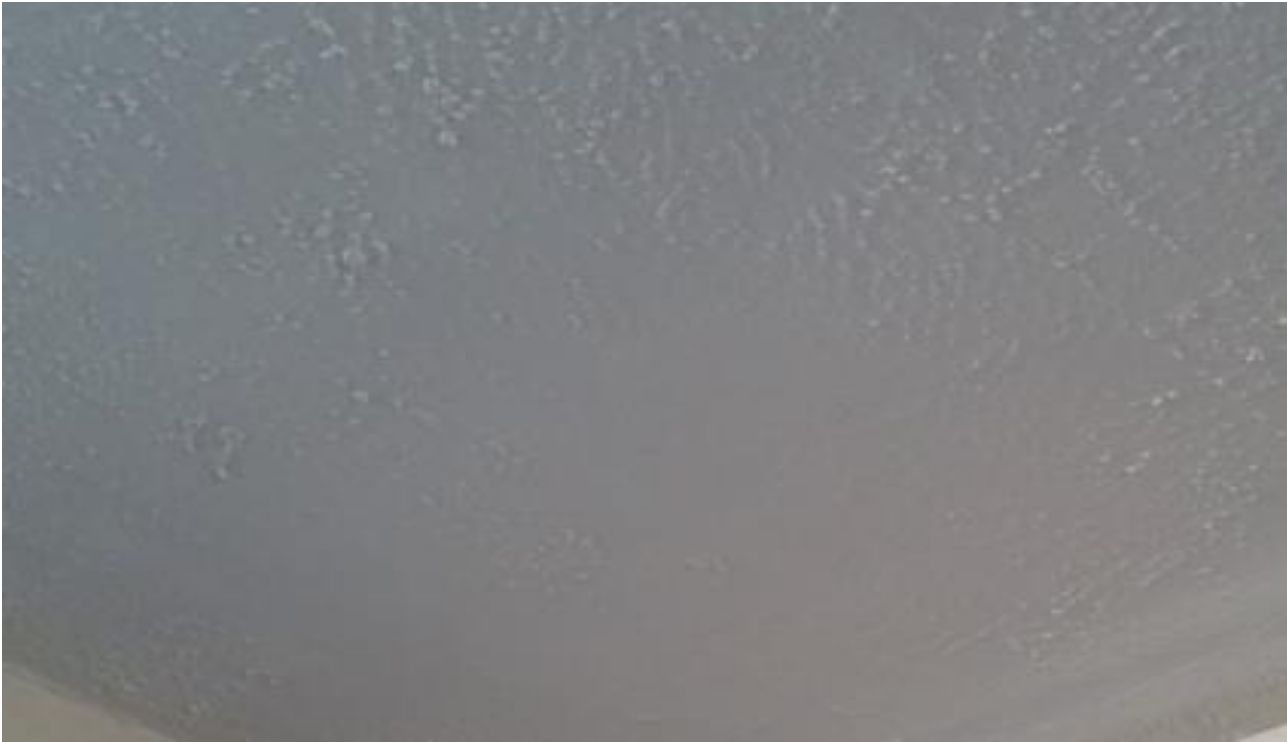
| Photo Number | 9 | Reference number | 040820DP09 |

| Area | Feature | Material Type - (Friability) | Photo No. | Asbestos Fibre | Condition / Surface Treatment | Extent | Access / Position | Reference Number / (Identification) | Risk Band | Recommendations |
|--|---|---|---|---|---|---|---|--|---|---|
| Dens Gym - Cannock Road, Ground, 05 / Lobby | Textured Coating to ceiling | Textured Coating - (Low) | 9 | Strongly Presumed Chrysotile (White Asbestos) | Fair / Composite materials, reinforced plastics, resin, vinyl materials | 6 sq. m. | Low / Internal | 040820DP09 (Same as Sample 040820DP07) | Risk Band D Very Low Risk | Manage in-situ via periodic re-inspection |

| Notes | ACM: Asbestos containing material | | |

| Building | Dens Gym - Cannock Road | Condition | Fair | 1 |

| Recommendation | Manage in-situ via periodic re-inspection | Assessment Score | | 3 |

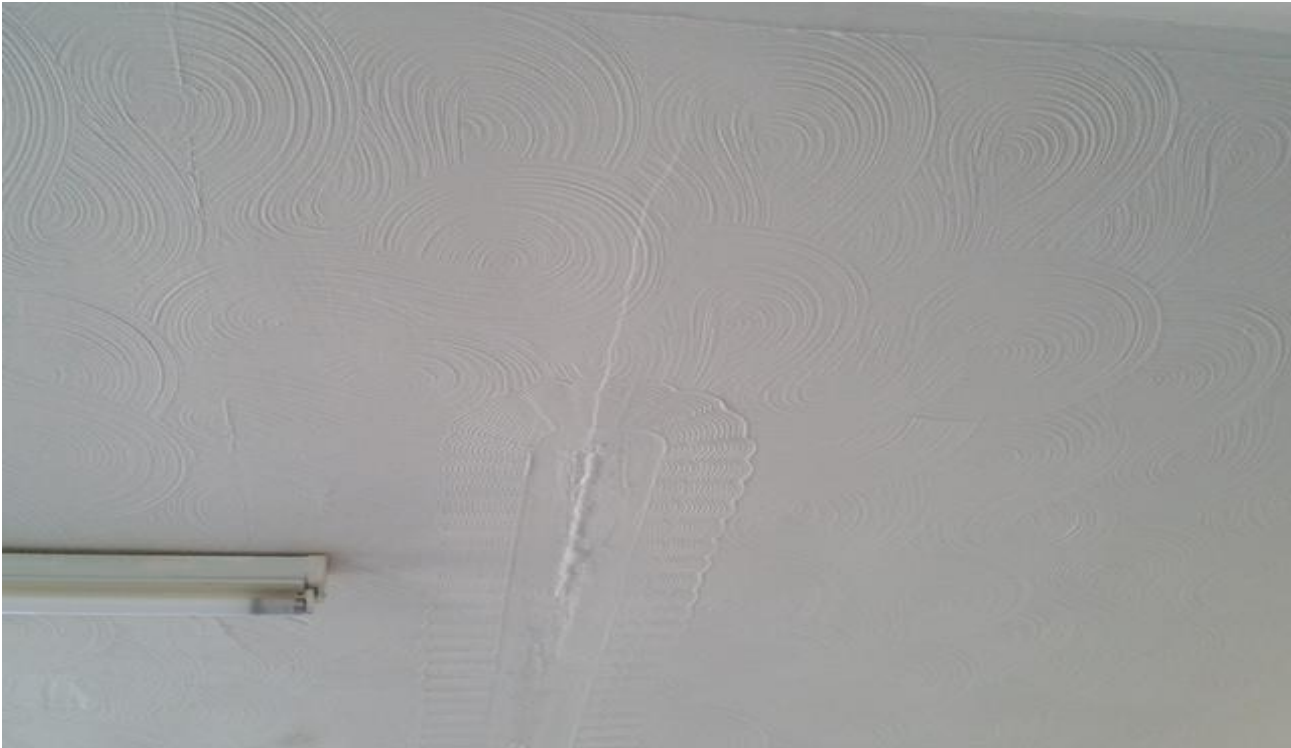
| Photo Number | 11 | Reference number | 040820DP11 |

| Notes | NADIS: No asbestos detected in sample | | |

| Building | Dens Gym - Cannock Road | Condition | Good | 0 |

| Recommendation | No action necessary | Assessment Score | | 0 |

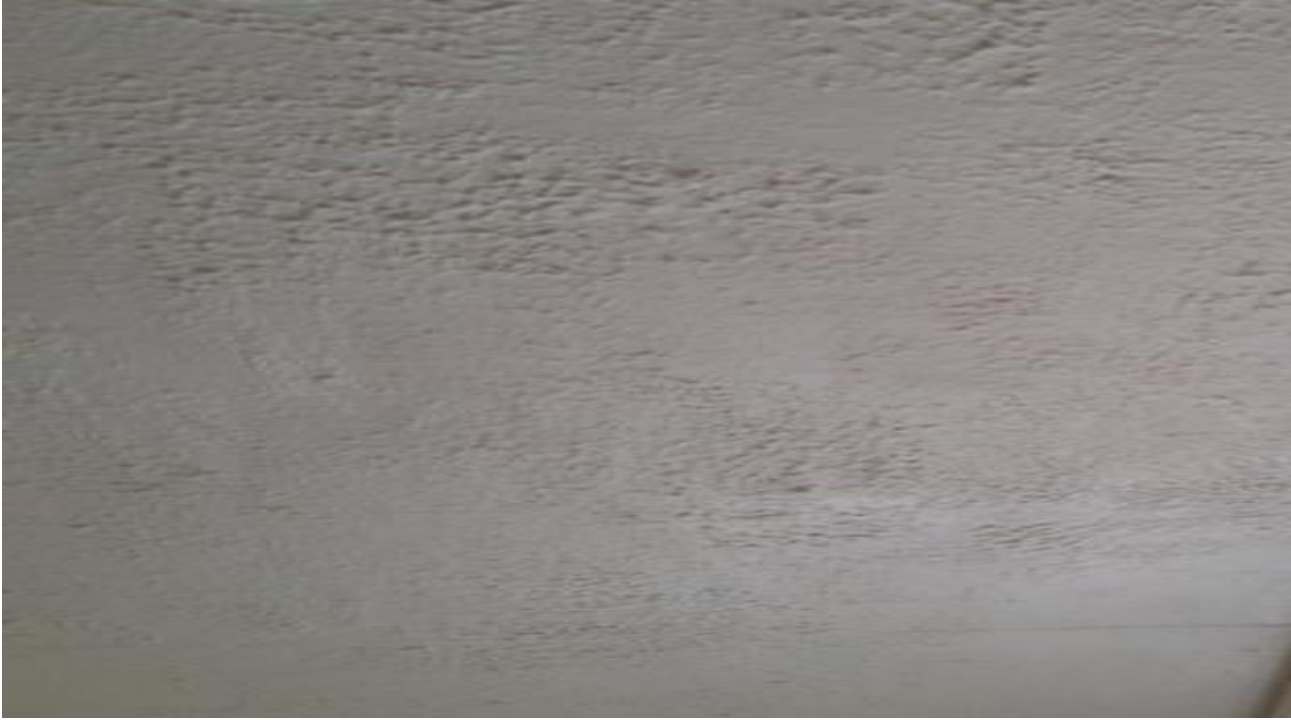
| Photo Number | 15 | Reference number | 040820DP16 |

| Notes | NADIS: No asbestos detected in sample | | |

| Building | Dens Gym - Cannock Road | Condition | Fair | 1 |

| Recommendation | No action necessary | Assessment Score | | 0 |

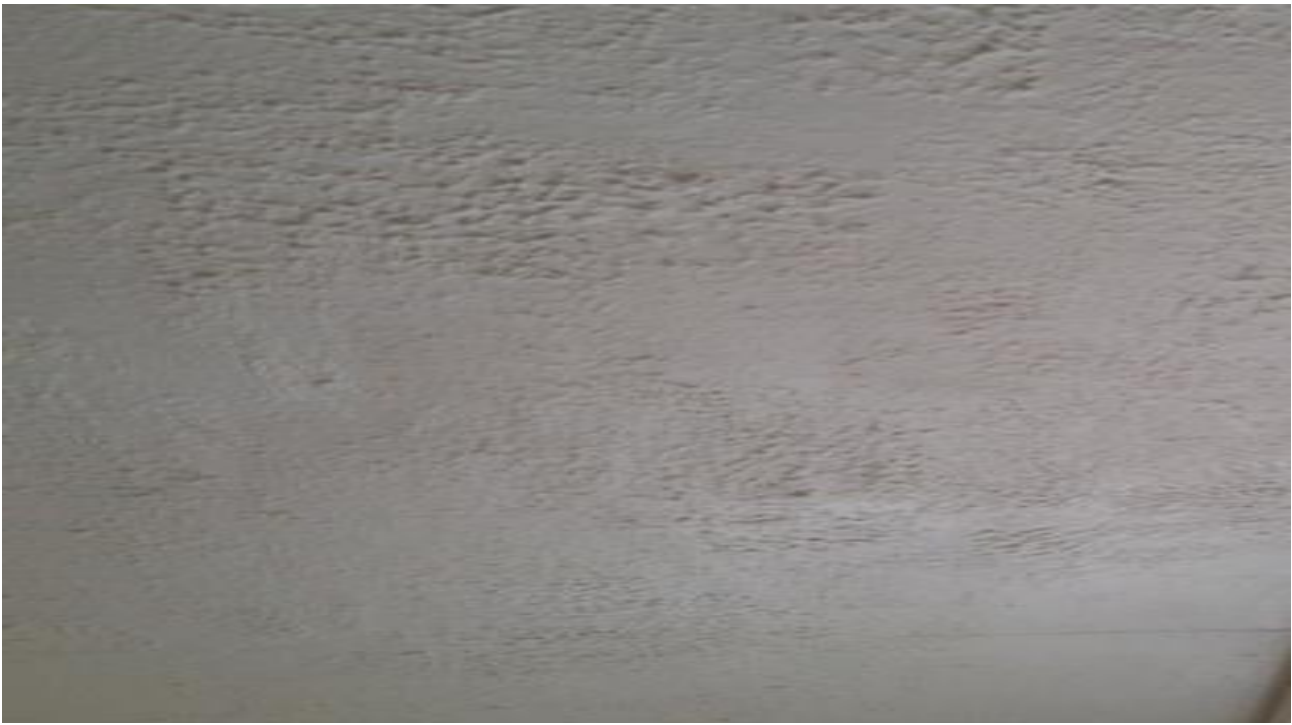
| Photo Number | 16 | Reference number | 040820DP17 |

| Notes | NADIS: No asbestos detected in sample | | |

| Building | Dens Gym - Cannock Road | Condition | Fair | 1 |

| Recommendation | No action necessary | Assessment Score | | 0 |
