Refurbishment Survey Report

10 Blandford Grove

Order Placed By: Paul Ainsley
Project Number: MCP-1189H-578

Survey Date: 10/07/2014

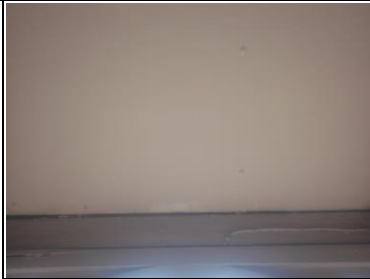
Sample 01	IB canopy	ID	External	3	2m²	-	-	-	NAD	-	N/A
		Photo Reference	24

SAMPLE REF	SAMPLE LOCATION	MATERIAL TYPE	SAMPLE COLLECTION DETAIL	
		ANALYSIS RESULT	SAMPLE ANALYSIS DETAIL	
1	MCP-1189H-578-01 - External canopy	Board	Client	11 July 2014
		No Asbestos Detected	E Lockwood	14 July 2014
