# Structural Conservation of Robert Stephenson's High Level Bridge across the River Tyne

by Graham Herdman,\* Tim Abbott† and Jon Powell†

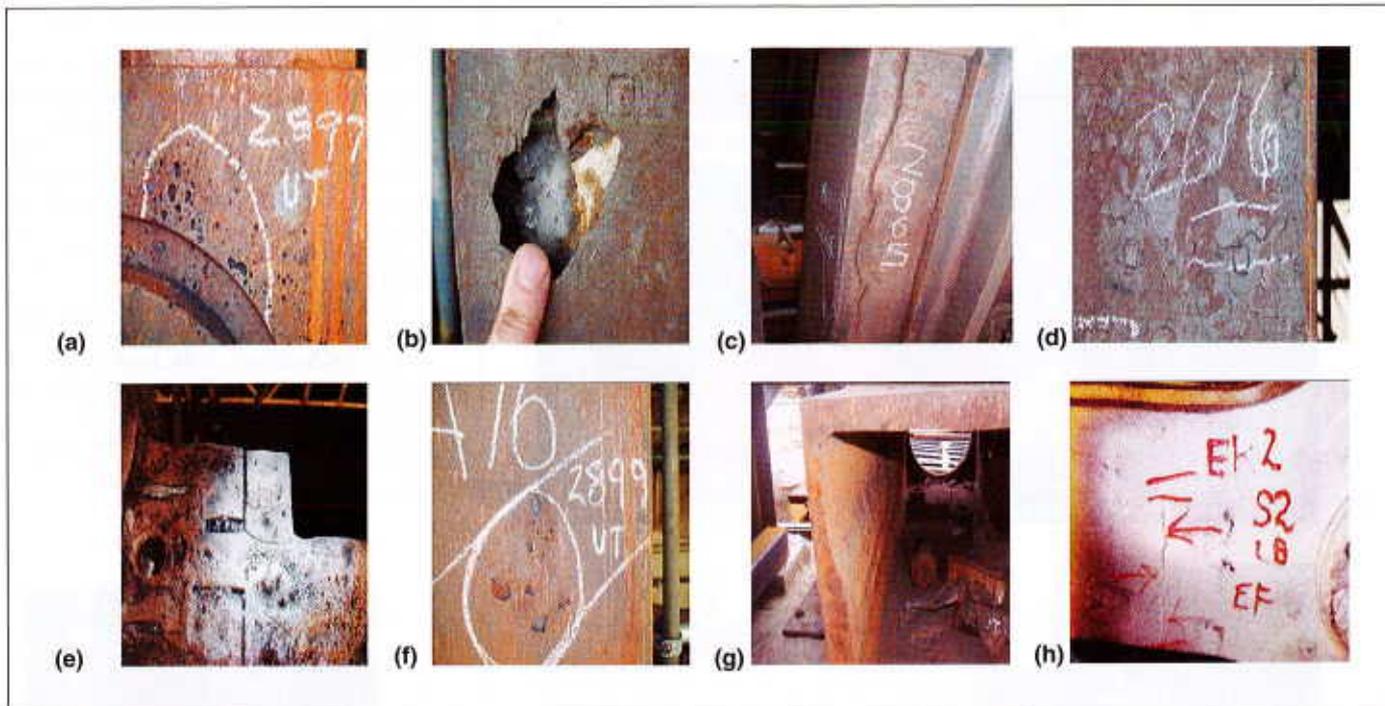
Those anomalies classed as "original casting discontinuities" can be further divided into the following categories (Figure 3):

Figure 3 — Original casting and forge discontinuities: (a) gas porosity and holes; (b) gas entrapment; (c) cold shuts; (d) unfused chills; (e) hot tears; (f) sand inclusions; (g) uneven wall thickness; (h) lack of weld fusion.

tapping or dampness in the mold, resulting in gas holes or wormholes

- gas entrapment (airlock) caused by air that has been trapped in the mold during pouring, resulting in a large void

- cold shuts caused by low metal temperature splashes of the molten metal onto the mold or streams of molten metal not fusing in the mold, resulting in lack of fusion

- unfused chills and chaplets caused by low metal temperature or contamination of the insert

- hot tears caused by lack of mold/core breakdown or restriction during the solidification process

- inclusions caused by sand erosion at the ingate during pouring or poor mold closure, resulting in pieces of sand scattered on up-surfaces of the casting

- uneven wall thickness caused by misplaced cores.

The original dropforge welding discontinuities were caused by low metal temperature, contamination or lack of hammering on the joint, resulting in lack of fusion at the joint.

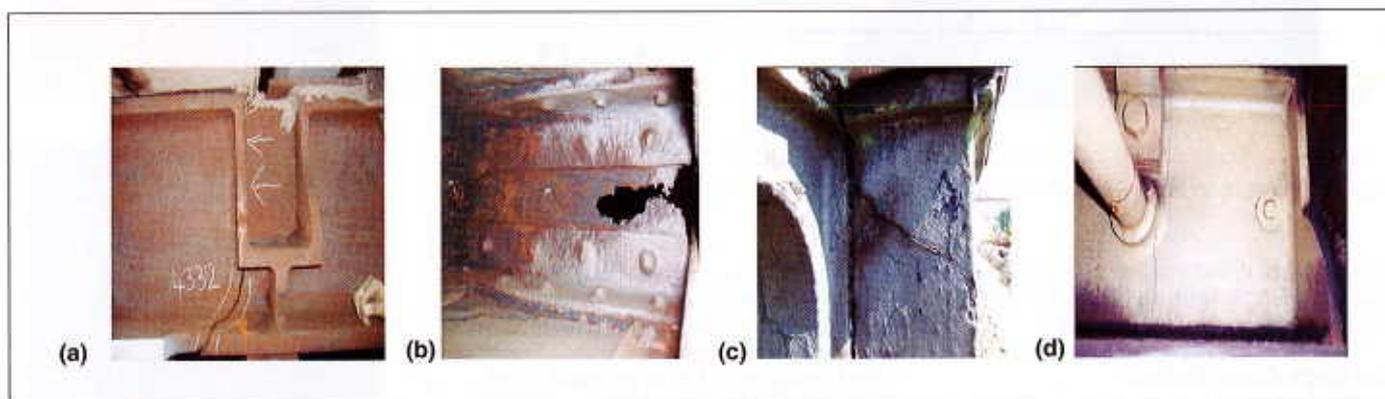
Figure 4 — Other forms of anomalies encountered on the bridge: (a) fatigue stress cracks; (b) girder corrosion; (c) weather damage; (d) heat damage.

The other problems encountered on the bridge (Figure 4) include fatigue anomalies caused by cyclic loading, resulting in cracks in various structural members including tie chains, columns, cross girders and longitudinal girders. Corrosion, caused by wind and water erosion and salt corrosion, resulted in section loss. Weather damage, caused by freeze/thaw action, resulted in cracks and ruptures. Heat damage, caused by a warehouse fire beneath Span 6 in 1886 (Addyman and Fawcett, 1999), resulted in quench cracks.

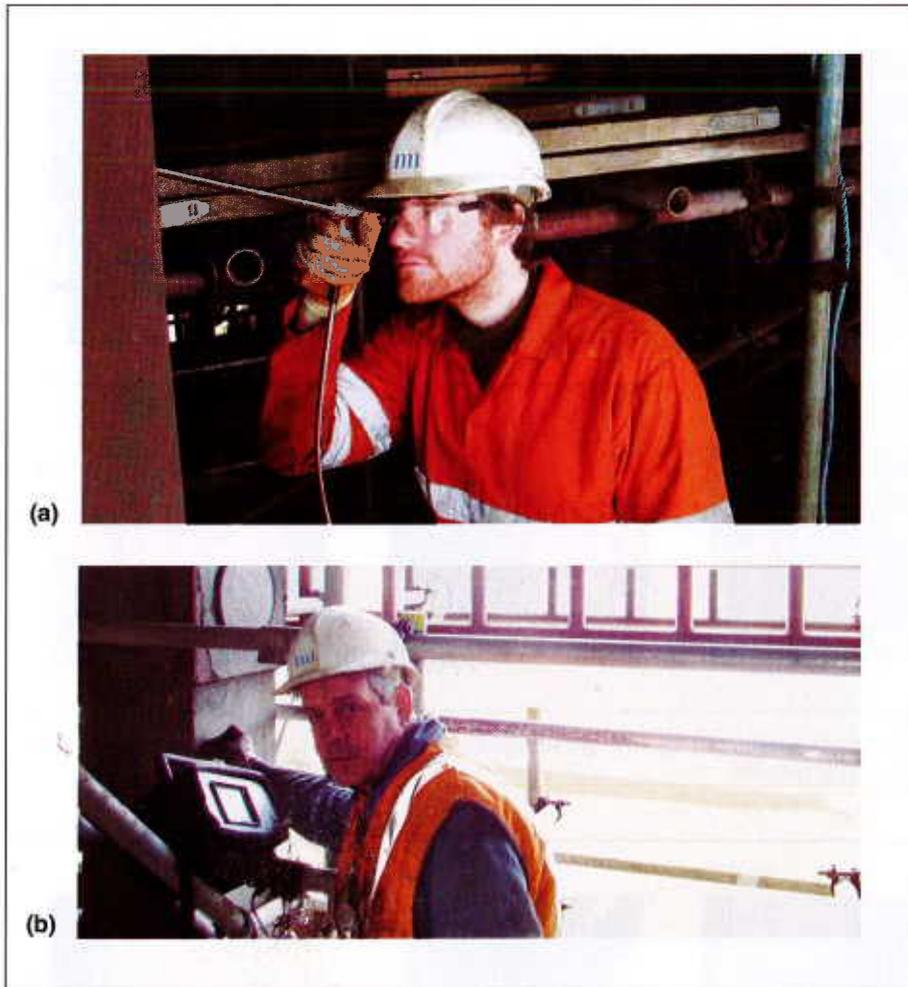
cracking of the original cast iron longitudinal girders was exposed (Figure 5). The same areas were targeted for testing throughout the structure and magnetic particle and ultrasonic testing were utilized extensively. A single girder was also extracted to validate the ultrasonic testing results. The decision was made to investigate the feasibility of providing an alternative load path. The requirements for working on protected structures in the UK, however, stipulate that the original members must be retained and that any solution should be concealed from the bridge users.

Figure 5 — Nondestructive testing of the columns: (a) visual testing; (b) ultrasonic testing.

The solution was a compact fabricated steel overbeam that suspended the cross girders of both the road deck and pedestrian walkway and removed all vertical loads from the original cast iron girder. The overbeam was designed to lie beneath a

maintenance cover plate at footpath level and with minimal intrusive fixings could, if required, be removed in the future.

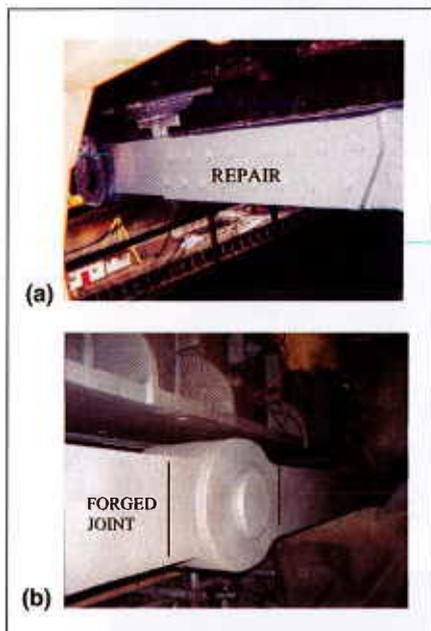
Figure 7 — Tie chain link assembly: (a) showing repair; (b) showing forged joints.

An examination of the structure in 1999, prior to any blast cleaning work, uncovered a single fracture of a tie chain link at the forged joint between the eye and main body of the link. This was attributed to rust forcing between adjacent tie chain links (imparting secondary load effects onto the forge weld), and the probability that the forge weld contained anomalies that had not been highlighted during the original

proof loading. The fracture was repaired by a combination of welding and steel splice plates in order to prevent locked-in stresses due to welding.

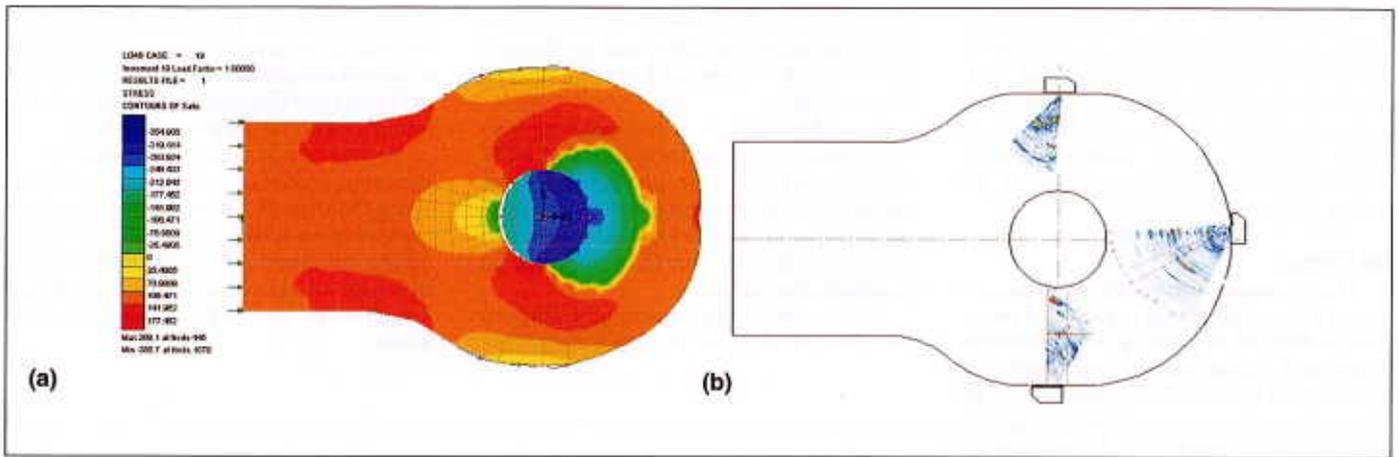
Figure 8 — Tie chain link data: (a) from finite element analysis; (b) from ultrasonic scanning.

Benchmarking was undertaken by drilling a number of 3 mm (0.12 in.) diameter holes at known stressed areas determined from finite element analysis of the tie chain (Figure 8). The depth of each 3 mm (0.12 in.) hole was increased until the ultrasonic operator could consistently and accurately locate the hole. All benchmarking was undertaken replicating actual testing conditions on the structure, with holes concealed from the ultrasonic operator and all testing being limited to the accessible faces of the tie chains. Upon completion of the benchmarking, the test piece was used as a calibration block. Benchmarking has allowed the NDT of the tie chains to proceed with a greater degree of confidence.

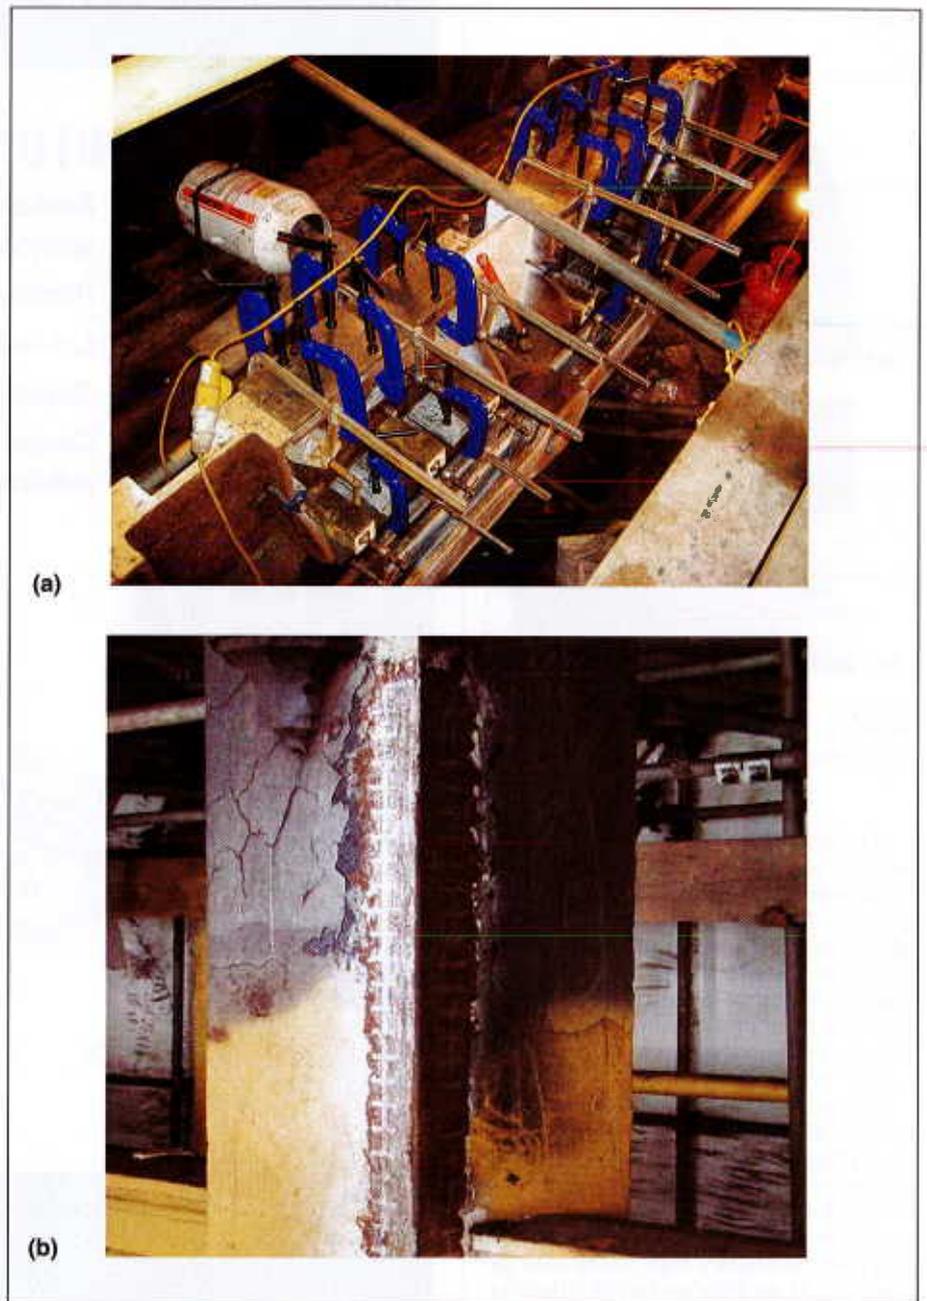
Figure 9 — Two methods of repairs: (a) plate bonding; (b) mechanical stitching.

Two methods of repair that have been popular with conservation officers include carbon fiber and steel bonded plates and mechanical stitching due to their subtle visual effects (Figure 9). Mechanical stitching

requires the incorporation of nickel alloy keys that are peened into jig-drilled holes across cracks.
