***Asbestos Refurbishment/ Demolition Survey
on behalf of
Liskeard Town Council***

***at
Liskeard Town Hall,
Liskeard
Cornwall.***

COMPILED BY: PDavies Consultancy Ltd 1st Issue DATE: 20th June 2016

SURVEY NUMBER**PD200616/01****DATE****12-13.04.16****SURVEYOR****P Davies****Signed
Date** 
20.06.16

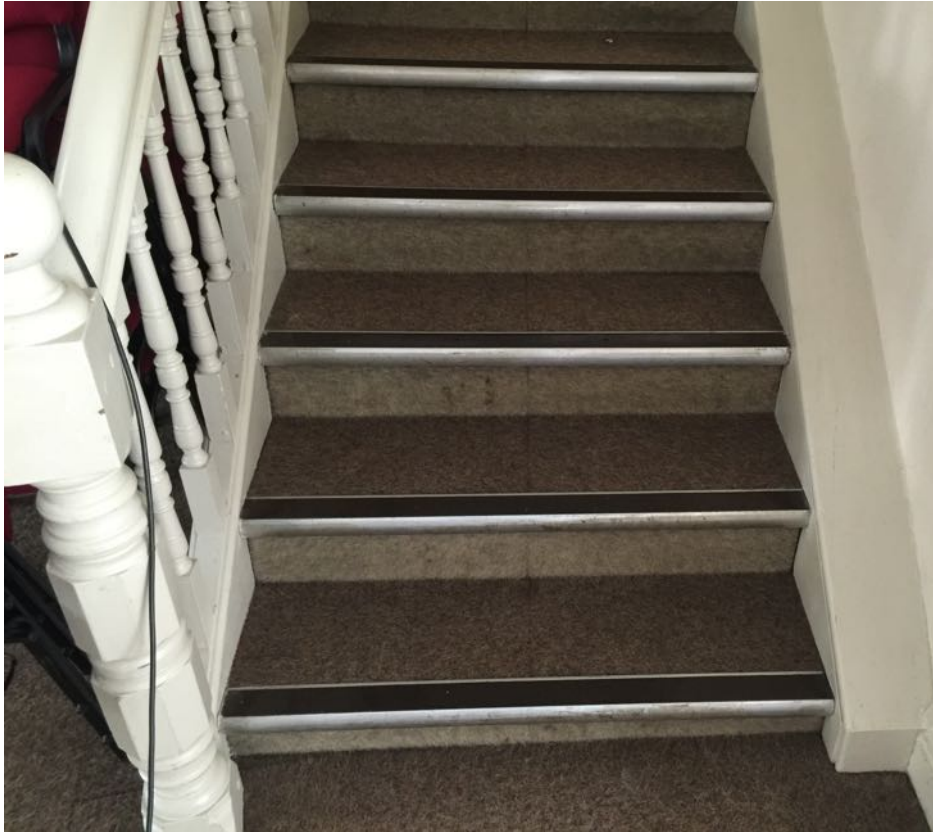
Photo 01

Plan Ref	Floor	Room	Location	Material	Quantity	Photo No.	Sampled	Condition	Risk	Comments
FF01	First	Refreshment Room	Stair nose tread	Vinyl		01	PD12051 6/04			No Asbestos Detected In Sample (N.A.D.I.S.). No Further Action Required
FF01	First	Refreshment Room	Ceiling Void	Roofing Felt		02	PD12051 6/05			N.A.D.I.S. No Further Action Required
FF01	First	Refreshment Room	Ceiling	Textured Coating		03	PD12051 6/07			N.A.D.I.S. No Further Action Required
FF01	First	Refreshment Room	Boxing to RSJ to be Inspected	Plasterboard		04				No Further Action Required
FF01	First	Refreshment Room	Floor Under Carpet Tiles	Wood & Concrete						No Further Action Required
FF02	First	New Liskeard Room	Ceiling	Textured Coating		05	PD12051 6/06			N.A.D.I.S. No Further Action Required
FF03	First	Kitchen	Ceiling	Textured Coating			Ref: PD12051 5/07			N.A.D.I.S. No Further Action Required
FF03	First	Kitchen	Dumb Waiter	No Asbestos Visually Detected (N.A.V.D.)						Timber Boxing on Brick & Block. No further Action Required

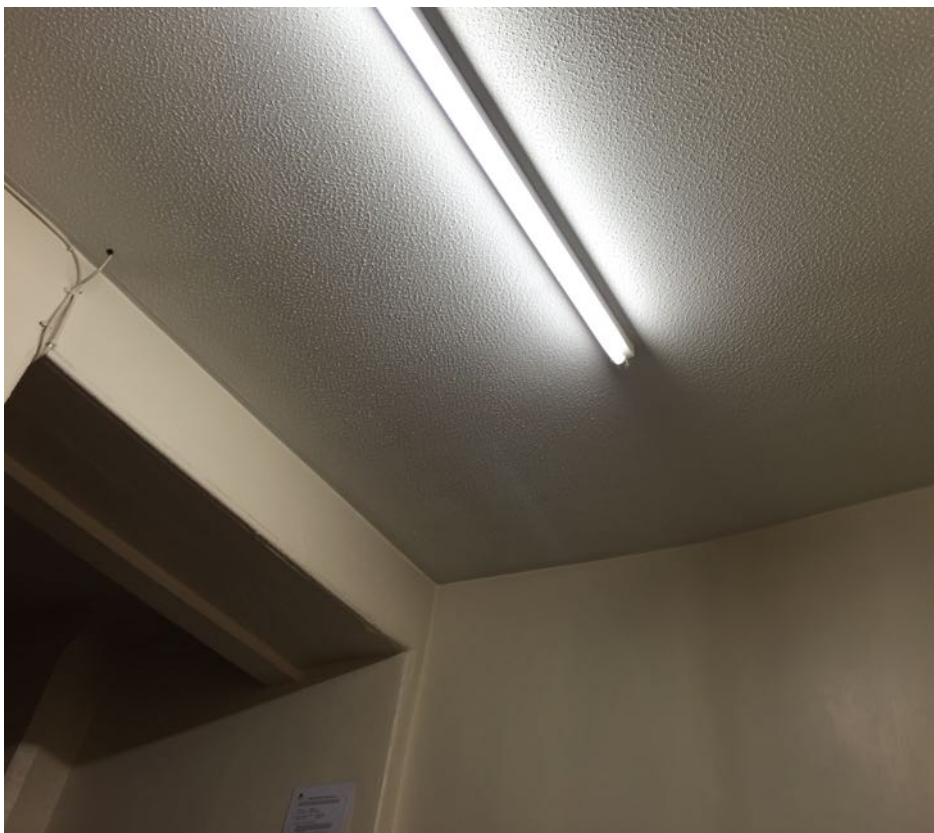
Photo 06

FF04	First	Caretakers room	Ceiling	Textured Coating		06	Ref: PD12051 5/06			N.A.D.I.S. No Further Action Required
FF05	First	Void	Floor drain	Asbestos Cement	1Lm Visible	07	Strongly Presumed	Good	Low	Monitor. Refer to Recommendations
FF06	First	Rear entrance to Quimperce room	Floor	Vinyl & Adhesive	2m ²	08	PD12051 6/08	Good	Very Low	Only Bitumen is Positive. Remove. Refer to Recommendations
FF06	First	Rear entrance to Quimperce Room	Core Sample	N.A.V.D.						Concrete - No Further Action Required
GF01	Ground	Long Room	Boxing to RSJ on Ceiling	N.A.V.D.		09				Plasterboard - No Further Action Required

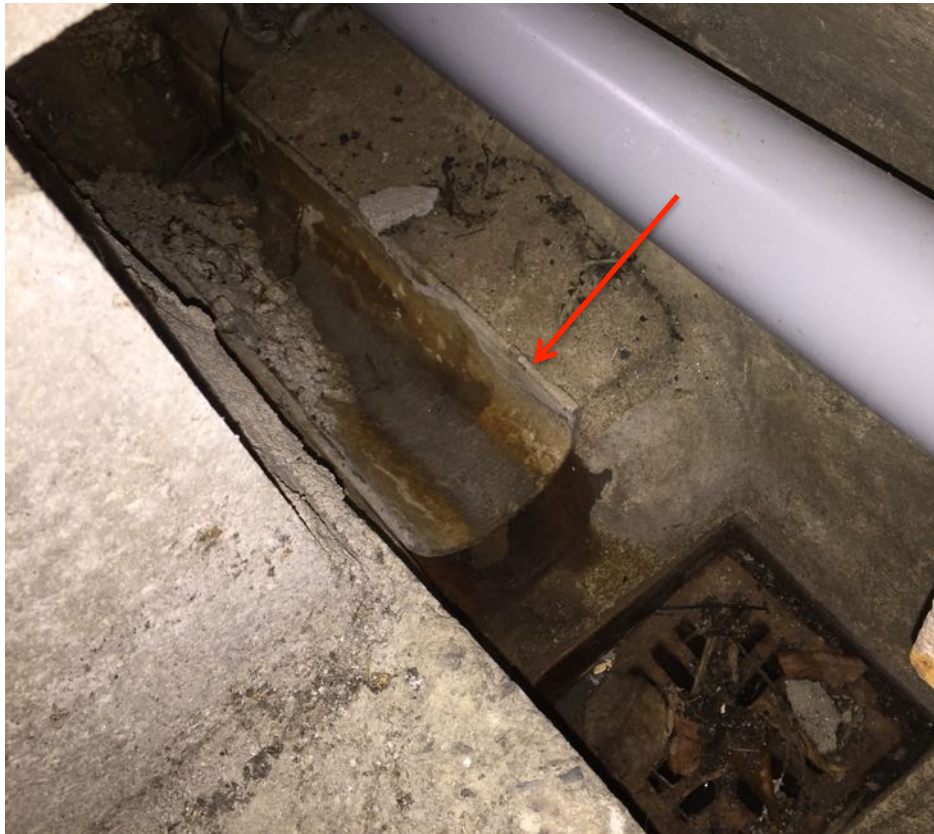
Photo 07

- In the void area on the first floor an asbestos cement drain has been identified, however the works which are being undertaken in this area will not effect the drain and therefore it has been recommended that the drain remains insitu. The material is classed as low grade, low risk and non licensable, which means that if the material is being removed it does not require a licensed contractor to remove it and it also does not require a 14 day notification to the HSE prior to the works. The contract involved in the works requires the relevant qualifications (working with non licensable materials and an in date asbestos refresher course) and the associated insurances.

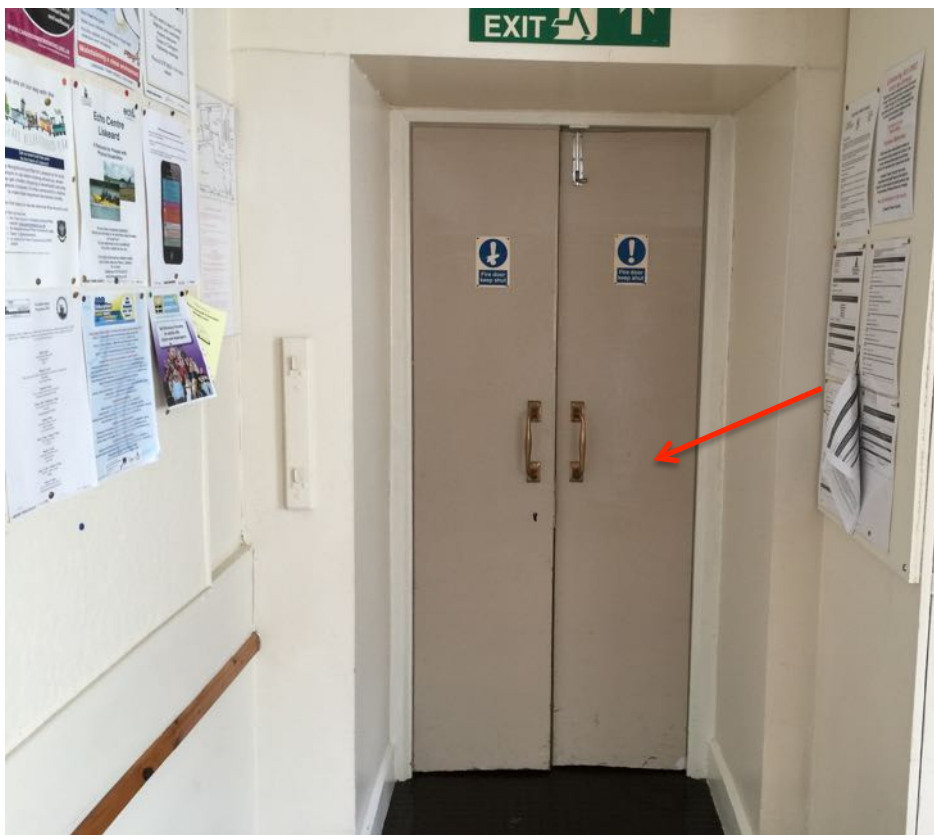
Photo 10

GF01	Ground	Long Room	Fire Door - Door Lining	Board		10	PD12051 6/01			N.A.D.I.S. No Further Action Required
GF02	Ground	Kitchen	Ceiling	N.A.V.D.						Plasterboard - No Further Action Required
GF02	Ground	Kitchen	Boxing	N.A.V.D.						Plasterboard & Ply wood – No Further Action Required
GF02	Ground	Kitchen	Dumb waiter	Panel – Low Level		11	PD12051 6/02			N.A.D.I.S. No Further Action Required
GF03	Ground	Store	Ceiling	N.A.V.D.						Plasterboard - No Further Action Required
GF03	Ground	Store	Ceiling Boxing	N.A.V.D.						Plasterboard- No Further Action Required
GF03	Ground	Store	Lintel Over Door way	N.A.V.D.						Plasterboard – Visible Lath & Plaster lining to stair case in refreshment room above. No Further Action Required
GF03	Ground	Store	Floor	Lino			PD12051 6/ 03			N.A.D.I.S. No Further Action Required
GF03	Ground	Store	Core Sample	N.A.V.D.						Concrete - No Further Action Required
