Asbestos Management Survey

Site Address:	Harlyn Bay Toilets Harlyn Bay Road Padstow	Surveyors:	Dave Matthews Lin Noble
	Cornwall PL28 8SB	Report prepared by:	Victoria Colliver
UPRN number:	14483	Date of survey:	12/12/2012
Project number:	76915	Report Date:	24/10/2012

Executive Summary

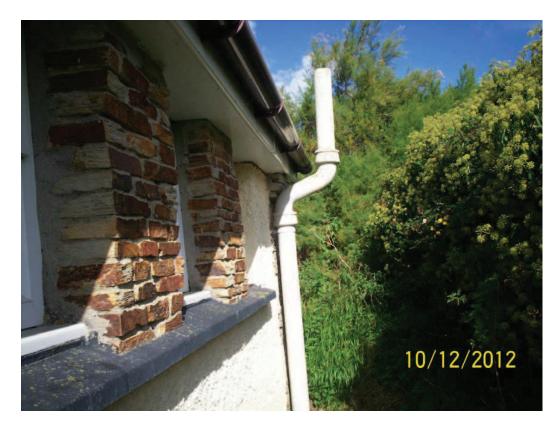
An asbestos soil vent pipe was detected within the areas surveyed.

BF	R	Room Description	Sample Ref. No:	Material Location	Approx. Quantity (m ²)	Product Type	Asbestos Type	Surface Treatment		Material Assem't Score	Accessibility	Comments
1 -	EXT	External to toilet	8201/02	Soil Vent Pipe	2.5m	Cement	Chrysotile	Painted	Good	3	High	-

Photo 1: Showing asbestos soil vent pipe

The type of asbestos material detected is not licensable, however only suitably trained and insured contractors can work on or remove these materials following the appropriate HSE guidance, including dealing with and transporting special waste.
