TASK NO.	TASK/DESCRIPTION		NOTES
	H3	HULL AND STRUCTURE – GUARDRAILS AND STANCHIONS	
H3.01	Vehicle Deck Guardrails <div data-bbox="397 434 1107 837">   </div> <p>Vehicle deck guardrail stanchions paint coatings are breaking down with active corrosion present at deck connection points. REPRESENTATIVE coatings.</p> <p>Allow for 15m² REPRESENTATION.</p>		<p>IAW Paint scheme -General 12 and Annex B refer.</p> <p>To be completed in conjunction with H2.17.</p> <p>Complete IAW Ref. 5.</p>

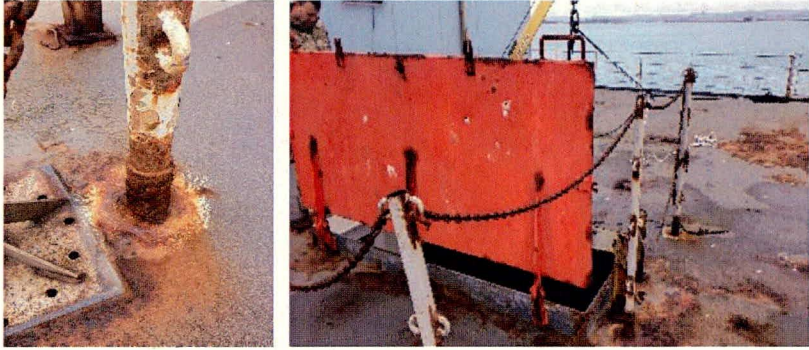
TASK NO.	TASK/DESCRIPTION		NOTES
	H3	HULL AND STRUCTURE – GUARDRAILS AND STANCHIONS	
H3.02	CASEVAC Hatch Guardrails

<p>CASEVAC hatch guardrail stanchions and stanchion deck supports have total paint covering breakdown with active corrosion present. Stanchion chains also suffering from active corrosion. SURVEY guardrail stanchion deck supports and RENEW as required. REPRESENTATIVE coatings on stanchion supports and stanchions. RENEW associated chains and shackles.</p> <p>ALLOW for 10m² REPRESENTATION.</p>		<p>Hotwork Required – Appropriate precautions to be taken iaw General 8.4.</p> <p>To be completed in conjunction with H2.17 and H4.01.</p> <p>IAW Paint scheme -General 12 and Annex B refer.</p> <p>Complete IAW Ref. 5.</p>

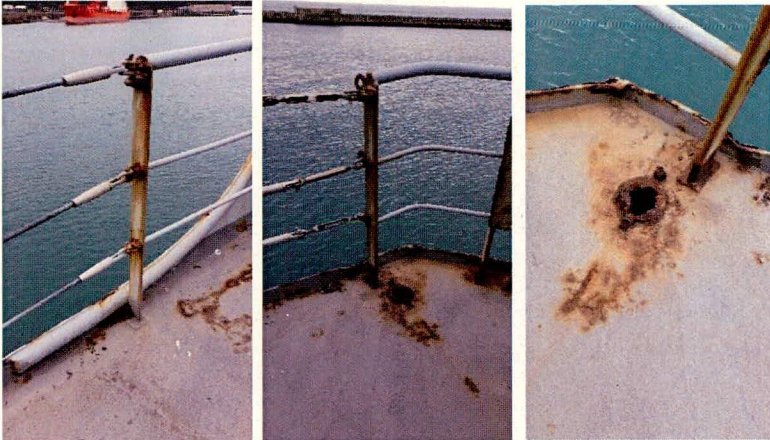
TASK NO.	TASK/DESCRIPTION	NOTES
	H3 HULL AND STRUCTURE – GUARDRAILS AND STANCHIONS	
H3.03	<p data-bbox="400 383 839 416">Forecastle Guardrail Stanchions</p> <div data-bbox="400 432 1174 869">

</div> <p data-bbox="400 887 1209 972">Both guardrail stanchions on the port side of the forecastle are bent and heavily corroded. REPLACE stanchions and REPRESENT deck and guardrails.</p> <p data-bbox="400 987 831 1016">ALLOW for 2m² REPRESENTATION.</p>	<p data-bbox="1251 383 1449 562">Hotwork Required – Appropriate precautions to be taken iaw General 8.4.</p> <p data-bbox="1251 589 1449 701">IAW Paint scheme -General 12 and Annex B refer.</p> <p data-bbox="1251 728 1449 786">Complete IAW Ref. 5.</p>

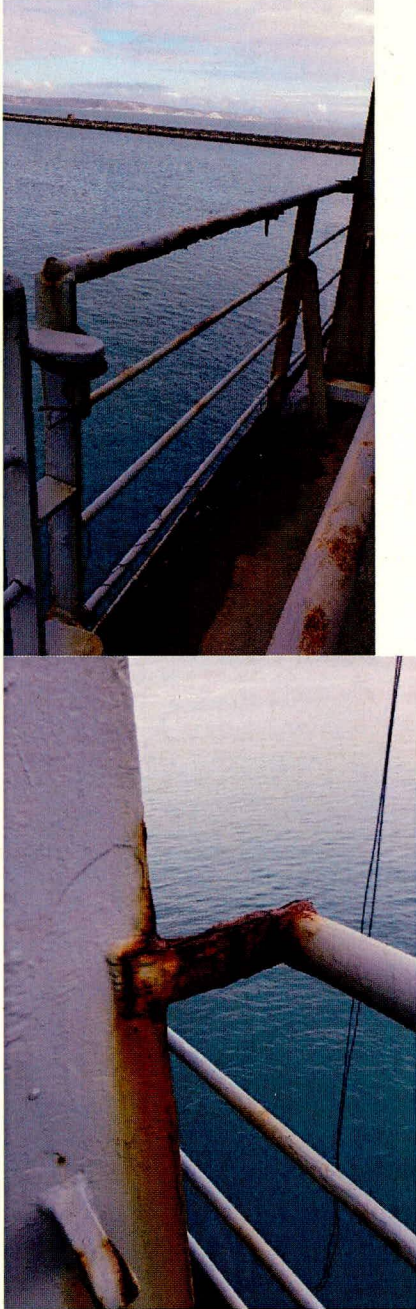
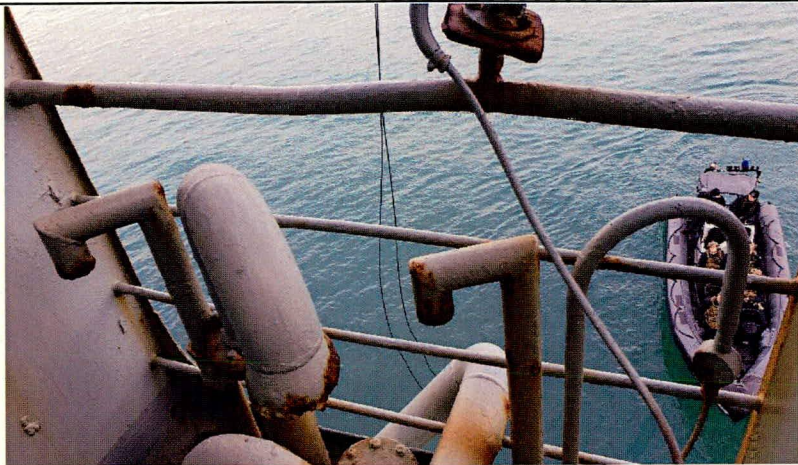
TASK NO.	TASK/DESCRIPTION	NOTES
	H3 HULL AND STRUCTURE – GUARDRAILS AND STANCHIONS	
H3.04	Guardrail 01 Deck

Guardrails have total paint covering breakdown in areas which has led to total thickness corrosion of tubular guardrails. Affected areas to be RENEWED including intermediate rails and end support fixings as shown. PRESERVE on completion.

ALLOW for 10m top rail and 6m intermediate rail RENEWAL. ALLOW for 6m² REPRESENTATION.

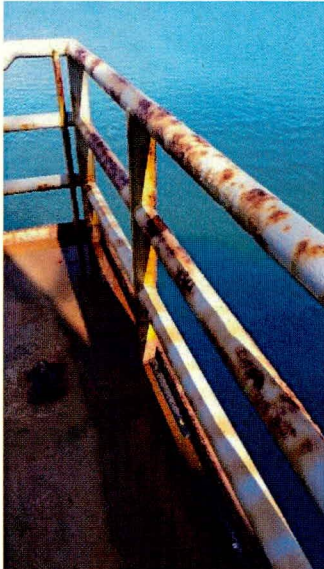
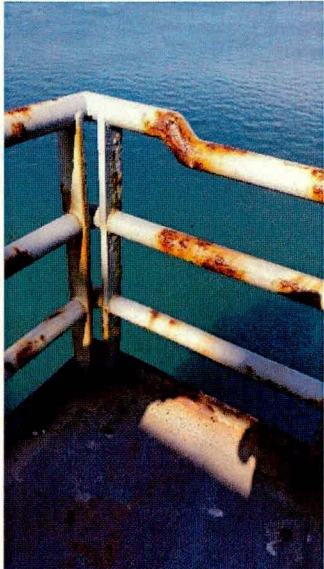
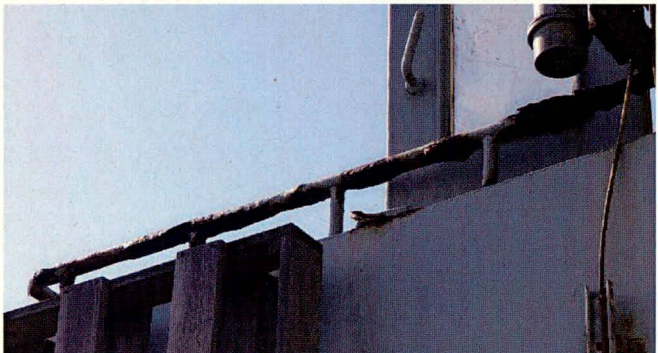
TASK NO.	TASK/DESCRIPTION		NOTES
	H3	HULL AND STRUCTURE – GUARDRAILS AND STANCHIONS	
H3.05	Port and Stbd Bridge Wing Guardrails <div style="display: flex; justify-content: space-around;">

<p>Stbd bridge wing guardrails show paint covering breakdown and active corrosion. REPRESENT all stbd guardrails. Port guardrail has severe full thickness active corrosion and requires RENEWAL.</p> <p>ALLOW for 8m guardrail RENEWAL. ALLOW for 20m² REPRESENTATION.</p>		<p>Hotwork Required – Appropriate precautions to be taken IAW General 8.4.</p> <p>IAW Paint scheme -General 12 and Annex B refer.</p> <p>To be completed in conjunction with H2.15.</p> <p>Complete IAW Ref. 5.</p>

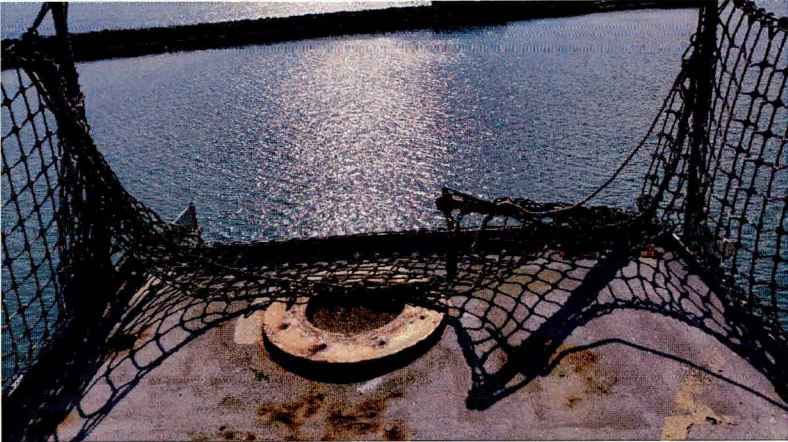
TASK NO.	TASK/DESCRIPTION		NOTES
	H3	HULL AND STRUCTURE – GUARDRAILS AND STANCHIONS	
H3.06	<p>Gundeck Guardrails</p>

<p>Strikable guardrails port and stbd are damaged and not fit for purpose. RENEW with fixed stanchions and permanent guardrails as fitted elsewhere on board. PRESERVE guardrails and deck area on completion.</p> <p>ALLOW for 15m guardrail RENEWAL. ALLOW for 10m² REPRESENTATION.</p>		<p>Hotwork Required – Appropriate precautions to be taken iaw General 8.4.</p> <p>IAW Paint scheme -General 12 and Annex B refer.</p> <p>Complete IAW Ref. 5.</p>

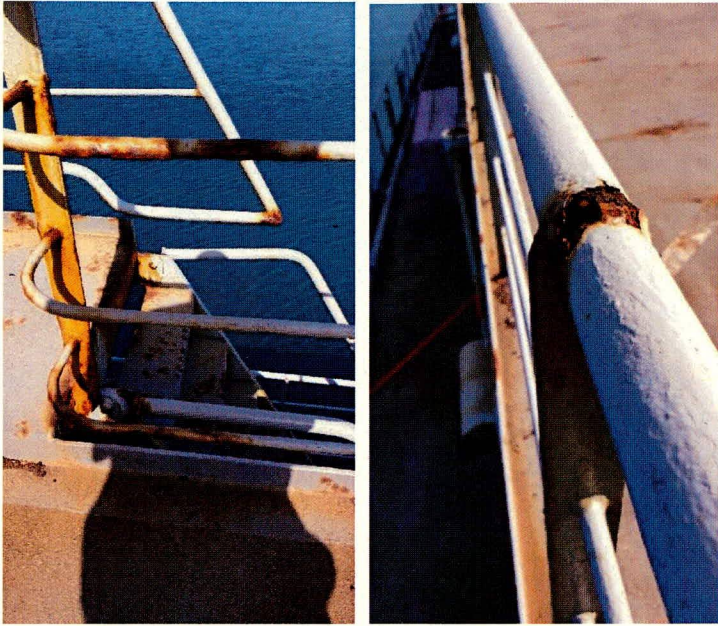
TASK NO.	TASK/DESCRIPTION	NOTES
	H3 HULL AND STRUCTURE – GUARDRAILS AND STANCHIONS	
H3.07	<p data-bbox="411 387 715 421">Flight Deck Guardrails</p> <div data-bbox="408 436 1129 1059">

</div> <p data-bbox="411 1075 1212 1160">The flight deck guardrails have areas of paint coating breakdown and active corrosion present. The top rail has suffered full thickness corrosion penetration and requires RENEWAL in certain areas.</p> <p data-bbox="411 1193 1212 1249">ALLOW for 8m top rail RENEWAL ALLOW for 10m² REPRESENTATION of all rails.</p>	<p data-bbox="1254 394 1449 562">Hotwork Required – Appropriate precautions to be taken iaw General 8.4.</p> <p data-bbox="1254 595 1449 703">IAW Paint scheme -General 12 and Annex B refer.</p> <p data-bbox="1254 736 1422 792">Complete IAW Ref. 5.</p>

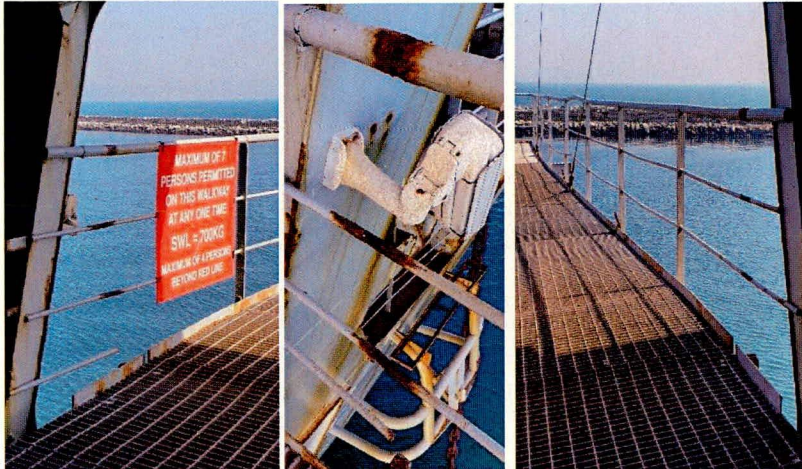
TASK NO.	TASK/DESCRIPTION		NOTES
	H3	HULL AND STRUCTURE – GUARDRAILS AND STANCHIONS	
H3.08	Aft Suspended Walkway Guardrails <div data-bbox="397 430 1203 896">

</div> <p>The aft suspended walkway guardrails are damaged and have areas of full thickness penetration due to corrosion on the top rail. REPLACE damaged lengths of top rail and also lengths of damaged/corroded/missing intermediate rails.</p> <p>ALLOW for 8m top rail and 30m intermediate rail RENEWAL. ALLOW for 15m² REPRESENTATION.</p>		<p>Hotwork Required – Appropriate precautions to be taken iaw General 8.4.</p> <p>IAW Paint scheme -General 12 and Annex B refer.</p> <p>Complete IAW Ref. 5.</p>
