JUNIPER STREET BUILDING I – ROOF CONDITION REPORT
NATIONAL MUSEUMS LIVERPOOL
AUGUST 2020

JUNIPER STREET ROOF CONDITION REPORT

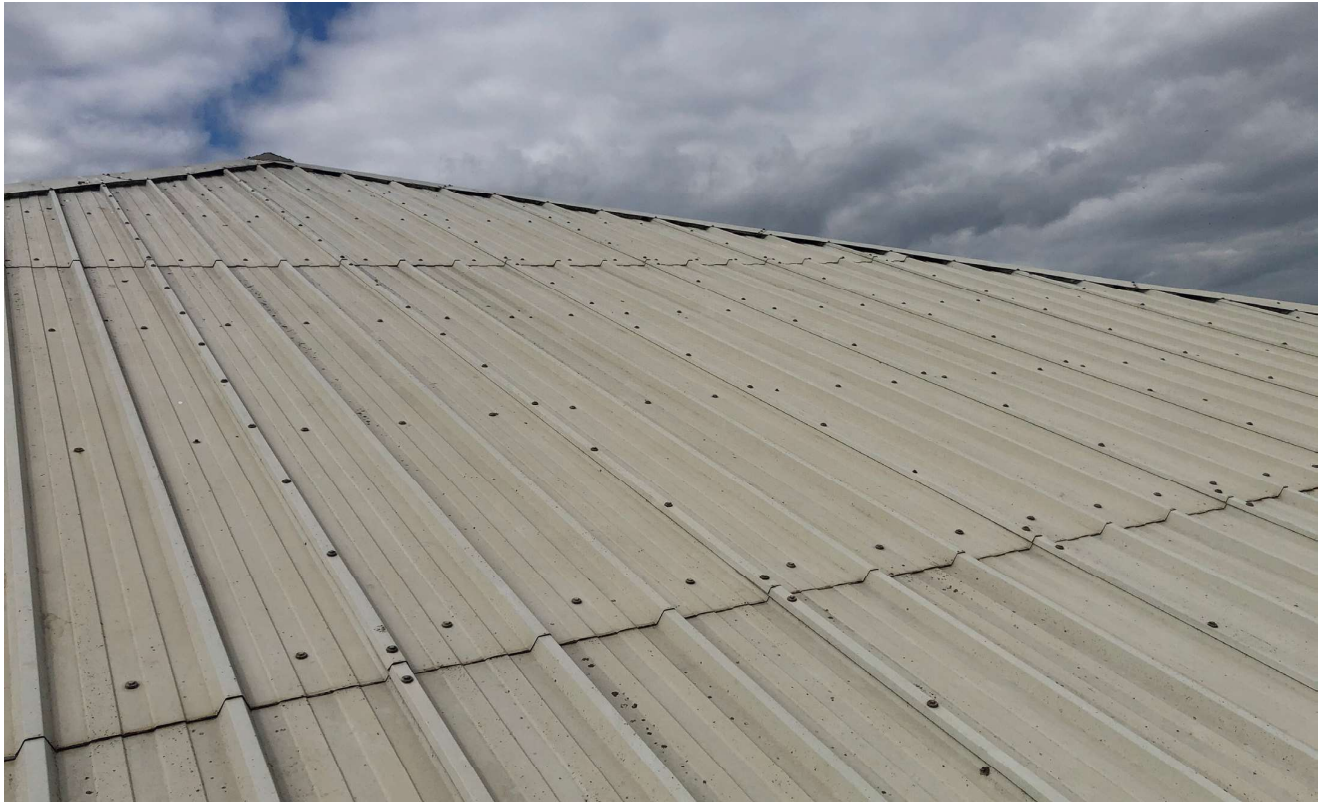
The roofing sheets all appeared to be in good condition, there were no significant defects, or penetrations noted which would contribute to water ingress. [Photo 3.2.1]

3.2.1 – roof sheets in good condition (Roof A)

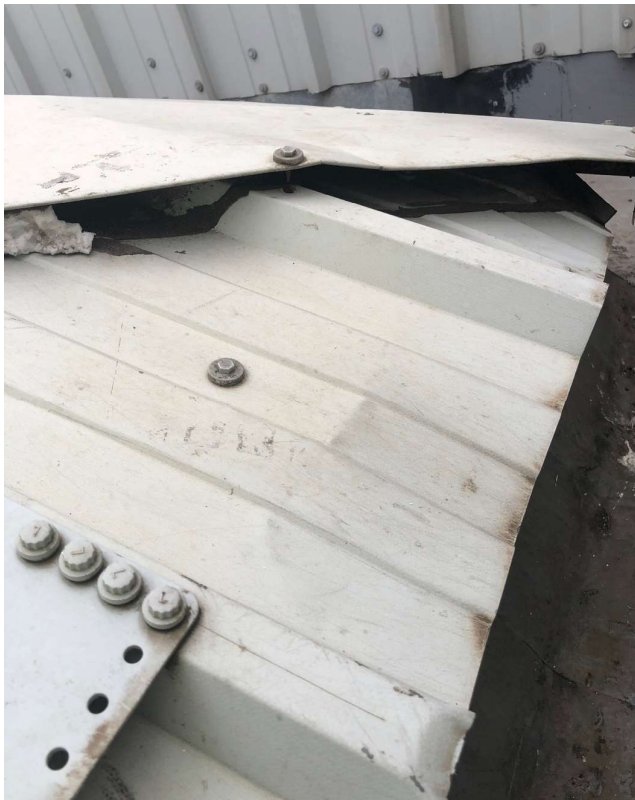
There were several areas where the edges of the panels have been depressed, likely due to being stood on during routine maintenance. This does not appear to be affecting the integrity of the system and cannot be seen unless on the roof. [Photo 3.2.2].

3.2.2 – depressed sheet edges due to being stood on

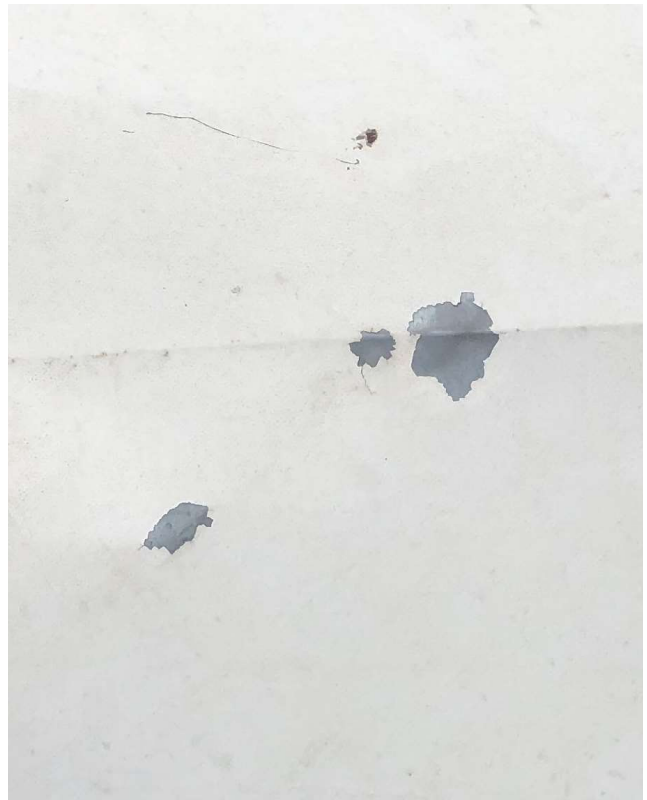
We noted a few isolated locations where the protective coating of the panels has been scratched, exposing bare metal below. In some locations this has begun to rust, and some remedial works should be considered. [Photo 3.2.3]

3.2.3 – protective coating removed and bare metal exposed (roof sheets)

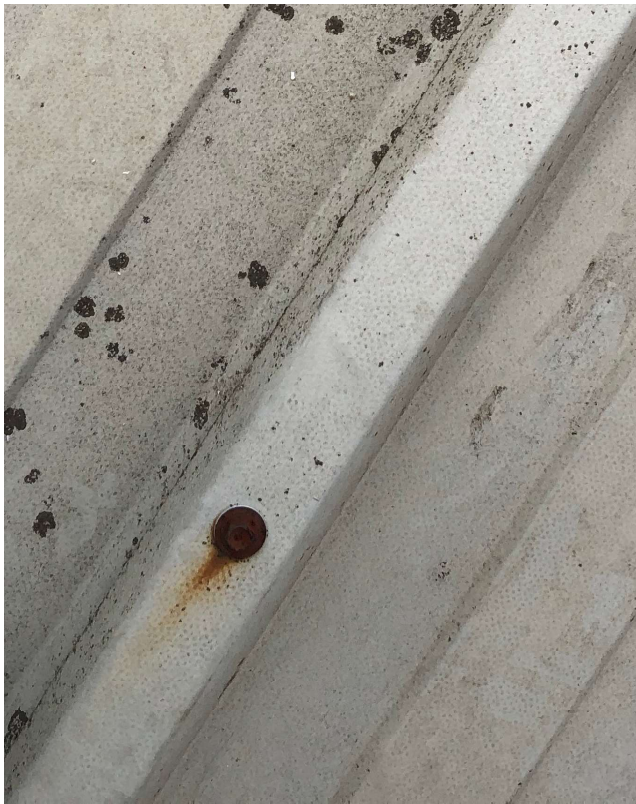
Aluminium panels are fixed down the steel roof structure with metal fixings. The fixings have self-sealing washers and waterproof caps, many of which have been lost or damaged. The corrosion to these fixings may be contributing to the high level of water ingress and further investigation by a specialist is required to confirm whether fixings should be resealed, replaced or covered by other maintenance works. [Photo 3.2.4]

3.2.4 – rusty fixings due to waterproof caps removed (roof sheets)

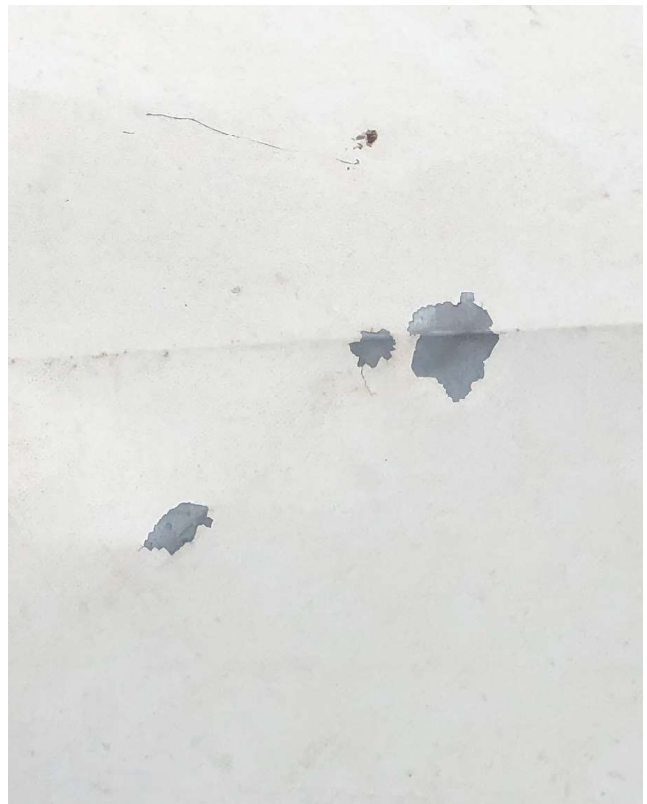
In general, the copings and parapets are in good condition. Similarly, to the roofing sheets there are isolated locations where the protective coating has been scratched leading to rusting. [Photo 3.3.1]

3.3.1 – protective coating removed and bare metal exposed (parapets and copings)

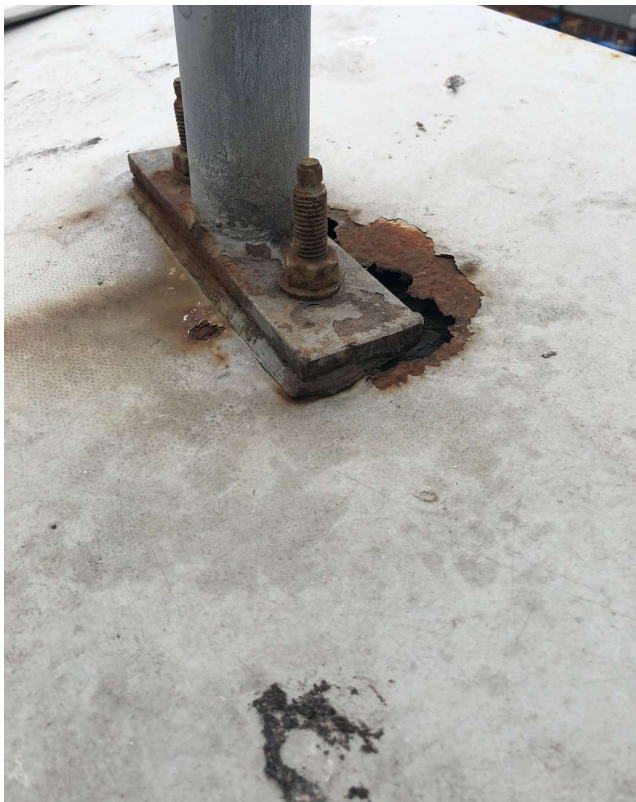
There were a few more significant defects noted, these were all in locations where fixings have been made through the surface, for example at the location of the roof access ladder; significant openings and rusting in the metal sheets have developed, allowing water to penetrate through the coping. These sheets should be replaced/repared. [Photo 3.3.2]

3.3.2 – parapet has corroded due to inappropriate fixings

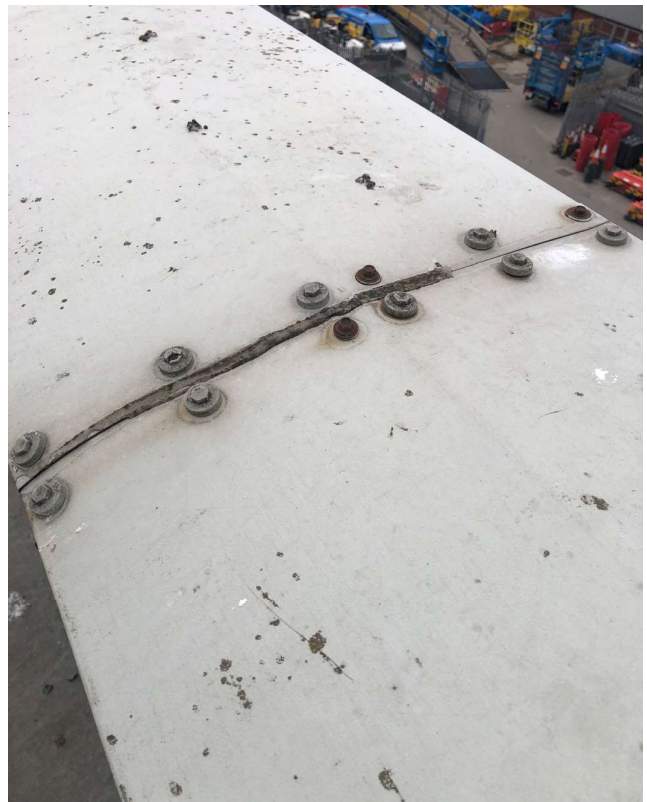
It also appears that some earlier remedial repair works have been carried out, attempting to seal the joints between the sheets. This sealant has failed/been picked away by seagulls. [Photo 3.3.3]

3.3.3 – earlier remedial works in an attempt to seal the gaps (parapet joints)

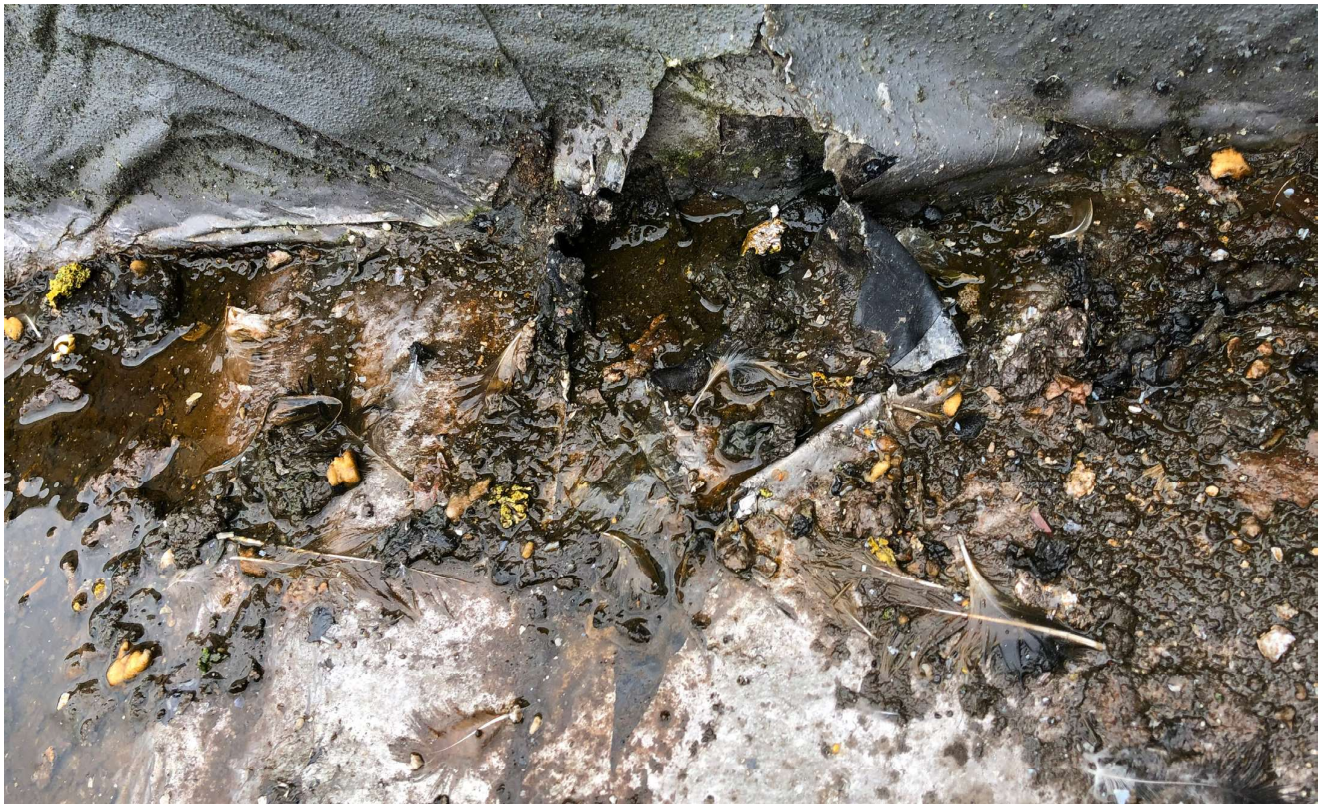
The gutters to roofs 1, 3 & 6 are insulated aluminium parapet gutters, secured to a parapet with secondary steel from beneath. Gutter panels are approximately 3m in length and therefore there are multiple joints along each gutter run. At each joint, the panels are fixed together with rivets and sealed with a heat welded membrane laid over the joint. At almost every panel joint the waterproof membrane has failed, in some locations they have been lost altogether. We believe this is the primary cause of the water ingress into the building at Roof Area A and remedial work is required as a high priority. [Photo 3.4.1]

3.4.1 – failed membrane at most joint locations

The prevailing solution seems to be that wholly lining the existing gutters with a new system was the appropriate and common resolution for the gutter repairs, a suggestion by Kingspan that each of the joints could be individually repaired was not considered a feasible solution given the work required to prepare the existing gutters for this work, and that this type of repair appears to have been attempted without success in several locations on the roof. Sharman's has a product called Plygene (other systems are available), a membrane on a roll which is laid in the gutters and is fixed at the abutment under the flashing, and under the metal roofing sheets with a combination of mechanical fixings and hot air welds. The system would include the insertion of liners into the rainwater outlets are heat welded into place.

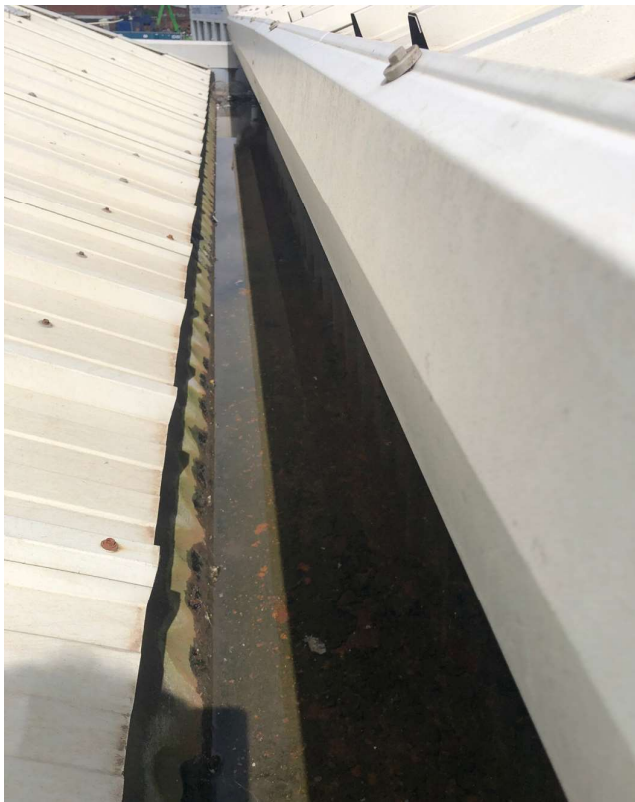
There was quite a lot of debris in the gutters and water is pooling in several of them. This is not considered to be a significant issue contributing to the water ingress, however the presence of the debris and water prevented full inspection of the condition of the panels. It is anticipated that similarly to the roofing sheets and parapet panels, there are areas of the gutters which have minor damage such as scratched protective coating. [Photo 3.4.2]

3.4.2 – water ponding which made it difficult to inspect the gutter

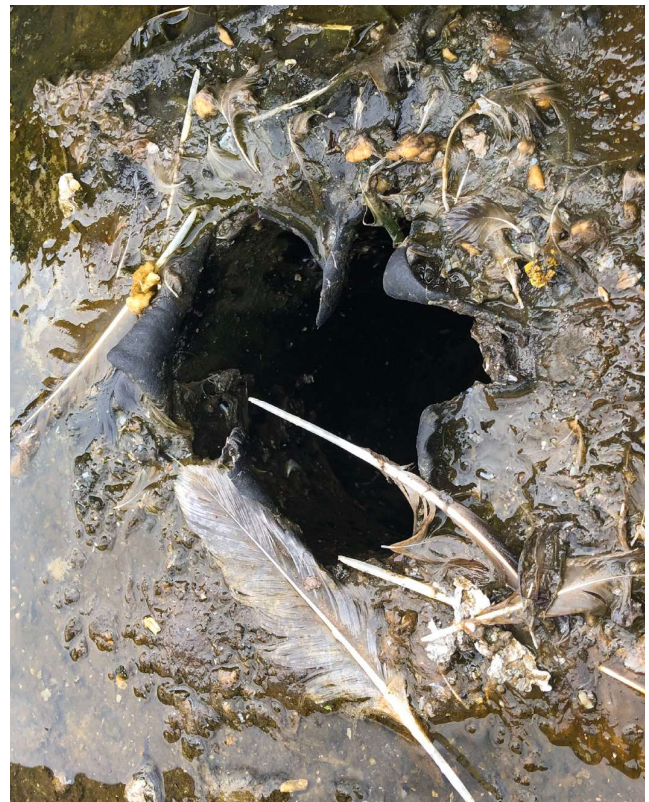
The rainwater outlets to Roof Area A direct all water to internal gravity-fed downpipes, through outlets in the base of the gutters. These outlets consist of preformed spigots with face plates which are fitted over and through a hole in the gutter. These outlets are fixed down and covered in a waterproof membrane as the gutter joints are. Similarly, to the gutter joints, almost every outlet is in poor condition, leaf guards are missing, and the waterproof membranes have failed. Remedial work should be carried out as a high priority. [Photo 3.5.1]

3.5.1 – rainwater outlet in poor condition, with missing leafguard

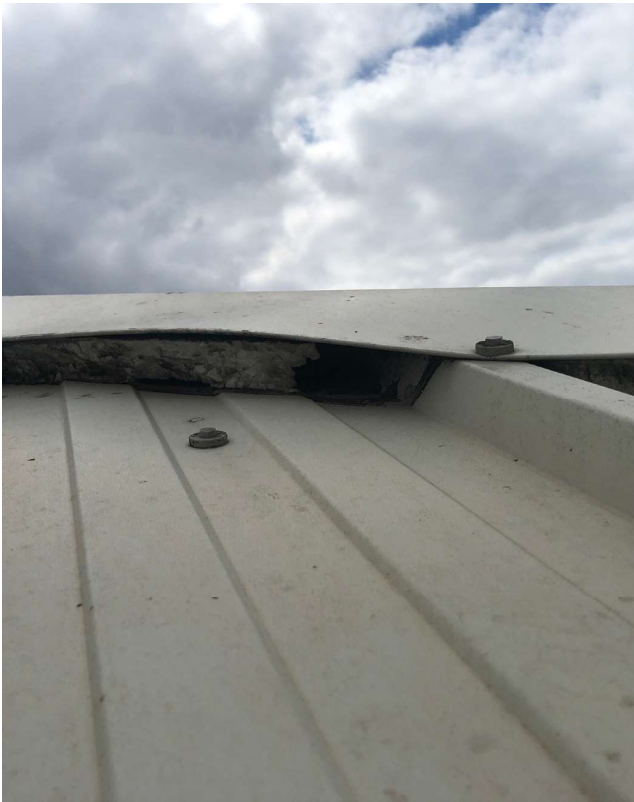
Many of the foam fillers have been lost or decayed. We believe that this may be contributing to the water entering the building at high level, this would explain how the water appears to be entering above the line of the gutters in areas such as IC, 3B and 3D as identified by NML during out walkaround the building. The width of the flashing sheets may also be the problem and only now the foam fillers have been lost has the issue become apparent [Photo 3.6.1]

3.6.1 — Missing foam fillers at ridge lines

The long term solution would be to remove and replace the flashings and all of the fixings. However in order to fully diagnose the problem, some shorter term measures could be undertaken, including; Replacing the foam profile fillers and encapsulating the bolts.

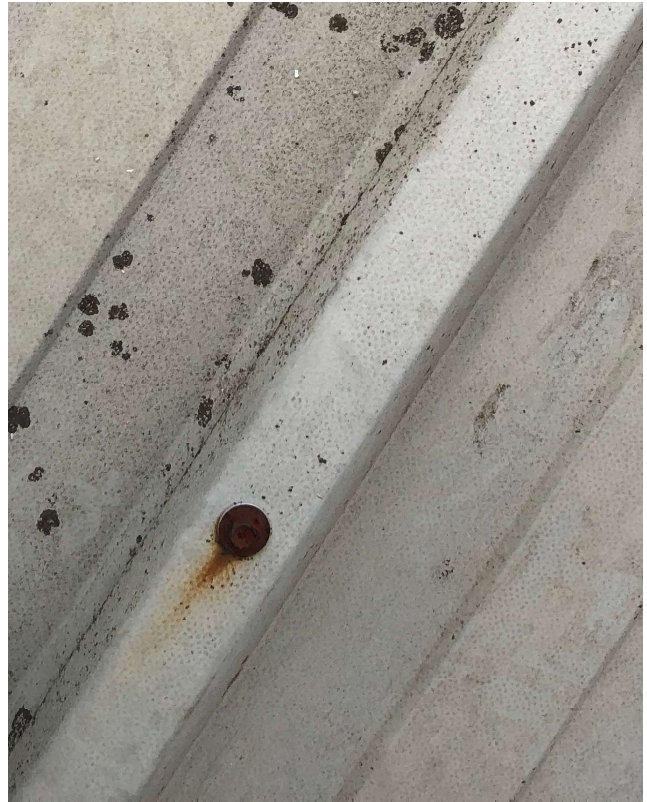
Aluminium flashing sheets are fixed down to the roofing sheets with metal fixings. The fixings have self-sealing washers and waterproof caps, many of which have been lost or damaged. The corrosion to these fixings may be further contributing to the high level water ingress and further investigation by a specialist is required to confirm whether fixings should be resealed, replaced or covered by other maintenance works. [Photo 3.6.2]

3.6.2 - rusty fixings due to waterproof caps removed (ridges)

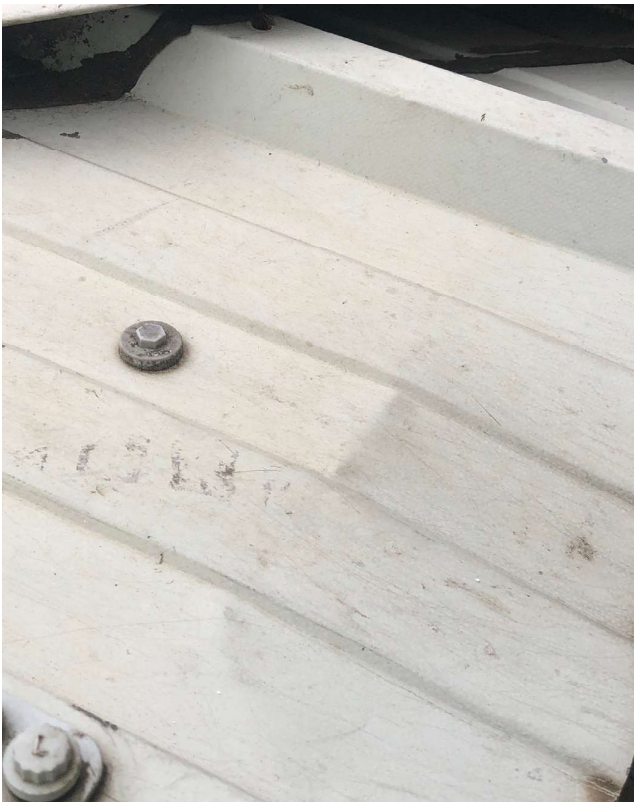
There are a number of isolated locations where the flashing sheets have been damaged, likely due to being trodden on during routine maintenance. We do not believe that this is a cause of water ingress, however, may be prudent to repair. [Photo 3.6.3]

3.6.3 — damaged or depressed flashings

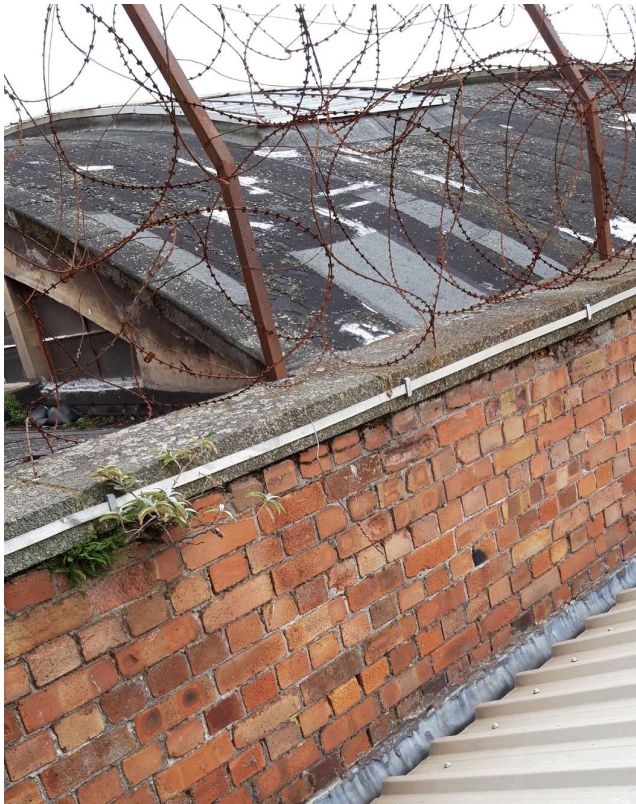
The presence of concertina razor wire for security purposes made it difficult to access roof 4C and gutter 4.3, however an overall impression of the condition was noted. [Photo 4.1.1]

4.1.1 – access was made difficult because of the concertina razor wire

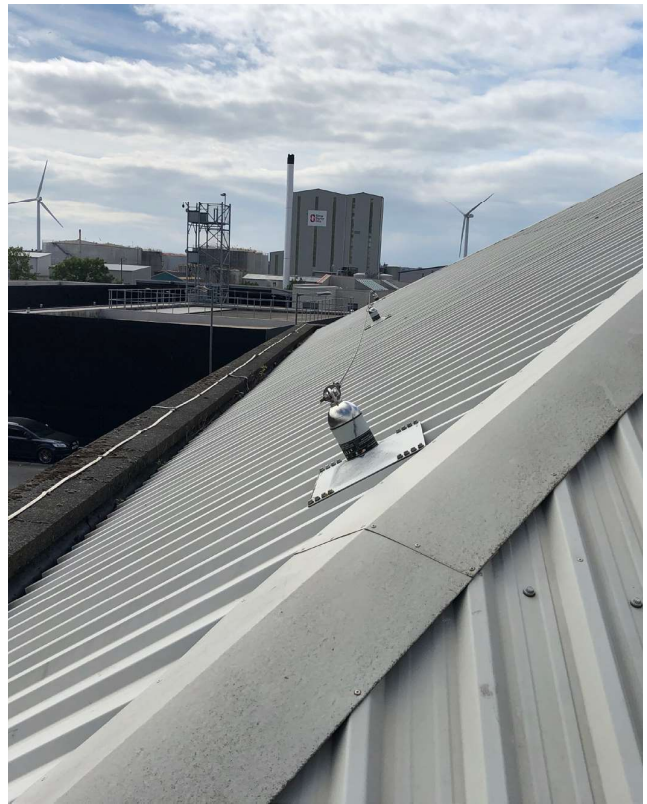
The roofing sheets all appeared to be in good condition, there were no significant defects, or penetrations noted which would contribute to water ingress. [Photo 4.2.1]

4.2.1 - roof sheets in good condition (Roof B)

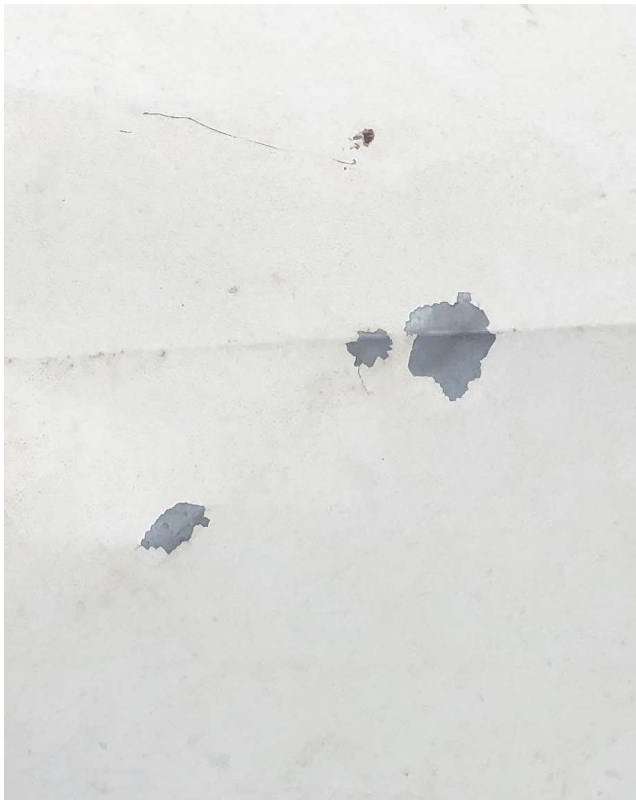
A few isolated locations where the protective coating of the panels has been scratched were noted, this has exposed bare metal and, in some locations, has begun to rust. Some remedial works should be considered. [Photo 4.2.2]

4.2.2 - protective coating removed and bare metal exposed (roof sheets)

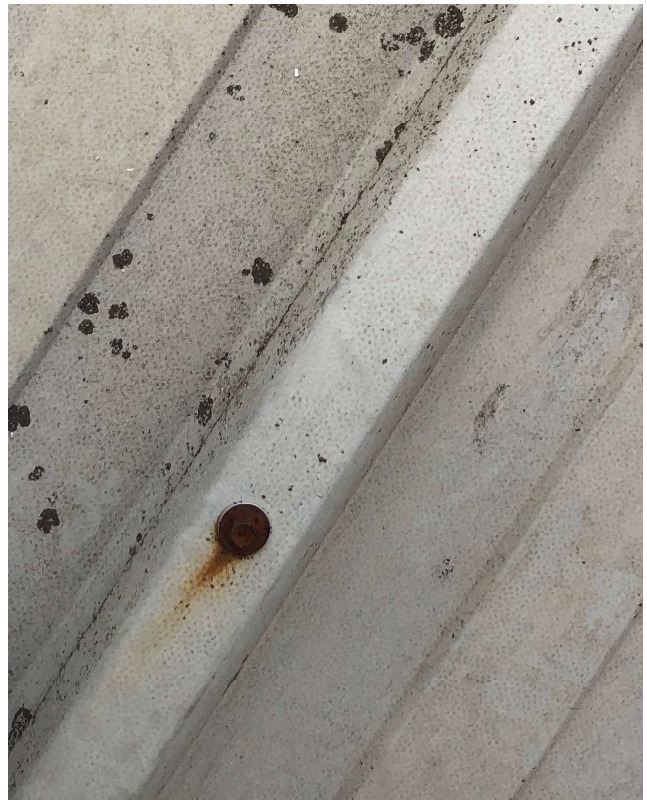
Aluminium panels are fixed down the steel roof structure with metal fixings. The fixings have self-sealing washers and waterproof caps, many of which have been lost or damaged. There is no particular evidence that this has allowed water to enter the building, however, repairing/replacing these fixings would prolong the life of the roof. [Photo 4.2.3]

4.2.3 - rusty fixings due to waterproof caps removed (roof sheets)

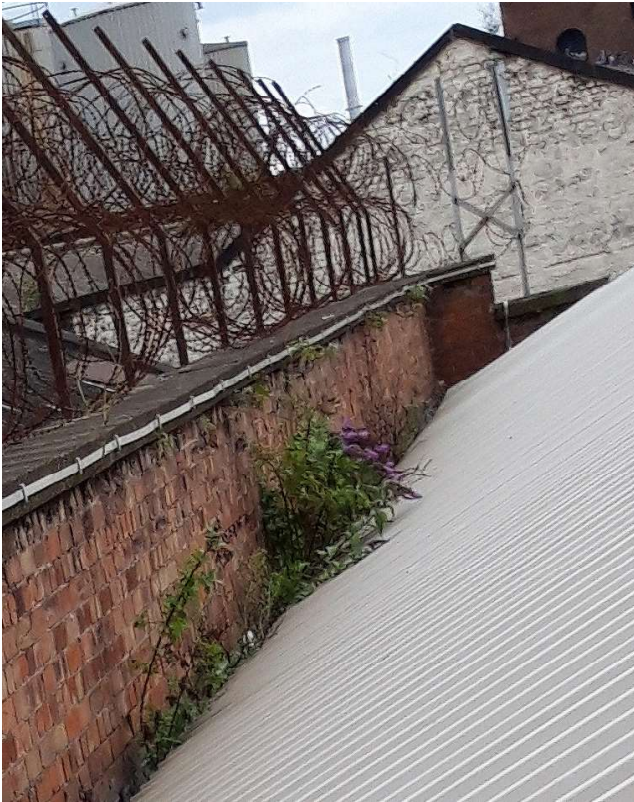
The parapets and copings look to be in generally good condition; however, some vegetation requires removing. [Photo 4.3.1]

4.3.1 – vegetation needs to be removed from masonry parapet and copings

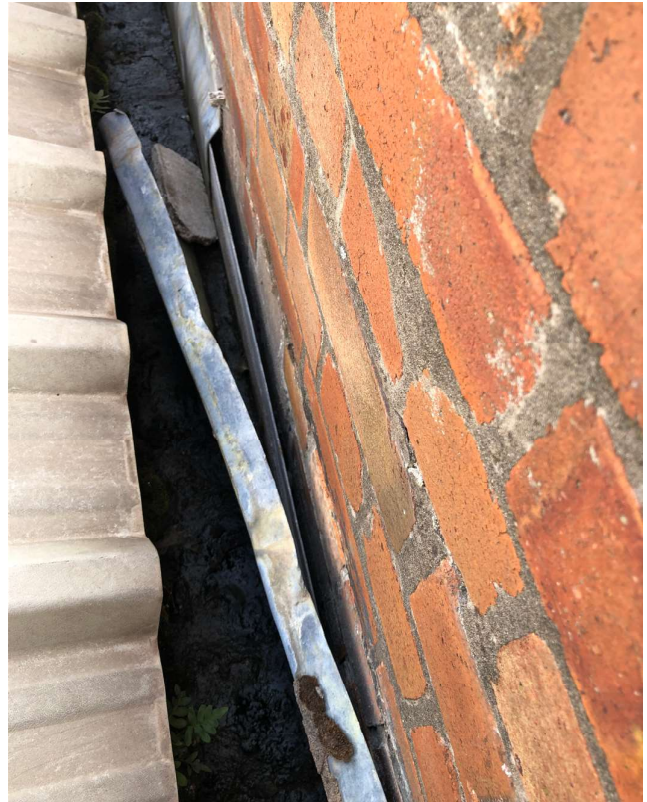
Where on Roof Area A, aluminium cladding has been used to cover the masonry upstands, the same has not been carried out to Roof Area B. Instead the weathering is relying on lead flashings which appear to be contemporary with the asbestos cement roof. These flashings in places have been lost or are falling out of the mortar joints in the masonry which is allowing water to stream into the

building in wet conditions, indeed from the inside daylight can be seen as some of the abutment locations where flashings have been lost. [Photo 4.3.2]

4.3.2 – failed lead flashings

We are confident that this is the primary cause of water ingress into the lower building and would recommend that repairs are carried out. It would be worth carrying out some masonry maintenance, such as repointing to the parapet walls at the same time.

As noted earlier, roofs 4 & 5 were treated differently to the others, these were encapsulated and over-boarded. Failing lead flashing being the primary issue caused as a result of these not being renewed at a higher level when the height of the roof was lifted slightly. Our initial reaction was that renewing these flashings in lead is sound, however is not the most cost effective solution. Lead is expensive and usually used where a good quality aesthetic finish is preferred or when replicating significant historic detailing. The flashings to these roofs are not seen from anywhere and this is not an architecturally significant building. Another point to note is that when the encapsulation was carried out, it appears that a flashing which is supposed to conceal the edges of the existing asbestos sheets has been missed (the edges are visible). With this in mind, we propose that these gutters are lined in the same Plygene (or similar) system as to Roofs 1, 3 & 6. A steel flashing, to match the steel roofing sheets will be used to cover the edges of the new gutter lining, this will be more cost effective than using lead.

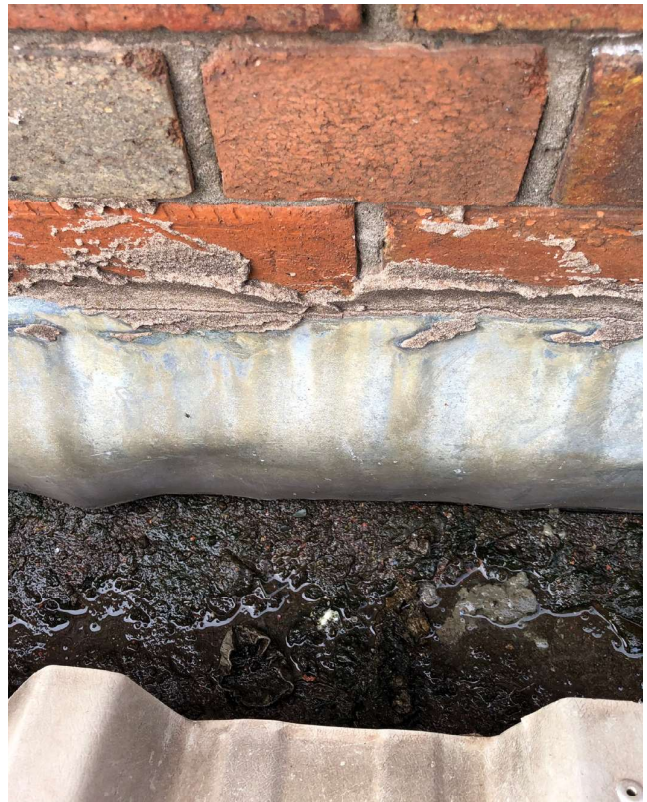
The gutters do not appear to have been cleaned out for some time, evident by up to 2 inches of sludge sitting in them, this may be a direct result of the proximity of the asbestos containing material which should have been concealed at the time the encapsulation was carried out. [Photo 4.3.1]

4.4.1 – thick sludge in gutters

All the outlets that were inspected were significantly blocked by sludge and debris and should be cleaned. A further inspection will be required after this has been carried out to determine whether there are any significant defects.
