ANNUAL MAIN INSPECTION REPORT FOR **CLIFFE PARK PLAY AREA**

Site address:-
Callywhite Lane, Dronfield, S18 2XP

Date of inspection:-
9/11/2016

Inspected by:
Gary Watkinson
RPii Certificate No 1041A

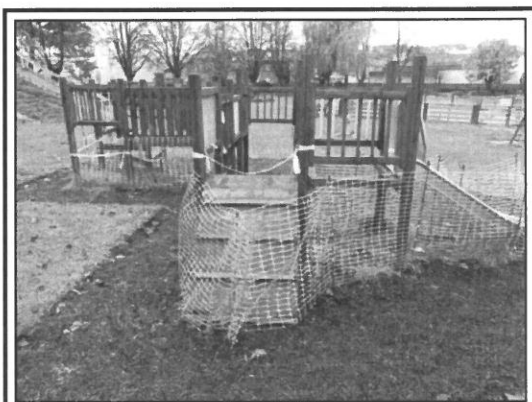
5. Ledon Spring Seesaw Life expectancy: 20 yrs Very Low Risk: 2	Satisfactory	Grass Worn – <u>monitor</u>
6. Unknown Make Junior Multi Unit Life expectancy: nil Medium Risk: 9	BS EN 1176-1, Sec. 4.2.7.2, head trap between bars in barriers; between barriers & platforms; between supports & slide sides BS EN 1176-3, Sec. 4.2, there should be a cross-bar of between 600mm & 900mm high across slide access openings BS EN 1176-1, Sec. 4.2.4.4, opening at top of incline climber wider than 500mm & without guardrail Platforms missing <u>Item taped off</u> REMOVE FROM SERVICE	Wood Chippings Satisfactory

(Missing platforms at taped-off junior multi unit)

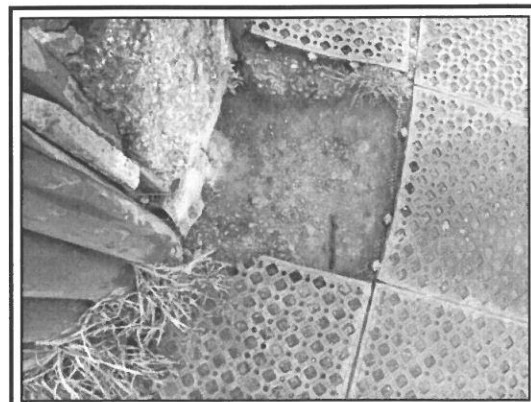
<u>Item/Make</u>	<u>Compliance/Condition</u>	<u>Surface</u>
<p>7. Playdale 2600 2 Bay Swing 3 Flat Seats Life expectancy: 19 yrs Medium Risk: 8</p>	<p>Replace all worn bushes in chain bearing blocks <u>Remove seats & chains until repaired *urgently (as discussed with park attendant)</u></p>	<p>Grass Mats Satisfactory</p>
<p>8. Fresh Air Fitness Six-item Fitness Station Life expectancy: 24 yrs Medium Risk: 8</p>	<p>BS EN 16630, Sec. 7.1, no sign provided BS EN 16630, Sec. 4.1, located adjacent to play equipment Possible broken welds on pull-down & chest press – <u>monitor</u> Recommend internal inspection of air walker (stoppers not working)</p>	<p>Grass Mats Satisfactory</p>
<p>9. Record Embankment Slide Life expectancy: 9 yrs Very Low Risk: 3</p>	<p>No handrail at steps</p>	<p>Matta Tiles Resecure one mat at top of slide Replace one missing mat at top of embankment Embankment in poor condition – reinstate</p>

(Missing grass mat at embankment slide)

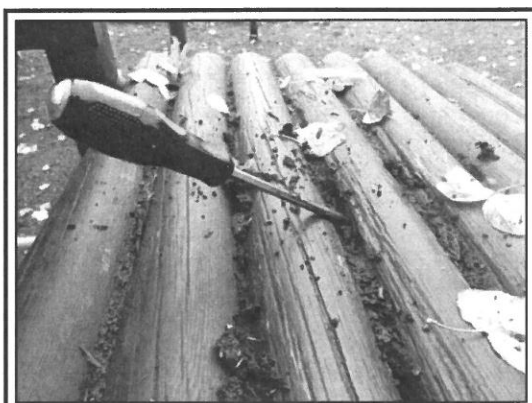
<p>10. Unknown Make Junior Multi Unit Life expectancy: 5 yrs High Risk: 14</p>	<p>BS EN 1176-1, Sec. 4.2.7.6, finger trap between slats on valley bridge & arch bridge BS EN 1176-1, Sec. 4.2.7.2, head trap between logs on arch climber; between arch climber & platform; between barriers & platforms; between two bars in one barrier; between arch bridge & platforms; between platform & slide guard; between slide guard & guardrail; between bridge & guardrail BS EN 1176-1, Sec. 4.2.4.3, bridge guardrail only 520mm high (should be between 600mm & 850mm) BS EN 1176-1, Sec. 4.2.5, radii not 3mm on underside edge of slide Posts & barriers showing signs of rotting – <u>monitor</u> Logs on arch climber showing signs of rotting – replace Replace rotten slats on platforms at various locations</p>	<p>Tiles & Wood Chippings Infill gap between tiles & slide runoff Requires top up (actually 150mm deep, should be at least 200mm)</p>

(Rotting logs on arch climber at junior multi unit)

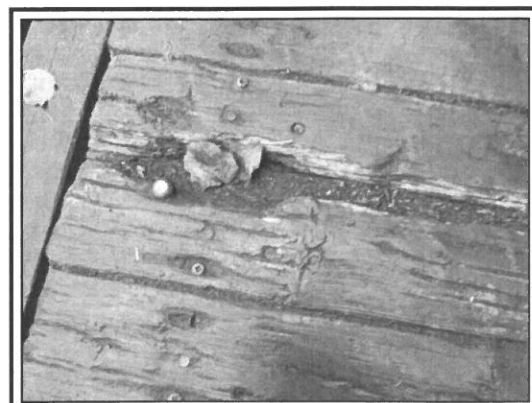
(Rotten slat on platform at junior multi unit)
