CBC Asbestos Re-Inspection Report Saxilby Store, Corby 22nd May 2020

Reference:		
Issue		
V1	May 20	JF

Saxilby Sub Depot
Saxilby Close
Corby
Northants

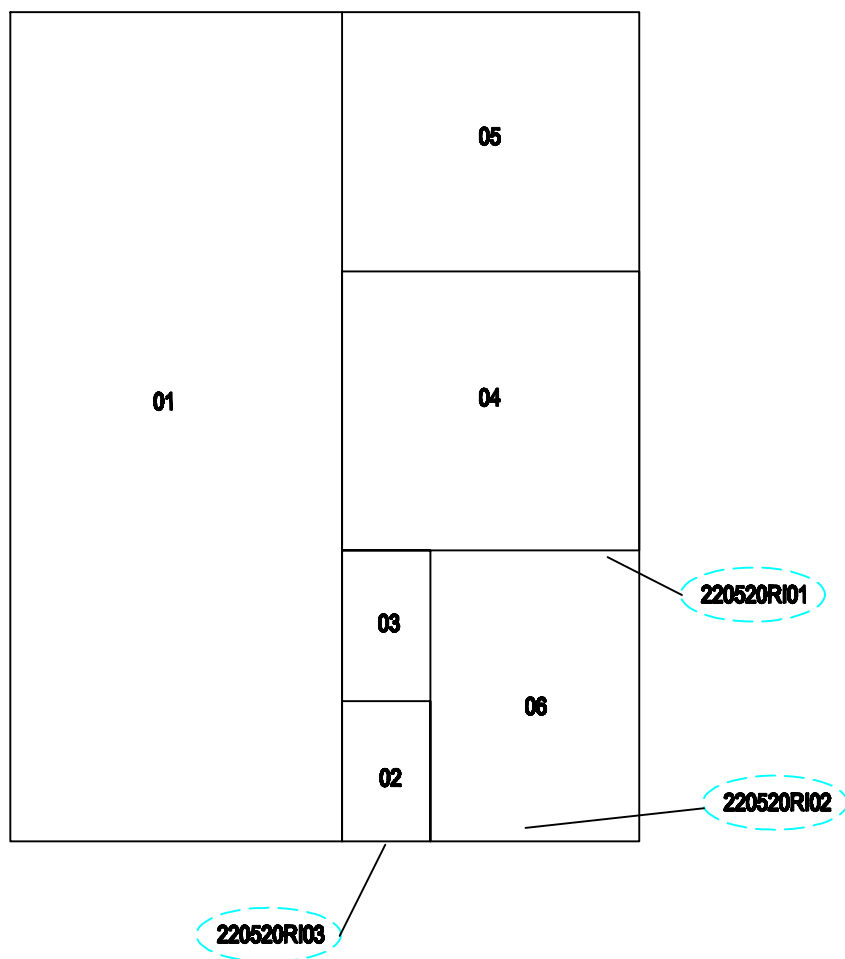
Drawing Title:
Corby Borough Council
Asbestos Survey Plan

No asbestos was detected following analysis after the survey at this property
