*Sewer Inspection,  
Cleaning and Repair*

***Project ref:TV200234***

# ***CCTV Survey Report***

**SITE: Leybourne Village Hall**

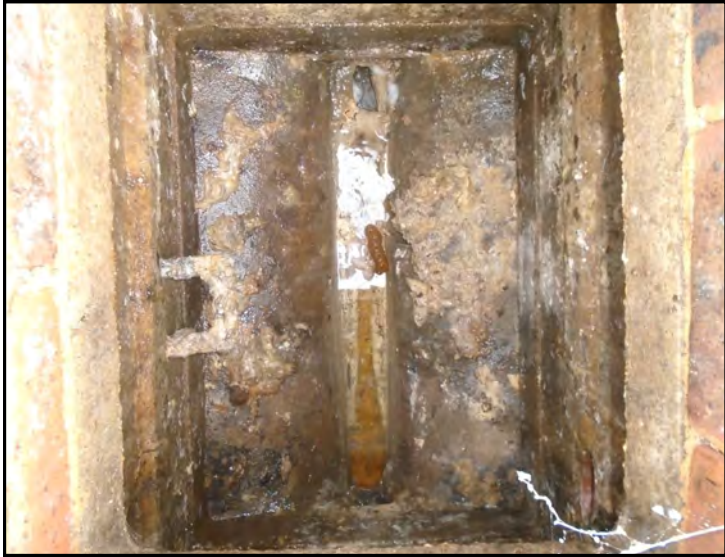
IC2 BACKFALL IN CHAMBER

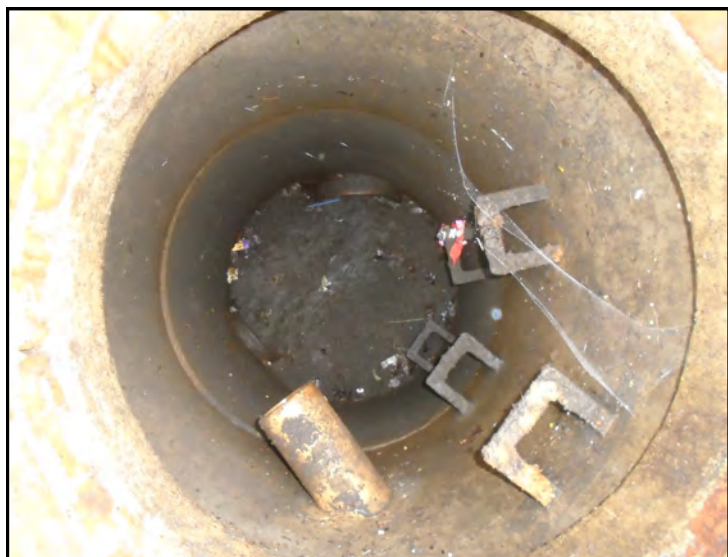
IC12 CATCHPIT SILTED

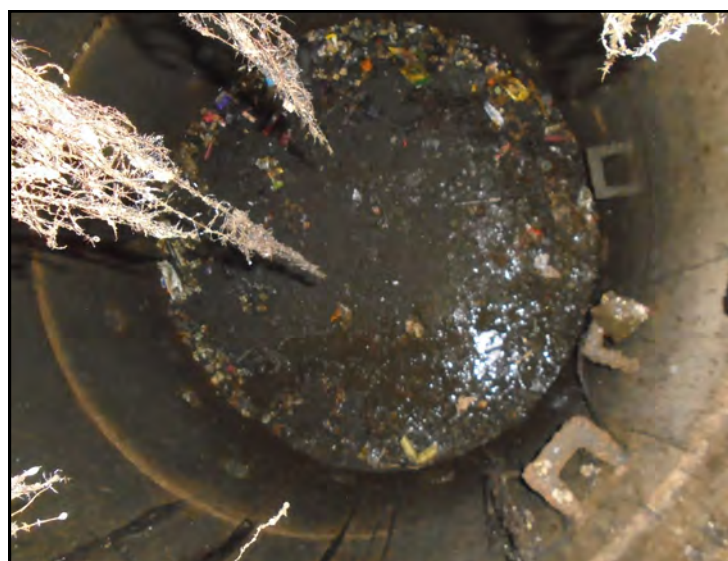
IC13 SOAKAWAY SILTED

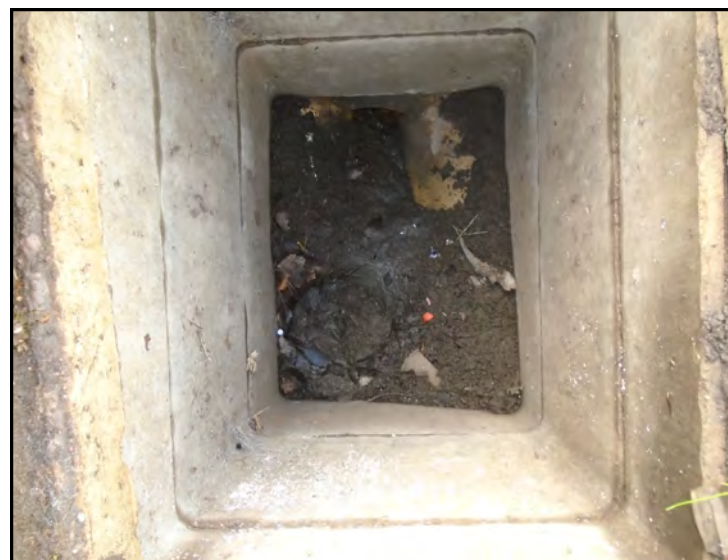
IC14 SILTED

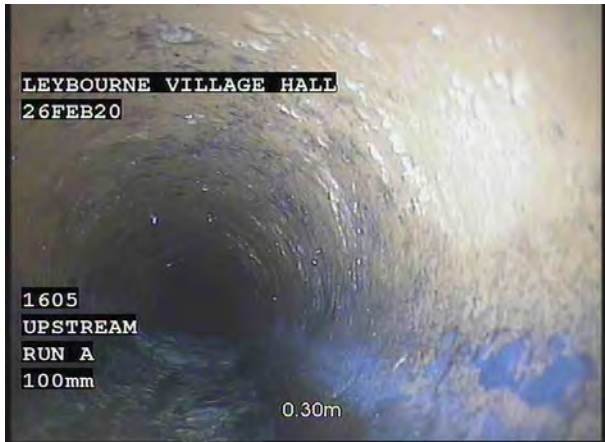
1, 00:00:15, 0.30 m

Attached deposits, encrustation from 04 o'clock to 08 o'clock,  
10% cross-sectional area loss, start

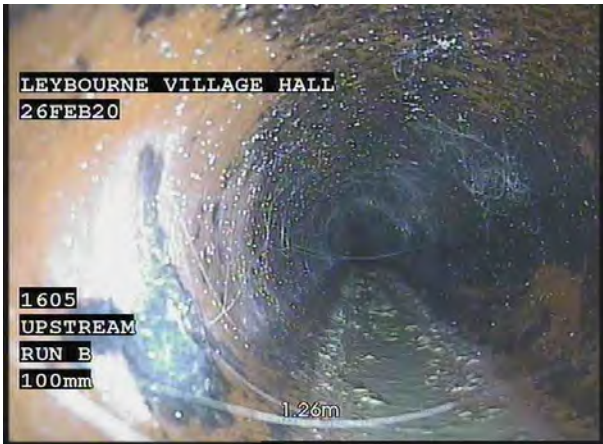
1, 00:00:30, 1.26 m

Attached deposits, encrustation from 04 o'clock to 08 o'clock,  
5% cross-sectional area loss, start

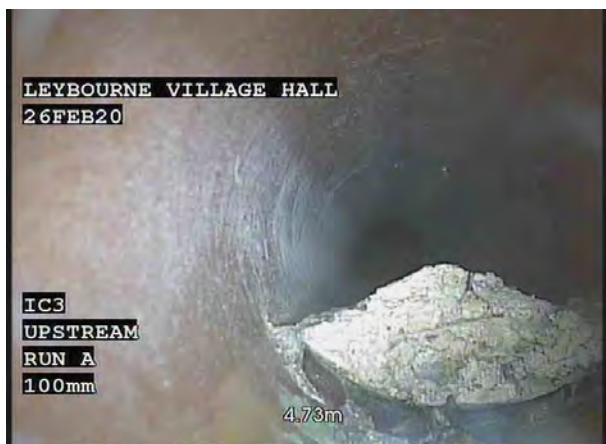
1, 00:00:40, 4.73 m

Obstacles, brick or masonry in invert from 04 o'clock to 05 o'clock, 25% cross-sectional area loss

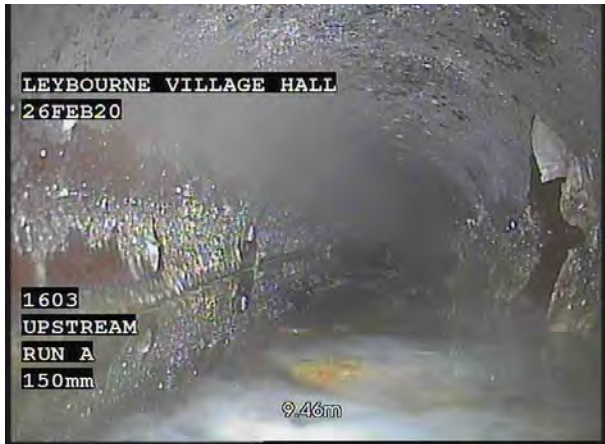
1, 00:00:45, 9.46 m  
Water level, 60% of the vertical dimension, Standing water - irregular gradient or backfall

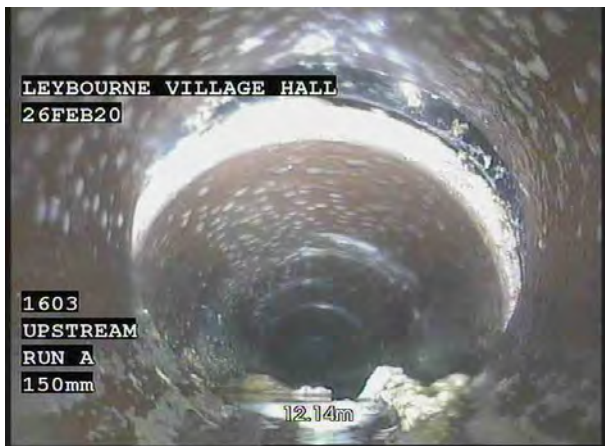
3, 00:01:31, 12.14 m  
Joint displaced, large

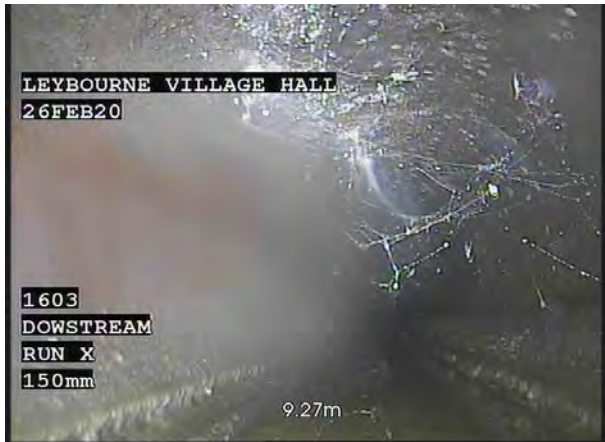
1, 00:01:01, 9.27 m

Attached deposits, grease from 04 o'clock to 08 o'clock, 10% cross-sectional area loss, start

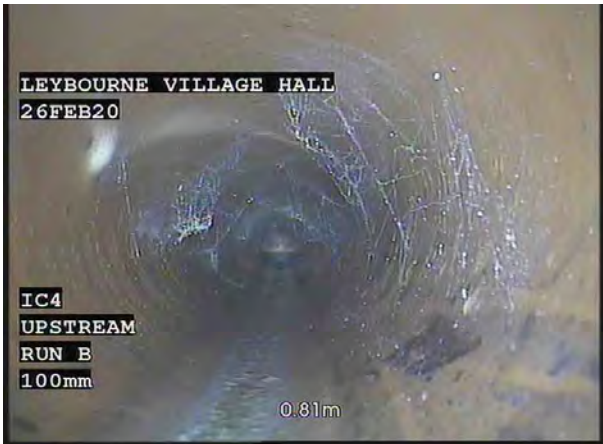
1, 00:00:17, 0.81 m  
Deformed drain or sewer, 5%

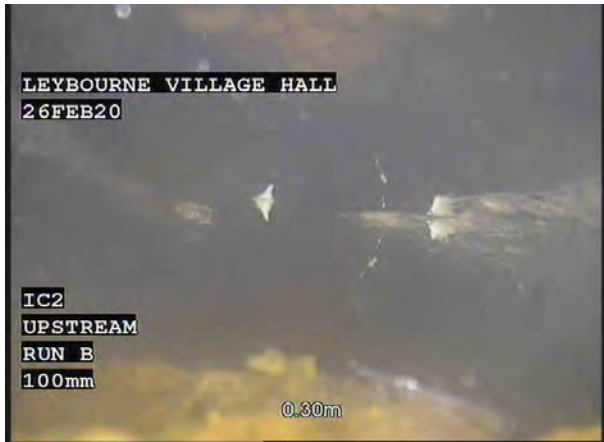
1, 00:00:14, 0.30 m  
Loss of vision, camera under water

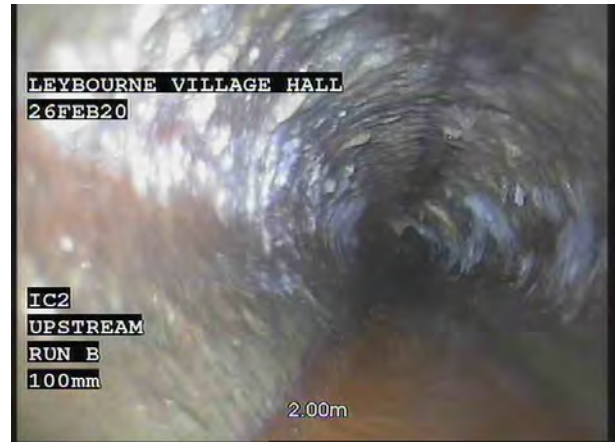
2, 00:00:42, 2.00 m  
Attached deposits, grease from 08 o'clock to 04 o'clock, 10% cross-sectional area loss, start

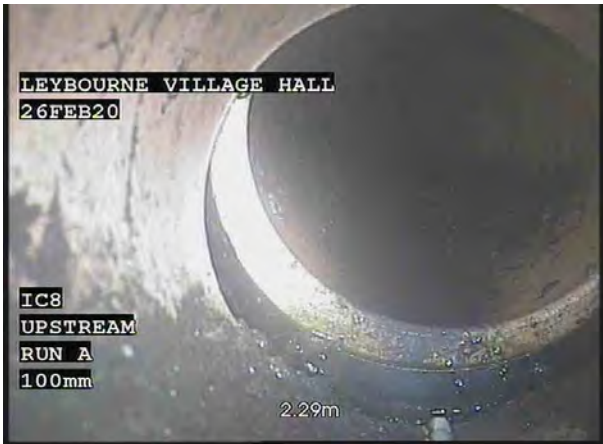
1, 00:00:19, 2.29 m  
Joint displaced, large

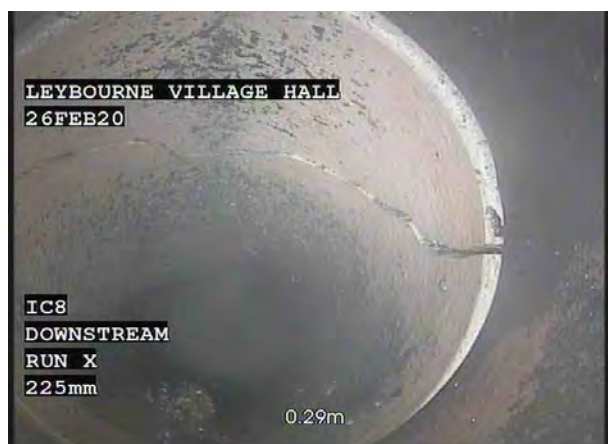
1, 00:00:29, 0.29 m

Fracture, circumferential at joint from 09 o'clock to 03 o'clock

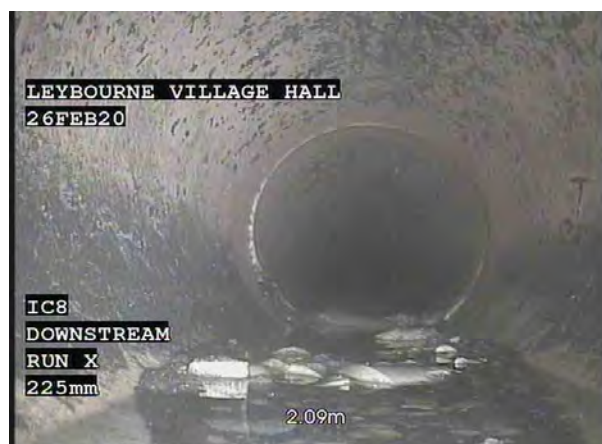
2, 00:00:48, 2.09 m

Settled deposits, coarse, 15% cross-sectional area loss, start

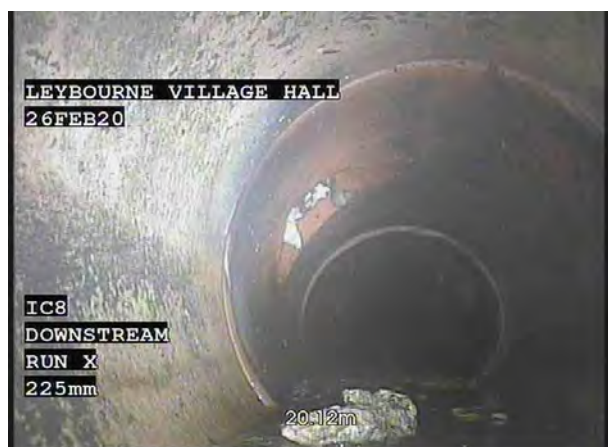
3, 00:02:17, 20.12 m

Settled deposits, coarse, 20% cross-sectional area loss, start

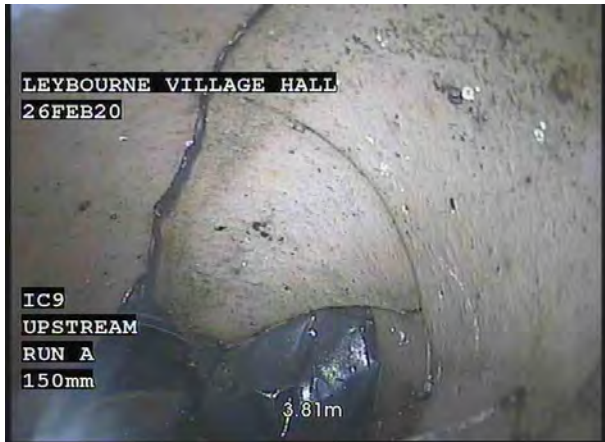
1, 00:01:24, 3.81 m  
Fracture, multiple from 12 o'clock to 12 o'clock

22	RUN A	Upstream	IC9	Repair defect/s by excavation
23	RUN C	Upstream	IC9	
24	IC9	Downstream	IC10	
25	RUN A	Upstream	IC10	Clean by HGV Jet vac unit and resurvey
26	RUN C	Upstream	IC10	
27	RUN D	Upstream	IC10	
28	IC10	Downstream	IC11	Clean by HGV Jet vac unit and repair by patch lining
29	IC14	Upstream	IC11	Clean by van pack jetting unit and resurvey
30	IC11	Downstream	IC12	Clean by HGV Jet vac unit and resurvey
31	RUN A	Upstream	IC12	Clean by van pack jetting unit and resurvey

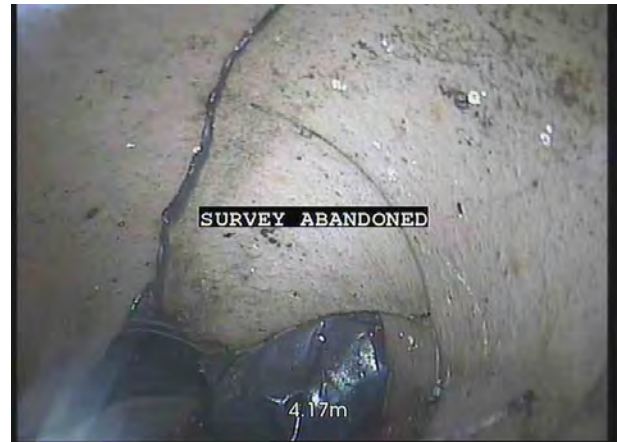
2, 00:01:43, 4.17 m  
Survey abandoned, Unable to pass

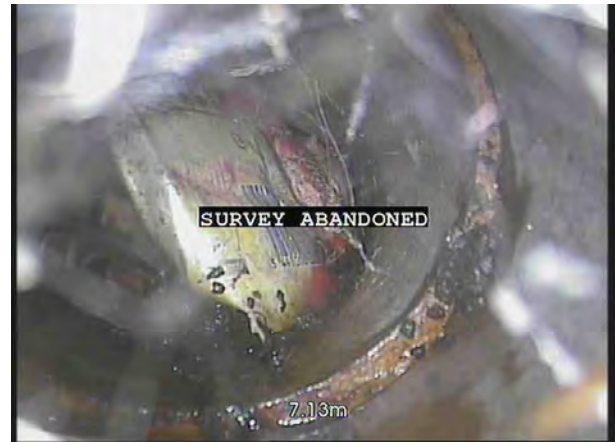
2, 00:01:57, 7.13 m  
Survey abandoned, Unable to pass

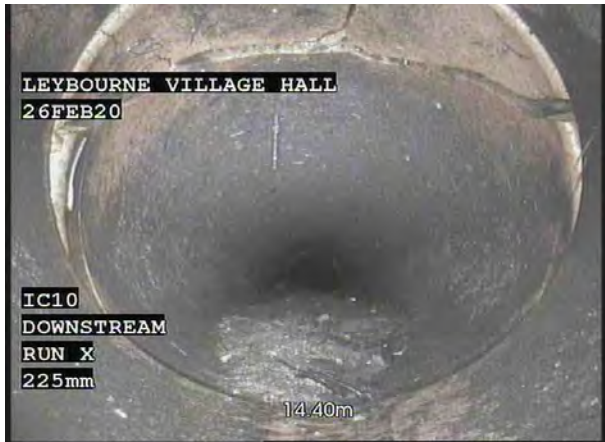
1, 00:01:06, 14.40 m  
Fracture, multiple at joint from 12 o'clock to 12 o'clock

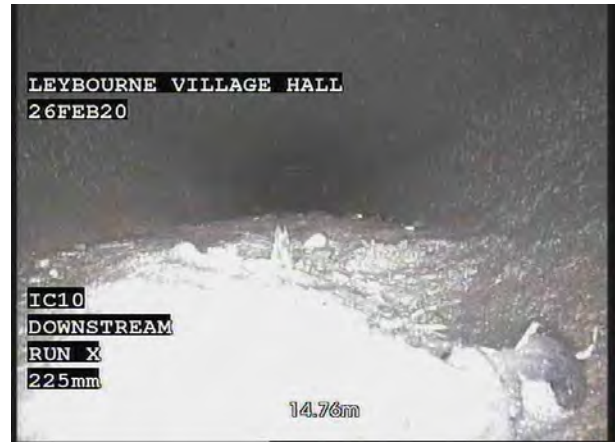
2, 00:01:19, 14.76 m  
Settled deposits, fine, 15% cross-sectional area loss, start

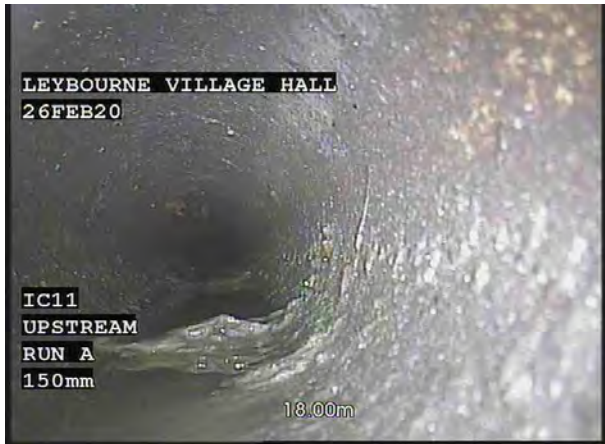
1, 00:01:51, 18.00 m  
Settled deposits, fine, 20% cross-sectional area loss, start

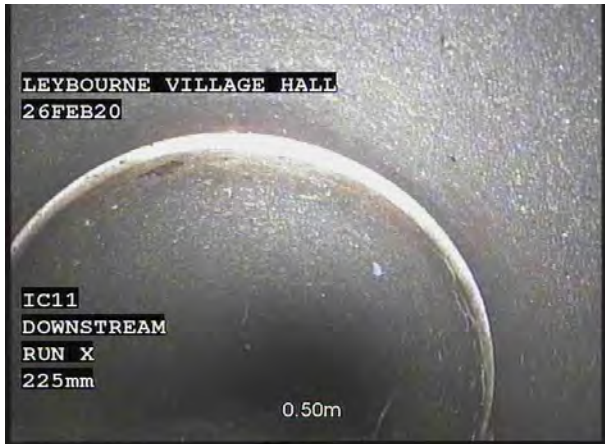
1, 00:00:12, 0.50 m  
Settled deposits, fine, 25% cross-sectional area loss, start

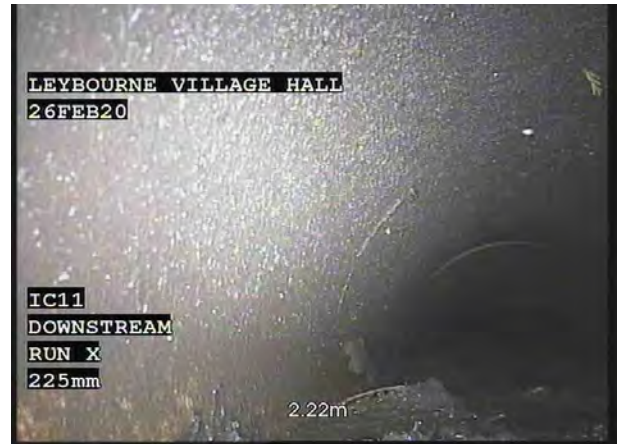
2, 00:00:44, 2.22 m  
Settled deposits, fine, 45% cross-sectional area loss, start

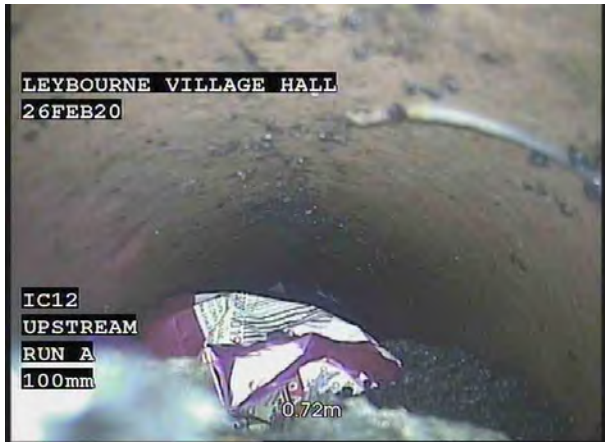
1, 00:00:18, 0.72 m  
Settled deposits, coarse, 70% cross-sectional area loss

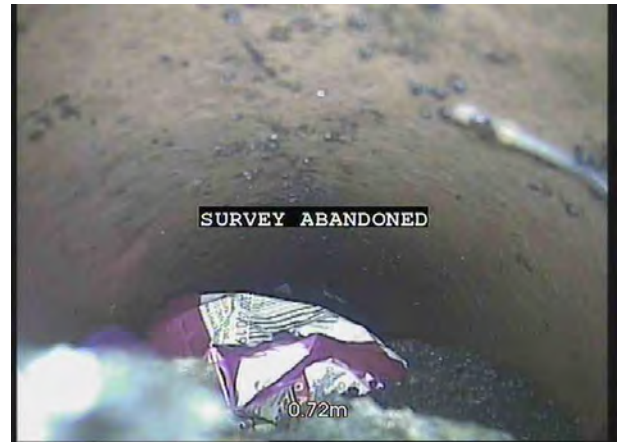
2, 00:00:24, 0.72 m  
Survey abandoned, Unable to pass
