# St. Mary's Church, Thornbury

## Churchyard Monument Condition Report

## Report into The Condition of The Churchyard Monuments, St. Mary's Church, Thornbury

Report prepared for  
Thornbury PCC

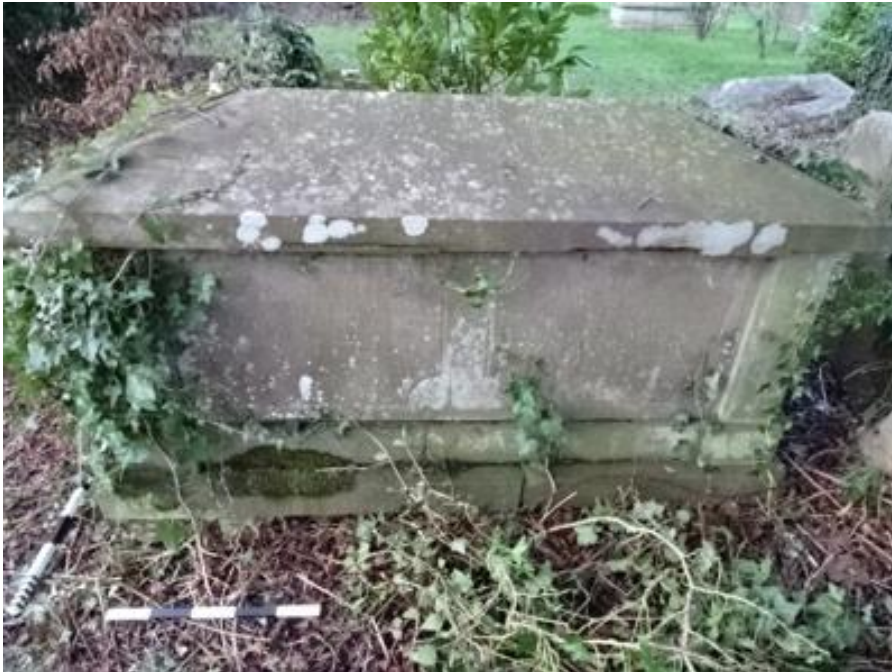
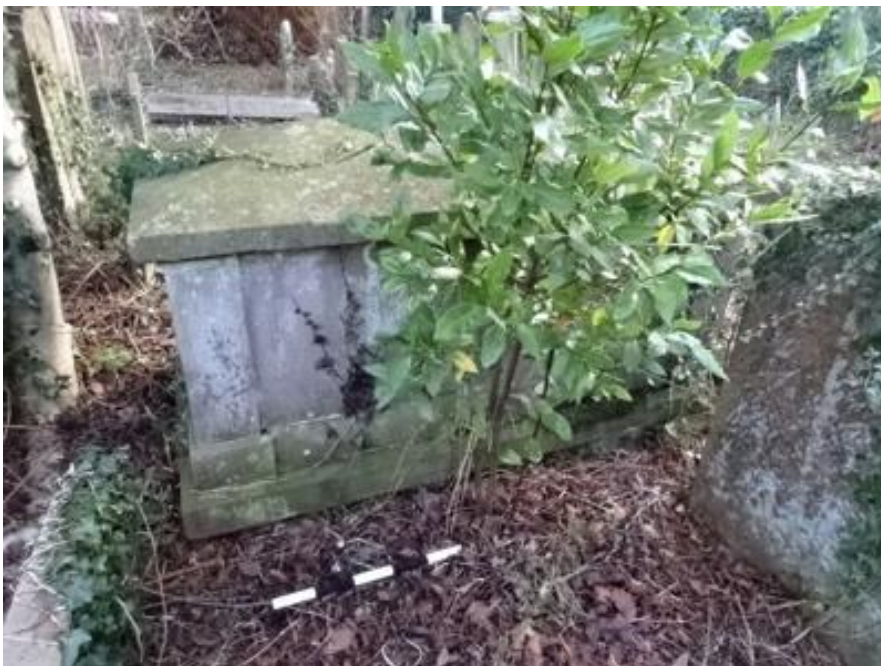
| | The underside of the southern and northern edges of the lid have delaminated resulting in 50% loss of the arises along each edge. | | Prev. repairs | |

| | Remove ivy.<br>Fill small lime rich joints in the base. | | | |

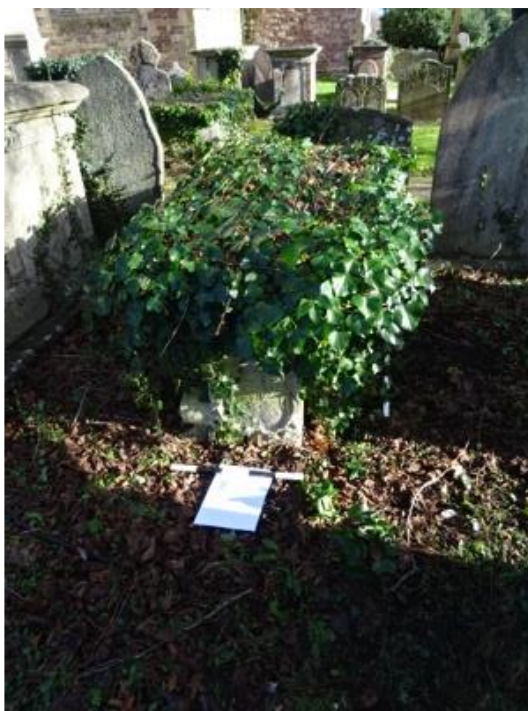
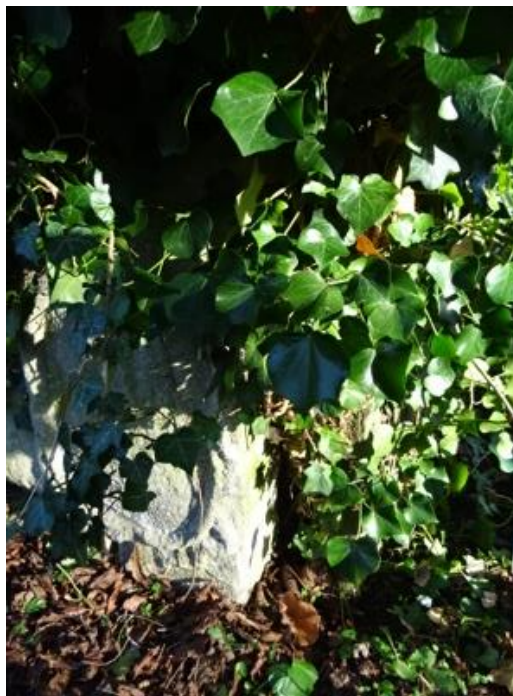
West end of tomb 76, the arrow marks the missing corner post on this side.

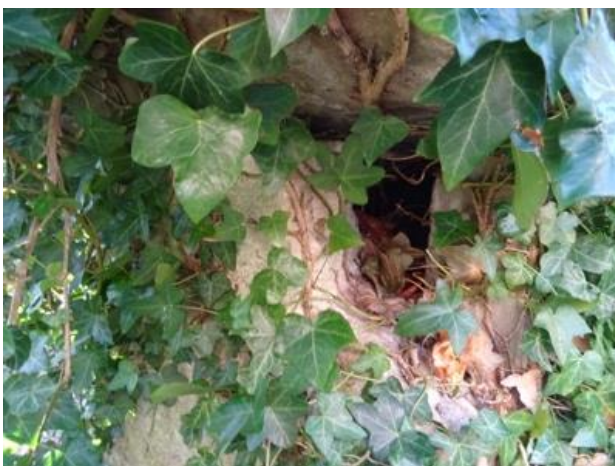
Hole at the top right corner of the east end.
