BUILDING SURVEY

**Redruth Town Clock
Fore Street
Redruth
Cornwall**

**on behalf of
Redruth Town Council**

Ref:WT/BS17(6597)

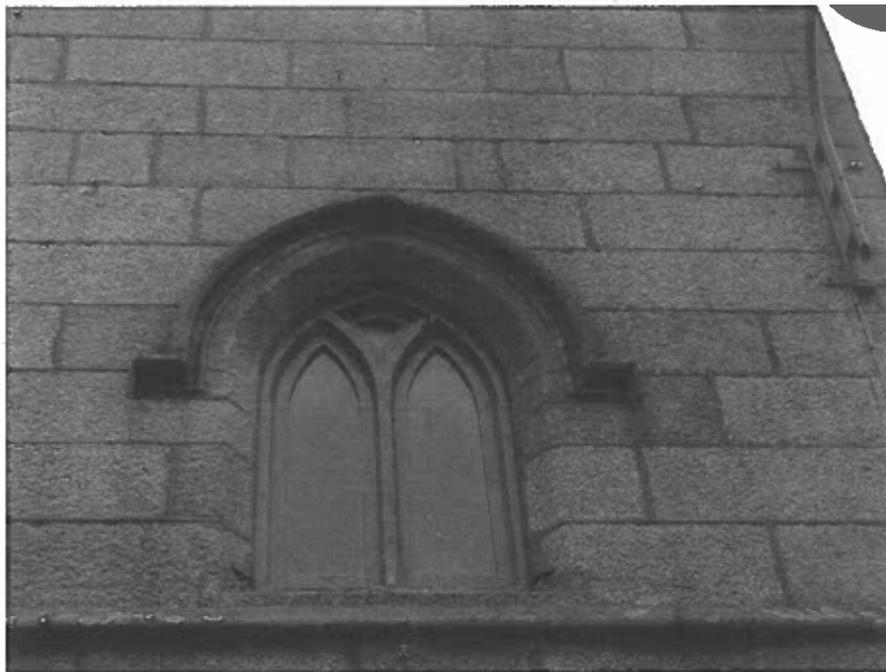
The main walls are of traditional stone construction with large stones being laid directly onto the substrata without any form of damp proof course. The window and door apertures are of cut quoins and lintels. Between the stonework there is a hard sand and cement pointing, which helps to prevent driving rain from entering the porous granite walls and this needs to be kept in good condition, **The external envelope of the clock tower has been finished with high-quality hand-fashioned stonework and this is reasonably well pointed, although some repairs are needed. It will be important to keep the pointing in good repair as it helps to prevent penetrating dampness through capillary action.**

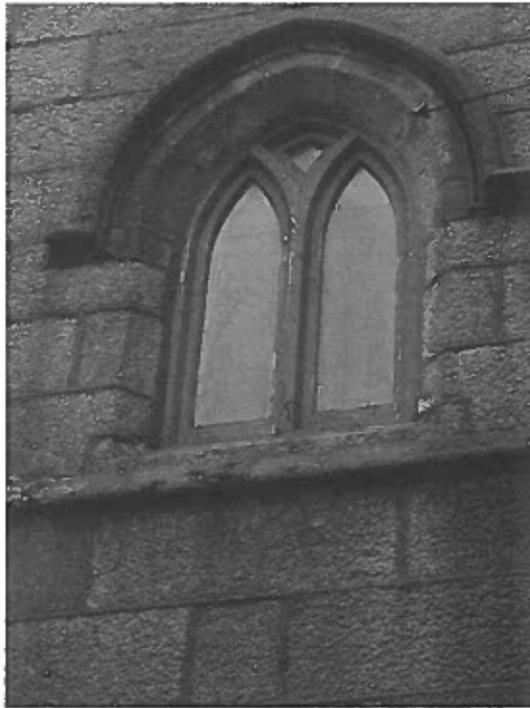
The archways for the window apertures in the external envelope are of a different type of stone and look to be of a sandstone material. Over time, these have suffered from driving wind and rain and the stone work has slightly deteriorated on the external surface. An attempt has been made to protect the first floor windows with a cement wash. This is somewhat unsightly.

You should consult a stonemason with regard to maintaining the sandstone arches of the windows, rather than making the adhoc repairs that are currently being undertaken.

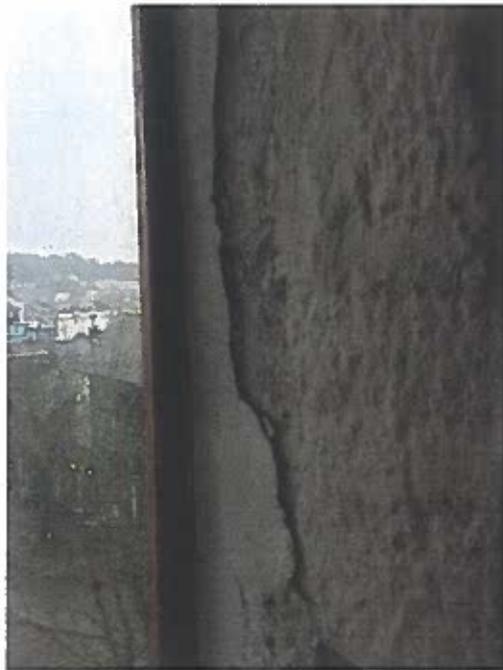
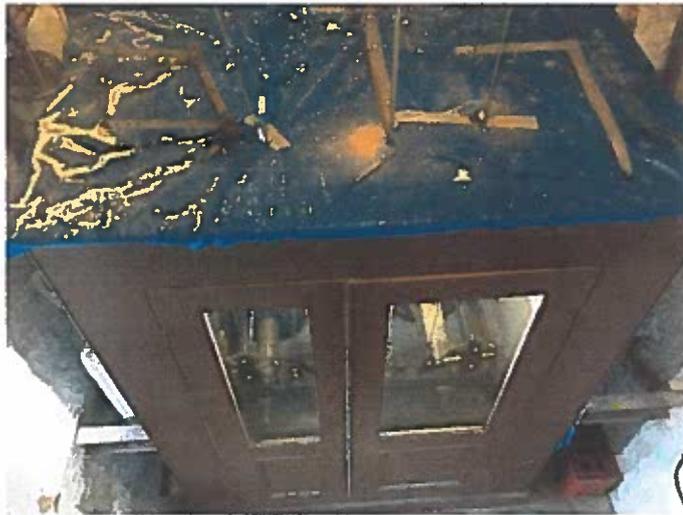
The inner sides of the main walls are of random rubble. The damp meter was applied at all levels of the building with high damp readings taken. Obviously, driving wind and rain are making their way through the external envelope and into the interior. The interior surface has been finished with a whitewash and paint material and this is in poor repair and has started to flake away. I would recommend that the Council consider waterproof tanking the interior surface of the tower and then apply a hard sand and cement render and paint over. Currently, the whitewash is flaking and leaving debris, particularly around the mechanisms of the clock workings. I would also refer you to 'Timberwork' below.

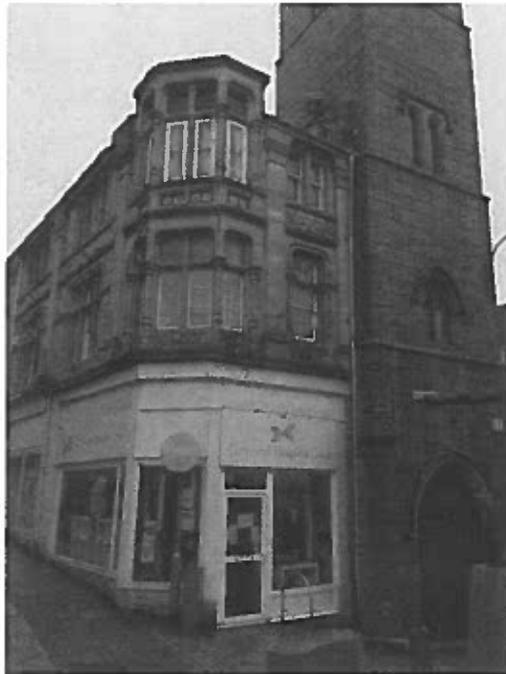
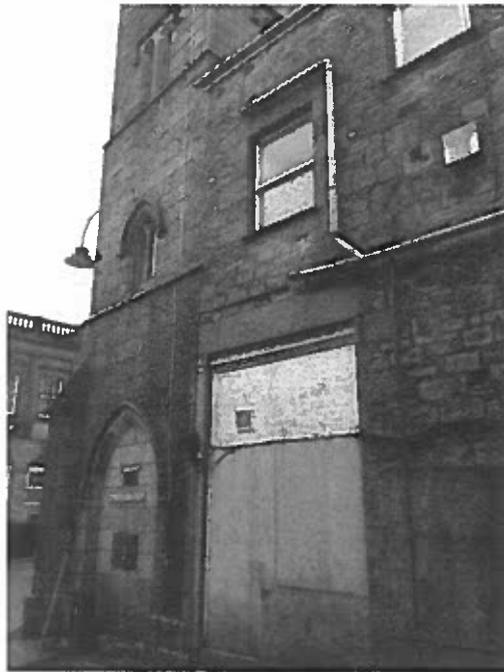
The building has a varied history and in 1841 the ground floor archways were filled to enable the ground floor to be utilised as a police cell. In the 1900s, neighbouring properties were added to the rear and left hand elevations. This involved the enclosing of the rear window apertures. Surprisingly, high damp readings were taken from these walls and I would refer you to 'Leadwork' below.

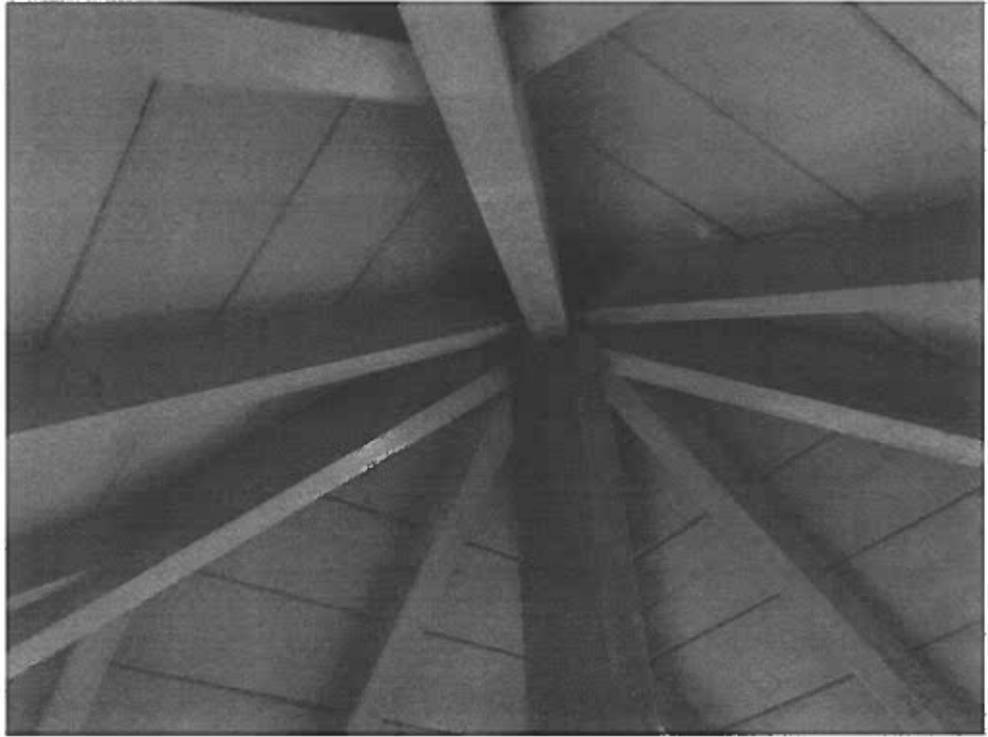
The clock tower has an open roof structure to enable the sound of the bells to permeate further through the town. It is of a hip design incorporating large rafters with a central wooden post. The corners are held up with old cast iron uprights. The external surface is covered with lead.

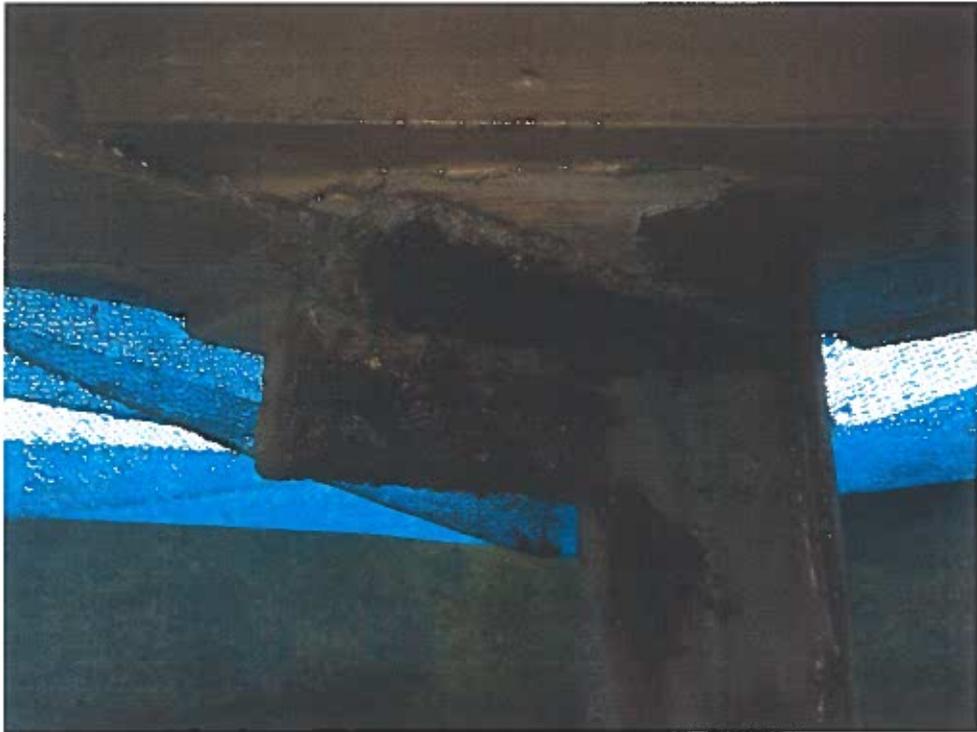
The underside of the roof timbers showed no particular evidence of deterioration and this indicates that the leadwork on top is functioning adequately. Unfortunately, the uprights holding this structure are heavily oxidised and will need to be replaced in the near future.

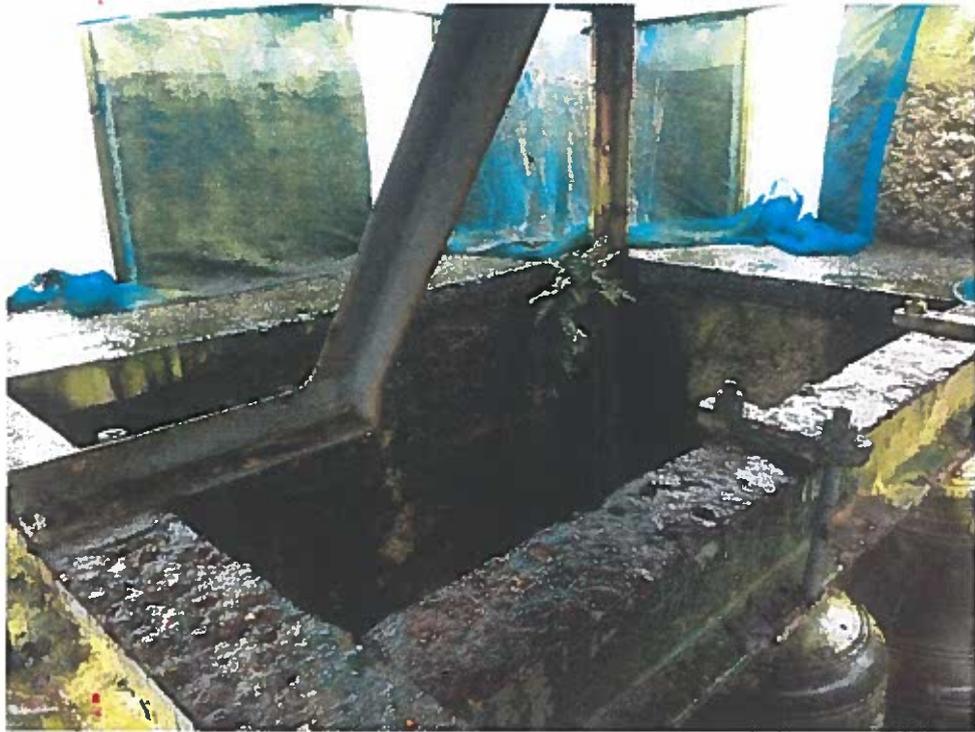
There is an obvious problem with seagulls and pigeons and an adhoc anti-bird netting has been added around the roof turrets. This looks recently installed but is already suffering from weather damage. Further attention may be needed regarding the roof structure and bird problem.

At the very least, the upright metal poles holding the roof structure up will need to be replaced in the very short term. These are extremely oxidised.

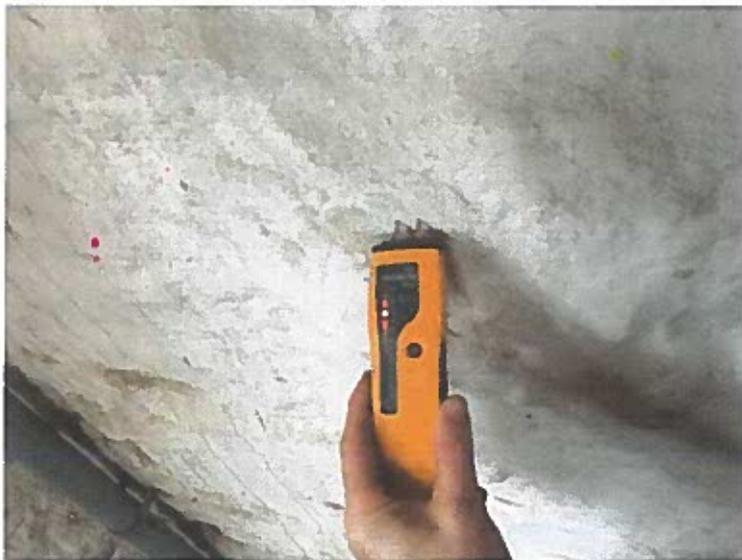
Some leadwork can be found at the base of some of the window apertures. This was no doubt installed to prevent driving wind and rain making its way beneath the windows. Unfortunately, high damp readings were taken around the apertures and this leadwork may not be functioning adequately although a great deal of water is permeating down through the building.

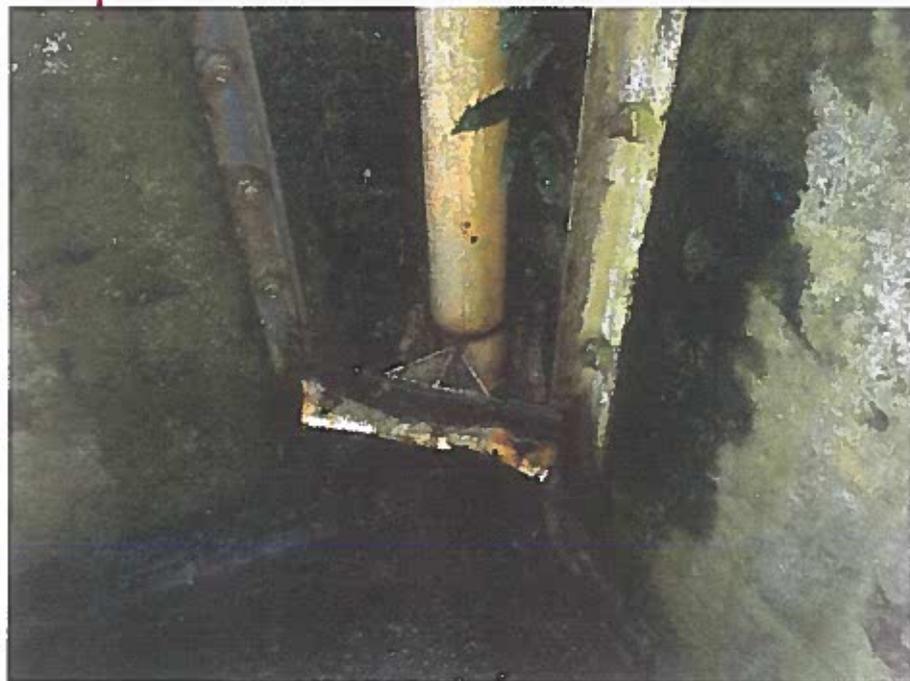
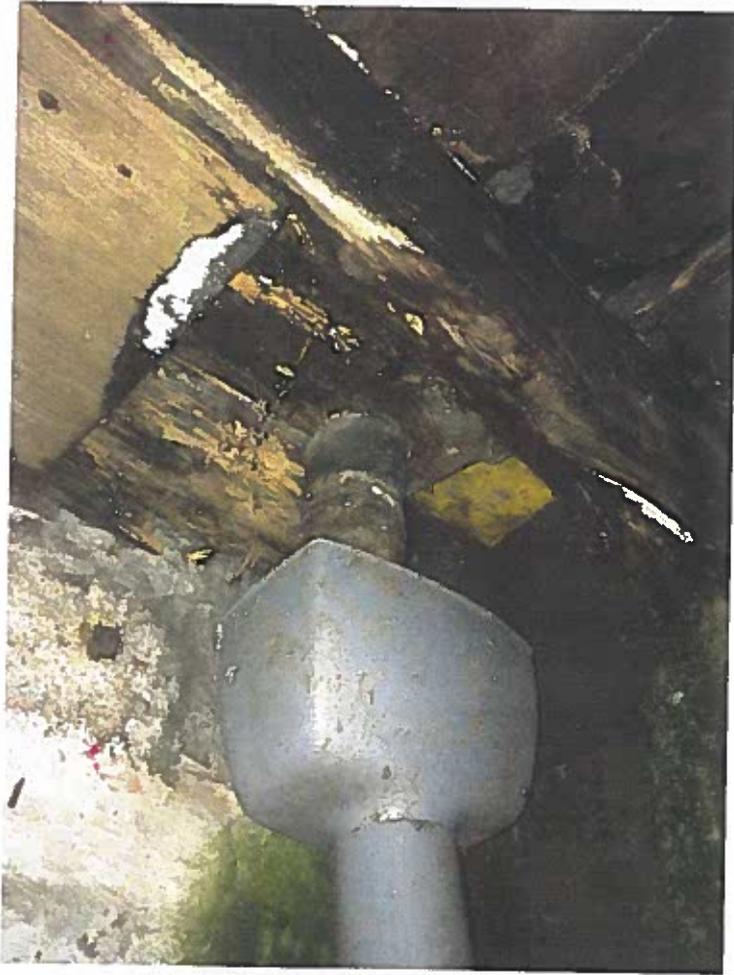
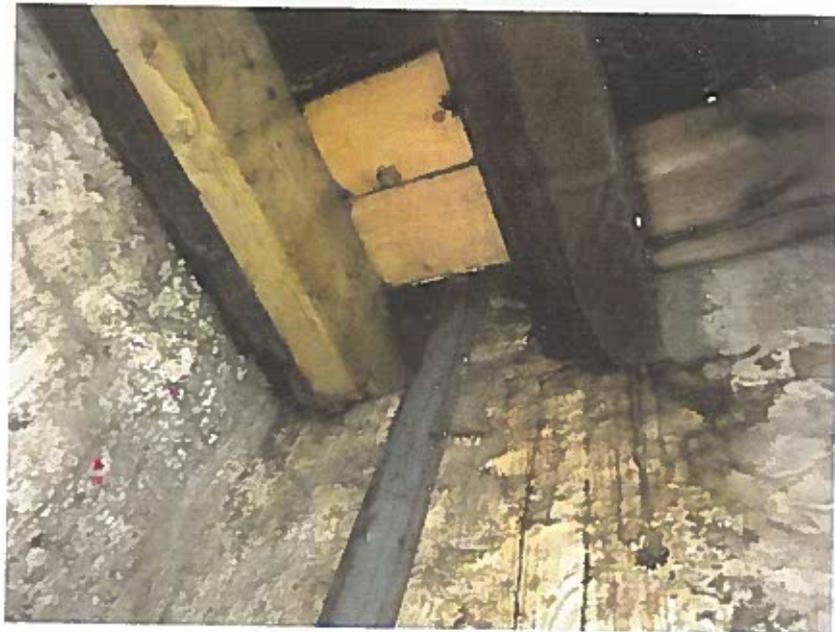
There is a lead tray directly beneath the bells which is designed to capture rainwater and direct it to a lead guttering in the front left hand interior corner. Unfortunately, this leadwork shows evidence of leakage beneath as some of the timbers were shown to be rotten. The lead guttering tray and downpipe have also leaked for a long period of time, causing the timbers beneath and all of the floors to have rotted out and some of these have needed to be replaced. This whole area of leadwork needs to be reworked to include a good surface water downpipe. The long term leakage in this area has caused damage throughout the building.

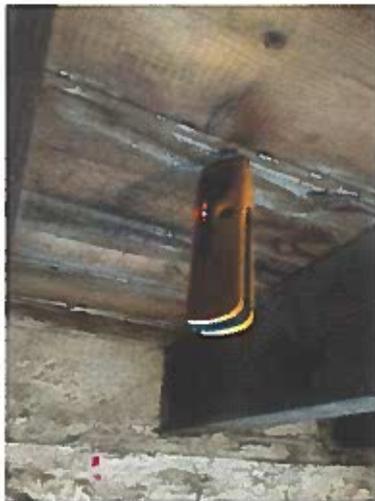
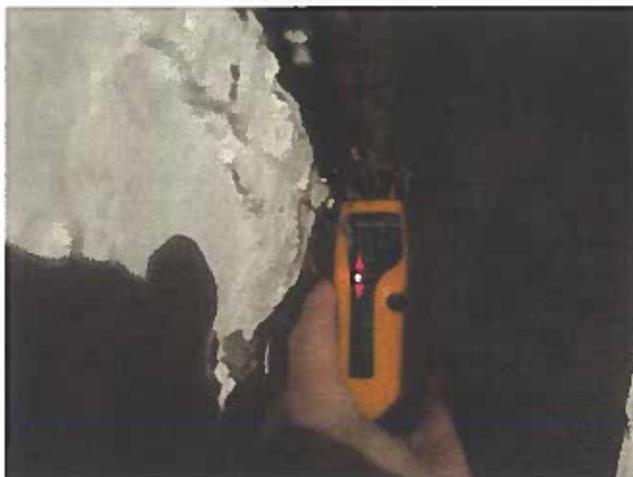
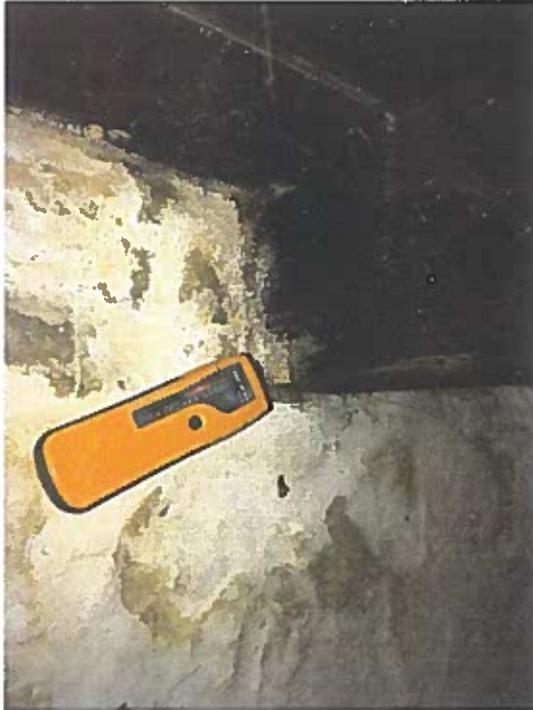
The floors above are of suspended timber joist construction with floorboards over. High damp readings were taken from each floor level and rotten timbers were noted.

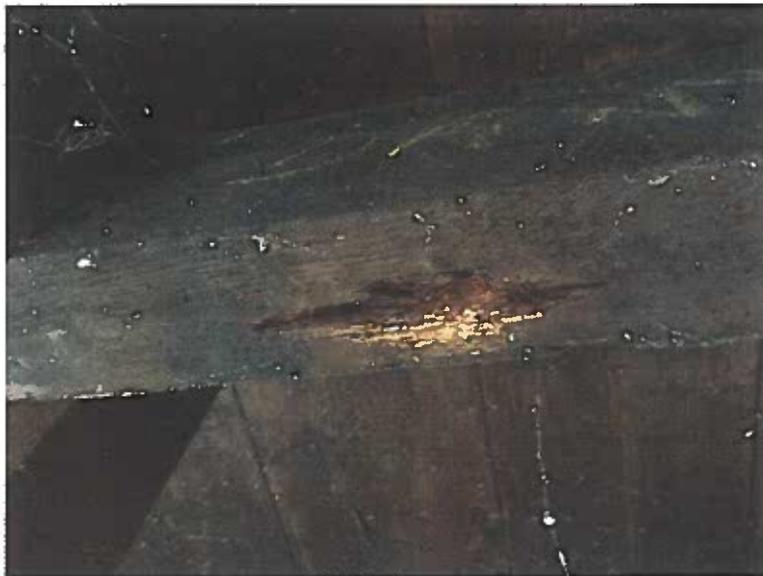
You should be aware that timber joist ends embedded in external walls can often be affected by rot which is not always visible until it breaks through to the boards. **Active woodworm was also detected during my inspection.**

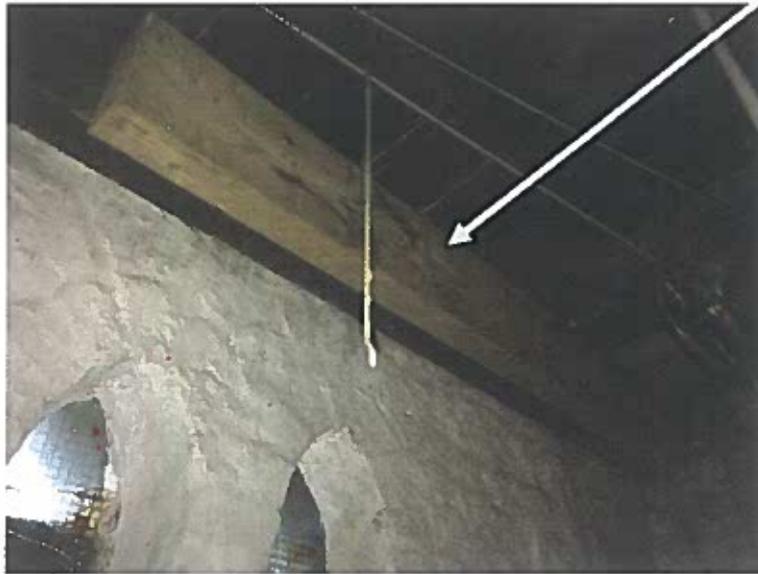
Adhoc repairs have been made to the floor joists where one or two modern timbers have been scarfed in but more work needs to be done. Unfortunately, the walls are so damp that the joist ends are suffering from long term moisture penetration. Whilst the floors in the property are currently sound underfoot, they will not remain so for long given the levels of moisture being experienced and the active woodworm, together with the timber rot noted.

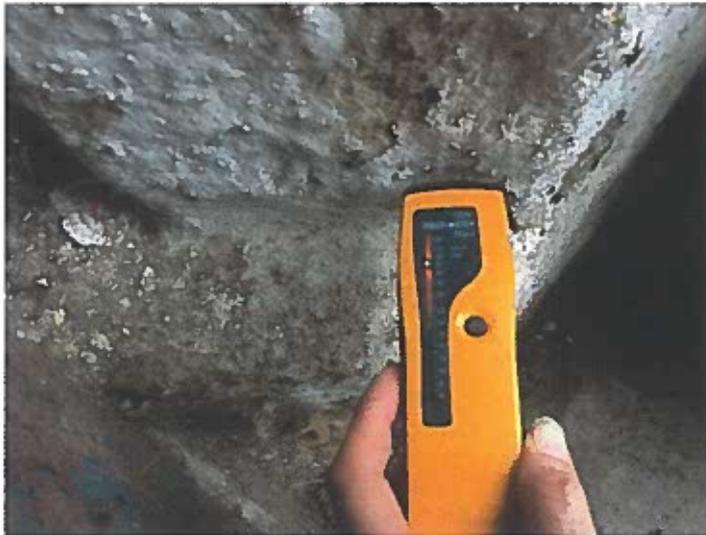
The moisture meter was randomly applied to the base of the main structural walls and rising damp was detected. Old stone buildings have no form of damp proof course and rising damp is common.

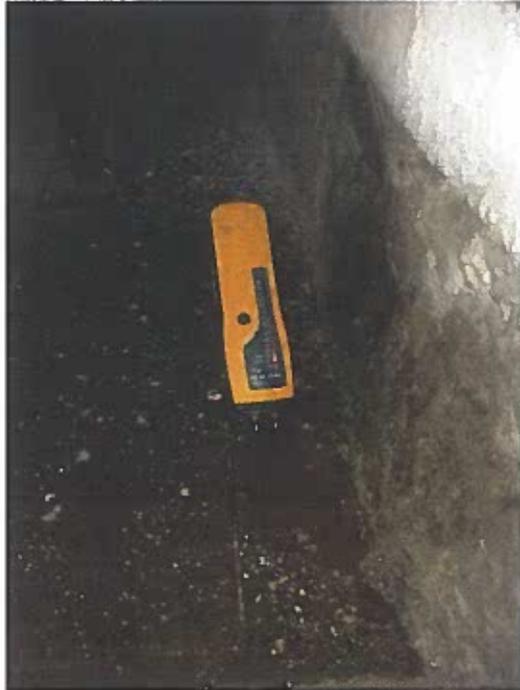
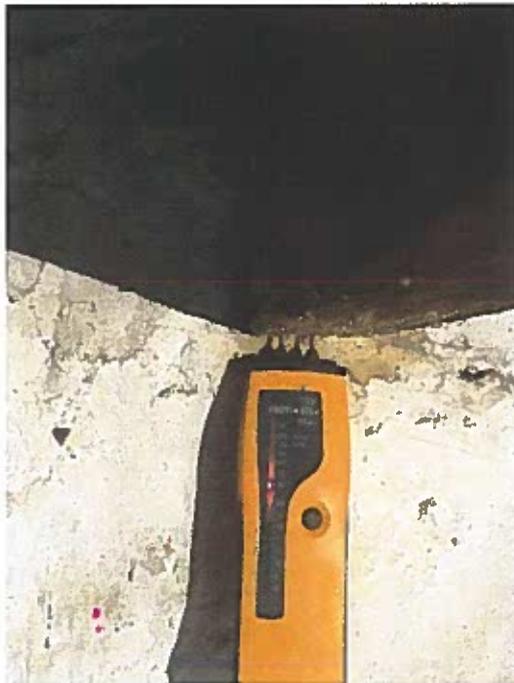
Penetrating dampness was recorded at all levels and around all window and door apertures. Old stone buildings have no form of vertical damp proofing other than the quality of the stonework and pointing. This property has an open roof, defective leadwork and a poor run off of surface water which

allows water to trickle down the stone walls. I would strongly recommend that the interior of the clock tower be waterproof tanked and when repairs are made to floor joists, that the ends are waterproofed.

You are strongly advised to consult with a timber and damp specialist with regard to this building. There was active woodworm, timber rot

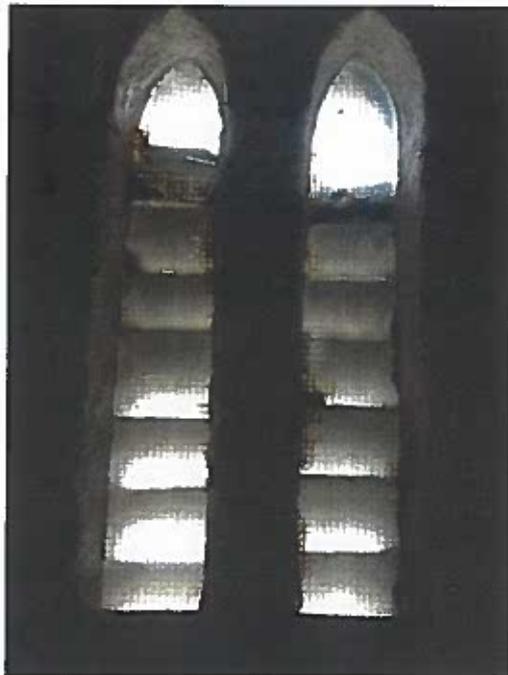
The fourth floor windows are glazed slats embedded in the stonework where originally there would have been slates. These are of a modern safety glass and have been poorly maintained.

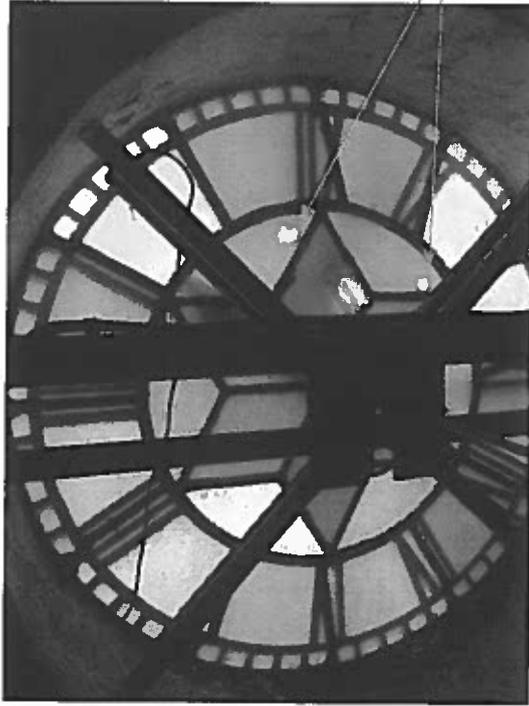
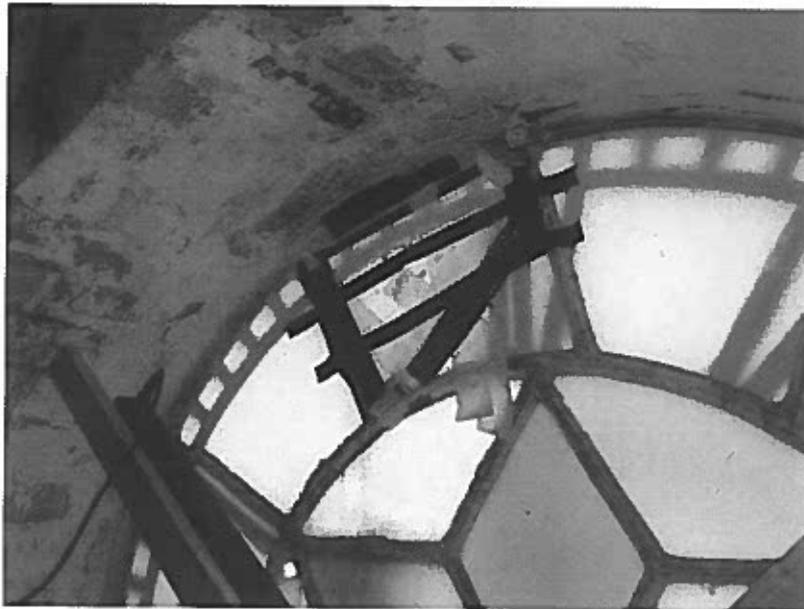
The glass on the clock faces themselves looks to have been vandalised, probably by airgun pellets, and there have been a number of repairs undertaken. There are other repairs required on the clock faces and I would refer you to metalwork below.

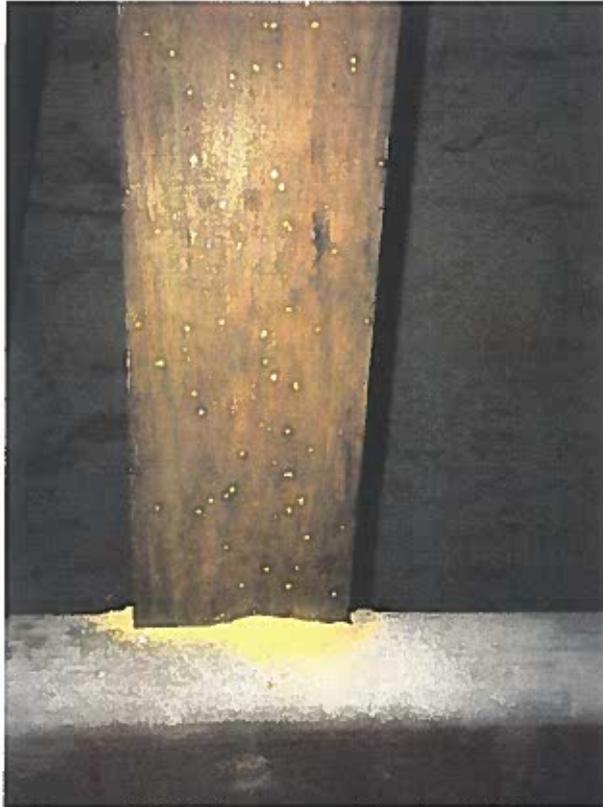
As stated above, the woodwork consists of window frames, suspended timber joist floors and the roof structure. The roof structure itself is in reasonable repair apart from the metal uprights. The floor joists are

suffering from long term exposure to dampness and exhibit signs of timber rot and woodworm infestation. As advised above, a timber and damp specialist should be employed to make recommendations.

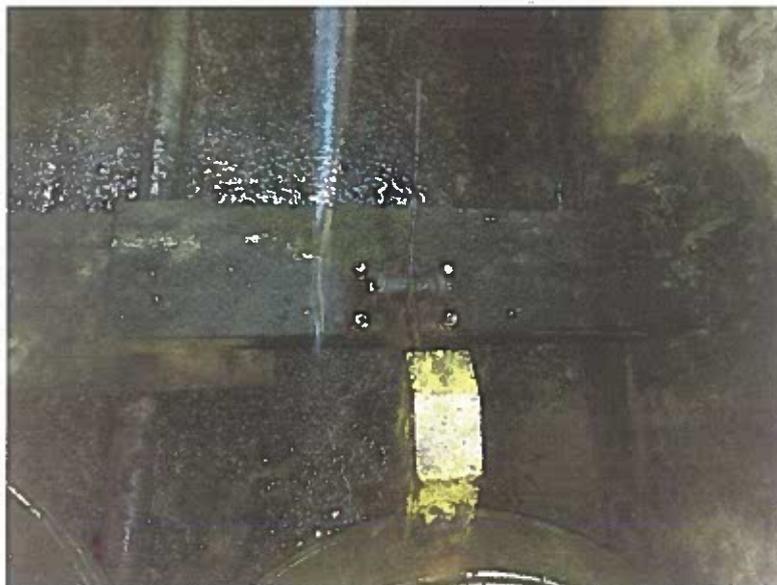
The woodwork for the hammers on the bells is in an advanced state of timber rot and needs immediate repair.

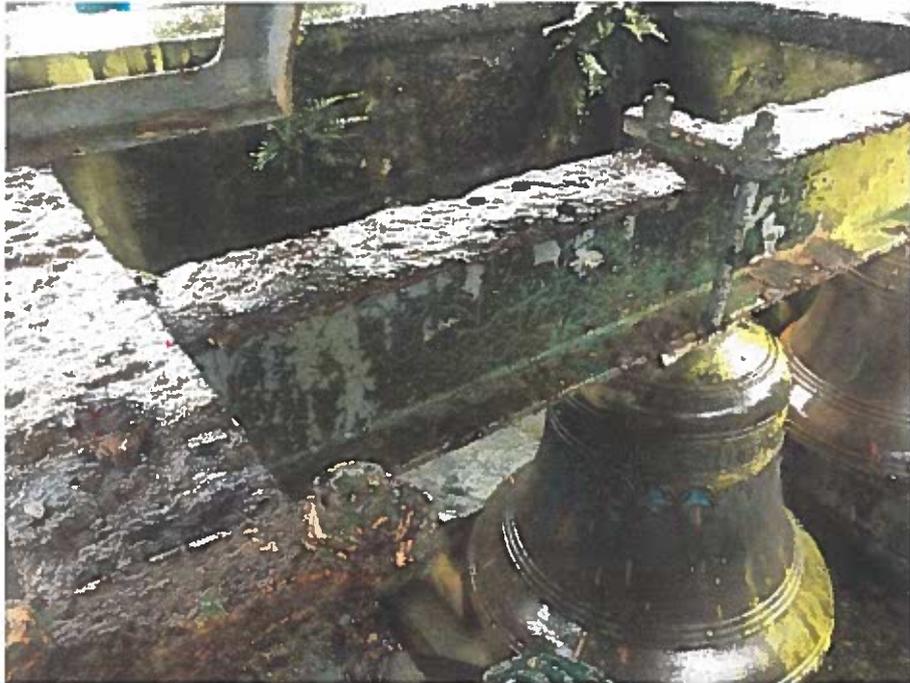
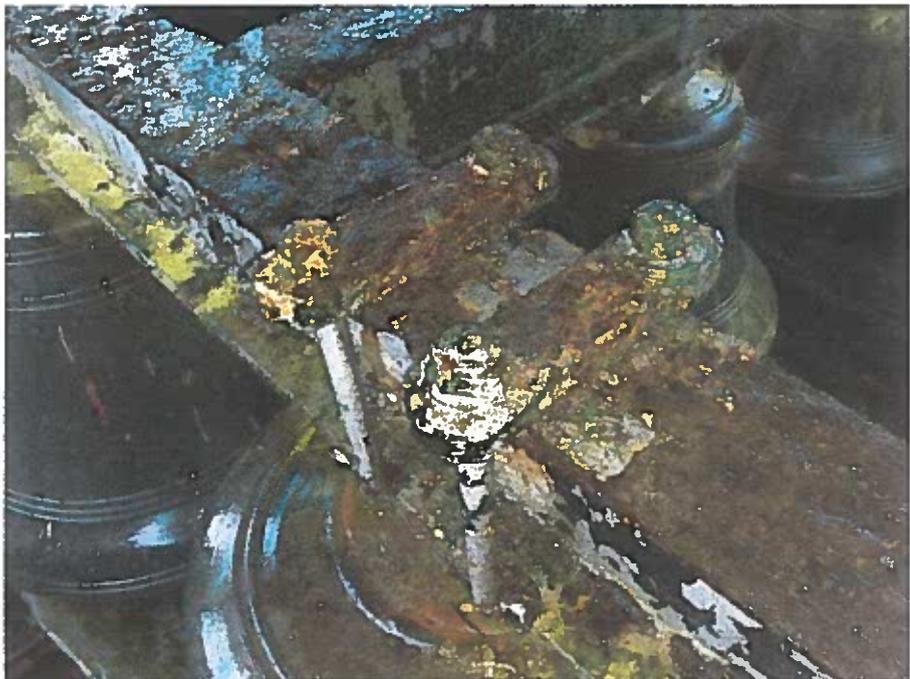
The bells are held up by large metal beams and these are heavily corroded and will need to be replaced in the short to medium term.

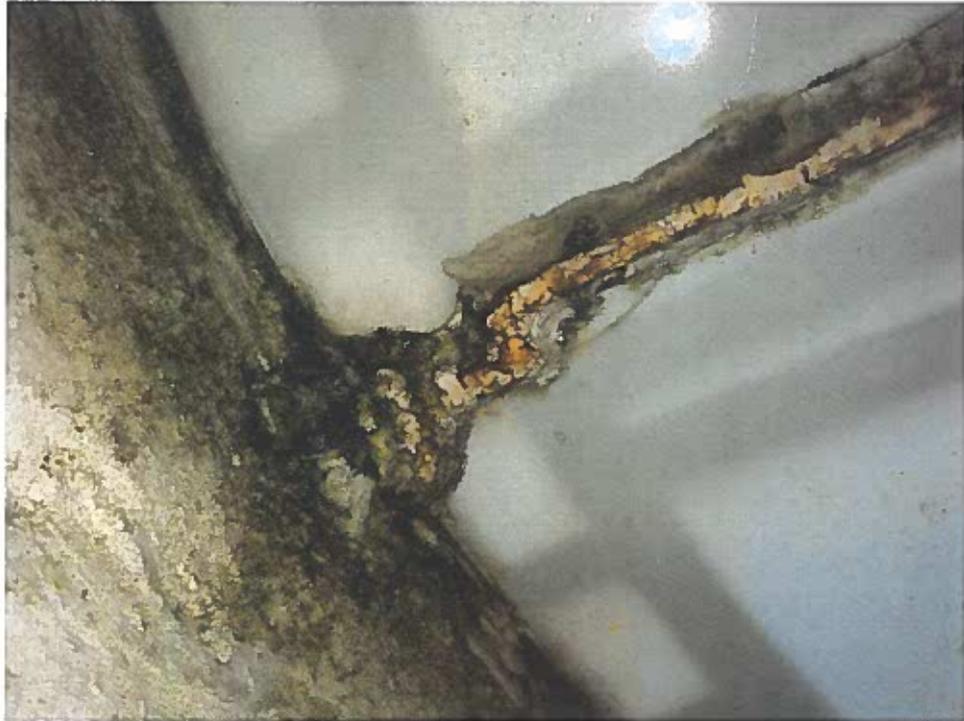
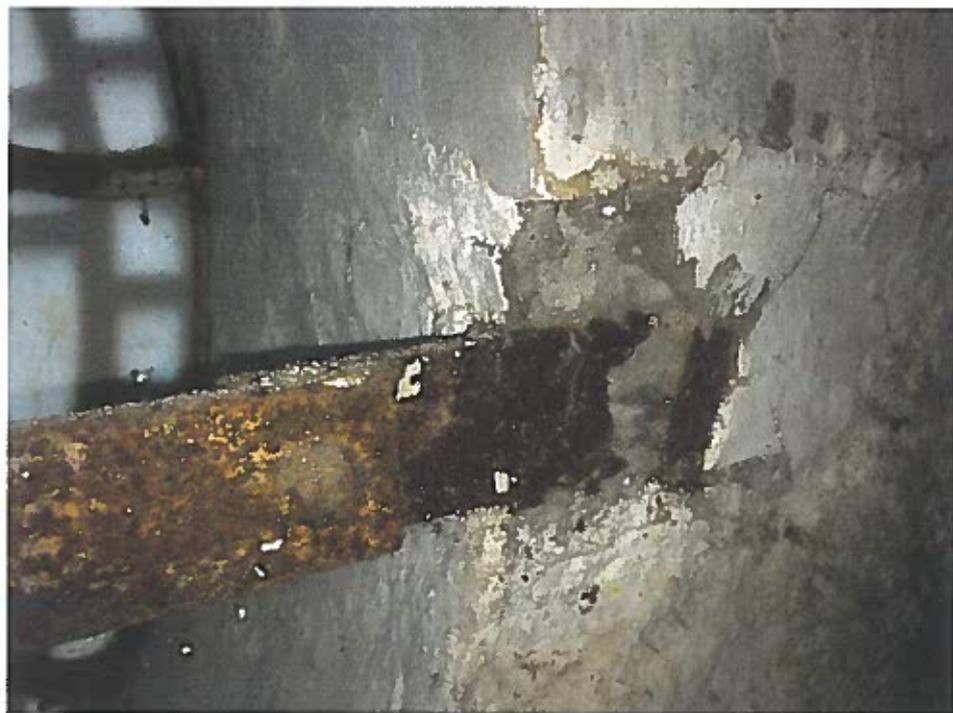
Throughout the clock tower there are embedded strips of metal in various places for the clock mechanism. This includes the clock face. Metalwork that is poorly maintained and exposed to moisture can oxidise quickly and

most of the metalwork in this building is in an advanced state of oxidation. The clock face itself is in need of immediate repair with regard to its metalwork, including where it is affixed into the stone walls.

Most of the metalwork within requires immediate replacement because, as it

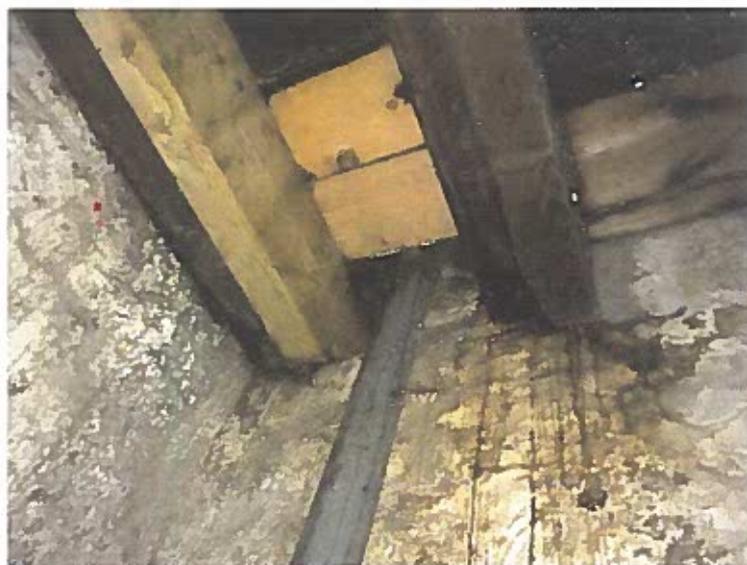
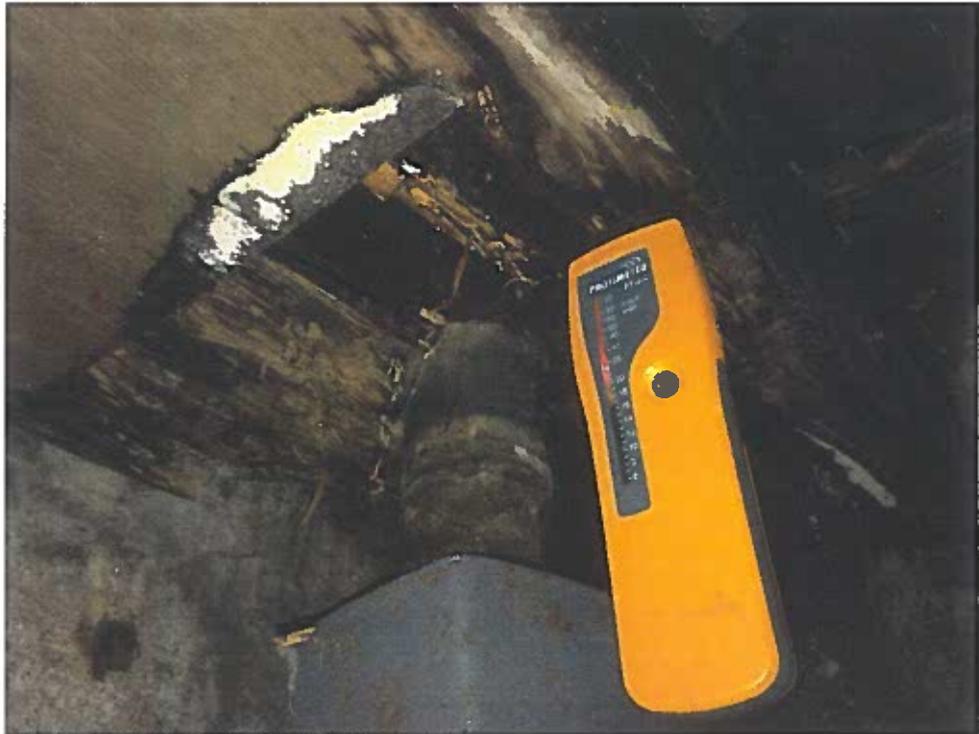
The building has one main gutter. There is a lead tray directly beneath the bells just under the roof covering which collects any water and sends it to a gully which runs to a downpipe, dropping the entire length of the building to an open trap found just inside the entrance door. **The lead tray is heavily clogged with bird mess and other debris and is not functioning adequately. The downpipe is also defective, allowing water to penetrate the floors below. There is water staining all the way down this gully. It seems a shame that this area of the building has not been maintained well as it is a low cost element and relatively easy to repair. It has had a large effect upon many of the defects in the building and I would recommend that this area is repaired immediately.**

Immediate repairs should be made to the surface water drainage and internal downpipe running down the left hand corner. This has had a long term detrimental effect on the surrounding timbers.

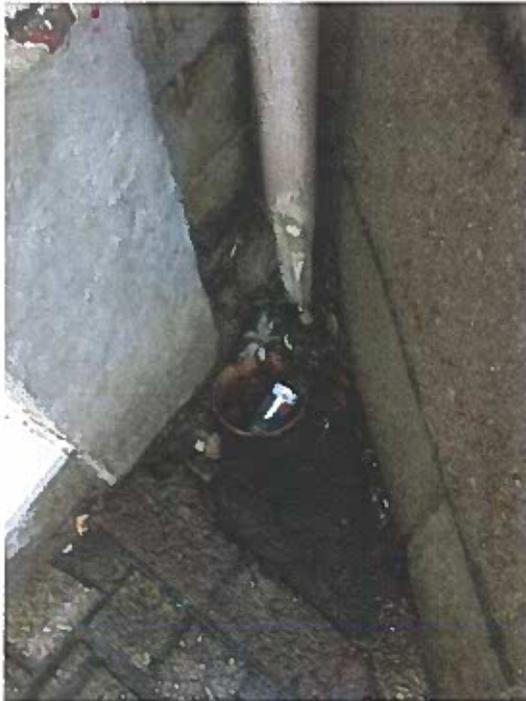
Externally, there is a downpipe running down the left hand corner and this is for the drainage for the neighbouring property to left. This runs to an open trap at the base of the clock tower which is heavily clogged with debris. You are advised to keep this cleared and flushed or ask the neighbours to do so.

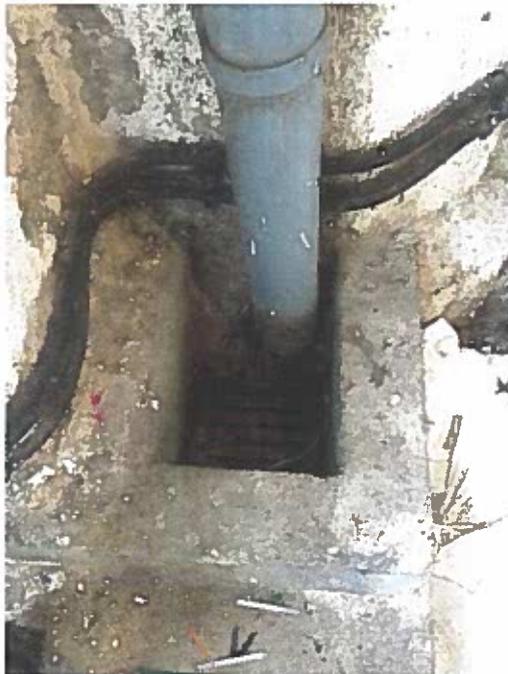
The building only has surface drainage. A neighbour's drain and the surface drain from this building run to open traps both found on the left hand corner. The surface drainage from this property runs to the internal trap with the neighbour's property running to the external trap. This will then run underground to the stormwater system. It would be advisable to have this system cleared and flushed to ensure a good run-off of surface water. **The surface water at this property has caused a great deal of long term damage due to a lack of maintenance. This is a relatively easy repair to make and will have a long lasting effect on the building.**
