# Building Refurbishment & Demolition Survey

P4 Pellet Plant Workshops , Restart Program, SSI UK, Redcar Main Gate, Trunk Road, Redcar, TS10 5QW.

**Project No:** 25860

**Job No:** 190590

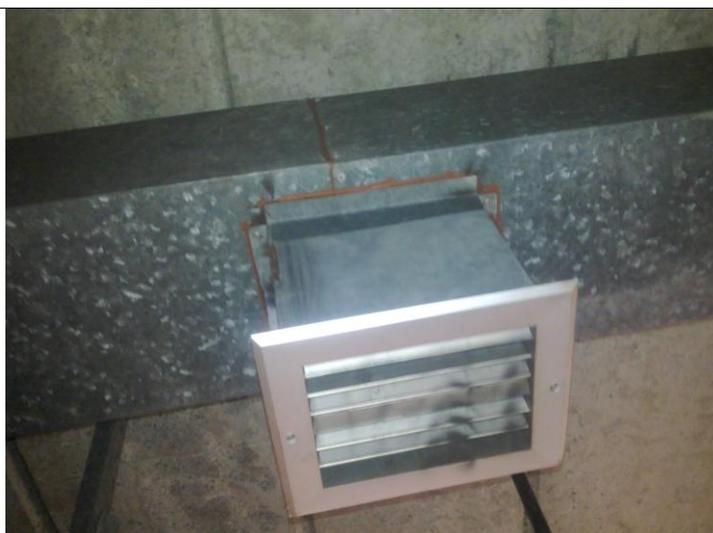
<b>Room</b>	Main Site, Toilet(s) - 0/09, Ductwork - Joint(s)					<b>Survey Date</b>	13/09/2011		
<b>Level of ID</b>	<b>Analyst Code</b>	<b>Quantity</b>	<b>Product</b>	<b>Condition</b>	<b>Surface Treatment</b>	<b>Result</b>	<b>Material Score</b>	<b>Risk Category</b>	
SP As	ND0804/11	0 Non Quantifiable	Composite Mastics	Low Damage	Composite	Chrysotile	3	VERY LOW RISK

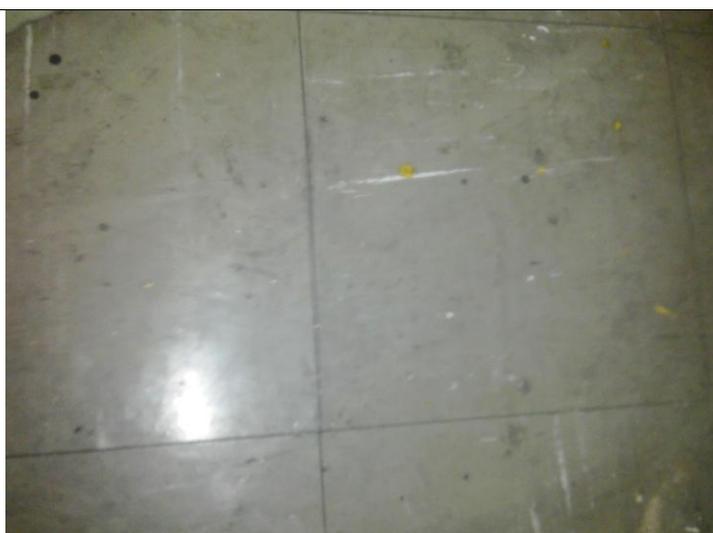
<b>Room</b>	Main Site, Toilet(s) - 0/09, Floor - Tile (with adhesive) - To Entrance Only					<b>Survey Date</b>	13/09/2011		
<b>Level of ID</b>	<b>Analyst Code</b>	<b>Quantity</b>	<b>Product</b>	<b>Condition</b>	<b>Surface Treatment</b>	<b>Result</b>	<b>Material Score</b>	<b>Risk Category</b>	
SP As	ND0815/11	6 m2	Composite Vinyl Tile, Vinyl/Lino with adhesive	High Damage	Composite	Chrysotile	5	LOW RISK

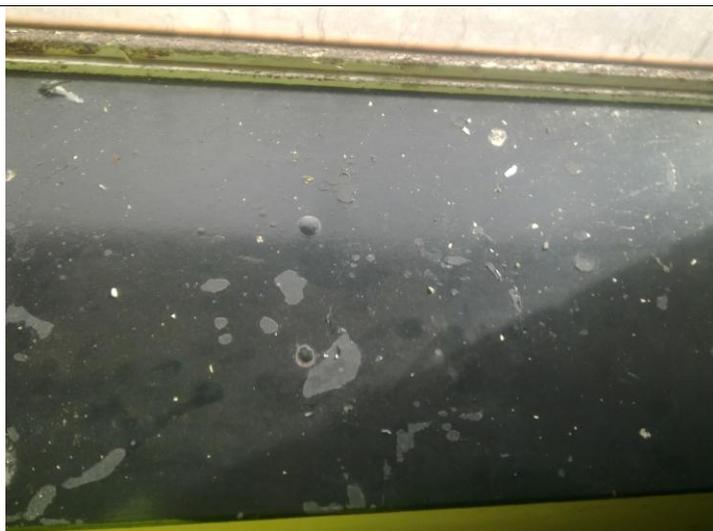
<b>Room</b>	Main Site, Store Room - 0/15, Window - Sill					<b>Survey Date</b>	13/09/2011		
<b>Level of ID</b>	<b>Analyst Code</b>	<b>Quantity</b>	<b>Product</b>	<b>Condition</b>	<b>Surface Treatment</b>	<b>Result</b>	<b>Material Score</b>	<b>Risk Category</b>	
SP As	ND0802/11	1 Item(s)	Composite Resinous/Reinforced Plastics	Low Damage	Composite	Chrysotile	3	VERY LOW RISK

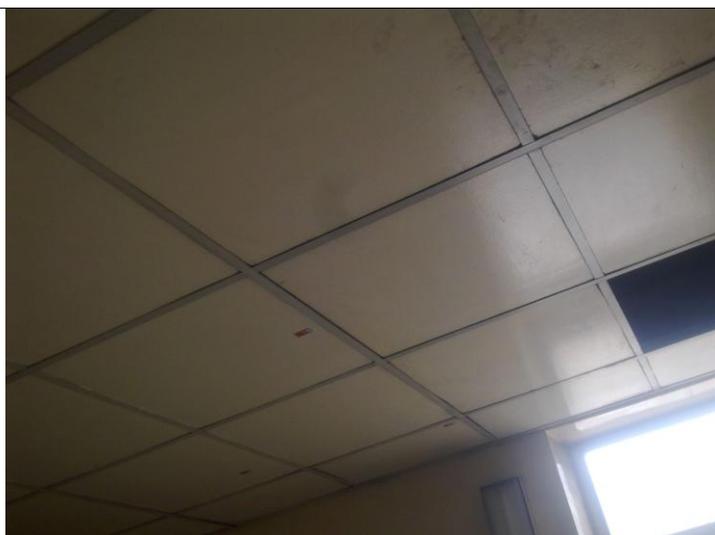
<b>Room</b>	Main Site, Stairs/hall/landing - 1/01, Ceiling Tile - Suspended, Solid					<b>Survey Date</b>	13/09/2011		
<b>Level of ID</b>	<b>Analyst Code</b>	<b>Quantity</b>	<b>Product</b>	<b>Condition</b>	<b>Surface Treatment</b>	<b>Result</b>	<b>Material Score</b>	<b>Risk Category</b>	
ID	ND0801/11	10 m2	Insulating Board	Low Damage	Sealed Board	Amosite, Chrysotile	6	LOW RISK

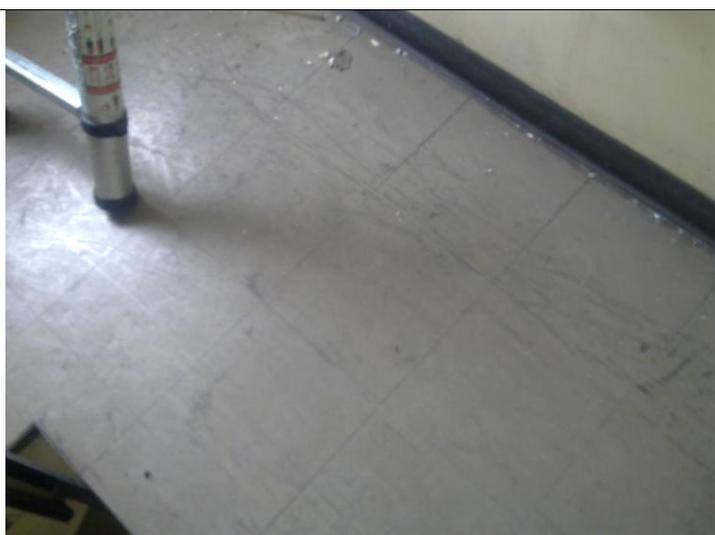
<b>Room</b>	Main Site, Stairs/hall/landing - 1/01, Floor - Tile (with adhesive)					<b>Survey Date</b>	13/09/2011		
<b>Level of ID</b>	<b>Analyst Code</b>	<b>Quantity</b>	<b>Product</b>	<b>Condition</b>	<b>Surface Treatment</b>	<b>Result</b>	<b>Material Score</b>	<b>Risk Category</b>	
ID	ND0799/11	10 m2	Composite Vinyl Tile, Vinyl/Lino with adhesive	Low Damage	Composite	Chrysotile	3	VERY LOW RISK

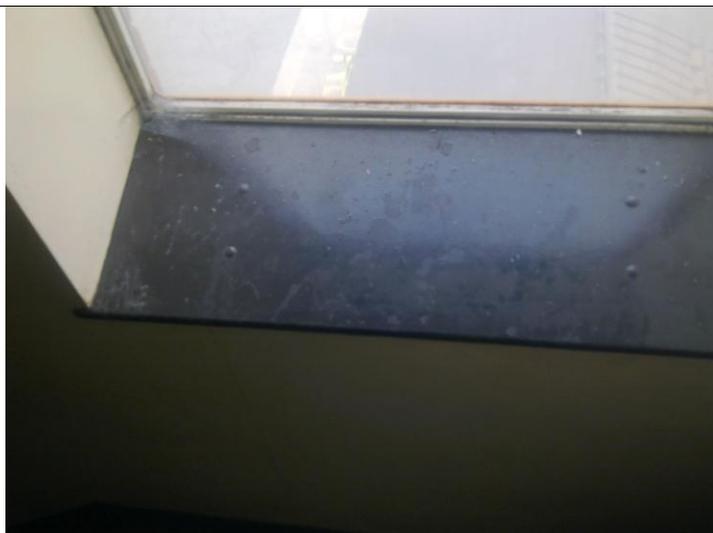
<b>Room</b>	Main Site, Stairs/hall/landing - 1/01, Window - Sill					<b>Survey Date</b>	13/09/2011		
<b>Level of ID</b>	<b>Analyst Code</b>	<b>Quantity</b>	<b>Product</b>	<b>Condition</b>	<b>Surface Treatment</b>	<b>Result</b>	<b>Material Score</b>	<b>Risk Category</b>	
ID	ND0802/11	1 Item(s)	Composite Resinous/Reinforced Plastics	Good	Composite	Chrysotile	2	VERY LOW RISK

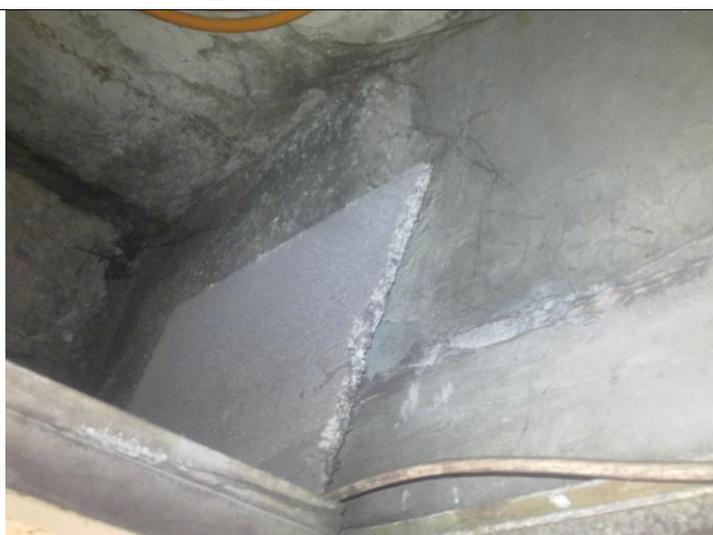
No high risk materials were identified during the survey. The only medium risk material found was in the ceiling void of stairwell 1/01 where some pieces of redundant AIB were identified in poor condition. All the other AIB found had only slight damage, but it has the potential to become a high risk material if disturbed.

<b>Room</b>	Main Site, Stairs/hall/landing - 1/01, Ceiling Tile - Suspended, Solid - Within Ceiling Void					<b>Survey Date</b>	13/09/2011		
<b>Level of ID</b>	<b>Analyst Code</b>	<b>Quantity</b>	<b>Product</b>	<b>Condition</b>	<b>Surface Treatment</b>	<b>Result</b>	<b>Material Score</b>	<b>Risk Category</b>	
ID	ND0803/11	1 m2	Insulating Board	High Damage	Sealed Board	Amosite, Chrysotile	8	MEDIUM RISK

Work with insulation materials such as AIB must only be carried out by a licensed asbestos removal contractor under controlled conditions, and it is a term of the HSE Asbestos Removal License that the HSE must be notified at least 14 days in advance of any licensed work being carried out. The 14 day notification period should be borne in mind when scheduling works which may be affected by such a delay.

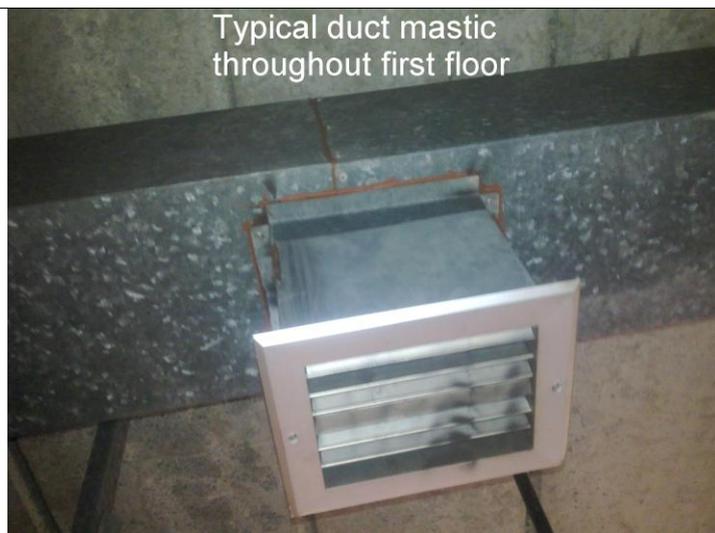
<b>Room</b>	Main Site, Room - Large Open Plan - 1/02, Ductwork - Joint(s)					<b>Survey Date</b>	13/09/2011		
<b>Level of ID</b>	<b>Analyst Code</b>	<b>Quantity</b>	<b>Product</b>	<b>Condition</b>	<b>Surface Treatment</b>	<b>Result</b>	<b>Material Score</b>	<b>Risk Category</b>	
ID	ND0804/11	0 Non Quantifiable	Composite Mastics	Low Damage	Composite	Chrysotile	3	VERY LOW RISK

Typical duct mastic throughout first floor

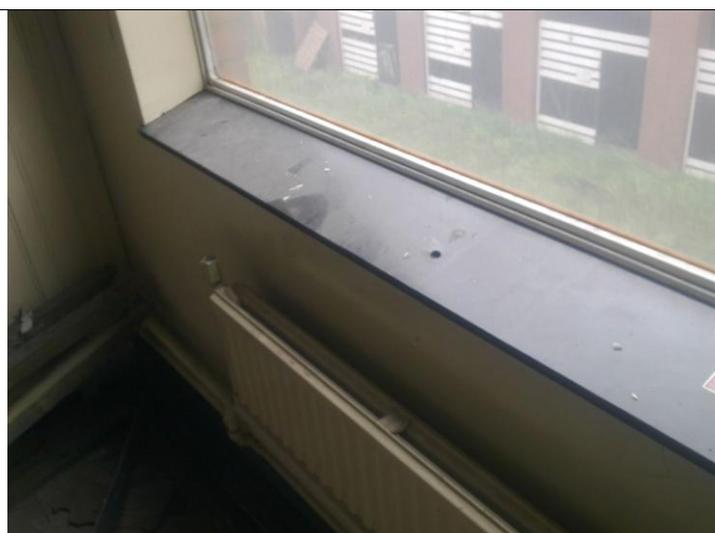
<b>Room</b>	Main Site, Room - Large Open Plan - 1/02, Window - Sill					<b>Survey Date</b>	13/09/2011		
<b>Level of ID</b>	<b>Analyst Code</b>	<b>Quantity</b>	<b>Product</b>	<b>Condition</b>	<b>Surface Treatment</b>	<b>Result</b>	<b>Material Score</b>	<b>Risk Category</b>	
SP As	ND0802/11	4 Item(s)	Composite Resinous/Reinforced Plastics	Good	Composite	Chrysotile	2	VERY LOW RISK

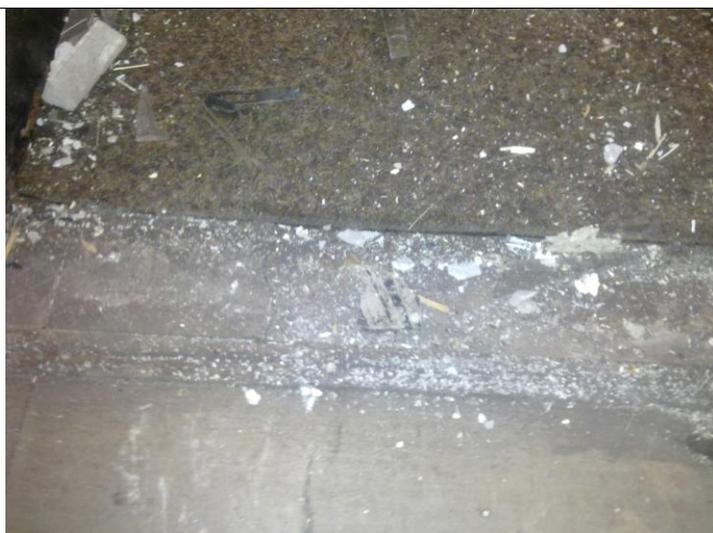
<b>Room</b>	Main Site, Room 1 - 1/03, Floor - Tile (Under floor covering)					<b>Survey Date</b>	13/09/2011		
<b>Level of ID</b>	<b>Analyst Code</b>	<b>Quantity</b>	<b>Product</b>	<b>Condition</b>	<b>Surface Treatment</b>	<b>Result</b>	<b>Material Score</b>	<b>Risk Category</b>	
SP As	ND0799/11	8 m2	Composite Vinyl Tile, Vinyl/Lino with adhesive	Low Damage	Composite	Chrysotile	3	VERY LOW RISK

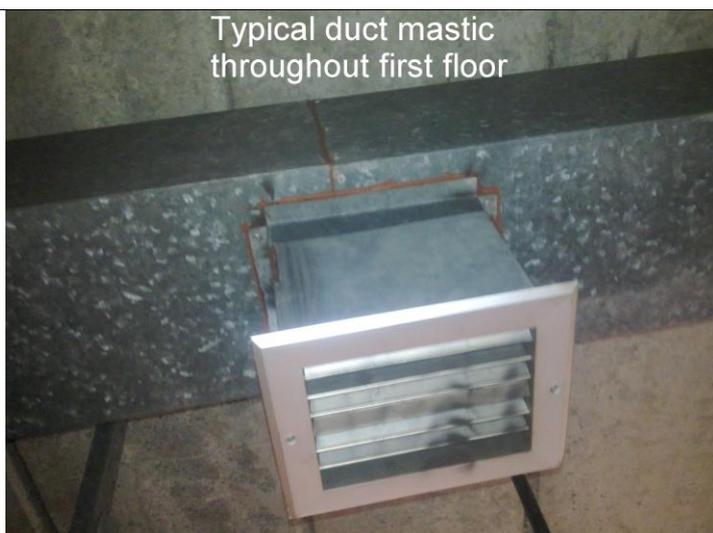
<b>Room</b>	Main Site, Room 1 - 1/03, Ductwork - Joint(s)					<b>Survey Date</b>	13/09/2011		
<b>Level of ID</b>	<b>Analyst Code</b>	<b>Quantity</b>	<b>Product</b>	<b>Condition</b>	<b>Surface Treatment</b>	<b>Result</b>	<b>Material Score</b>	<b>Risk Category</b>	
SP As	ND0804/11	0 Non Quantifiable	Composite Mastics	Low Damage	Composite	Chrysotile	3	VERY LOW RISK

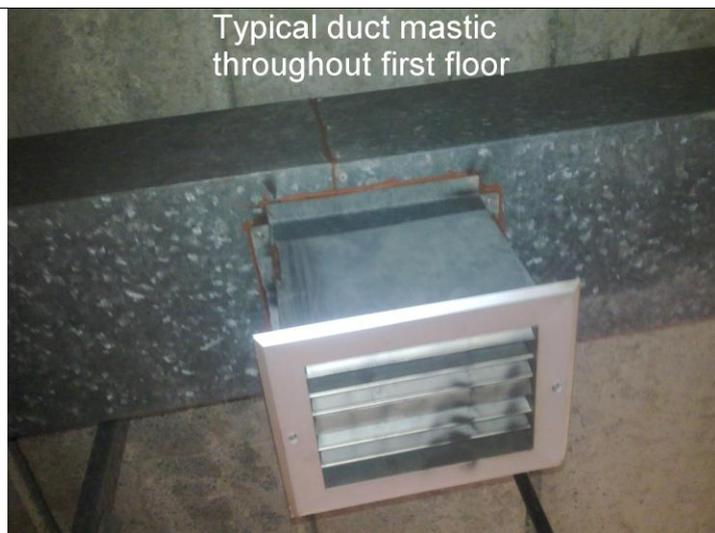
<b>Room</b>	Main Site, Room 2 - 1/04, Ductwork - Joint(s)					<b>Survey Date</b>	13/09/2011		
<b>Level of ID</b>	<b>Analyst Code</b>	<b>Quantity</b>	<b>Product</b>	<b>Condition</b>	<b>Surface Treatment</b>	<b>Result</b>	<b>Material Score</b>	<b>Risk Category</b>	
SP As	ND0804/11	0 Non Quantifiable	Composite Mastics	Low Damage	Composite	Chrysotile	3	VERY LOW RISK

Typical duct mastic throughout first floor

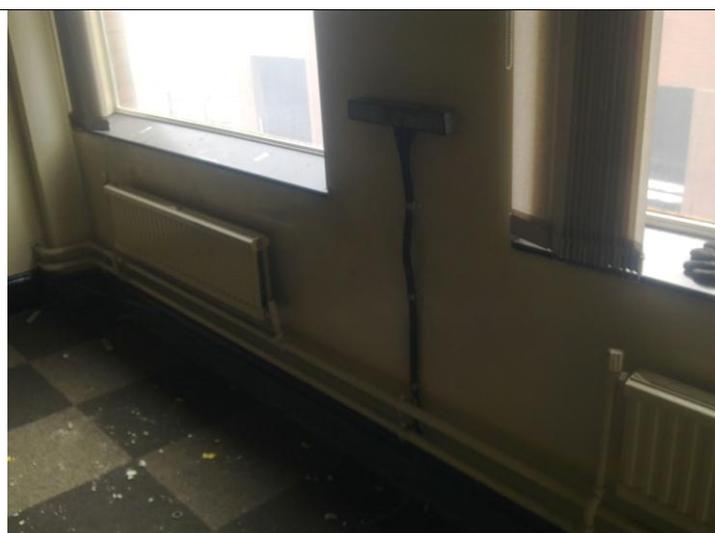
<b>Room</b>	Main Site, Room 2 - 1/04, Window - Sill					<b>Survey Date</b>	13/09/2011		
<b>Level of ID</b>	<b>Analyst Code</b>	<b>Quantity</b>	<b>Product</b>	<b>Condition</b>	<b>Surface Treatment</b>	<b>Result</b>	<b>Material Score</b>	<b>Risk Category</b>	
SP As	ND0802/11	2 Item(s)	Composite Resinous/Reinforced Plastics	Good	Composite	Chrysotile	2	VERY LOW RISK

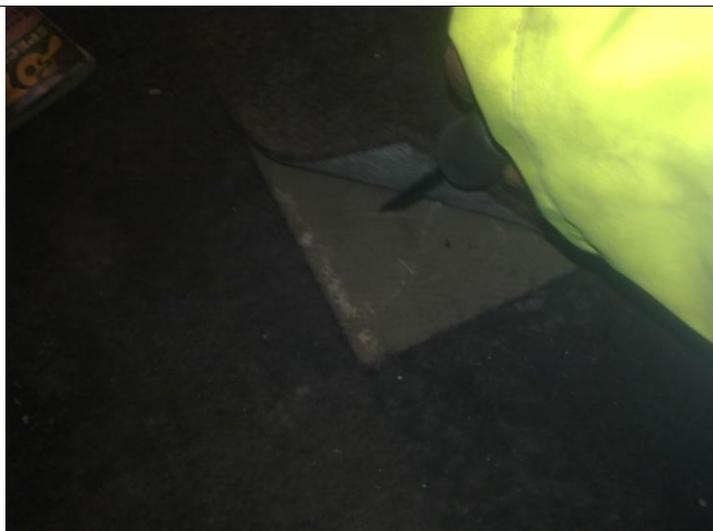
<b>Room</b>	Main Site, Room 2 - 1/04, Floor - Tile (Under floor covering)					<b>Survey Date</b>	13/09/2011		
<b>Level of ID</b>	<b>Analyst Code</b>	<b>Quantity</b>	<b>Product</b>	<b>Condition</b>	<b>Surface Treatment</b>	<b>Result</b>	<b>Material Score</b>	<b>Risk Category</b>	
SP As	ND0799/11	20 m2	Composite Vinyl Tile, Vinyl/Lino with adhesive	Low Damage	Composite	Chrysotile	3	VERY LOW RISK

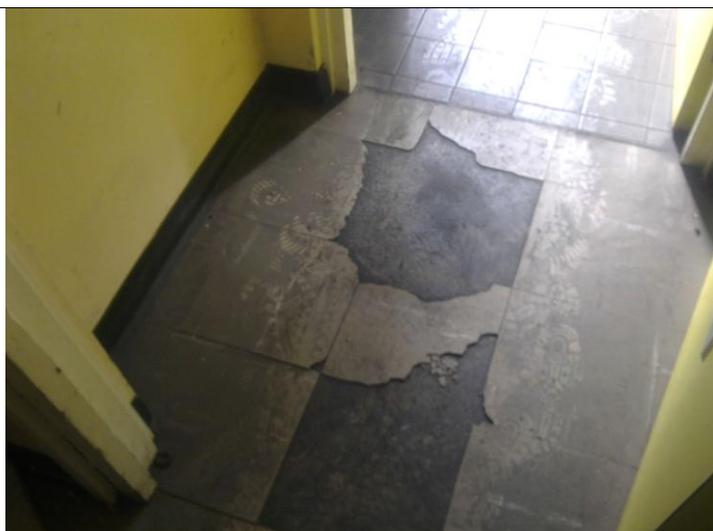
<b>Room</b>	Main Site, Corridor - 1/05, Floor - Tile (with adhesive)					<b>Survey Date</b>	13/09/2011		
<b>Level of ID</b>	<b>Analyst Code</b>	<b>Quantity</b>	<b>Product</b>	<b>Condition</b>	<b>Surface Treatment</b>	<b>Result</b>	<b>Material Score</b>	<b>Risk Category</b>	
SP As	ND0799/11	15 m2	Composite Vinyl Tile, Vinyl/Lino with adhesive	High Damage	Composite	Chrysotile	5	LOW RISK

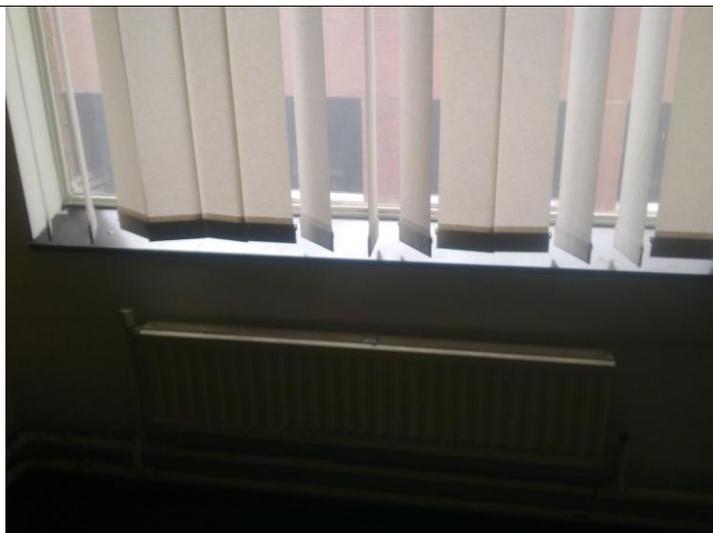
<b>Room</b>	Main Site, Room 3 - 1/06, Window - Sill					<b>Survey Date</b>	13/09/2011		
<b>Level of ID</b>	<b>Analyst Code</b>	<b>Quantity</b>	<b>Product</b>	<b>Condition</b>	<b>Surface Treatment</b>	<b>Result</b>	<b>Material Score</b>	<b>Risk Category</b>	
SP As	ND0802/11	2 Item(s)	Composite Resinous/Reinforced Plastics	Good	Composite	Chrysotile	2	VERY LOW RISK

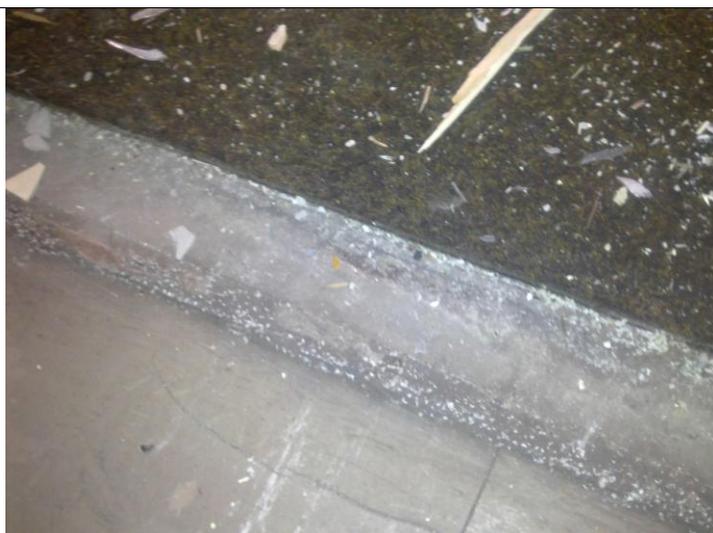
<b>Room</b>	Main Site, Room 3 - 1/06, Floor - Tile (Under floor covering)					<b>Survey Date</b>	13/09/2011		
<b>Level of ID</b>	<b>Analyst Code</b>	<b>Quantity</b>	<b>Product</b>	<b>Condition</b>	<b>Surface Treatment</b>	<b>Result</b>	<b>Material Score</b>	<b>Risk Category</b>	
SP As	ND0799/11	20 m2	Composite Vinyl Tile, Vinyl/Lino with adhesive	Low Damage	Composite	Chrysotile	3	VERY LOW RISK

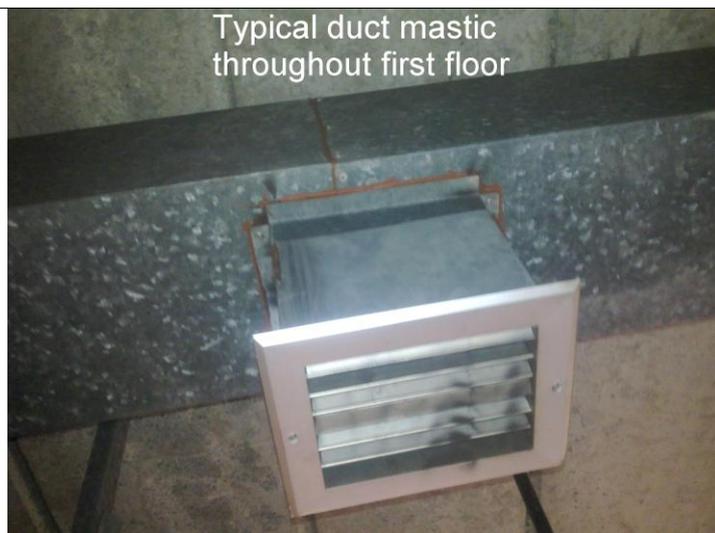
<b>Room</b>	Main Site, Room 3 - 1/06, Ductwork - Joint(s)					<b>Survey Date</b>	13/09/2011		
<b>Level of ID</b>	<b>Analyst Code</b>	<b>Quantity</b>	<b>Product</b>	<b>Condition</b>	<b>Surface Treatment</b>	<b>Result</b>	<b>Material Score</b>	<b>Risk Category</b>	
SP As	ND0804/11	0 Non Quantifiable	Composite Mastics	Low Damage	Composite	Chrysotile	3	VERY LOW RISK

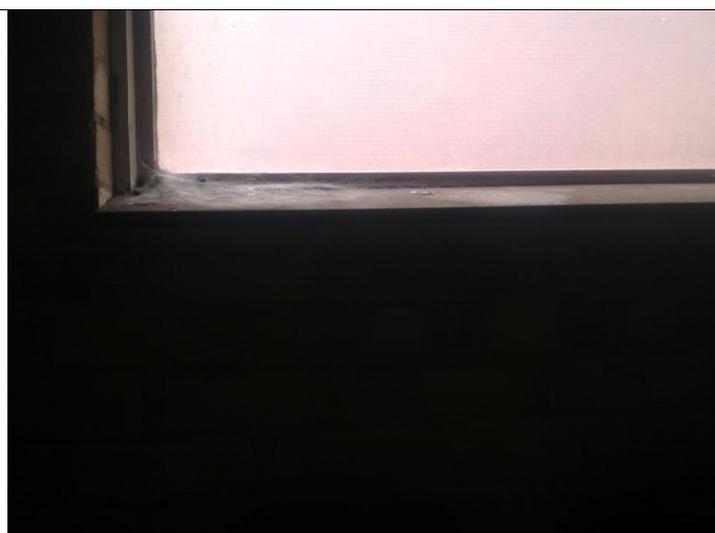
<b>Room</b>	Main Site, Plant Room - 1/07, Window - Sill					<b>Survey Date</b>	13/09/2011		
<b>Level of ID</b>	<b>Analyst Code</b>	<b>Quantity</b>	<b>Product</b>	<b>Condition</b>	<b>Surface Treatment</b>	<b>Result</b>	<b>Material Score</b>	<b>Risk Category</b>	
SP As	ND0802/11	1 Item(s)	Composite Resinous/Reinforced Plastics	Good	Composite	Chrysotile	2	VERY LOW RISK

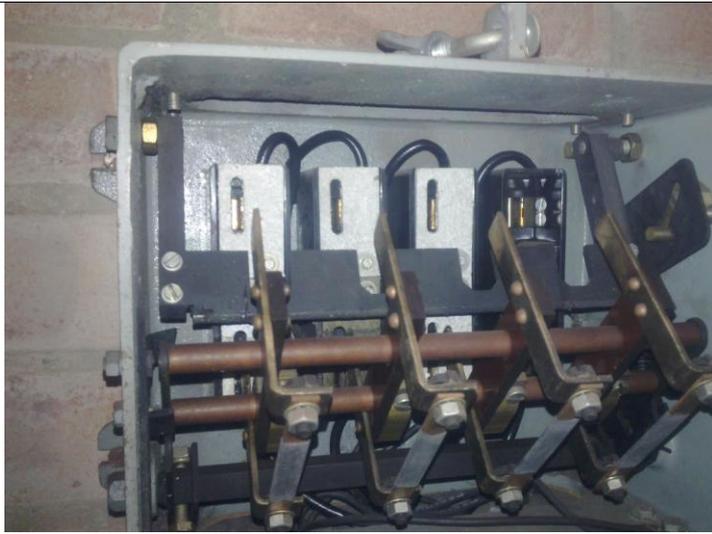
<b>Room</b>	Main Site, Plant Room - 1/07, Electrical Services - Arch Shields - In Live Switchgear					<b>Survey Date</b>	13/09/2011	
<b>Level of ID</b>	<b>Analyst Code</b>	<b>Quantity</b>	<b>Product</b>	<b>Condition</b>	<b>Surface Treatment</b>	<b>Result</b>	<b>Material Score</b>	<b>Risk Category</b>
SP	N/A	6 Item(s)	Insulating Board	Low Damage	Unsealed Board	Amosite	7	MEDIUM RISK

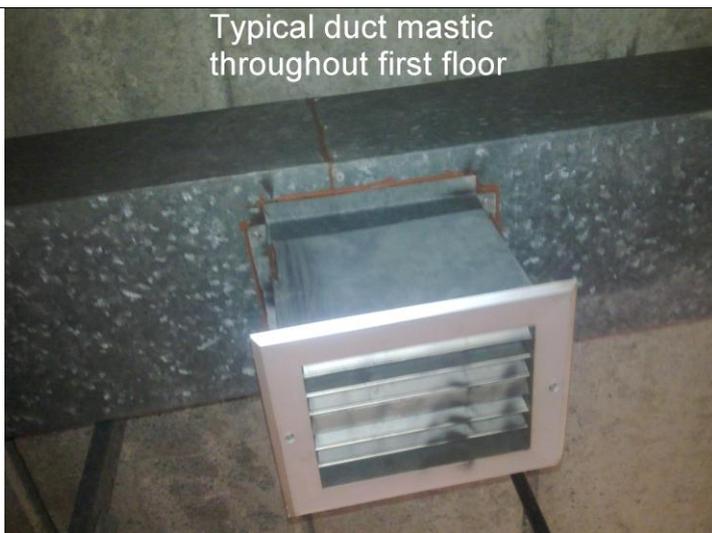
<b>Room</b>	Main Site, Plant Room - 1/07, Ductwork - Joint(s)					<b>Survey Date</b>	13/09/2011	
<b>Level of ID</b>	<b>Analyst Code</b>	<b>Quantity</b>	<b>Product</b>	<b>Condition</b>	<b>Surface Treatment</b>	<b>Result</b>	<b>Material Score</b>	<b>Risk Category</b>
SP As	ND0804/11	0 Non Quantifiable	Composite Mastics	Low Damage	Composite	Chrysotile	3	VERY LOW RISK

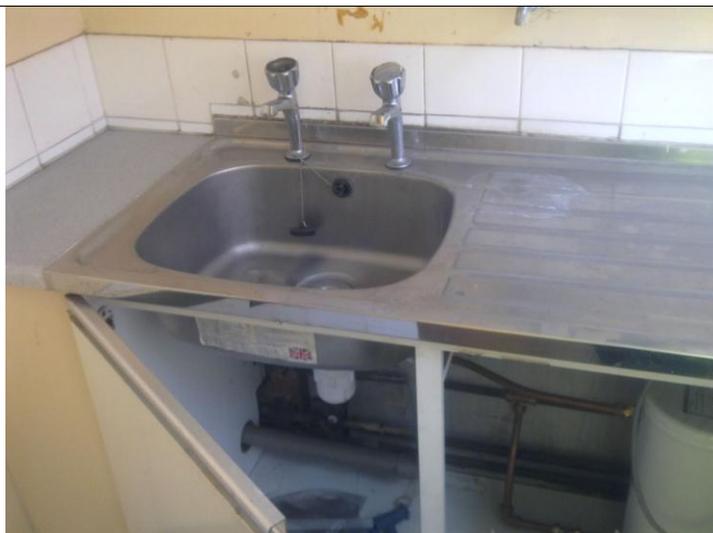
<b>Room</b>	Main Site, Kitchen - 1/09, Under Sink Mat					<b>Survey Date</b>	13/09/2011		
<b>Level of ID</b>	<b>Analyst Code</b>	<b>Quantity</b>	<b>Product</b>	<b>Condition</b>	<b>Surface Treatment</b>	<b>Result</b>	<b>Material Score</b>	<b>Risk Category</b>	
ID	ND0806/11	2 Item(s)	Composite Bitumen	Medium Damage	Composite	Chrysotile	4	VERY LOW RISK

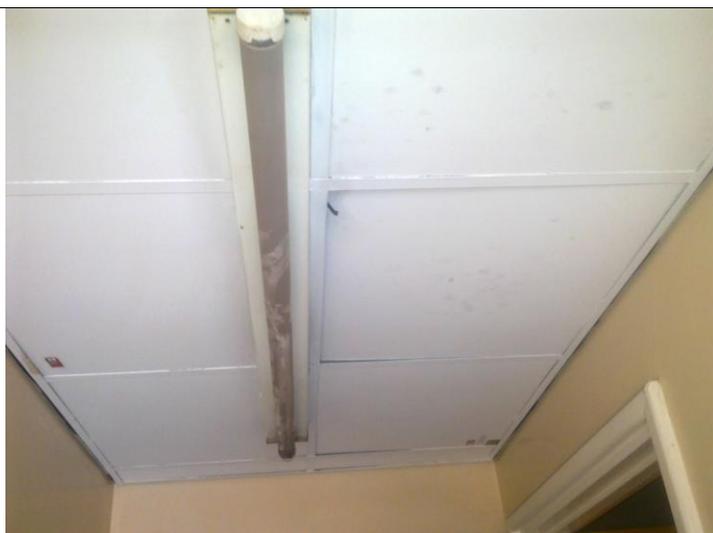
<b>Room</b>	Main Site, Kitchen - 1/09, Ceiling Tile - Suspended, Solid					<b>Survey Date</b>	13/09/2011		
<b>Level of ID</b>	<b>Analyst Code</b>	<b>Quantity</b>	<b>Product</b>	<b>Condition</b>	<b>Surface Treatment</b>	<b>Result</b>	<b>Material Score</b>	<b>Risk Category</b>	
SP As	ND0801/11	6 m2	Insulating Board	Low Damage	Sealed Board	Amosite, Chrysotile	6	LOW RISK

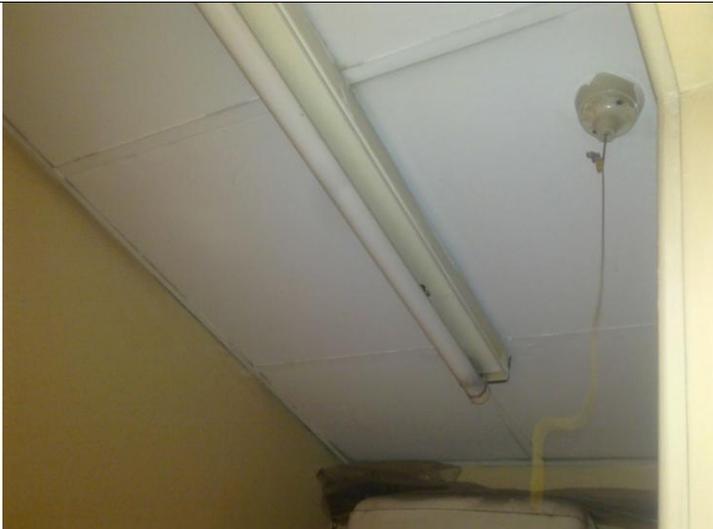
<b>Room</b>	Main Site, Wash Room - 1/10, Ceiling Tile - Suspended, Solid					<b>Survey Date</b>	13/09/2011		
<b>Level of ID</b>	<b>Analyst Code</b>	<b>Quantity</b>	<b>Product</b>	<b>Condition</b>	<b>Surface Treatment</b>	<b>Result</b>	<b>Material Score</b>	<b>Risk Category</b>	
SP As	ND0801/11	6 m2	Insulating Board	Low Damage	Sealed Board	Amosite, Chrysotile	6	LOW RISK

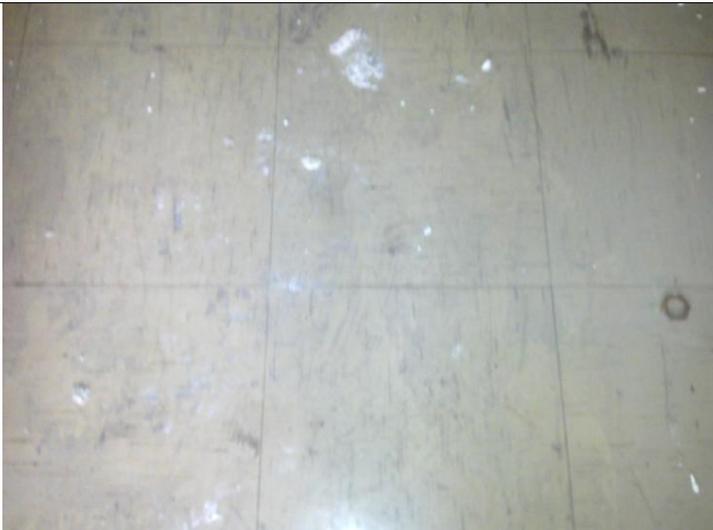
<b>Room</b>	Main Site, Toilet(s) - Male - 1/11, Floor - Tile (with adhesive) - To Entrance Only					<b>Survey Date</b>	13/09/2011		
<b>Level of ID</b>	<b>Analyst Code</b>	<b>Quantity</b>	<b>Product</b>	<b>Condition</b>	<b>Surface Treatment</b>	<b>Result</b>	<b>Material Score</b>	<b>Risk Category</b>	
SP As	ND0799/11	1 m2	Composite Vinyl Tile, Vinyl/Lino with adhesive	High Damage	Composite	Chrysotile	5	LOW RISK

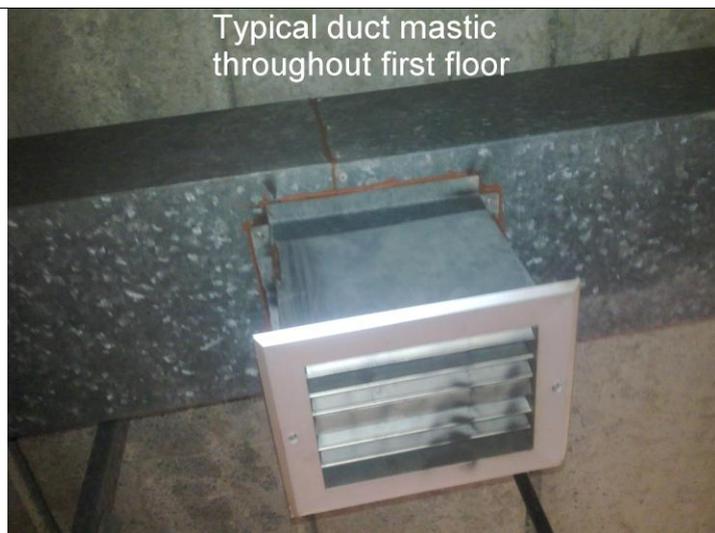
<b>Room</b>	Main Site, Toilet(s) - Male - 1/11, Ductwork - Joint(s)					<b>Survey Date</b>	13/09/2011		
<b>Level of ID</b>	<b>Analyst Code</b>	<b>Quantity</b>	<b>Product</b>	<b>Condition</b>	<b>Surface Treatment</b>	<b>Result</b>	<b>Material Score</b>	<b>Risk Category</b>	
SP As	ND0804/11	0 Non Quantifiable	Composite Mastics	Low Damage	Composite	Chrysotile	3	VERY LOW RISK

Typical duct mastic throughout first floor

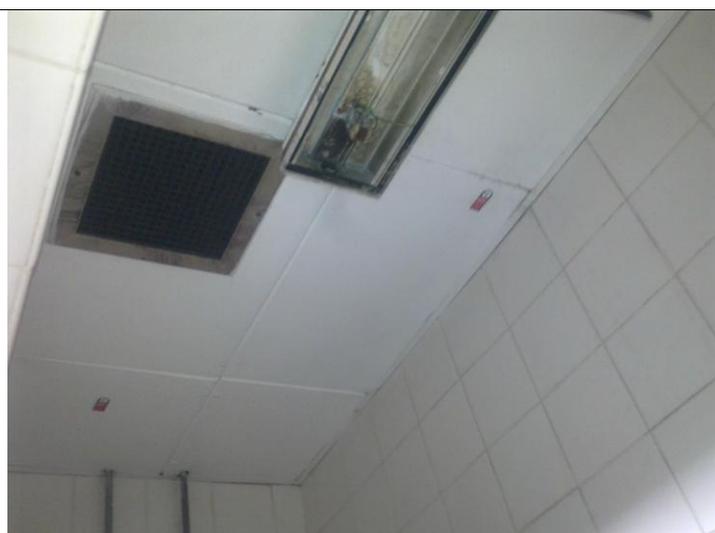
<b>Room</b>	Main Site, Toilet(s) - Male - 1/11, Ceiling Tile - Suspended, Solid - To Shower Only					<b>Survey Date</b>	13/09/2011		
<b>Level of ID</b>	<b>Analyst Code</b>	<b>Quantity</b>	<b>Product</b>	<b>Condition</b>	<b>Surface Treatment</b>	<b>Result</b>	<b>Material Score</b>	<b>Risk Category</b>	
SP As	ND0801/11	2 m2	Insulating Board	Low Damage	Sealed Board	Amosite, Chrysotile	6	LOW RISK

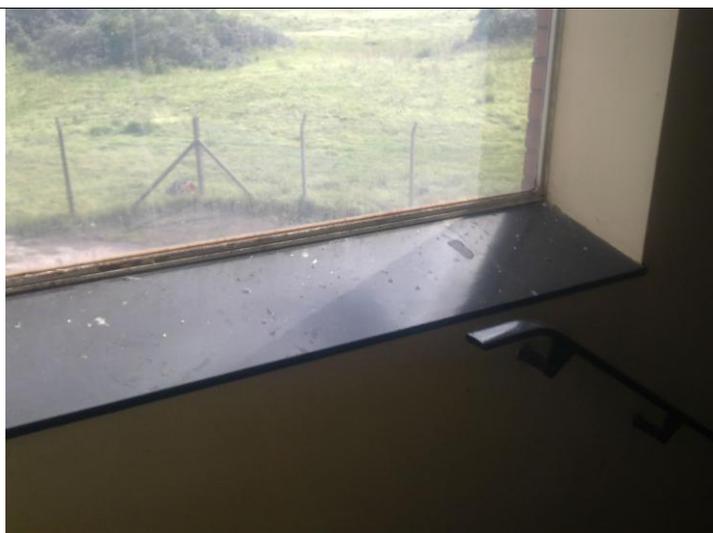
<b>Room</b>	Main Site, Stairs/hall/landing - 1/12, Window - Sill					<b>Survey Date</b>	13/09/2011		
<b>Level of ID</b>	<b>Analyst Code</b>	<b>Quantity</b>	<b>Product</b>	<b>Condition</b>	<b>Surface Treatment</b>	<b>Result</b>	<b>Material Score</b>	<b>Risk Category</b>	
SP As	ND0802/11	1 Item(s)	Composite Resinous/Reinforced Plastics	Good	Composite	Chrysotile	2	VERY LOW RISK

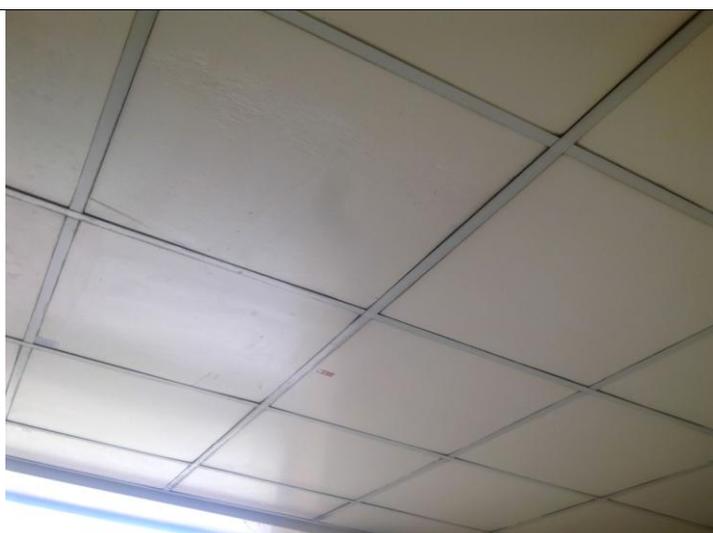
<b>Room</b>	Main Site, Stairs/hall/landing - 1/12, Ceiling Tile - Suspended, Solid					<b>Survey Date</b>	13/09/2011		
<b>Level of ID</b>	<b>Analyst Code</b>	<b>Quantity</b>	<b>Product</b>	<b>Condition</b>	<b>Surface Treatment</b>	<b>Result</b>	<b>Material Score</b>	<b>Risk Category</b>	
SP As	ND0801/11	10 m2	Insulating Board	Low Damage	Sealed Board	Amosite, Chrysotile	6	LOW RISK

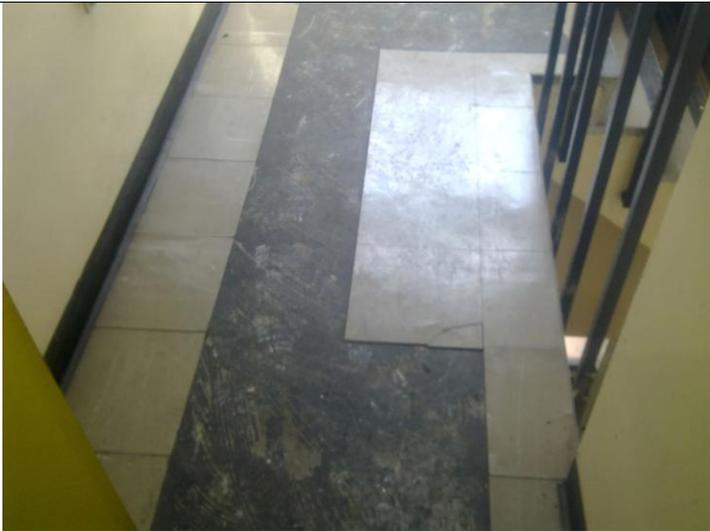
<b>Room</b>	Main Site, Stairs/hall/landing - 1/12, Floor - Tile (with adhesive)					<b>Survey Date</b>	13/09/2011		
<b>Level of ID</b>	<b>Analyst Code</b>	<b>Quantity</b>	<b>Product</b>	<b>Condition</b>	<b>Surface Treatment</b>	<b>Result</b>	<b>Material Score</b>	<b>Risk Category</b>	
SP As	ND0799/11	10 m2	Composite Vinyl Tile, Vinyl/Lino with adhesive	Low Damage	Composite	Chrysotile	3	VERY LOW RISK
