## ASBESTOS SURVEY REPORT

### Demolition Survey (with MA only)

Report Number	Issue Number	Issue Date
J019761	1	21 Feb 2017
Site Address		UPRN
St Mary's Way Public Toilet (in St Mary's Way Car Park), Melton Mowbray, Leicestershire, LE13		Unknown
Scope of Survey		
Demolition survey to all internal and external locations		
Client Specific Requirements		
None

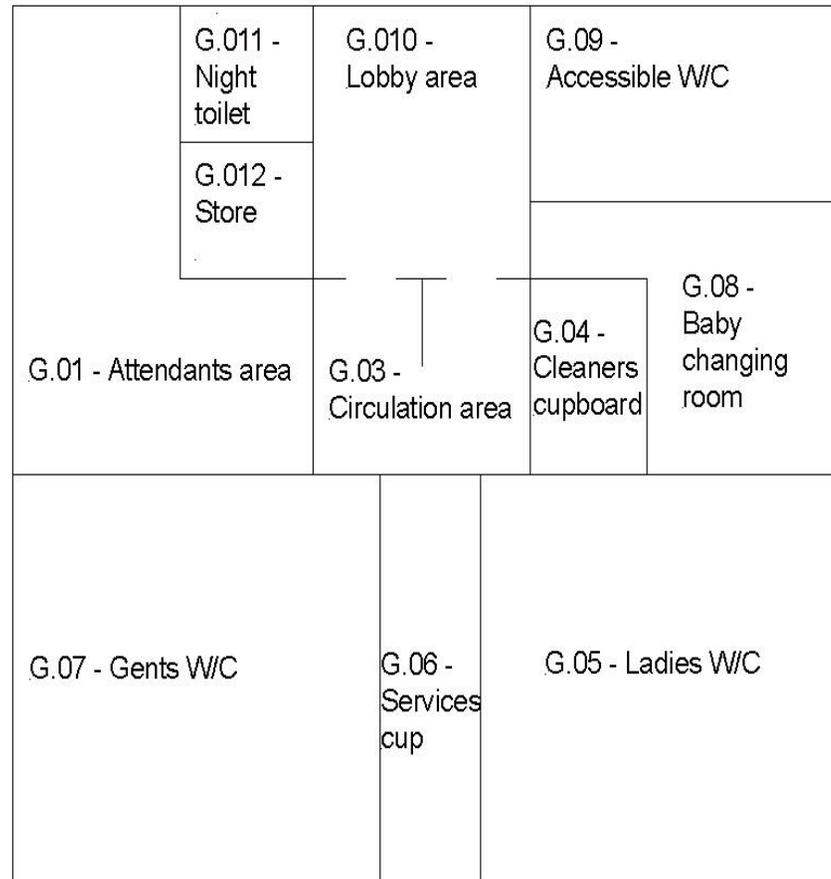
<b>Floorplan No: 2</b>	<b>Floor: Ground Floor</b>	<b>Building: St Mary's Way</b>	<b>Description: N/A</b>
		Asbestos containing materials	
Inaccessible location/s

No asbestos materials identified during survey
