**CBC Asbestos Refurbishment Survey Report
Neville House, George Street, Corby
22nd – 24th March 2016**

Reference:					
Issue			Prepared by	Verified by	
V1	Apr 16	JQ

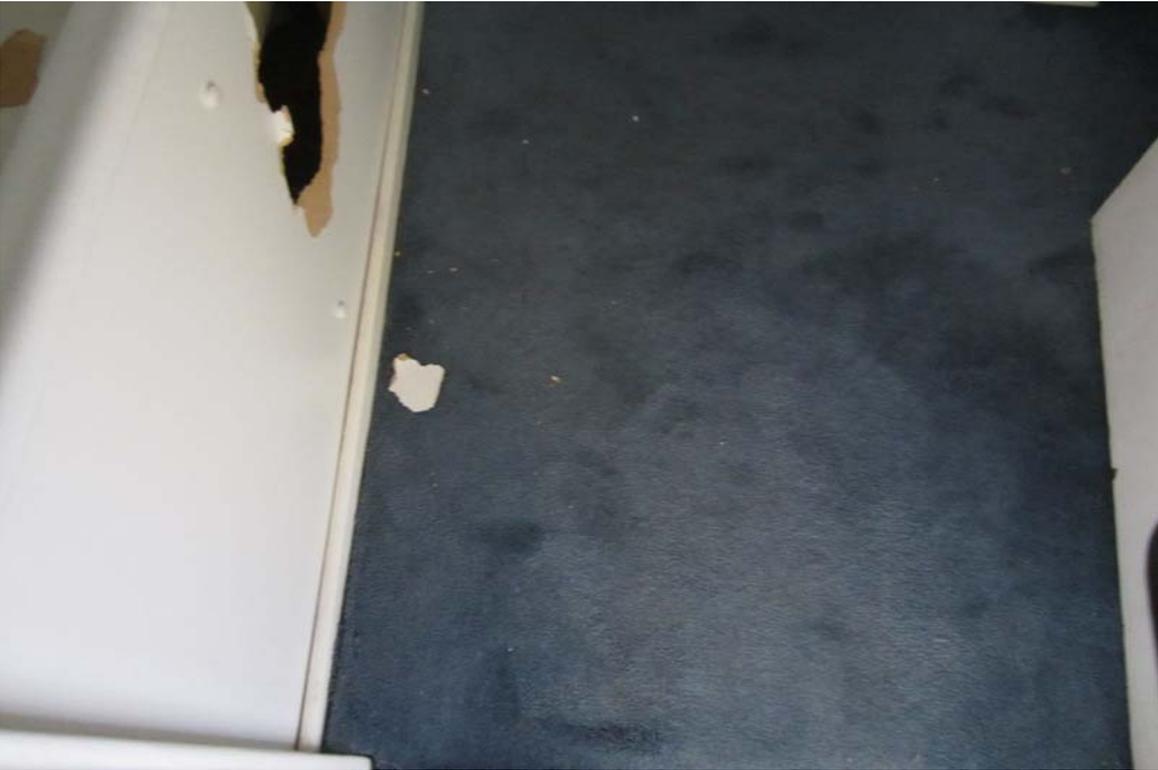
Photo Number	107	Reference number	230316MW115
Inspection / Sample	Inspection	Inspection Cross Reference / Visual I.D.	230316MW81

Notes	ACM: Asbestos Containing Material

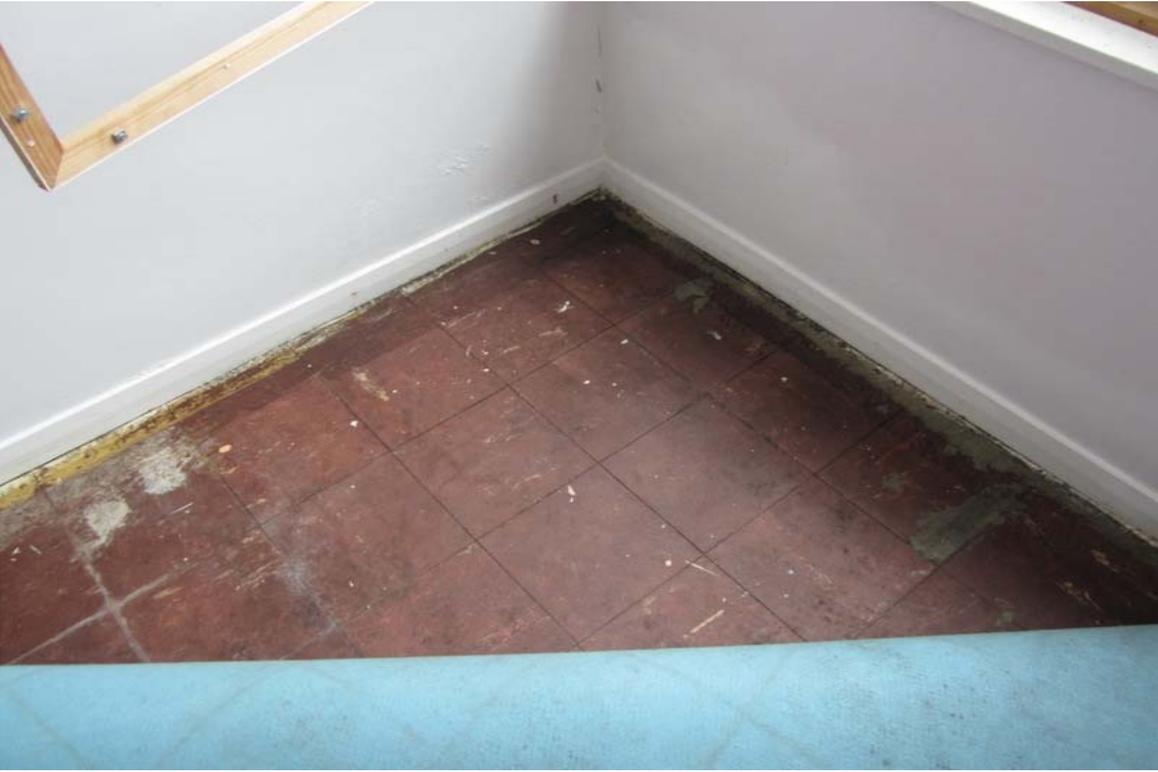
Photo Number	108	Reference number	230316MW116
Inspection / Sample	Inspection	Inspection Cross Reference / Visual I.D.	230316MW70

Notes	ACM: Asbestos Containing Material

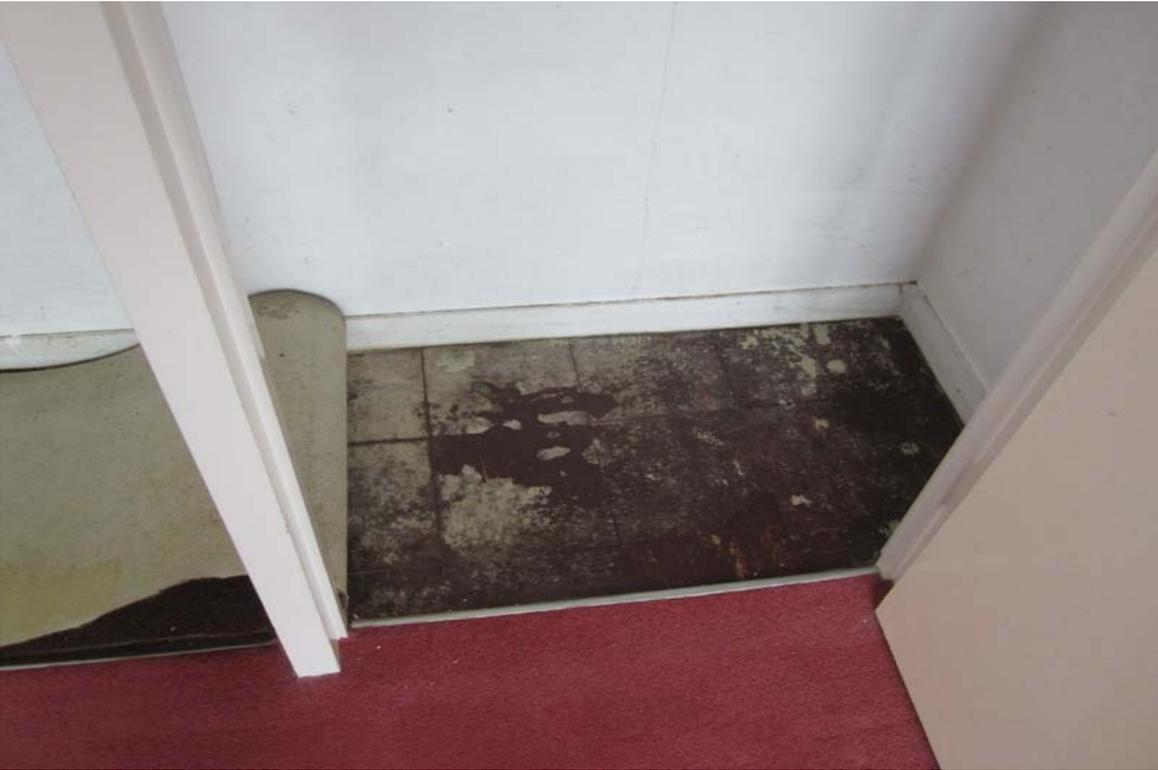
Photo Number	109	Reference number	230316MW117
Inspection / Sample	Inspection	Inspection Cross Reference / Visual I.D.	230316MW70

Notes	ACM: Asbestos Containing Material

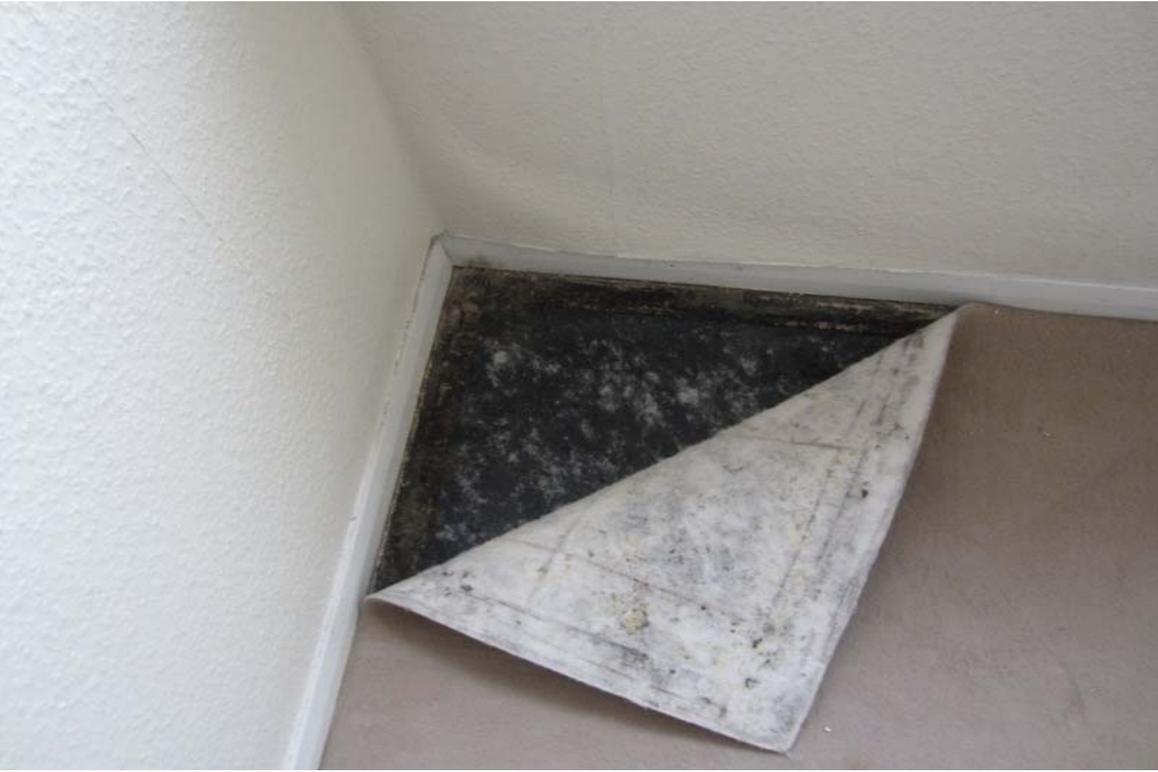
Photo Number	110	Reference number	230316MW118
Inspection / Sample	Inspection	Inspection Cross Reference / Visual I.D.	230316MW72

Notes	ACM: Asbestos Containing Material

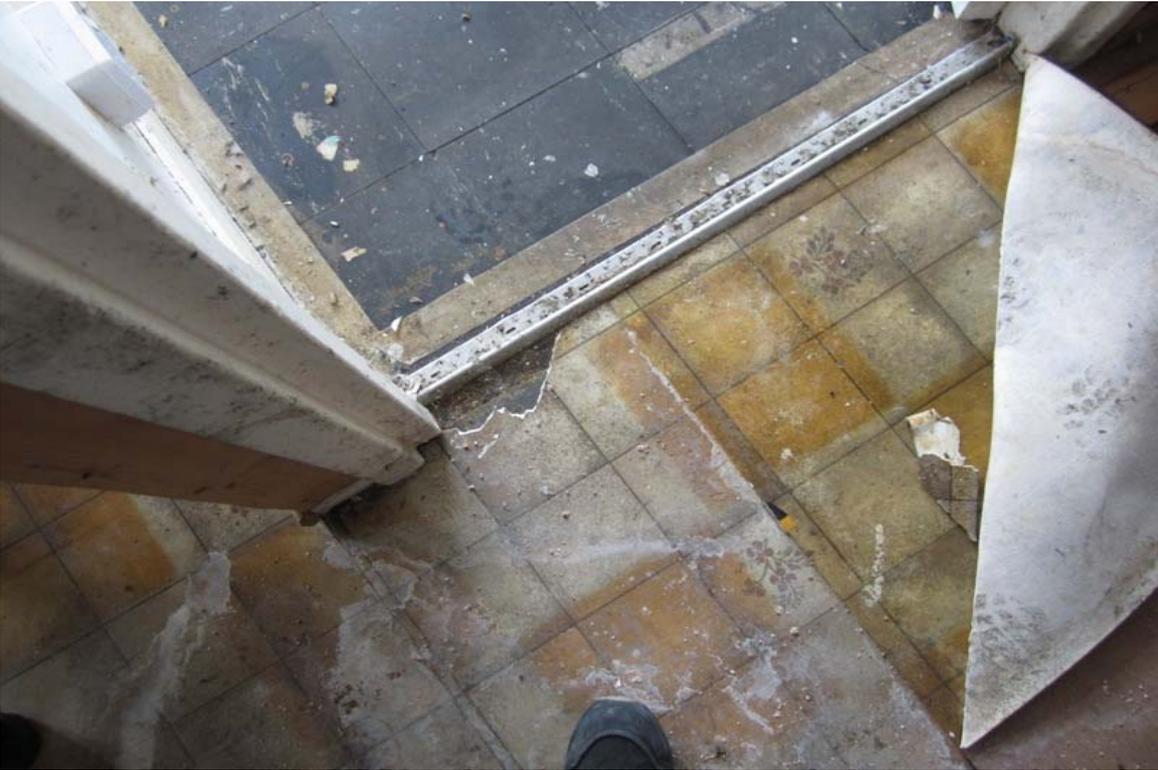
Photo Number	113	Reference number	230316MW121
Inspection / Sample	Inspection	Inspection Cross Reference / Visual I.D.	230316MW72

Notes	ACM: Asbestos Containing Material

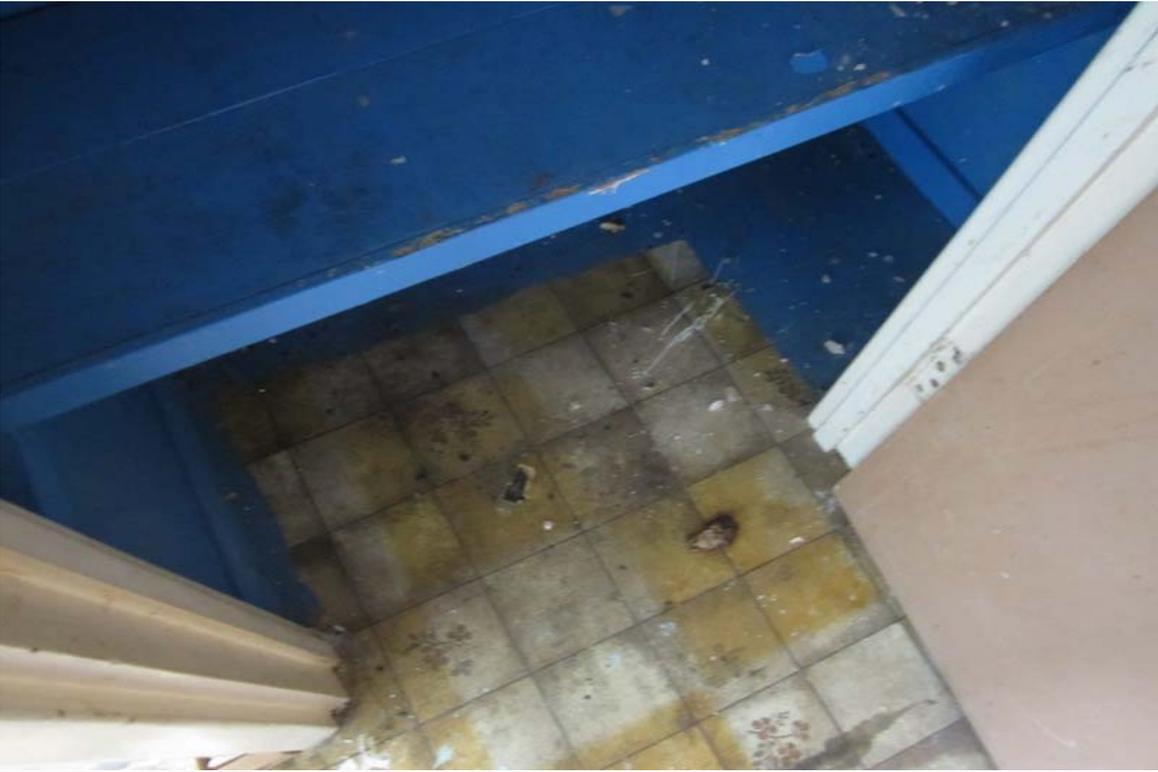
Photo Number	115	Reference number	230316MW123
Inspection / Sample	Inspection	Inspection Cross Reference / Visual I.D.	230316MW72

Notes	ACM: Asbestos Containing Material

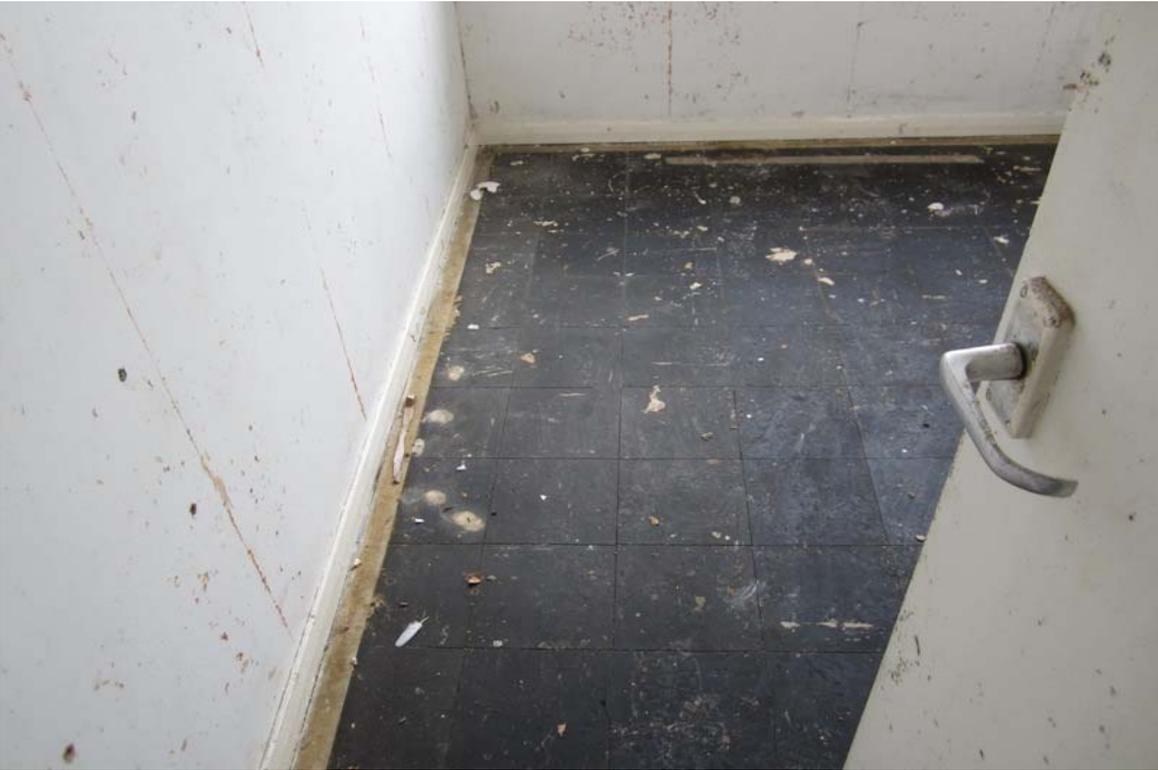
Photo Number	116	Reference number	230316MW124
Inspection / Sample	Inspection	Inspection Cross Reference / Visual I.D.	230316MW72

Notes	ACM: Asbestos Containing Material

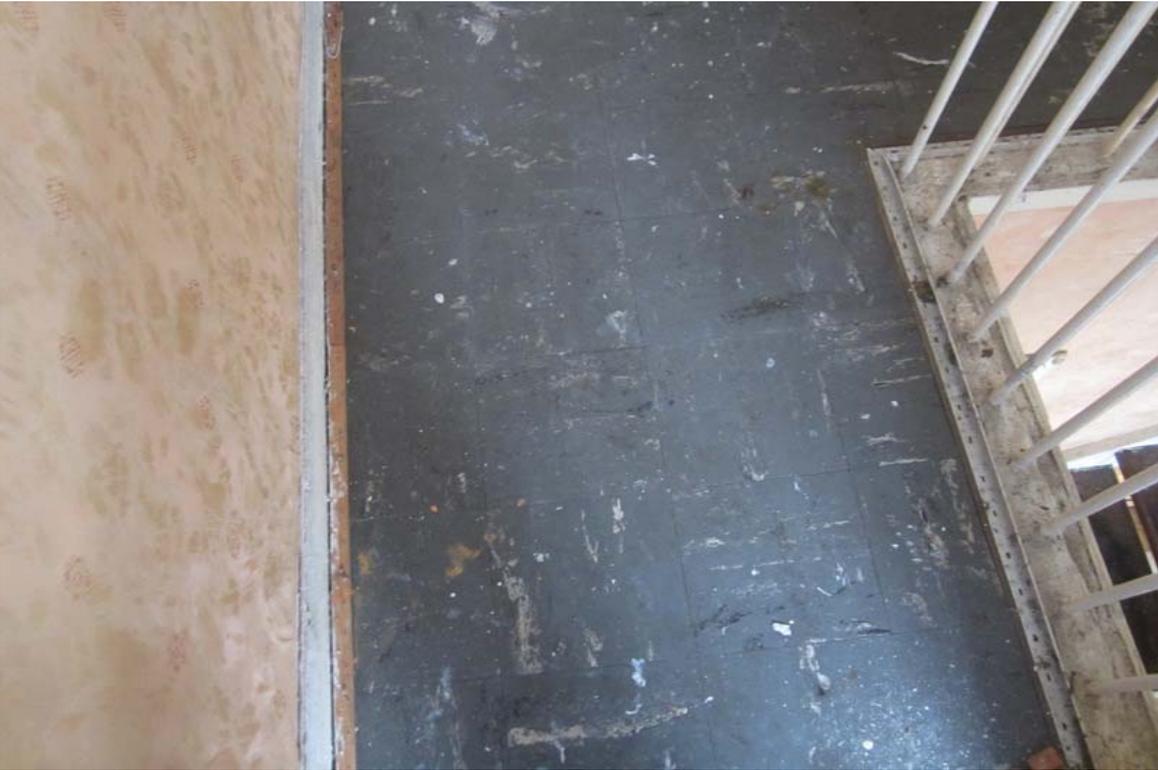
Photo Number	117	Reference number	230316MW125
Inspection / Sample	Inspection	Inspection Cross Reference / Visual I.D.	230316MW72

Notes	ACM: Asbestos Containing Material

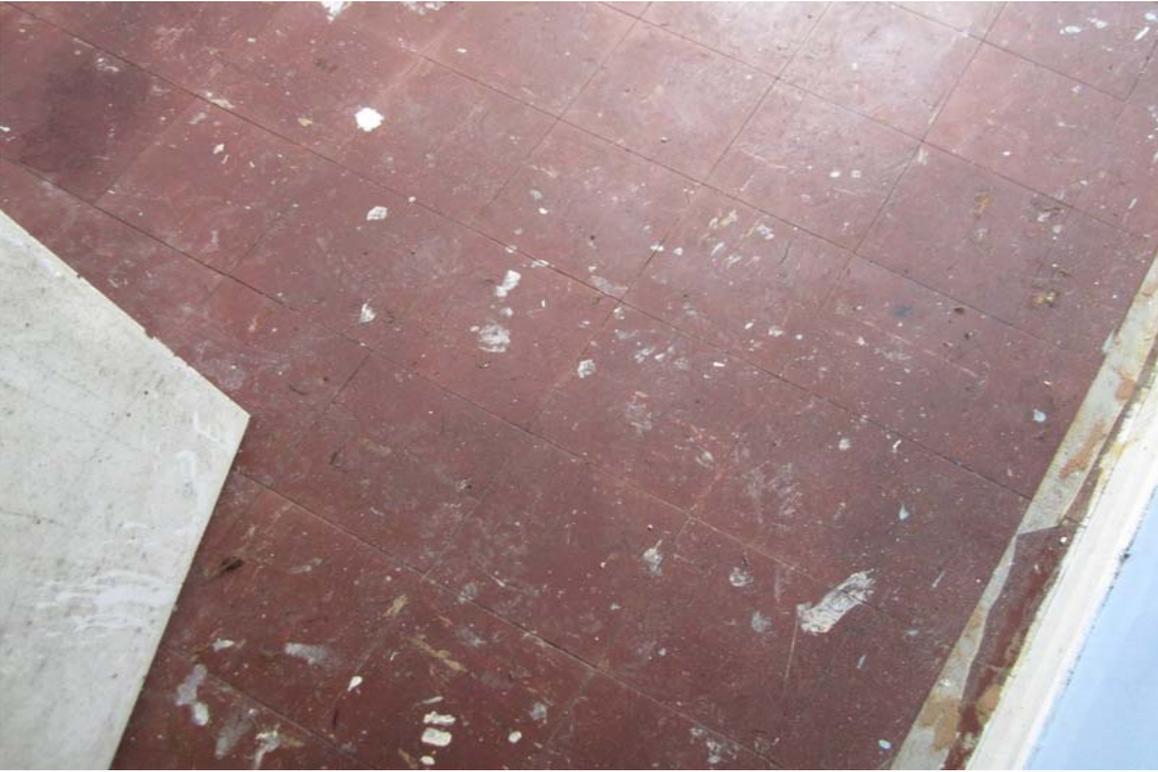
Photo Number	118	Reference number	230316MW126
Inspection / Sample	Inspection	Inspection Cross Reference / Visual I.D.	230316MW70

Notes	ACM: Asbestos Containing Material

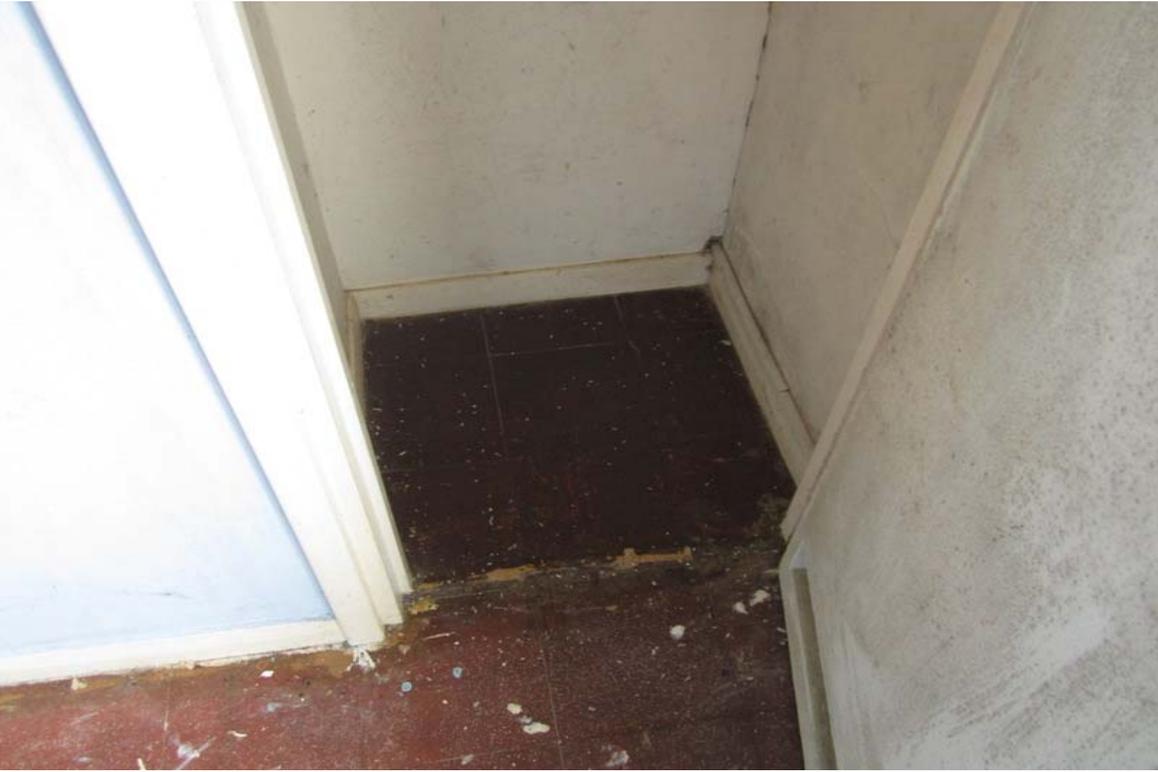
Photo Number	119	Reference number	230316MW127
Inspection / Sample	Inspection	Inspection Cross Reference / Visual I.D.	230316MW70

Notes	ACM: Asbestos Containing Material

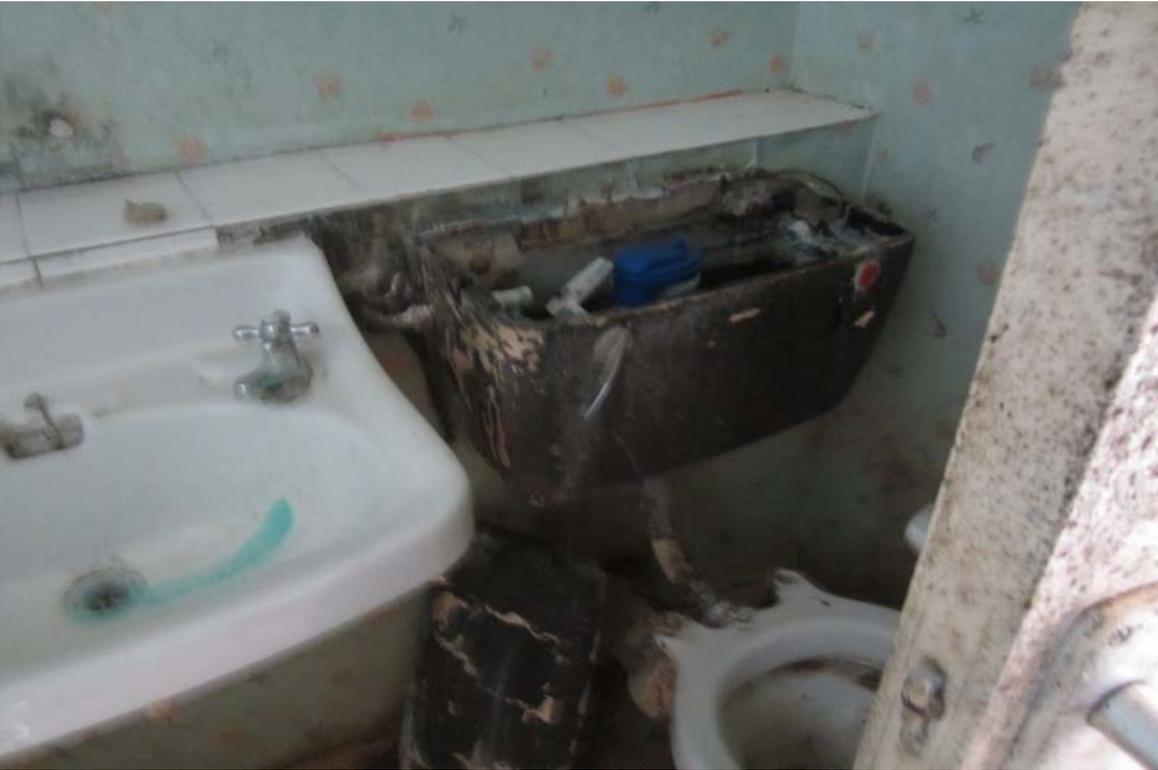
Photo Number	121	Reference number	230316MW129
Inspection / Sample	Inspection	Inspection Cross Reference / Visual I.D.	220316MW20

Notes	ACM: Asbestos Containing Material

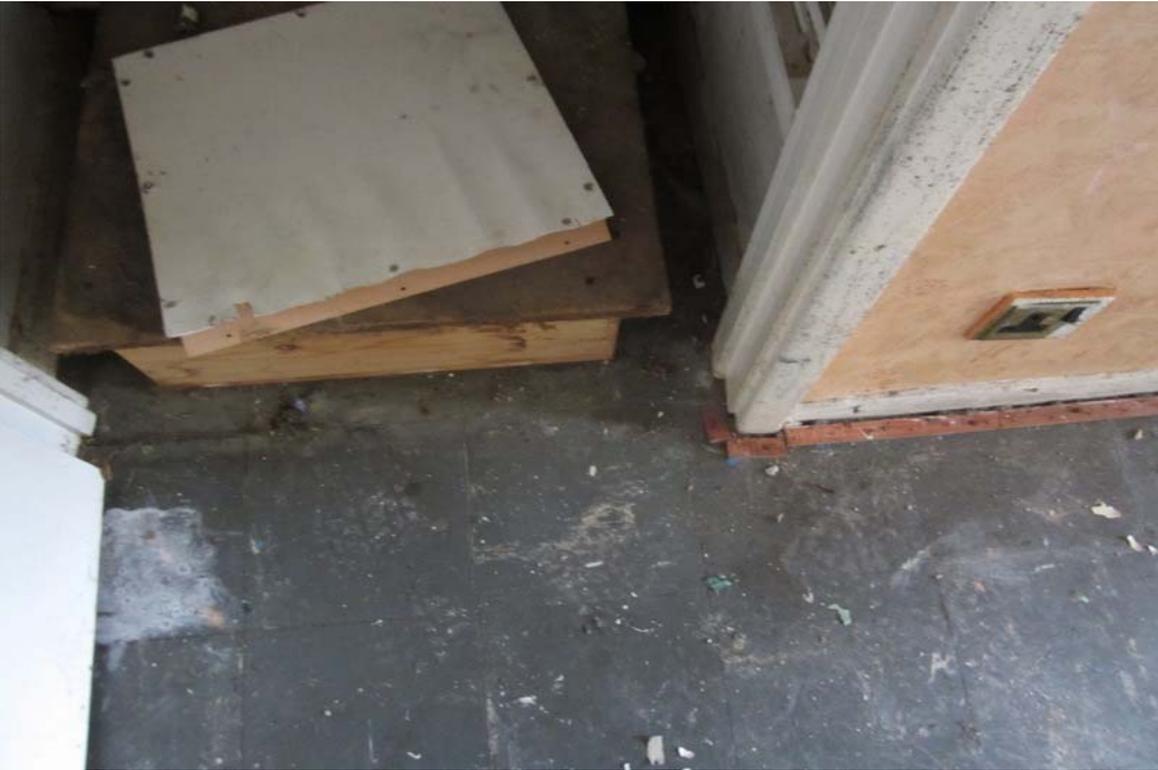
Photo Number	123	Reference number	230316MW131
Inspection / Sample	Inspection	Inspection Cross Reference / Visual I.D.	230316MW72

Notes	ACM: Asbestos Containing Material

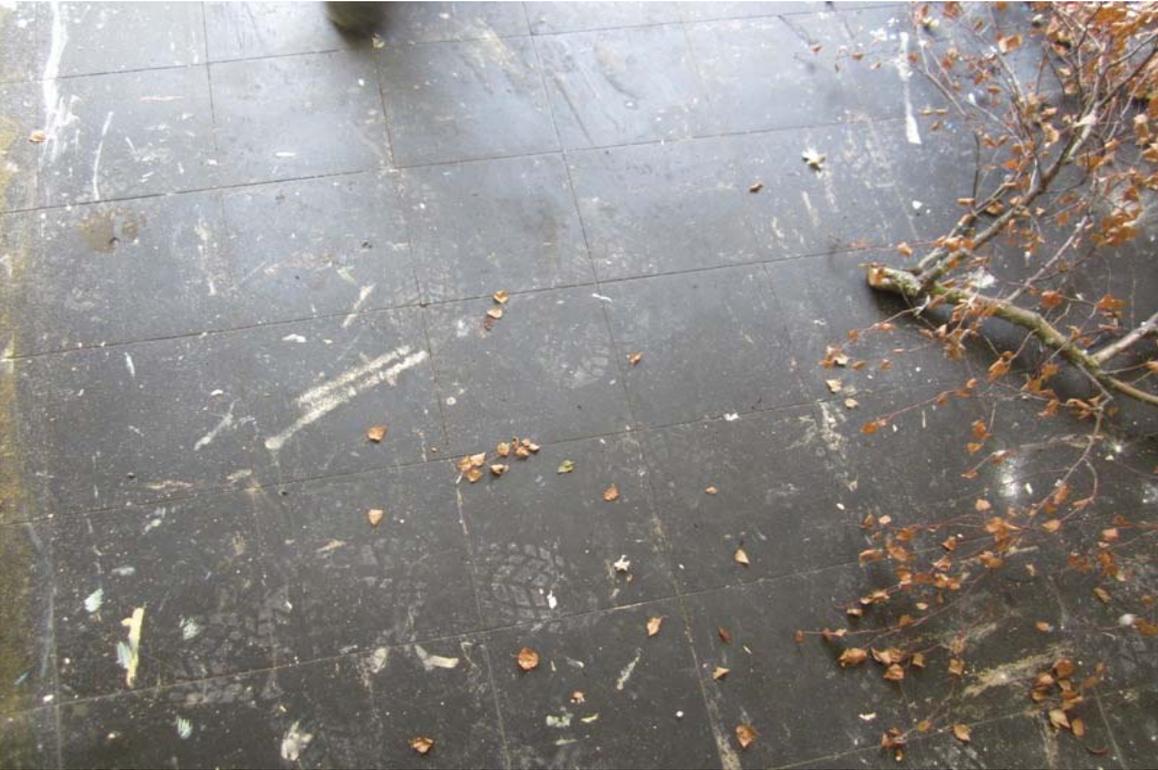
Photo Number	124	Reference number	230316MW132
Inspection / Sample	Inspection	Inspection Cross Reference / Visual I.D.	230316MW72

Notes	ACM: Asbestos Containing Material

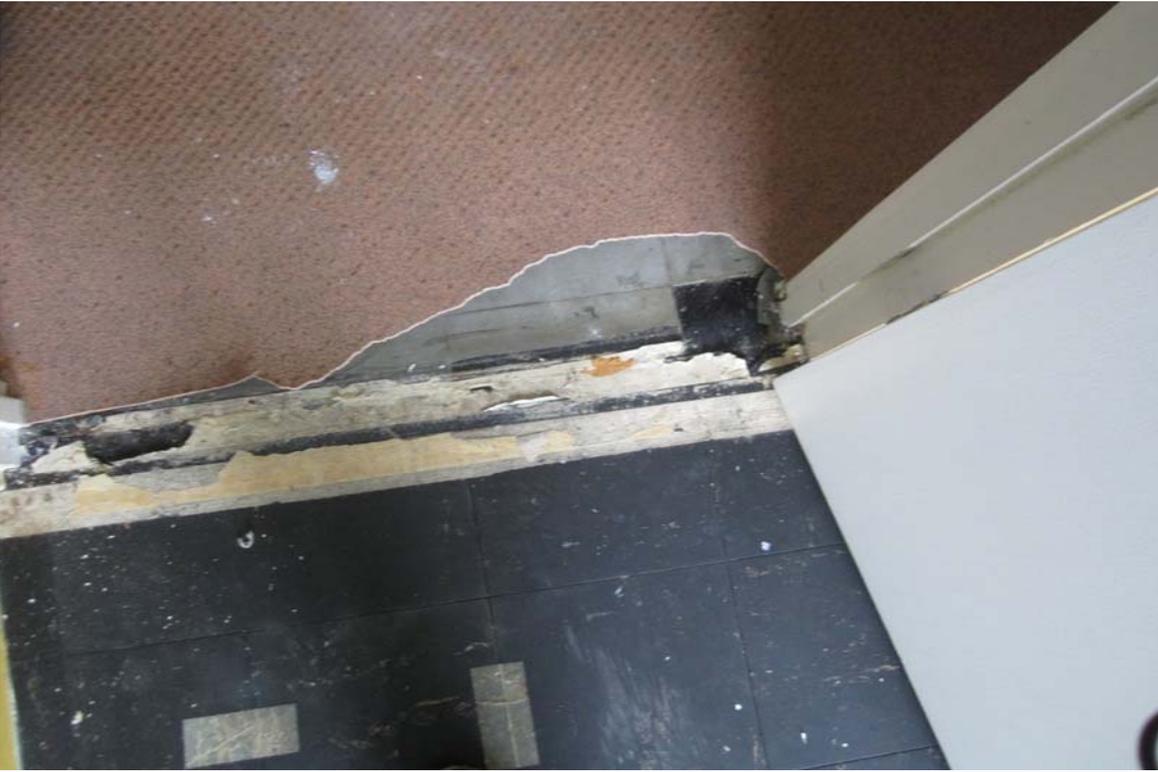
Photo Number	127	Reference number	230316MW135
Inspection / Sample	Inspection	Inspection Cross Reference / Visual I.D.	230316MW72

Notes	ACM: Asbestos Containing Material

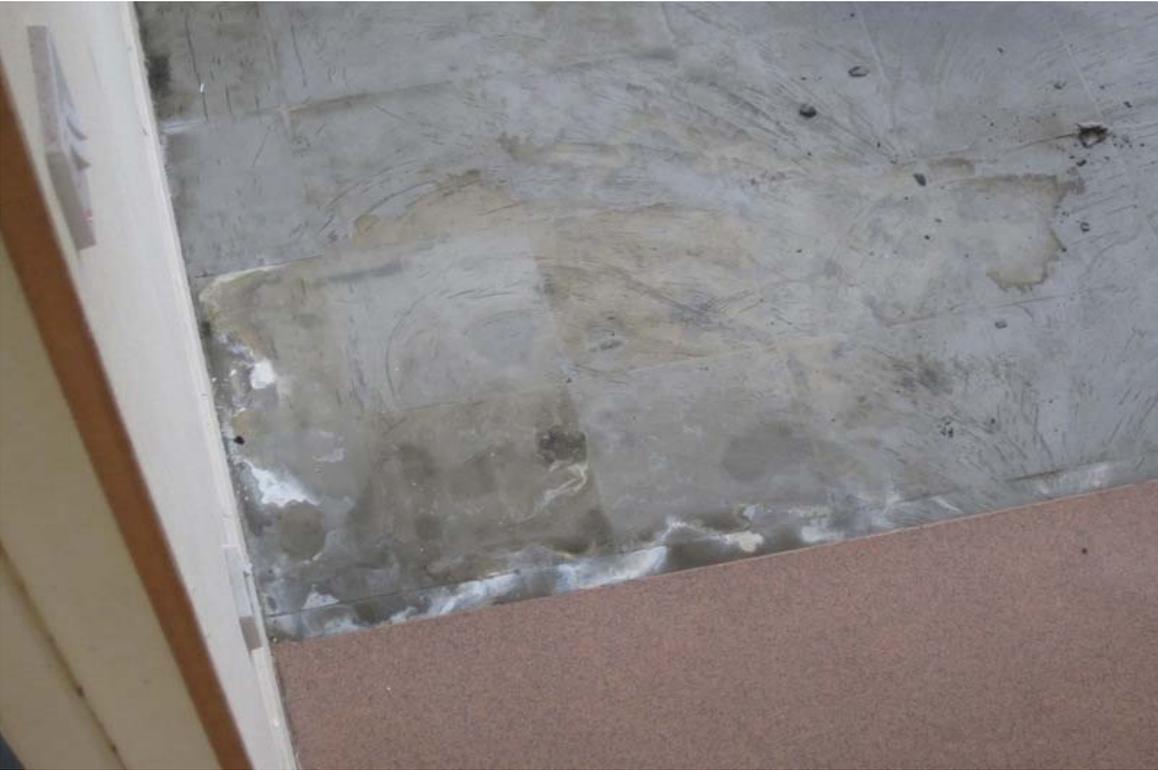
Photo Number	128	Reference number	230316MW136
Inspection / Sample	Inspection	Inspection Cross Reference / Visual I.D.	230316MW72

Notes	ACM: Asbestos Containing Material

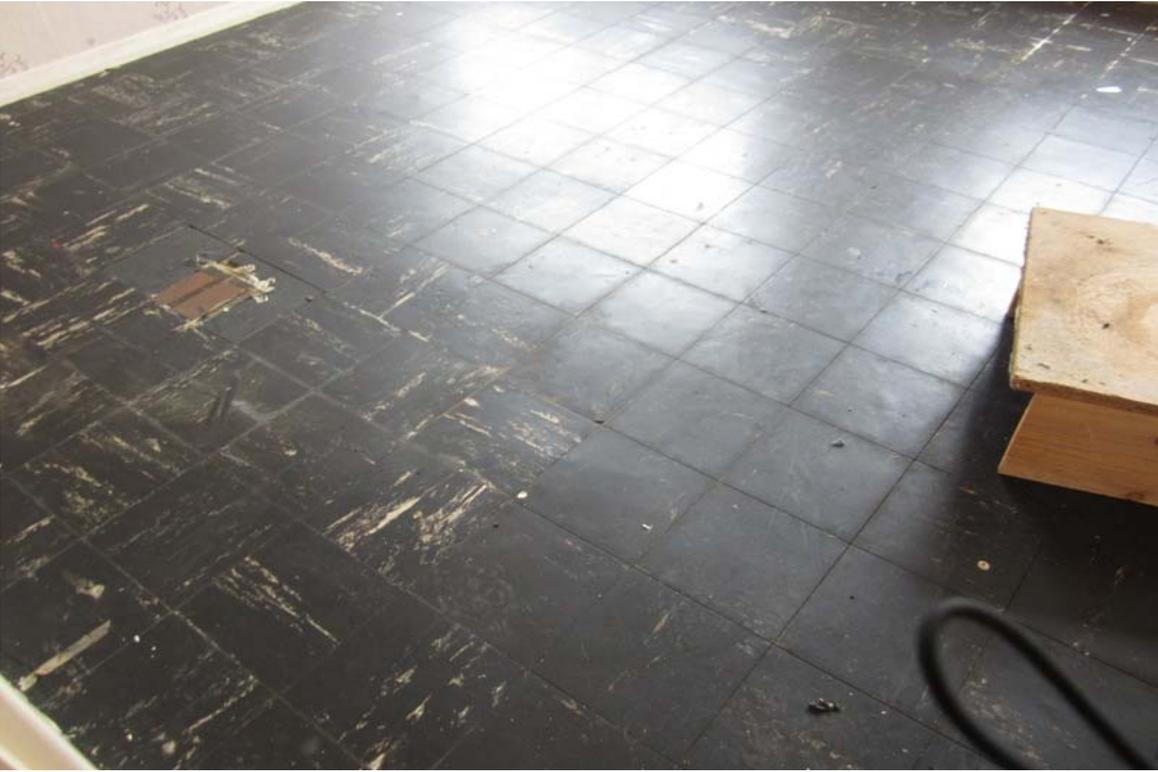
Photo Number	129	Reference number	230316MW140
Inspection / Sample	Inspection	Inspection Cross Reference / Visual I.D.	230316MW72

Notes	ACM: Asbestos Containing Material

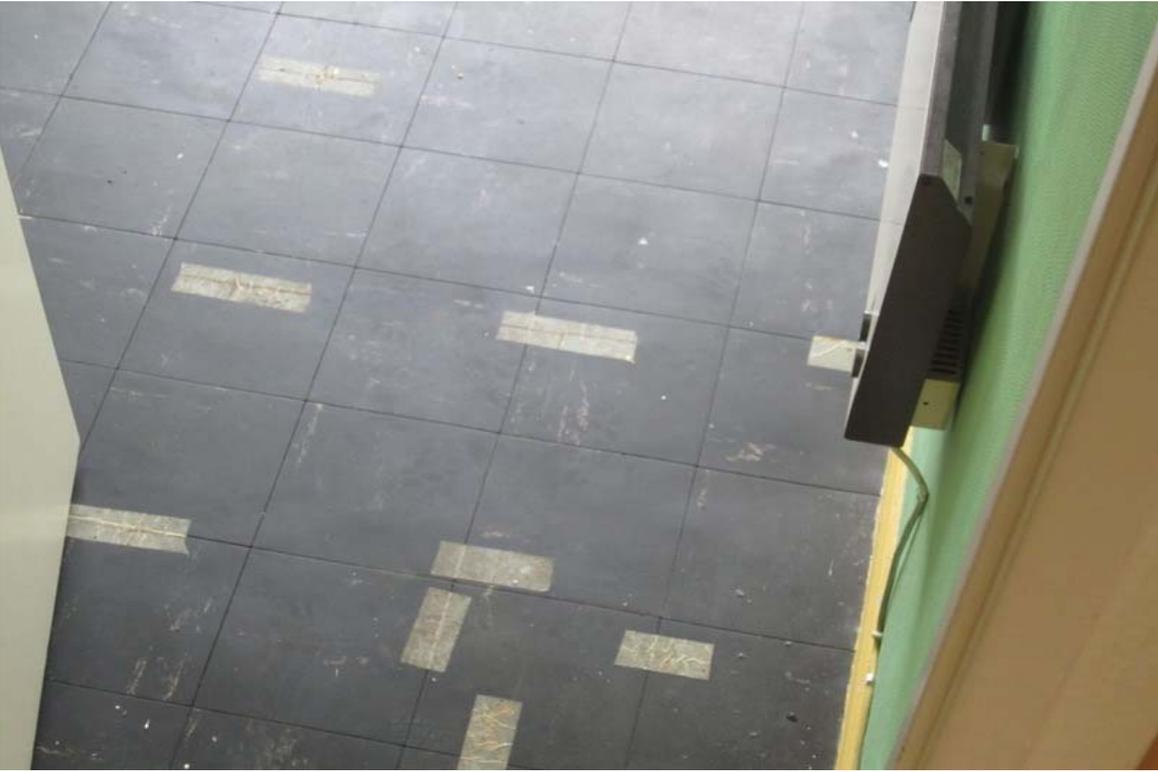
Photo Number	130	Reference number	230316MW137
Inspection / Sample	Inspection	Inspection Cross Reference / Visual I.D.	230316MW72

Notes	ACM: Asbestos Containing Material

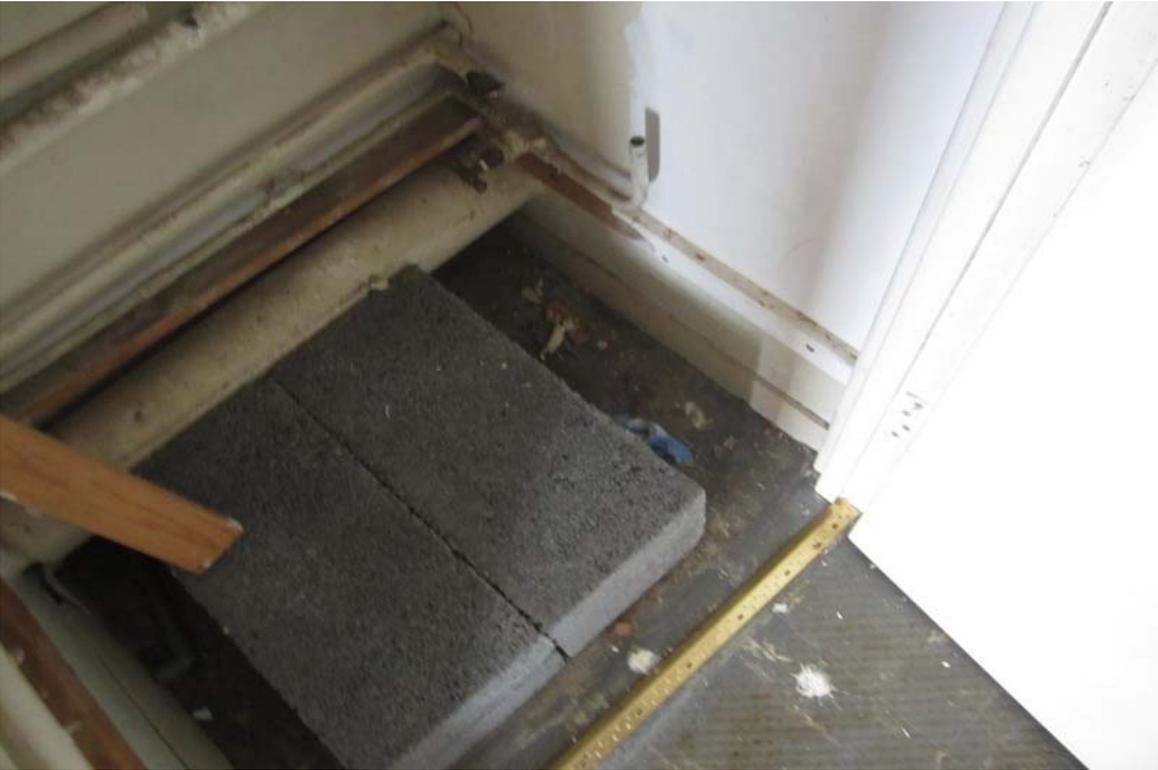
Photo Number	132	Reference number	230316MW139
Inspection / Sample	Inspection	Inspection Cross Reference / Visual I.D.	230316MW72

Notes	ACM: Asbestos Containing Material

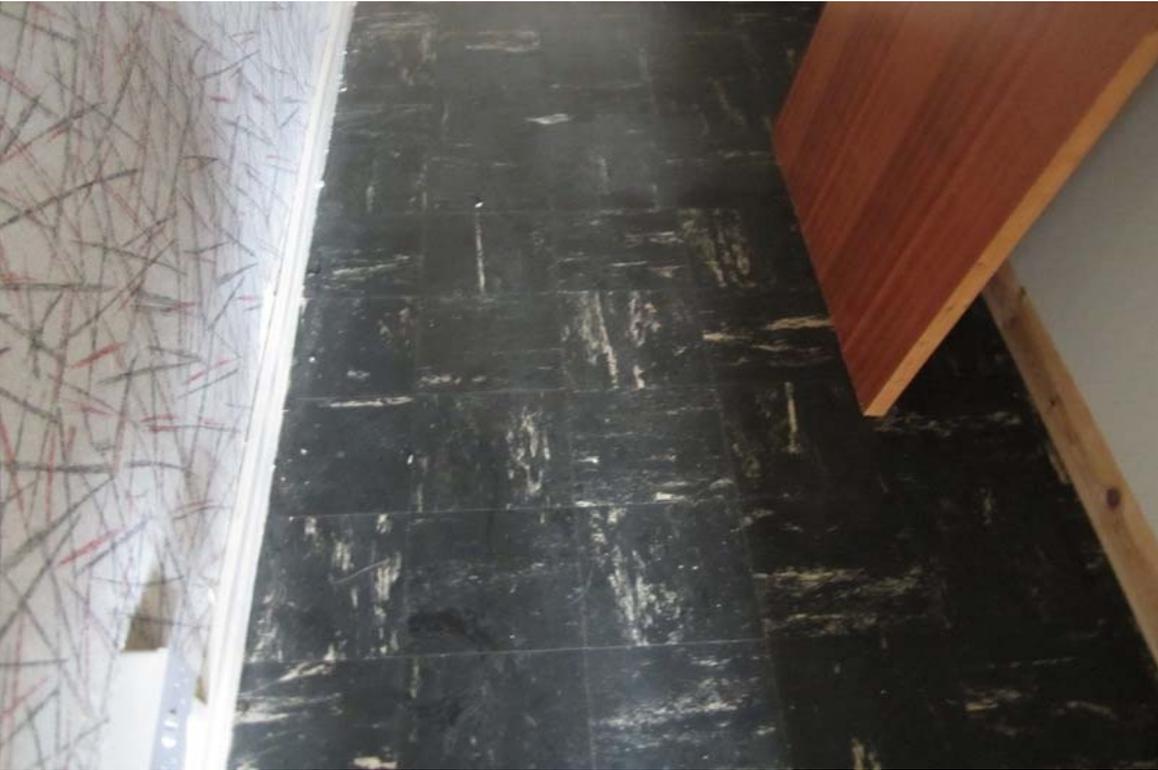
Photo Number	134	Reference number	230316MW142
Inspection / Sample	Inspection	Inspection Cross Reference / Visual I.D.	230316MW72

Notes	ACM: Asbestos Containing Material

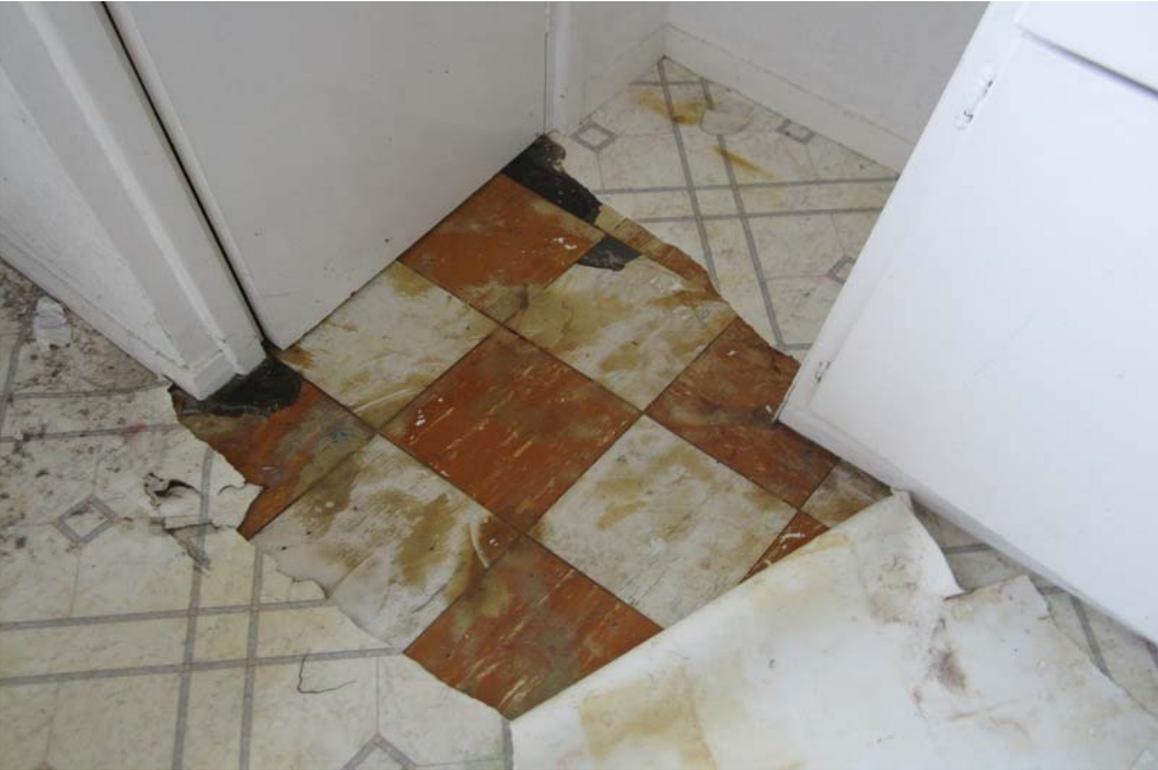
Photo Number	136	Reference number	230316MW144
Inspection / Sample	Inspection	Inspection Cross Reference / Visual I.D.	230316MW72

Notes	ACM: Asbestos Containing Material

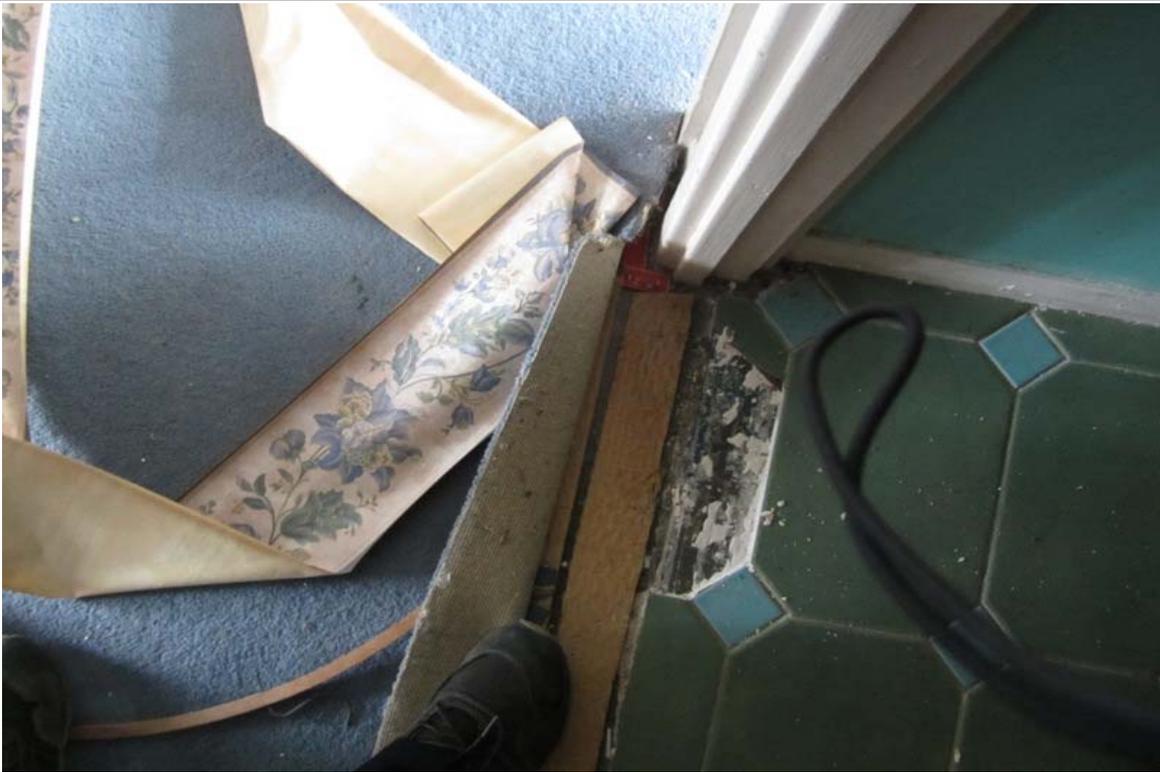
Photo Number	138	Reference number	230316MW146
Inspection / Sample	Inspection	Inspection Cross Reference / Visual I.D.	230316MW72

Notes	ACM: Asbestos Containing Material

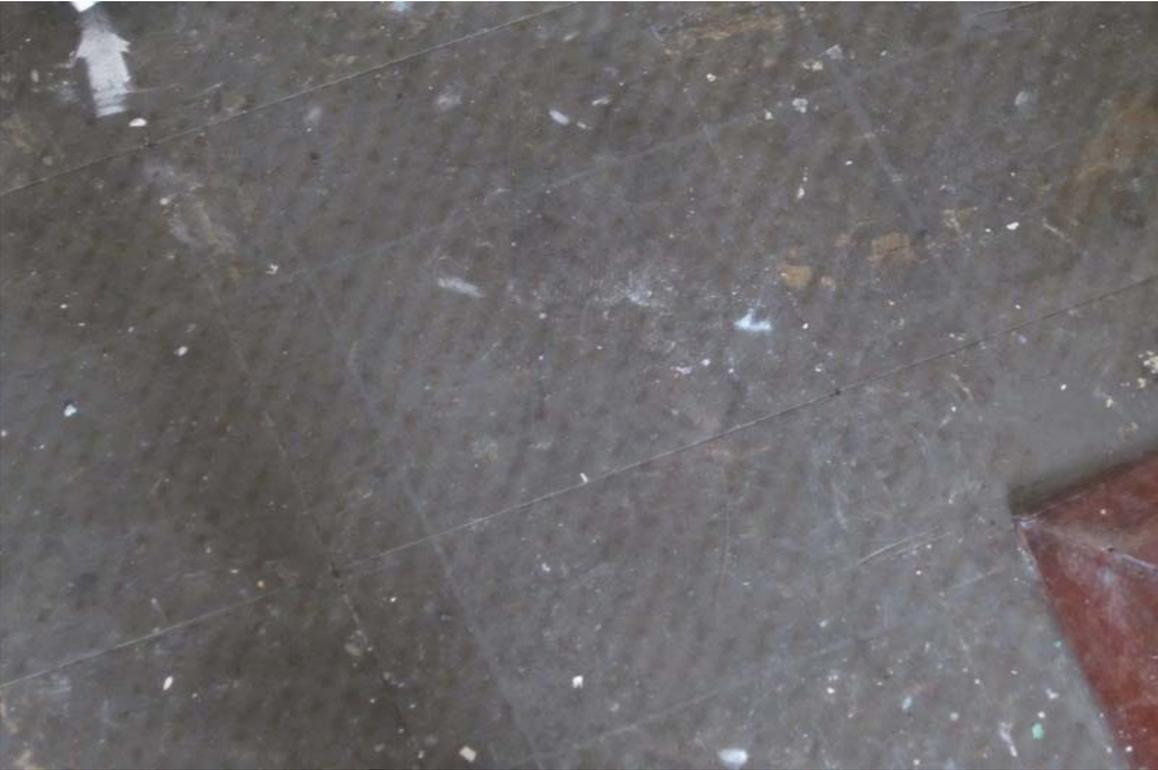
Photo Number	139	Reference number	230316MW147
Inspection / Sample	Inspection	Inspection Cross Reference / Visual I.D.	230316MW72

Notes	ACM: Asbestos Containing Material

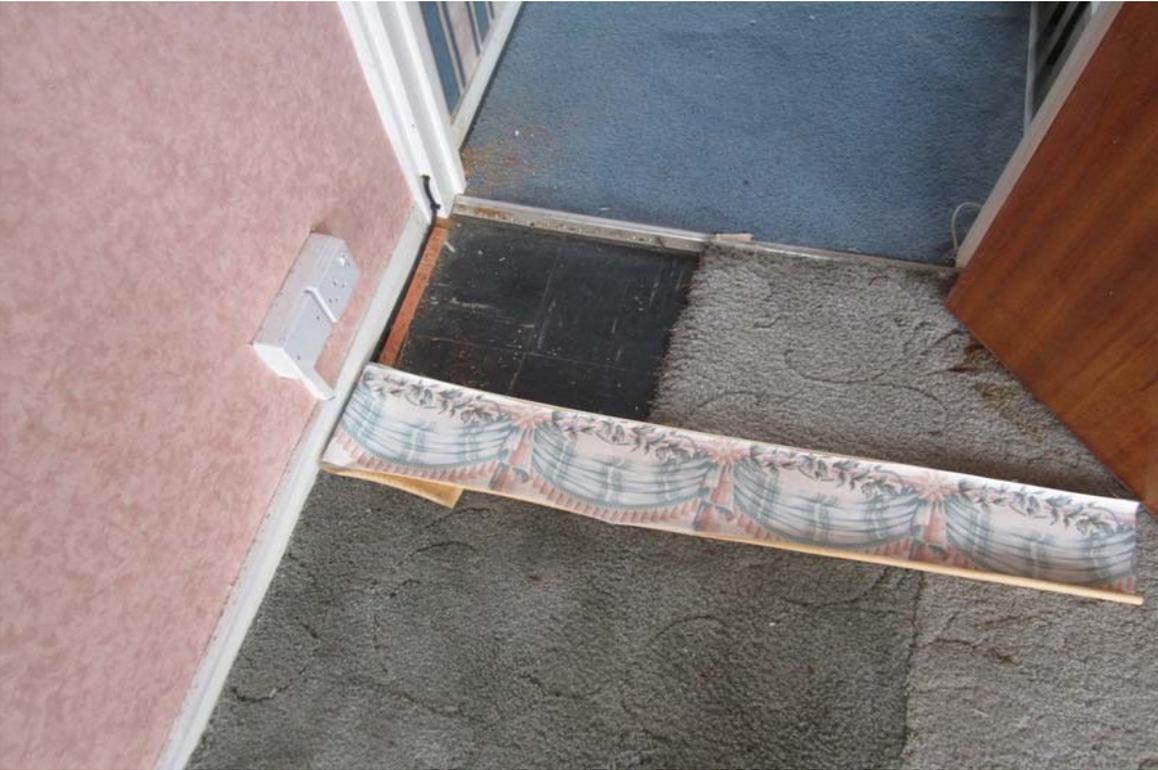
Photo Number	141	Reference number	230316MW149
Inspection / Sample	Inspection	Inspection Cross Reference / Visual I.D.	230316MW72

Notes	ACM: Asbestos Containing Material

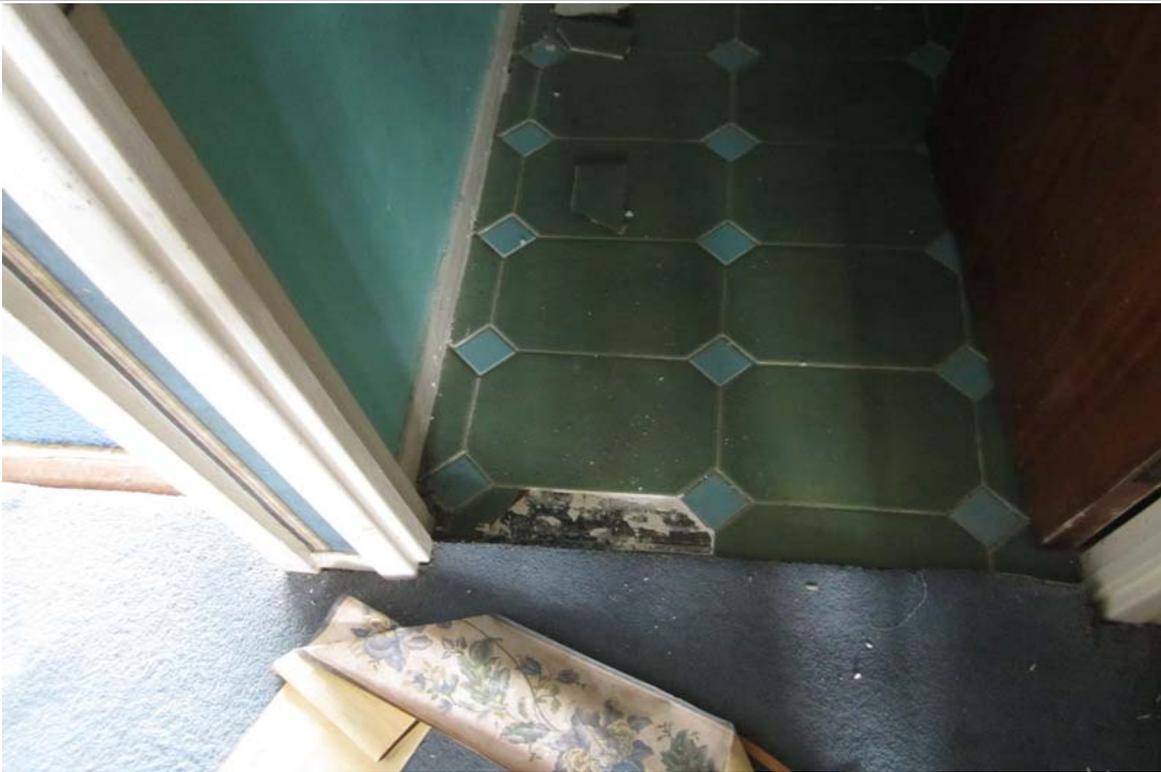
Photo Number	145	Reference number	230316MW153
Inspection / Sample	Inspection	Inspection Cross Reference / Visual I.D.	230316MW81

Notes	ACM: Asbestos Containing Material
